**Happy Drains Ltd**

| Project Name | 52 Station Road West Drayton UB7 7BT |
| Project Description | General CCTV + HP Jetting |
| Inspection Standard | MSCC4 Sewers & Drainage (GB) (SRM4 Scoring) |

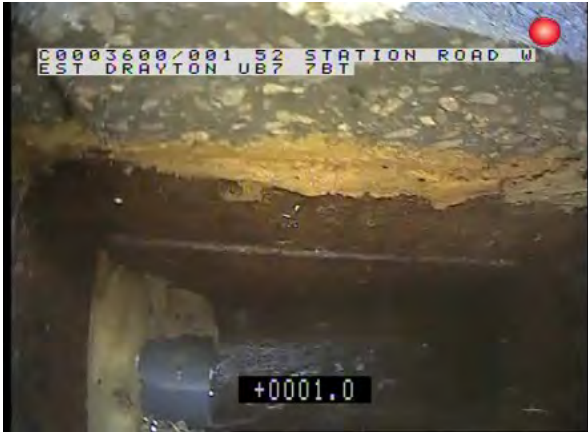
RWG1\_69213870-0e87-463f-b282-60f6e9c5ee1f\_20170824\_125825\_786.jpg, 00:00:00, -0.01m  
General photograph taken at this point / Overview

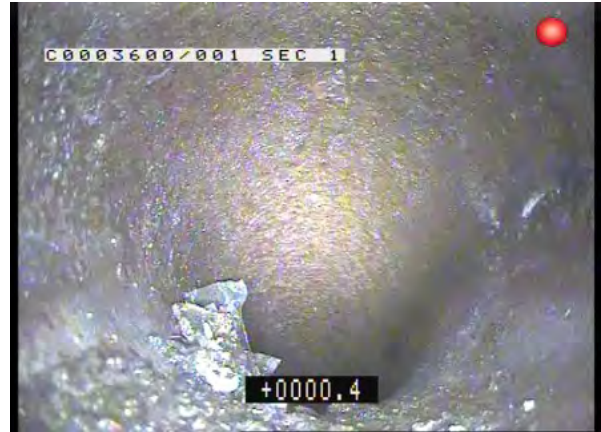
RWG1\_f7727c03-b052-402c-98d4-87d5b4573e5b\_20170824\_125937\_540.jpg, 00:00:29, 0.50m  
Survey abandoned / Unable To Traverse Camera Down

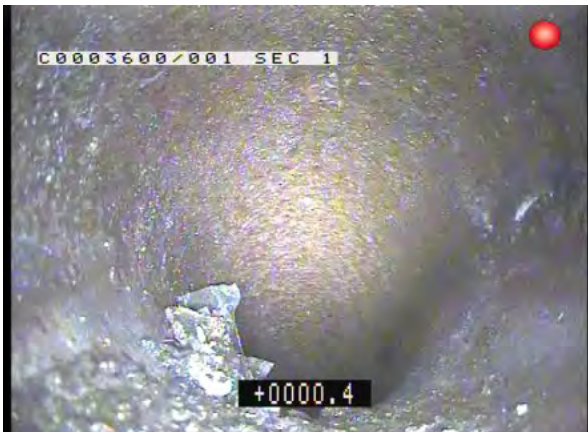
RWG1\_b5b79b33-aecc-47b1-adaf-fec0bbae398e\_20170824\_125903\_053.jpg, 00:00:29, 0.40m  
Line deviates down

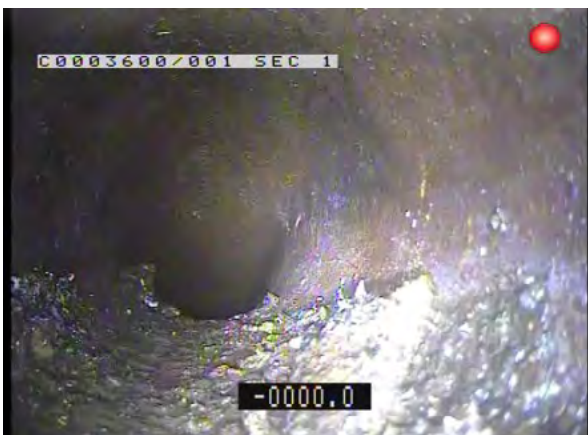
RWG1\_64405c57-93fc-43ec-a8fd-9fc42fc2e512\_20170824\_125836\_236.jpg, , 0.00m  
Start node type, gully, reference number: RWG1

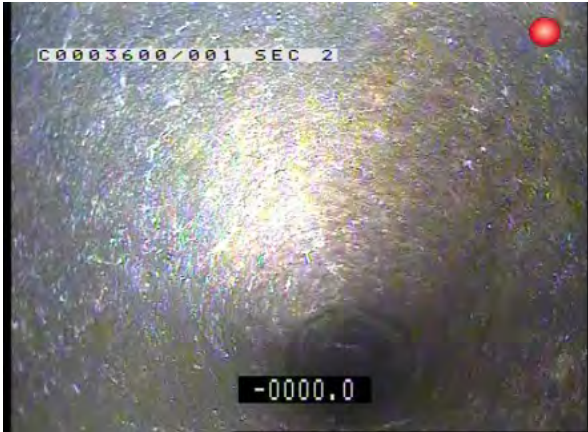
RWG2X\_1baada2c-5331-42c1-bf49-12e2365e9bdc\_20170824\_130246\_644.jpg, 00:00:00, 0.00m  
Start node type, gully, reference number: RWG2

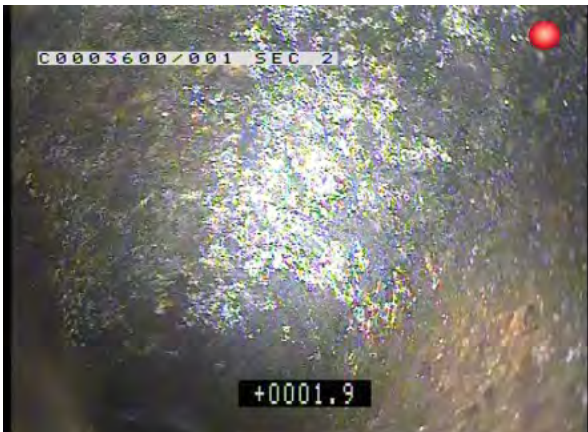
RWG2X\_e89098c4-1efe-4dc8-80f4-da86b229d413\_20170824\_130330\_347.jpg, 00:00:42, 1.90m  
Line deviates down

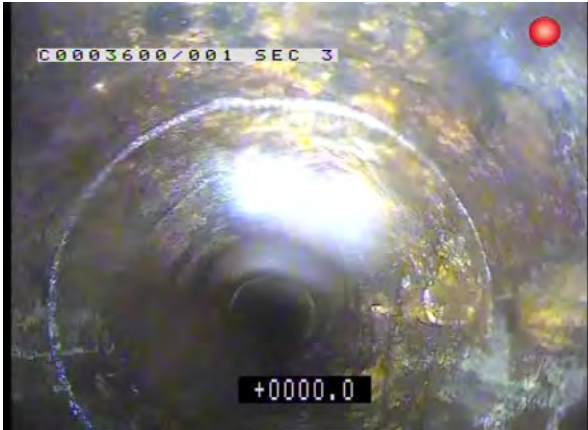
GULLYX\_22c54bfb-4af5-41ef-abdb-1e6d672bafde\_20170824\_130748\_949.jpg, 00:00:00, 0.00m  
Start node type, manhole, reference number: SW1

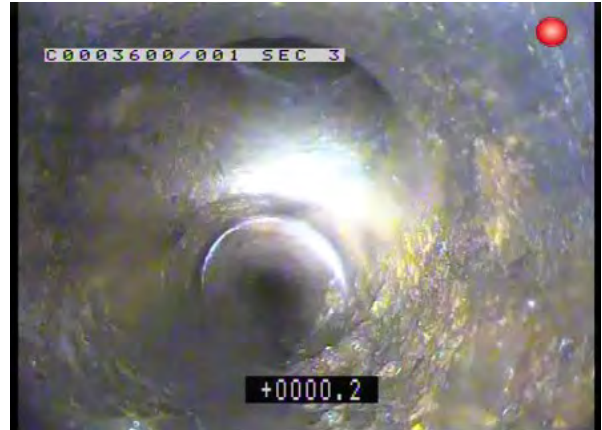
GULLYX\_8b33ade3-fc07-4751-89fa-16827cc054ba\_20170824\_130805\_937.jpg, 00:01:00, 0.20m  
Junction at 12 o'clock, diameter: 100mm

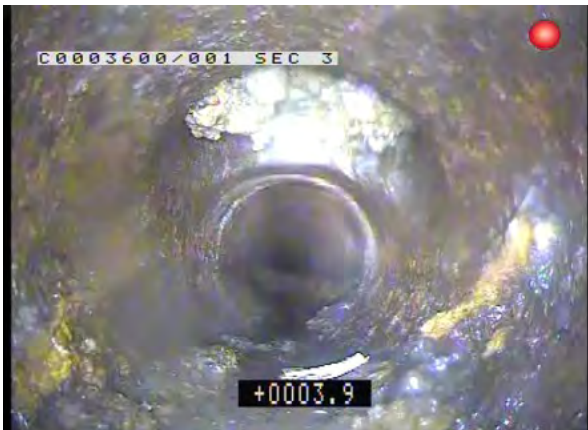
GULLYX\_bff1f71b-96d5-4cfb-8bc6-4c75d21ddf41\_20170824\_130842\_284.jpg, 00:01:17, 3.90m  
Junction at 12 o'clock, diameter: 100mm

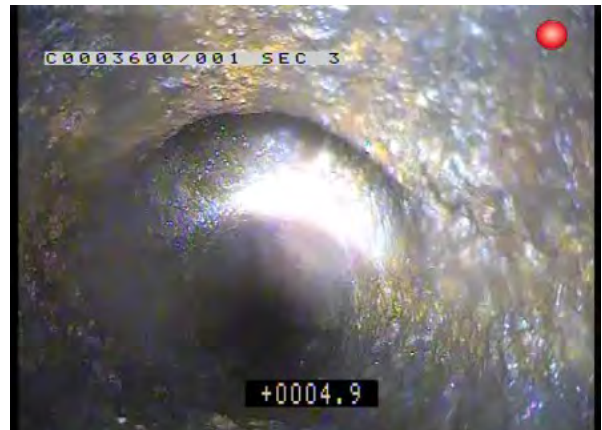
GULLYX\_e6cea38e-25f1-4658-9ebd-6f6ab1a0be2d\_20170824\_130911\_648.jpg, 00:01:30, 4.90m  
Junction at 12 o'clock, diameter: 100mm

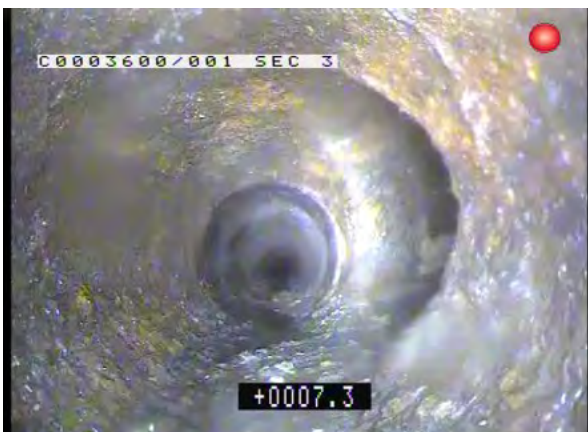
GULLYX\_2d001cc5-c8bf-4880-9be3-b9503964a490\_20170824\_130941\_471.jpg, 00:01:40, 7.30m  
Junction at 3 o'clock, diameter: 100mm

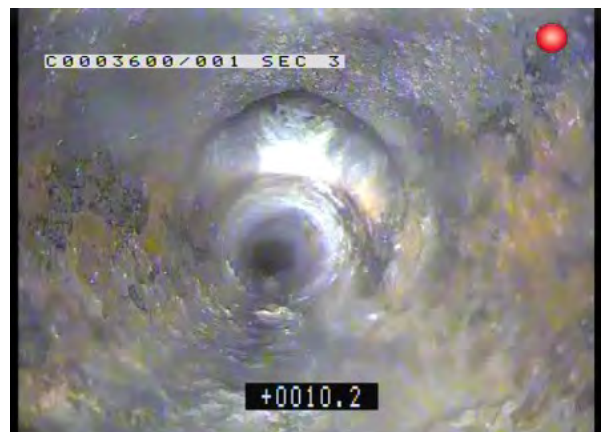
GULLYX\_1032c5f9-15bc-46af-bc6e-35cdb97d10b2\_20170824\_131026\_437.jpg, 00:02:00, 10.20m  
Junction at 12 o'clock, diameter: 100mm

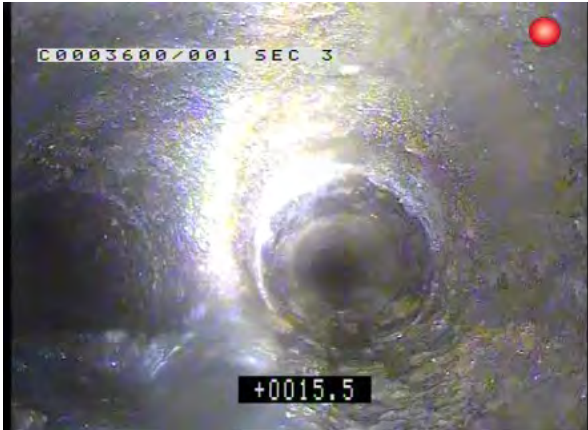
GULLYX\_cfbfb68-e0be-425c-a01d-3d8438f830c9\_20170824\_131121\_822.jpg, 00:02:34, 15.50m  
Junction at 9 o'clock, diameter: 100mm

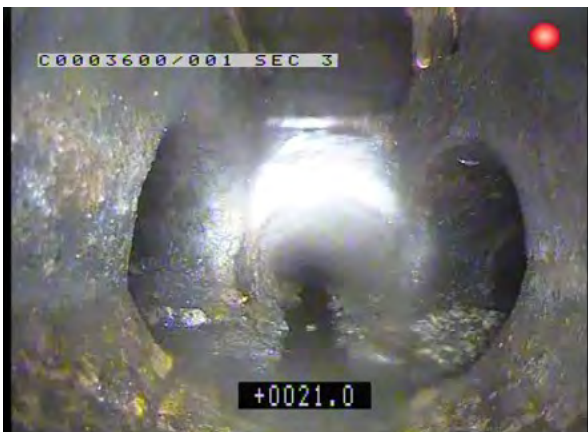
GULLYX\_0033bda3-d509-497c-bbc3-1dc352e9ddb4\_20170824\_131253\_547.jpg, 00:03:11, 21.00m  
Finish node type, manhole, reference number: GULLY

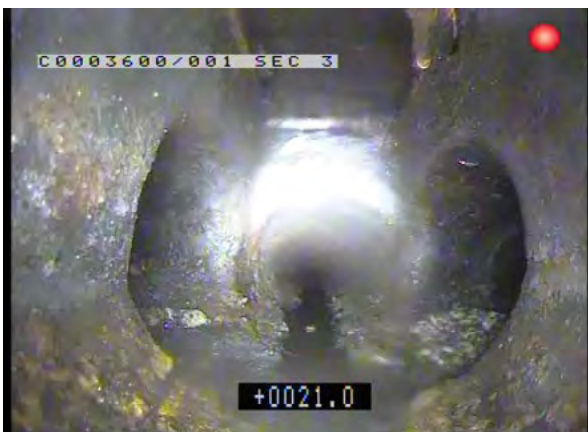
GULLYX\_2dd90ab7-53dd-4902-8b93-1cdd8c3dc74b\_20170824\_131228\_540.jpg, 00:03:09, 21.00m  
Junction at 3 o'clock, diameter: 100mm

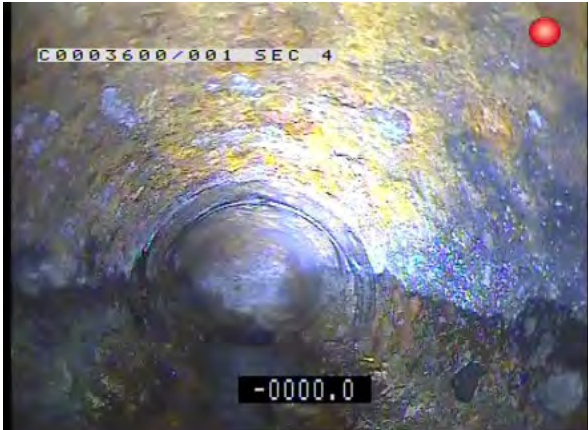
RWPX\_d59d8097-ca9d-4a8f-a9d1-12efe58f5bc6\_20170824\_131513\_067.jpg, 00:00:00, 0.00m  
Start node type, manhole, reference number: SW1

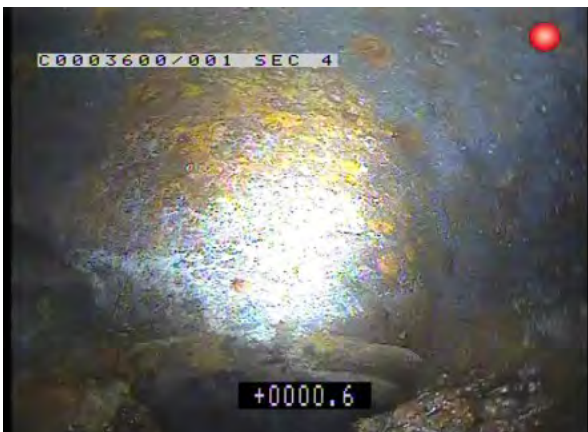
RWPX\_27eb1a31-3c5f-4d5f-b5ac-b1955a5e28a2\_20170824\_131533\_694.jpg, 00:03:57, 0.60m  
Finish node type, gully, reference number: RWP

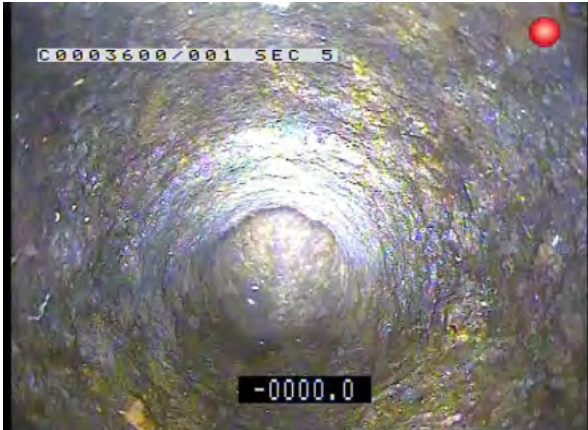
RWGX\_35fcc129-c86f-4c07-9370-31b634003727\_20170824\_1  
31729\_547.jpg, 00:00:00, 0.00m  
Start node type, manhole, reference number: SW1

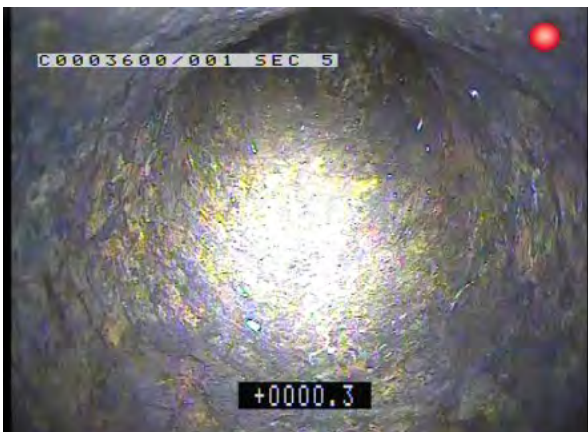
RWGX\_f39017c3-8a31-43f6-8028-c3a3f333a637\_20170824\_1  
31826\_322.jpg, 00:04:16, 0.30m  
Finish node type, gully, reference number: RWG

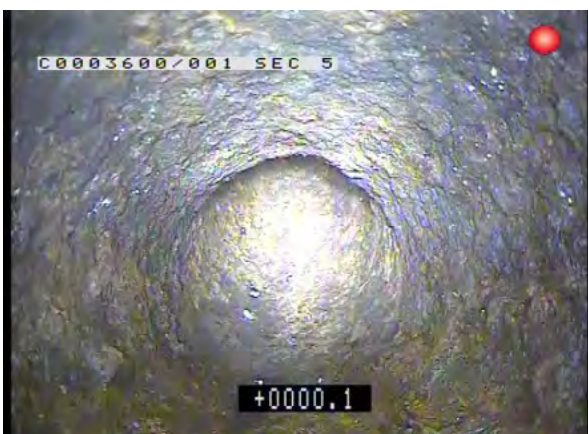
RWGX\_0d509d9f-5890-4bb1-998b-04930288a1a0\_20170824\_1  
131758\_067.jpg, 00:04:04, 0.10m  
Line deviates up

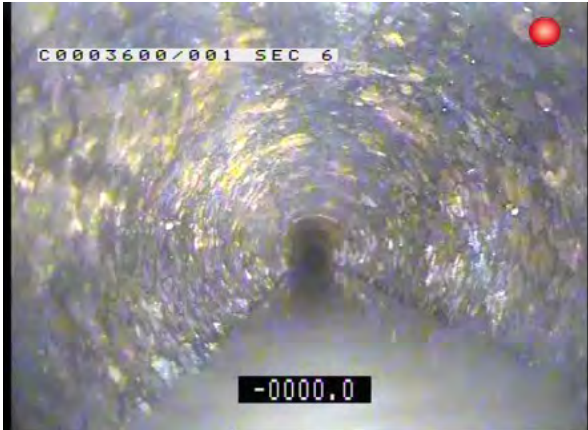
SW1X\_42f3eab4-fc1b-403f-9e39-5eda5f1000fc\_20170824\_131948\_443.jpg, 00:00:00, 0.00m  
Start node type, manhole, reference number: SW1

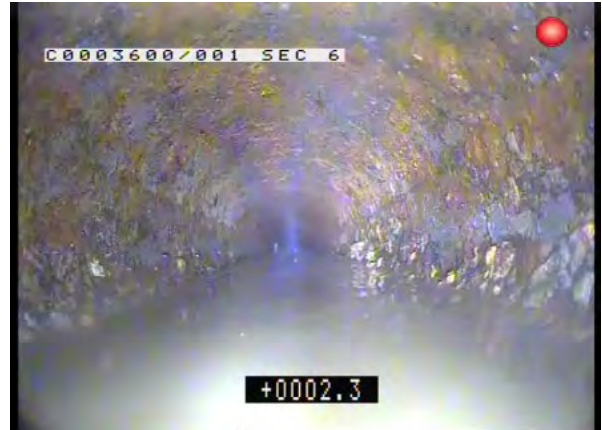
No structural defects but cast-iron pipework in Sections 5 & 6 has surface corrosion and is causing a water level in pipework. (this section we jetted for over 1.5hrs).

SW1X\_4aa6789e-51c5-47d0-b167-90124c401110\_20170824\_132143\_642.jpg, 00:00:20, 2.30m  
Water level, 10% of the vertical dimension

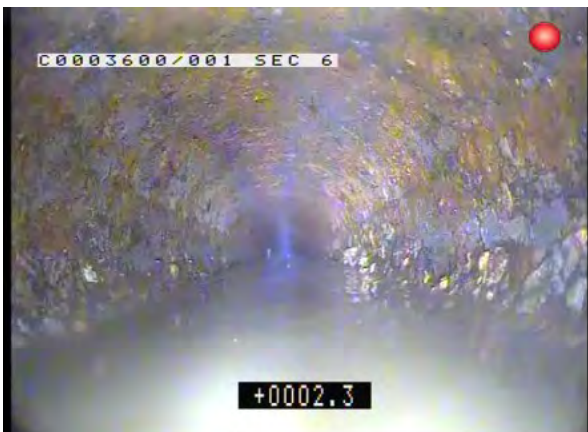
The scale and associated debris will cause future blockages and the works as recommended should be carried within the very near future.

| 1:144 | Position m | Code | Observation | Grade |
|---|---|---|---|---|
| | 2.30 | S01 SCP | Surface damage, corrosion products from 4 o'clock to 8 o'clock, start | |
| | 15.60 | F01 SCP | Surface damage, corrosion products from 4 o'clock to 8 o'clock, finish | 2 |

SW1X\_08cef109-c8c3-4d99-b512-d535b8a4b1ca\_20170824\_132702\_478.jpg, 00:00:20, 2.30m  
Surface damage, corrosion products from 4 o'clock to 8 o'clock,

The survey found substantial corrosion up within the Sections 5 & 6 , we strongly recommend a specialist picote the chain flail grinding tool the to restore maximum flow.

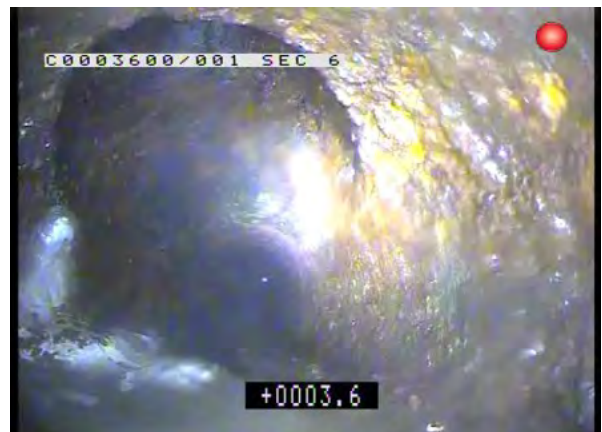
SW1X\_a6e38308-1e08-4efb-853a-517ced4cdb53\_20170824\_132217\_886.jpg, 00:00:29, 3.60m  
Junction at 12 o'clock, diameter: 100mm

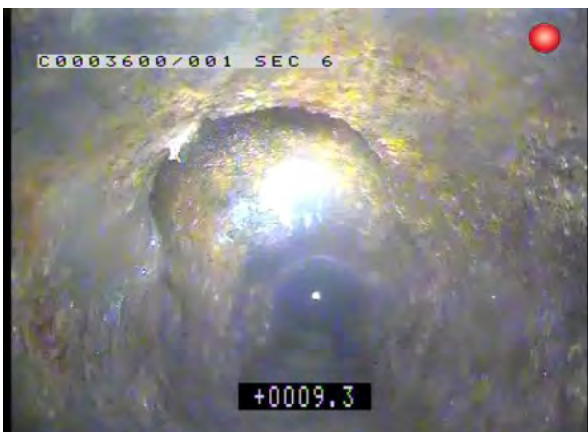
SW1X\_243a8409-1834-4bc0-be0e-16071e3a554e\_20170824\_132307\_211.jpg, 00:00:54, 9.30m  
Junction at 11 o'clock, diameter: 100mm

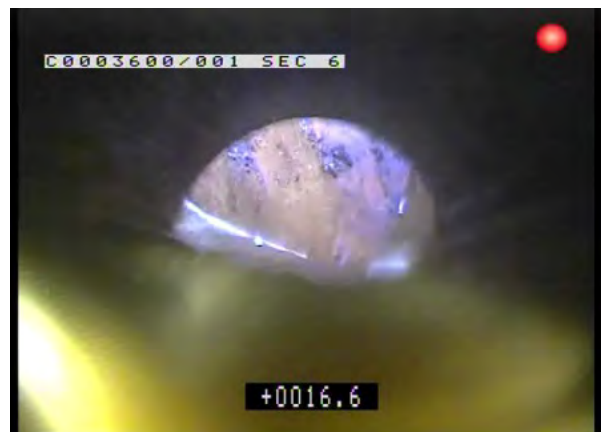
SW1X\_a9807cbf-935b-4227-93ae-bbb2dcf80117\_20170824\_132504\_659.jpg, 00:02:02, 16.60m  
Finish node type, manhole, reference number: SW2

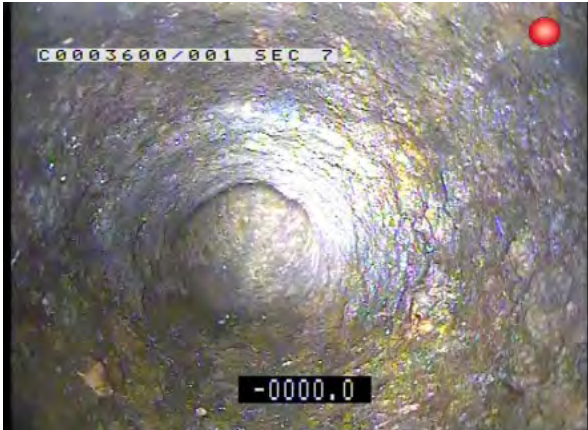
RWPX\_c0b022f0-c988-4763-8b87-8dd4613abe74\_20170824\_132930\_971.jpg, 00:00:00, 0.00m  
Start node type, manhole, reference number: SW2

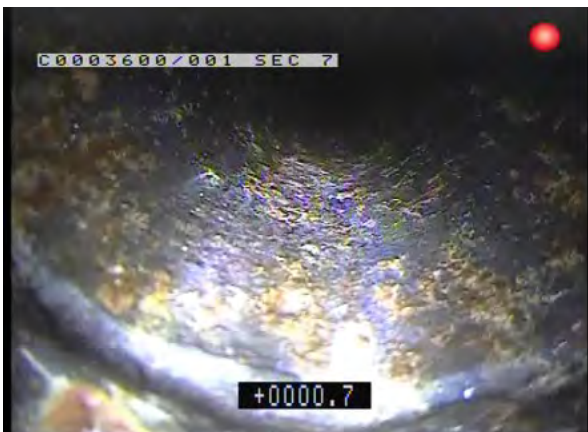
RWPX\_b90c3937-81da-43ee-9148-c78e6cd11ce0\_20170824\_132949\_775.jpg, , 0.70m  
Finish node type, gully, reference number: RWP

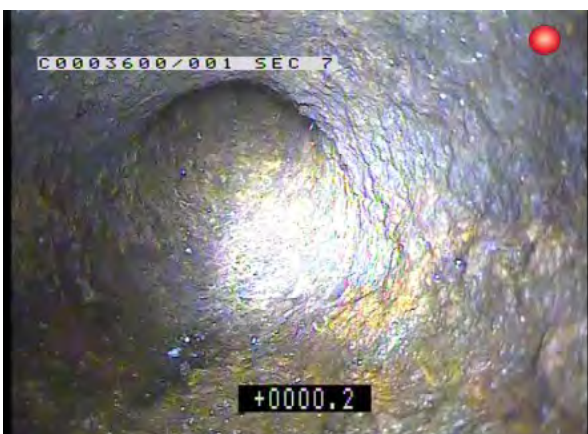
RWPX\_fb4cb278-faa2-44d5-b9d4-a4d607830da4\_20170824\_132937\_250.jpg, , 0.20m  
Line deviates up
