## **Figures**

PHASE 2 SITE INVESTIGATION  
HPH5

Design and Construct Remediation

**Project:**  
HPH5 Hayes

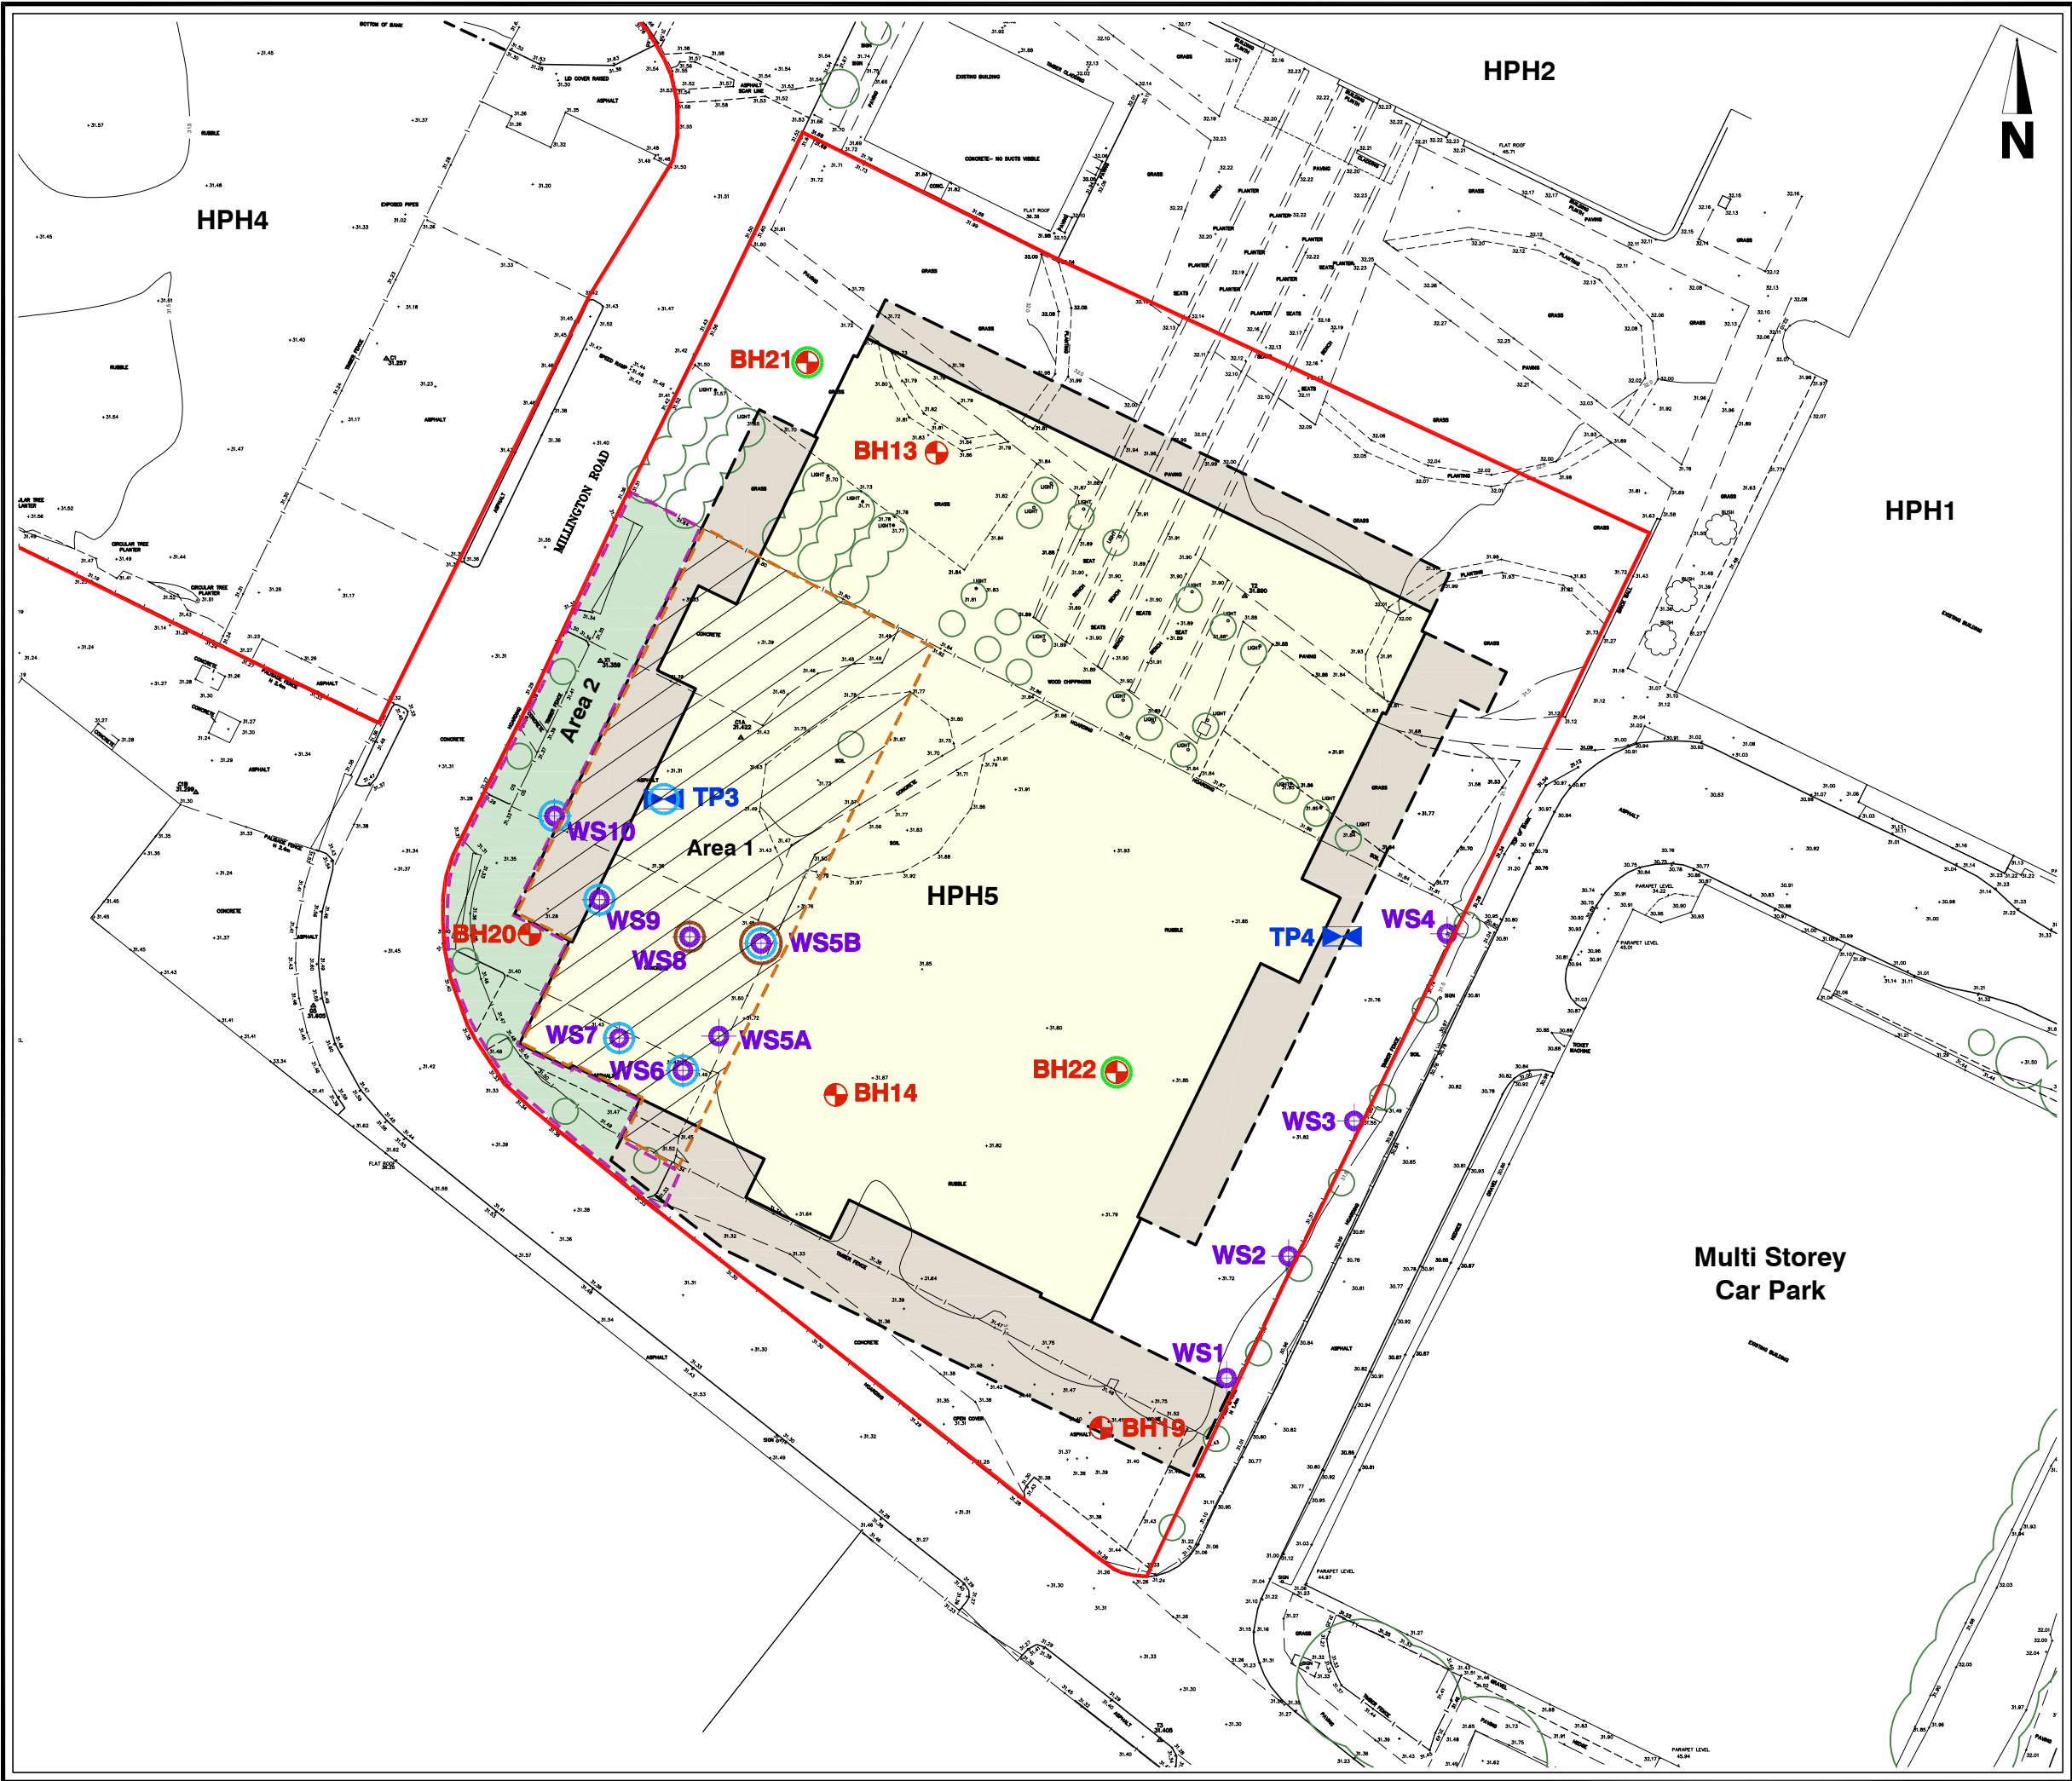
FIGURE 5  
EXISTING TOPOGRAPHIC PLAN  
OVERLAID WITH BASEMENT/  
BUILDING FOOTPRINT AND AREAS  
OF SOIL AND GROUNDWATER  
CONTAMINATION

- SKME Window Samples: January 2013
- Made Ground Classified as Hazardous  
Waste WM2 Screening
- Asbestos Present, Chrsotile - Loose Fibres
- Elevated Concentrations of Trichloroethene  
(TCE); 1,2 - Dichloroethene (1,2 DCE), and  
Vinyl Chloride (VC) in Groundwater in  
Lynch Hill Gravels above UKDWS and  
WHO Drinking Water Standards

- Area 1 - Made Ground (ca. 1.5m thick) Under  
Hardstanding for Off Site Disposal  
(Basement Dig) likely to be Classified as  
Hazardous Waste (WM2 Screening)  
(Area : 806m<sup>2</sup> , Volume: 1209m<sup>3</sup>)

- Area 2 - Made Ground (ca. 1.5m thick) Under  
Hardstanding for Off Site Disposal  
(Basement Dig) likely to be Classified as  
Hazardous Waste (WM2 Screening)  
(Area : 327m<sup>2</sup> , Volume: 490.50m<sup>3</sup>)

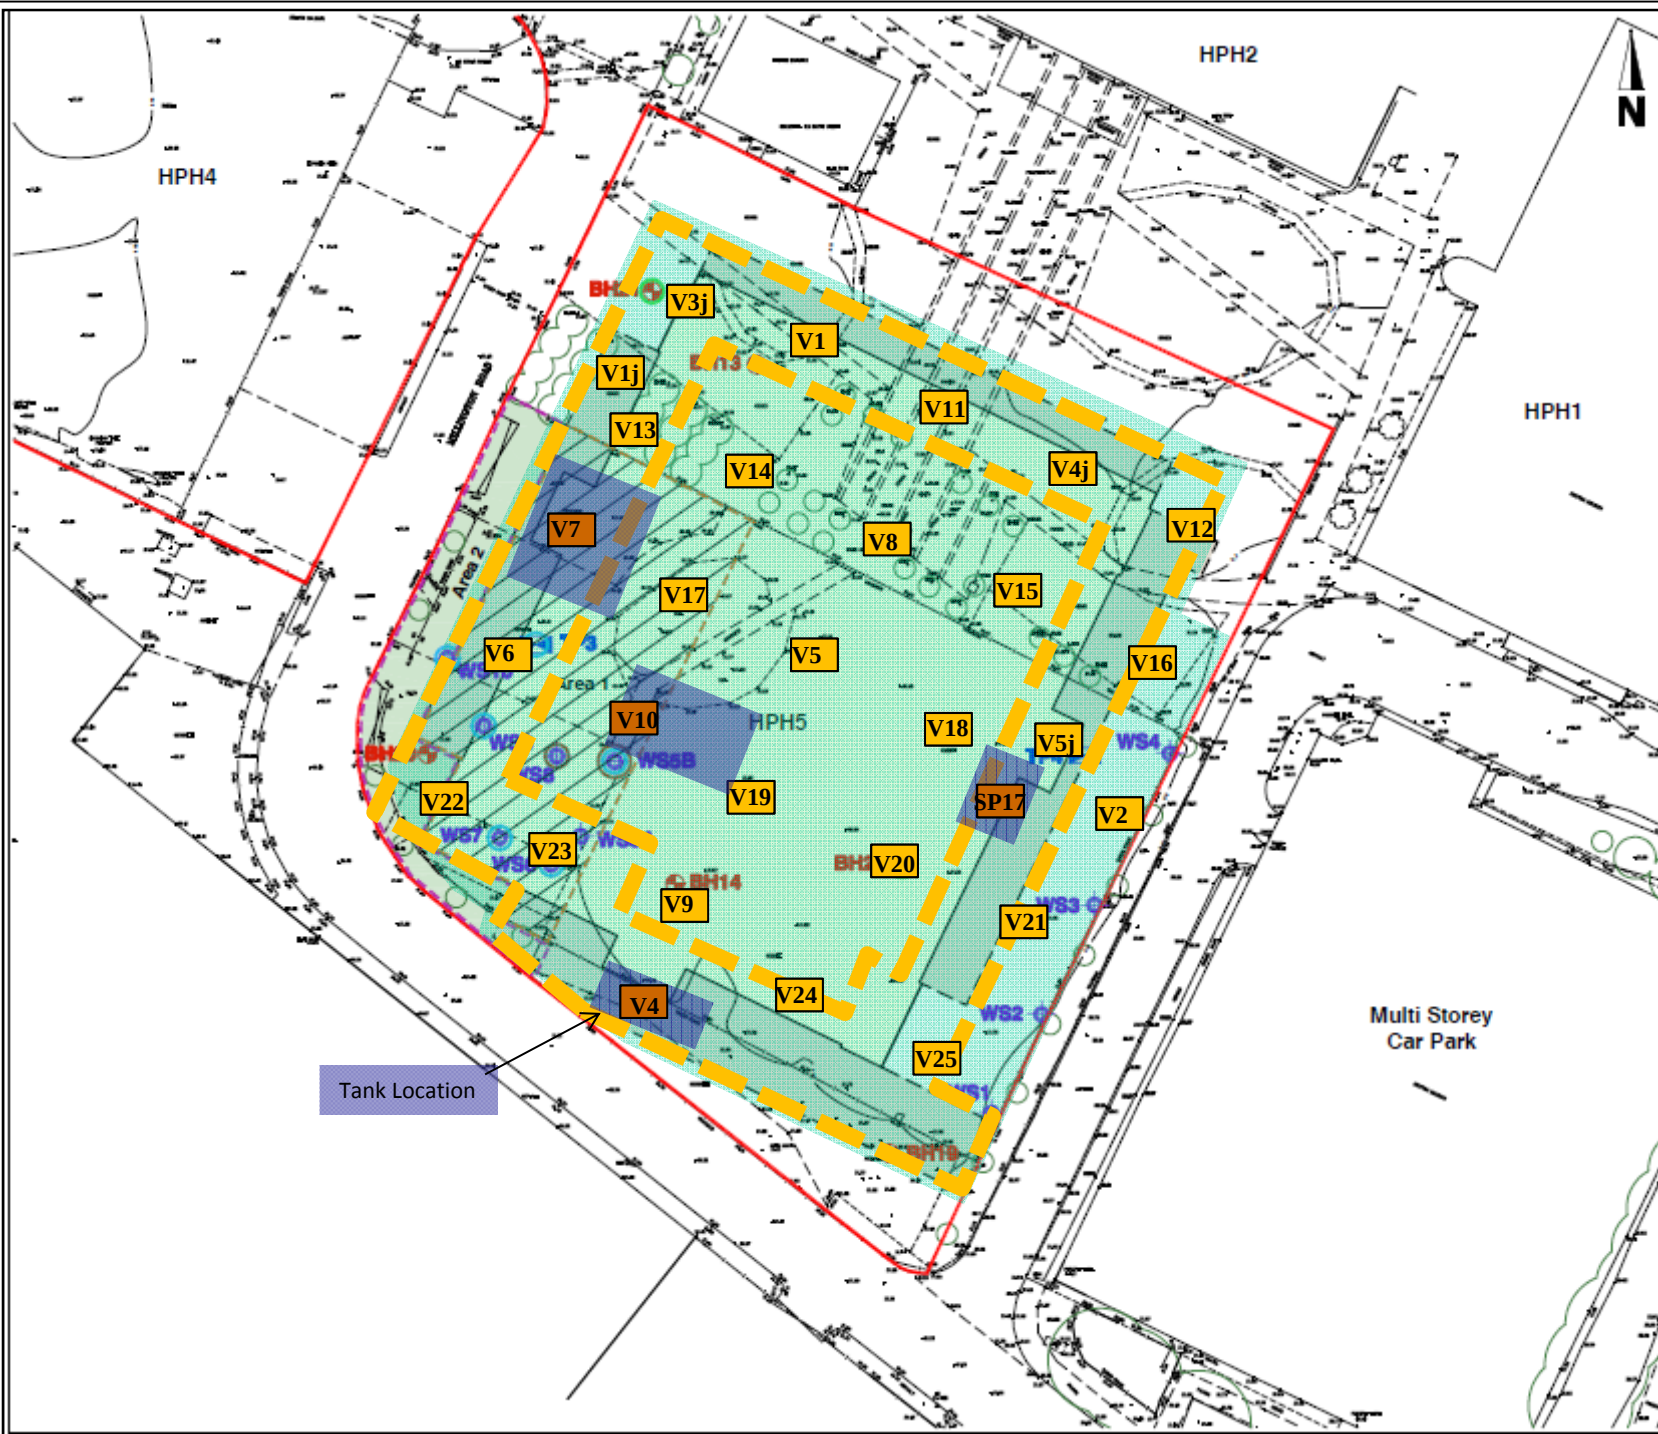
Title: Validation Sampling Locations

Approximate Piling Mat  
Excavation to 1.5m bgl

Approximate excavation area

Odorous gravels noted

Sample locations of  
odorous gravels

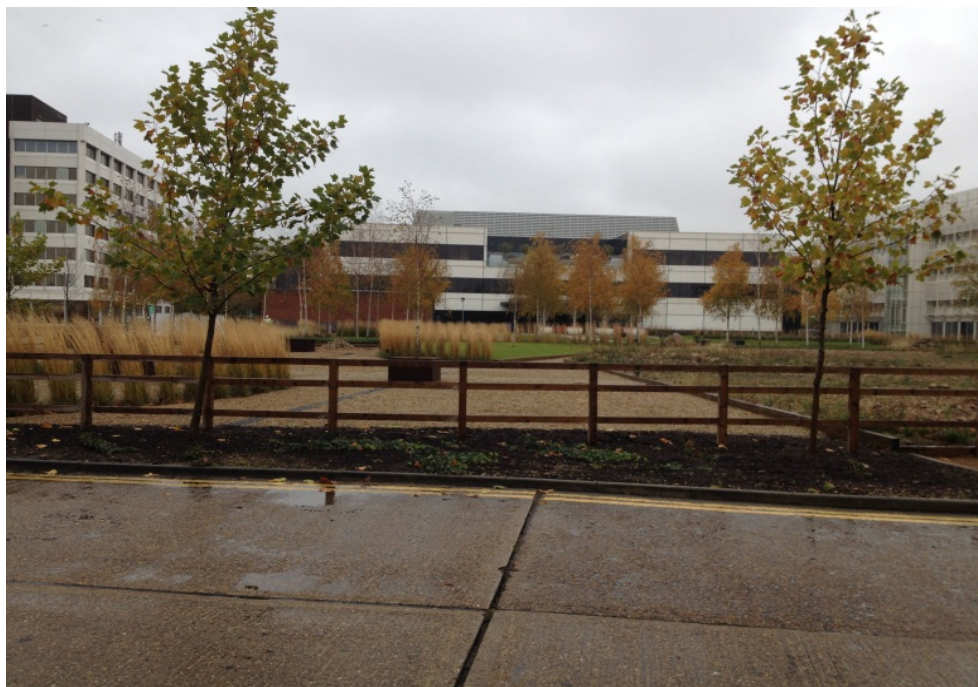
Photo 1: Hayes HPH5 was landscaped with an area of hard core fill

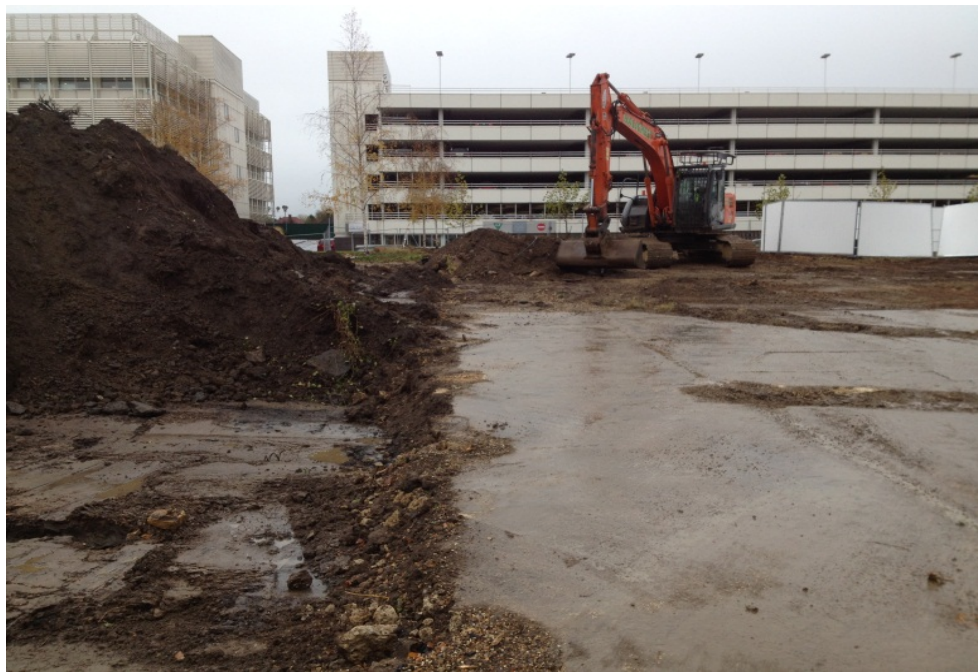
Photo 2: Topsoil and concrete were removed and segregated for off site reuse / recycling

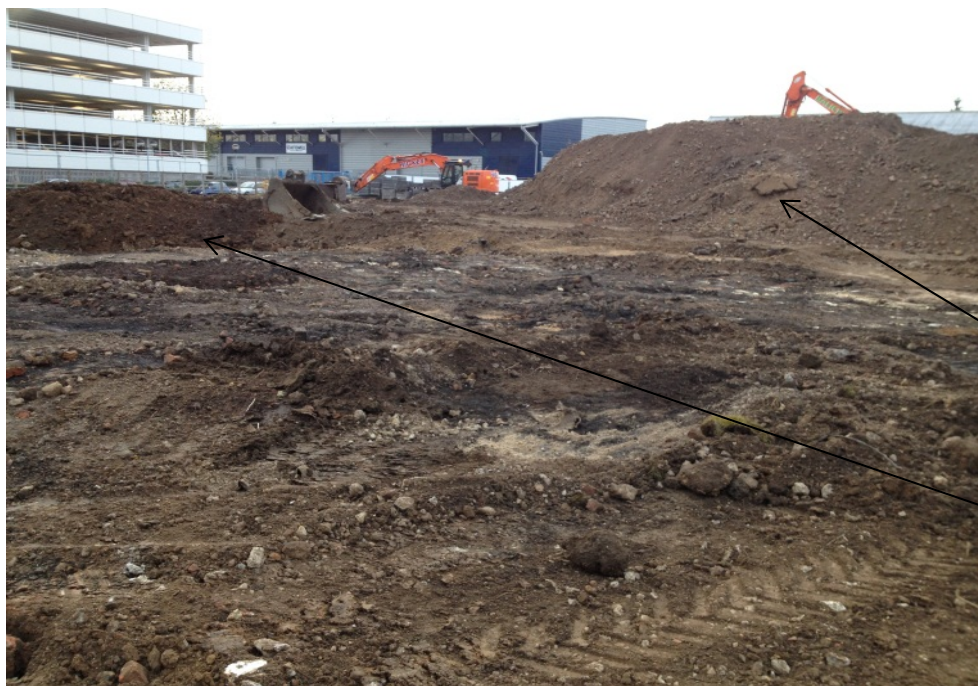
Photo 3: Non-hazardous and inert materials were segregated

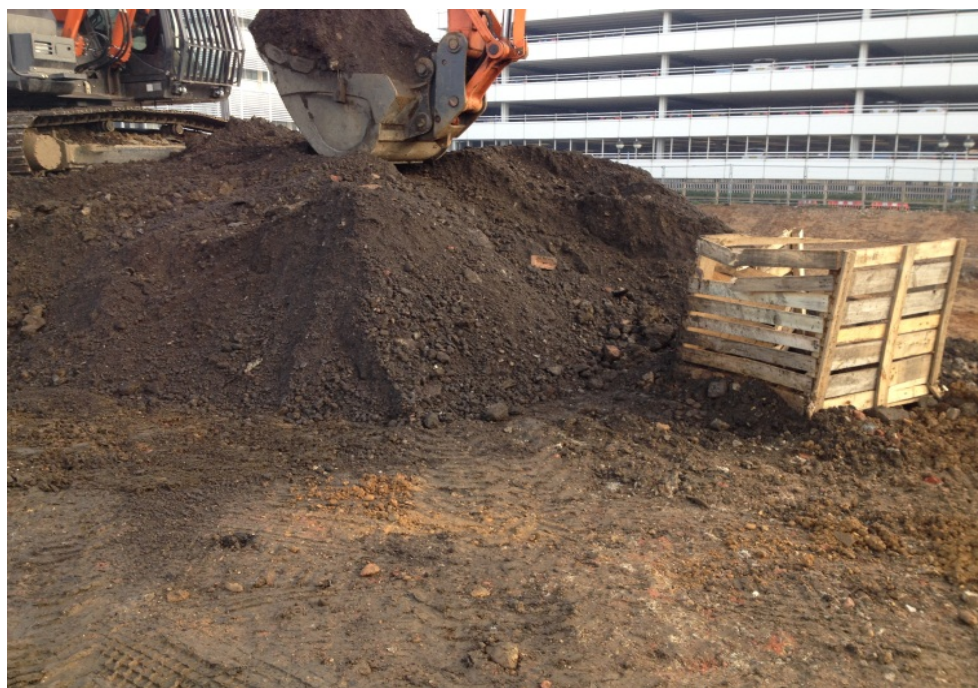
Photo 4: Hazardous soils were excavated and sent for off site disposal

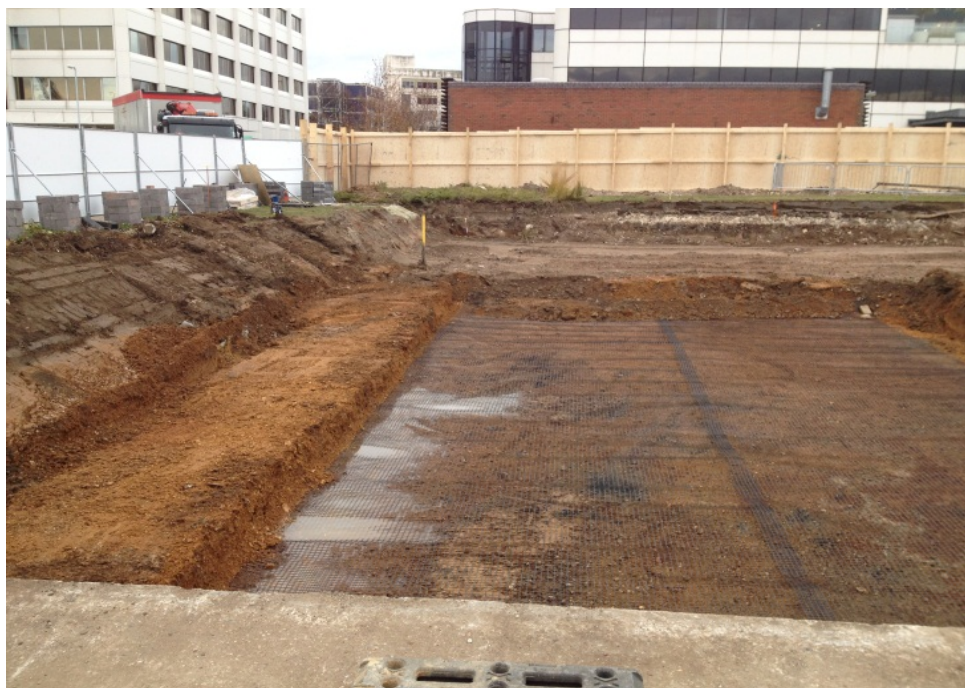
Photo 5: A piling mat was installed using inert fill material from the site

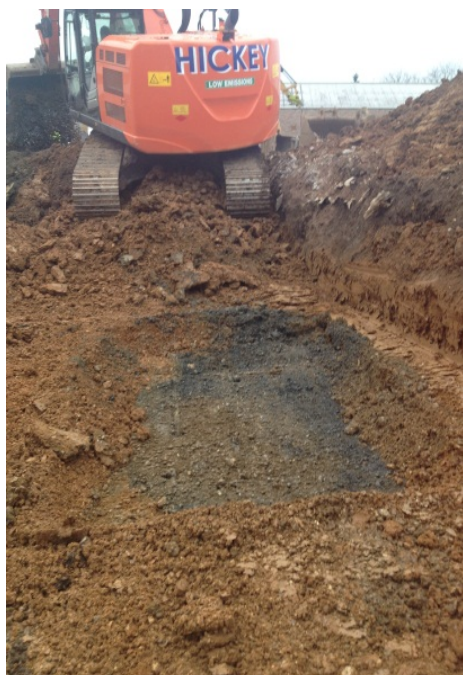
Photo 6: Areas of odorous gravels were encountered (SP17 shown here)

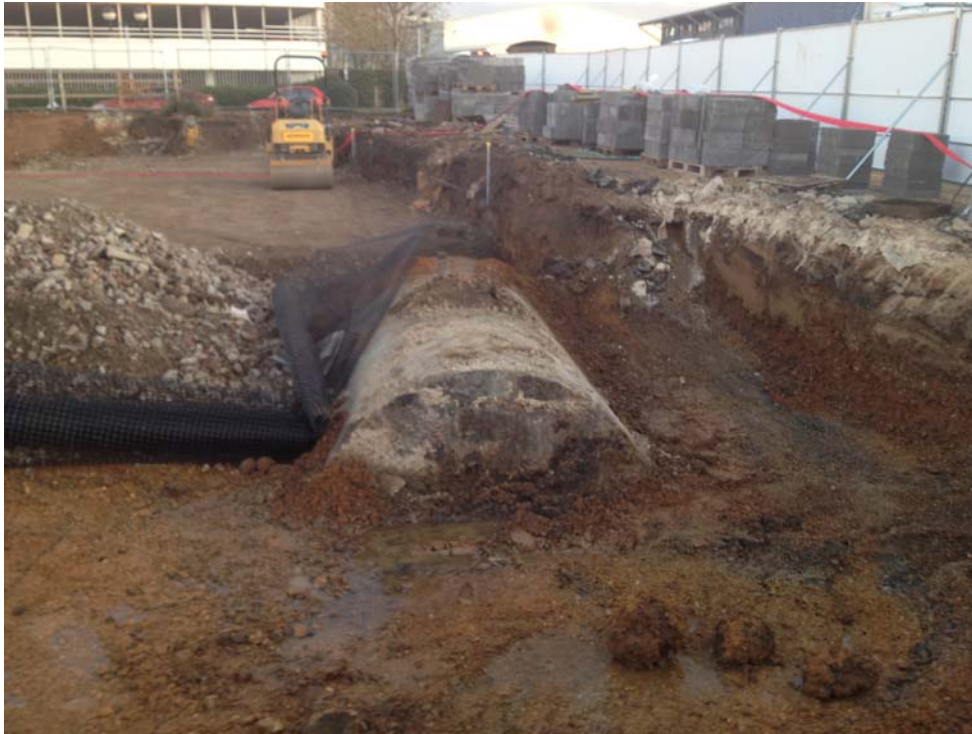
Photo 7: A large below ground oil storage tank was encountered on site and removed
