**Re: 1A, 1B & 1 HIGH STREET, RUISLIP HA4 7AU**

Thank you for your recent instruction when you asked us to carry out an inspection on the damaged front elevation following impact at the subject property.

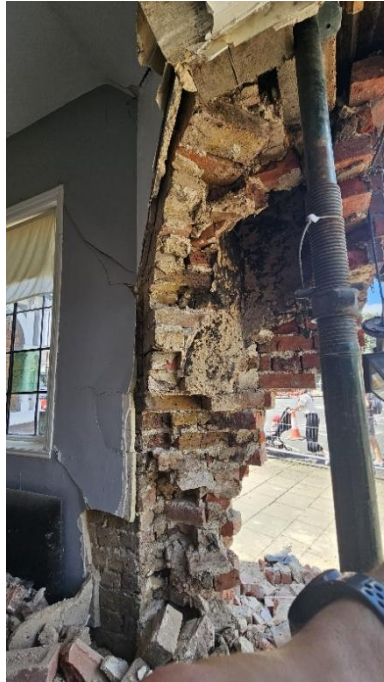
- 3.13 Since the majority of the debris was left on site, we were unable to enter the property. However, from what we can see from outside, all the internal damage can be seen to the right-hand side elevation of the property.
- 3.14 A large crack can be seen to the near side of the right-hand elevation of the property. A horizontal crack can be seen on the left-hand side of the window. This crack forms through the plaster and ends where the flue is located.
- 3.15 A crack can be seen on the wall/ceiling of the property. This crack is a horizontal crack which forms through the plaster.
- 3.16 A third crack can be seen on the lower portion of the wall. this horizontal crack can be seen on the lower left-hand side of the window. The crack forms through the plaster ending at where the flue is located.

Plate 1. Showing internal damage to the chimney flue and right-hand side elevation wall.

- 4.3.10 Reconstruct the existing flue and corner of property 1a, to match the existing, with salvaged bricks.
- 4.3.11 Reconstruct the front elevation with any salvaged bricks and, where necessary, new bricks to match existing. Opening locations and sizes for the 2No windows and front door are to be agreed between the conservation officer and property owner. Existing wall plate is to be inspected/surveyed during the works for defects and/or issues. Any defects/issues to be remediated prior to the completion of the reconstruction of the external wall.

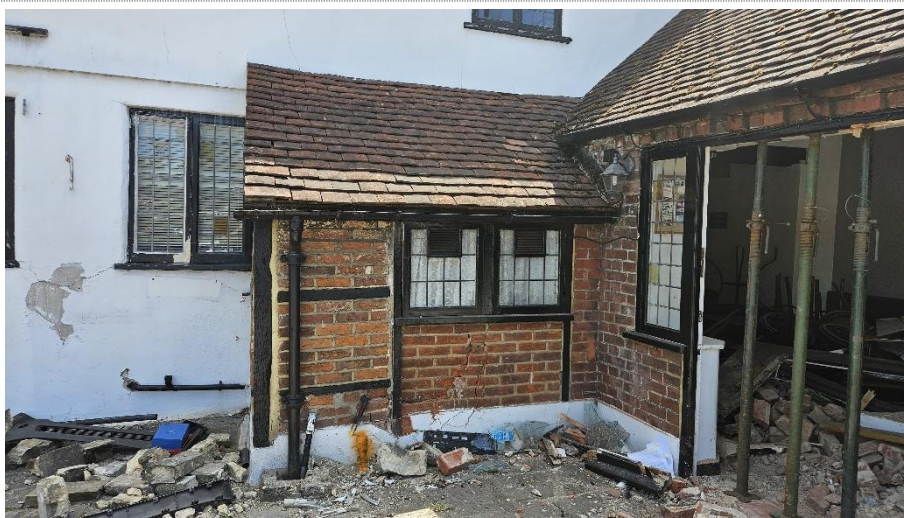
- 3.7 A large crack can be seen under the window frame on the left-hand side elevation of the property. The impact has caused this part of the property to have some deformation. The impact has caused large cracks to be seen, these cracks forms through the brick and mortar. These cracks starts under the window and ends towards the ground.
- 3.8 The left-hand side elevation is constructed with masonry, with vertical and horizontal timber posts in between the masonry. As a result of the impact, the left sided timber post has shifted. However, cracks could not be seen on the timber post.
- 3.9 Cracks can be seen on the masonry underneath the lower horizontal timber post. The masonry in this area has been displaced as a result of the impact.

Plate 2. Showing damage on the left-hand side elevation.

- 4.3.5 Locally deconstruct the damaged and displaced masonry beneath the window seen on the left-hand store building. We would recommend the use of Acrows with strongboy heads internally to support the existing wall plate above the window.

- 4.3.6 Make local repairs to displaced timber members adjacent to the deconstructed masonry panel.
- 4.3.7 Reconstruct previously deconstructed section of the left-hand side elevation with reusing salvaged original bricks where possible. If necessary, source new bricks to match existing.

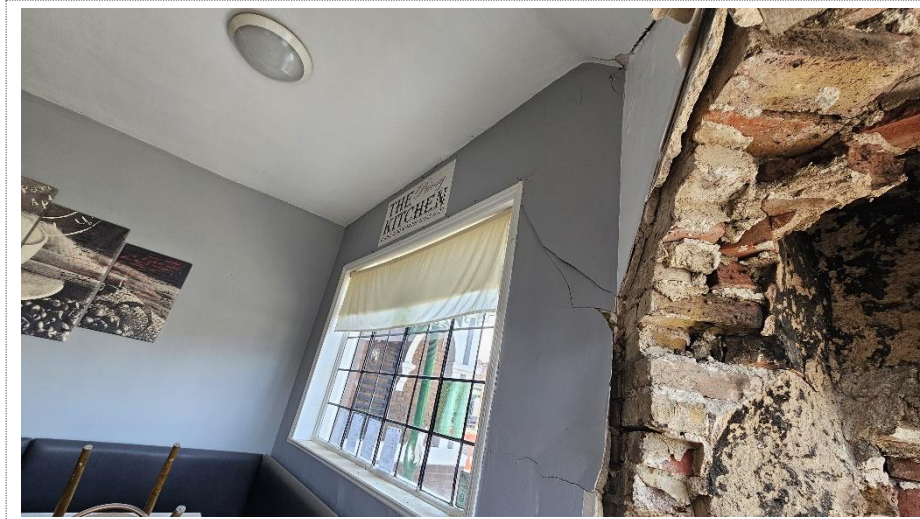
- 3.10 The masonry on the lower left-hand corner of the right side elevation can be seen to have been destroyed as a result of the impact.
- 3.11 The impact has caused the masonry arch located on the right-hand side of the property to slightly lose structural support, hence why two Acrow props have been installed to provide support to the window and the remaining structure above.
- 3.12 Cracks can be seen along the masonry on the right-hand side elevation of the property. These cracks form through the mortar and brickwork. A few cracks can be seen starting to form underneath the window frame, spanning downwards to the floor. Other cracks can be seen at about halfway to the left of the window near the black chalkboard, spanning vertically to the window sill and below.

Plate 3. Image showing cracks in the right-hand side elevation.

- 4.3.9 Repoint any cracked or damaged mortar joints on the right-hand side elevation of property 1a with a suitable lime-based mortar. Ensure mortar mix is compatible with the existing and match the colour as closely as possible.

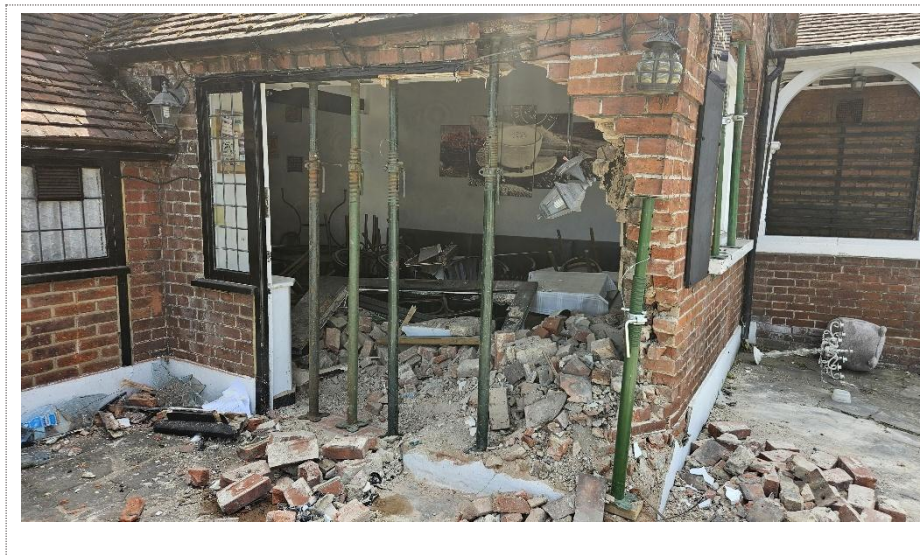
- 3.1 The majority of the damage can be seen on the front and side elevations of property 1a.
- 3.2 The impact has caused almost the entire front elevation to be destroyed, leaving a large void in the front elevation of the property.
- 3.3 As a result of the impact, the right-hand side of the pitched roof can be seen to have moved and has lost support, due to the missing masonry.

- 3.4 Cracks can be seen on the top two courses of masonry at the front elevation, this is above where the door and window would have been located. This crack is a medium sized crack, which forms through the brickwork and mortar.
- 3.5 Small cracks can be seen on the lower, left-hand side front elevation of the property, underneath the existing window. The crack starts directly below the window frame and ends as it reaches the floor of the property. This crack forms through the brick and mortar.
- 3.6 The flue located to the right-hand side of the front elevation has been completely destroyed as a result of the impact.

Plate 4. Image showing damaged front elevation.

- 4.3.1 Using 4No Acrow props and a 2No 152x152x23 UC Needle beams prop the front elevation of property 1a. The needle beams should be installed to support the underside of the existing wall plate and arranged such that 1No needle beam is located in line with the right-hand corner of the front door and 1No needle beam is located equidistant between the front door and the old (partially destroyed) flue. Props should be braced together with scaffold tubes where possible and the needle beams are to be bolted to the prop heads with Gr8.8 bolts. Props should be fixed down with M10 coach screws to a 38mm x 225mm C24 sole plate and the sole plate should bear on to solid ground. Contractor will need to assess the floor/ground conditions beneath the props, prior to installation, for suitability to bear the propping loads.

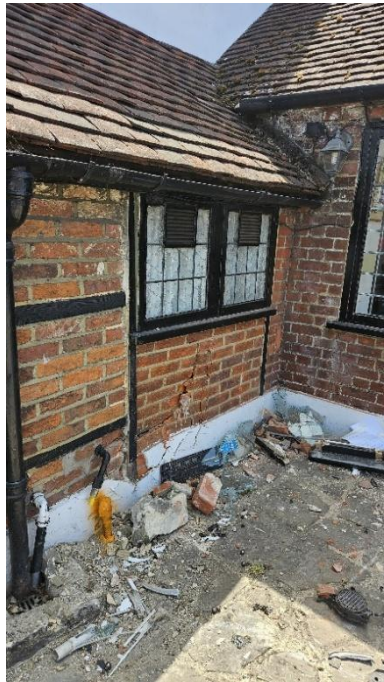
Plate 5. Another image showing the lefthand small store building.

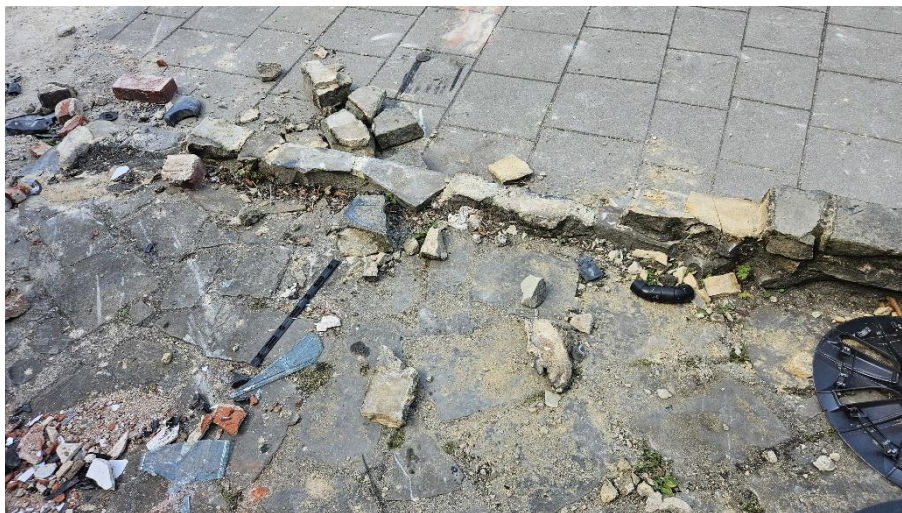
- 3.22 There is a very small wall located to the front of the property 1a. This previously acted like a boundary between the property and the pavement. The right section of this wall has been destroyed as a result of the impact.

Plate 6. Image showing damaged boundary wall at front elevation.

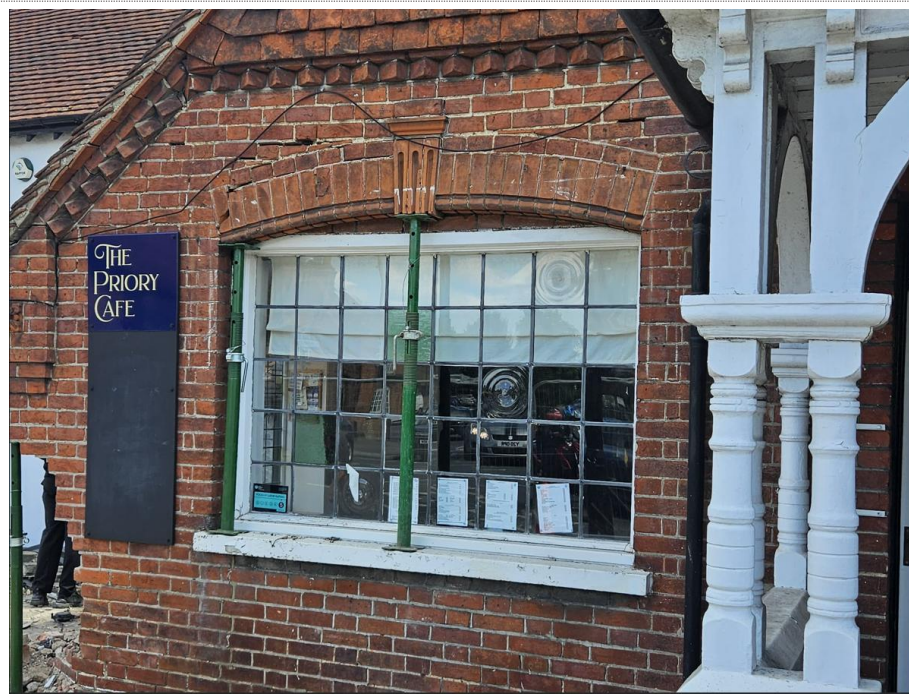
Plate 7. Image showing the damage seen on the right-hand side elevation.

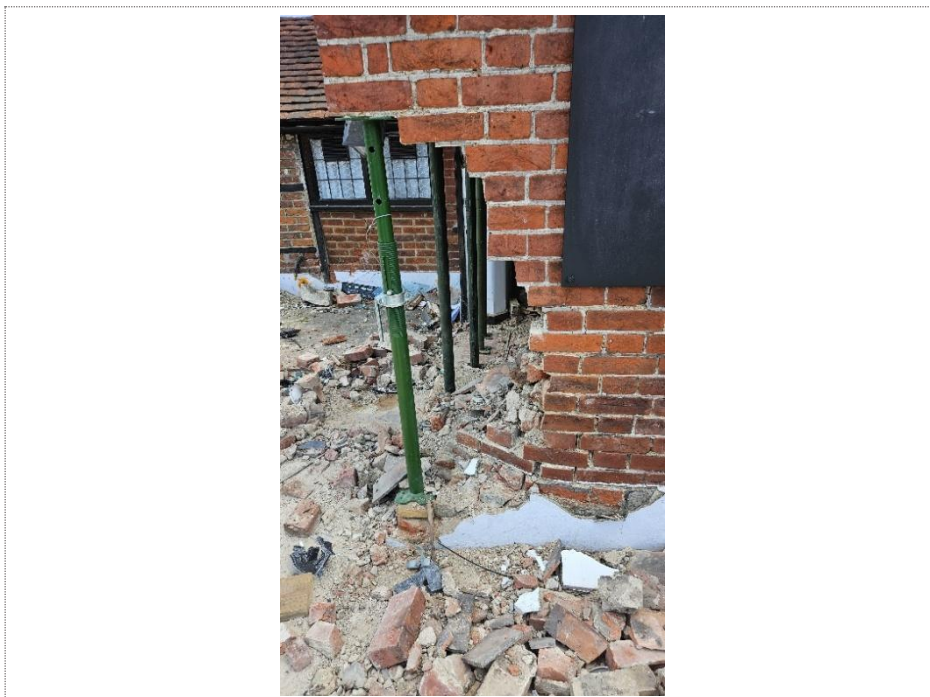
Plate 8. Image showing close up of the damage seen on the right-hand side elevation.

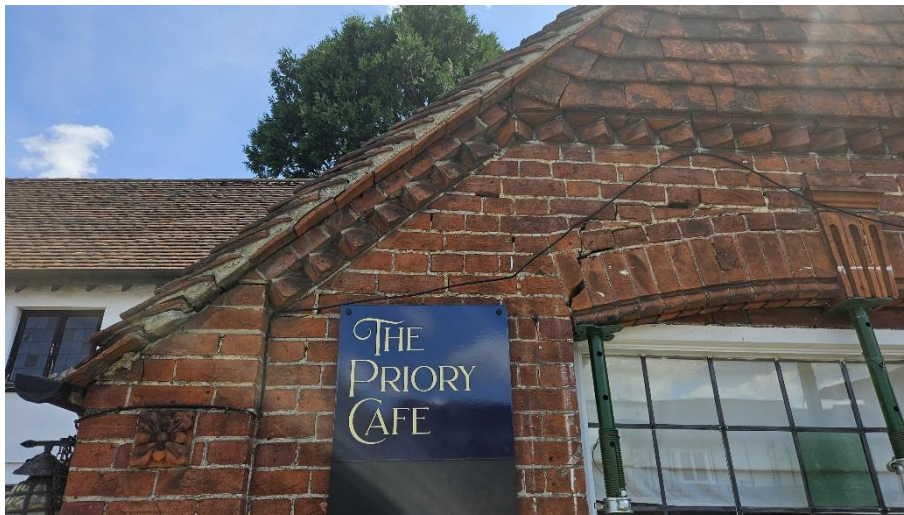
Plate 9. Showing cracks in the arch.

- 4.3.8 In terms of the right-hand side elevation of property 1a, the arch above the window will need to be carefully and slowly jacked up into its original location. Once back in its correct position, we would recommend the use of Helifix Helibars in the horizontal mortar joints to reinforce the arch and the masonry above the arch. We would then suggest using Helifix CemTies to retrospectively tie the masonry of the arch back to the masonry wall. We would suggest getting specialist advice from Helifix's technical department with regards to this work.

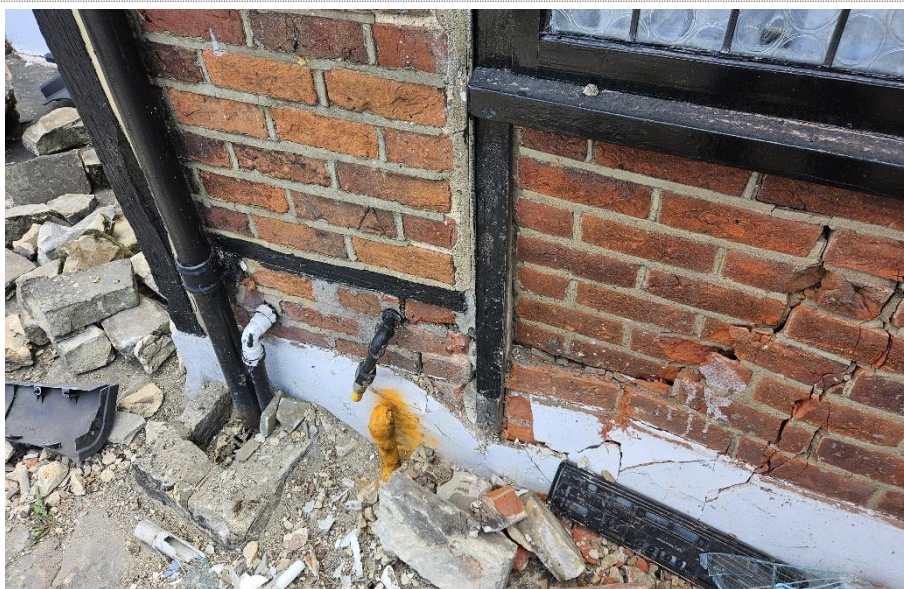
Plate 10. Showing close up of damage seen on the left-hand side elevation.

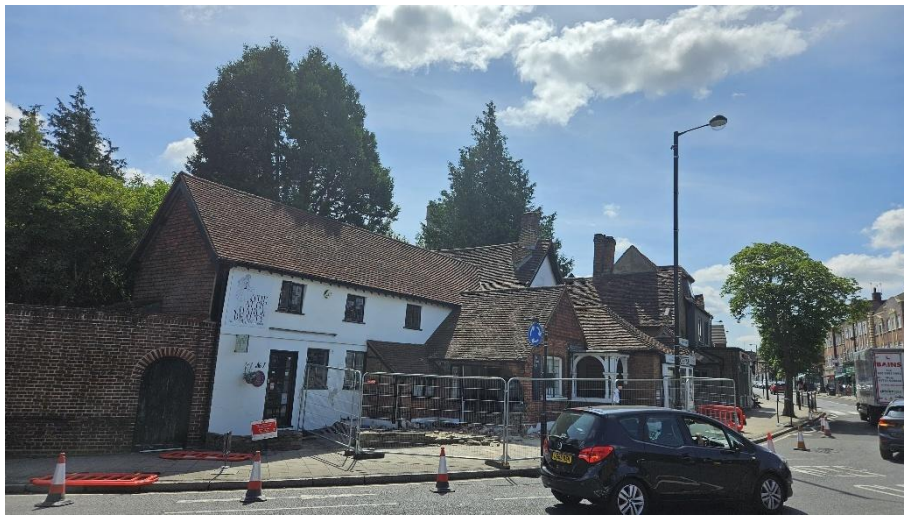
Plate 11. Overview of the damaged properties.

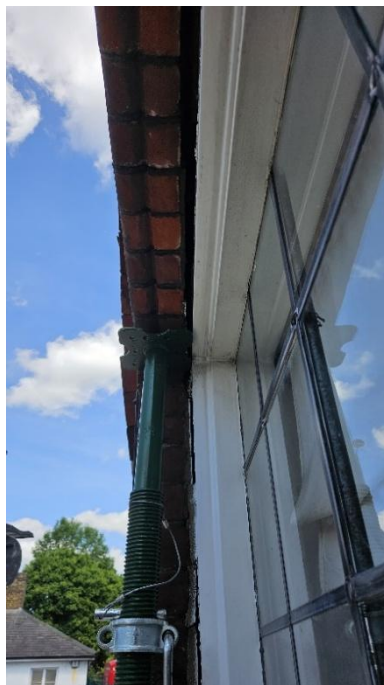
Plate 12. Showing crack in the right-hand side elevation windowsill.

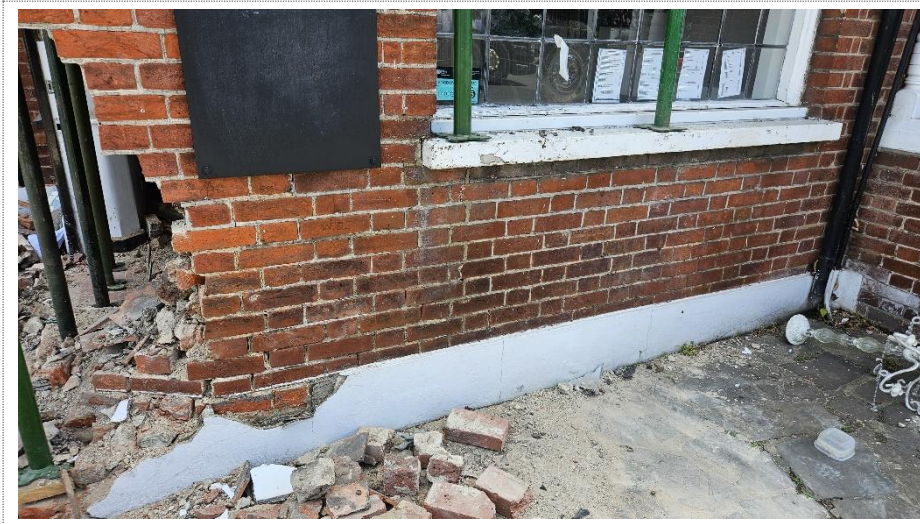
Plate 13. Image showing close up of the damage seen on the right-hand side elevation.

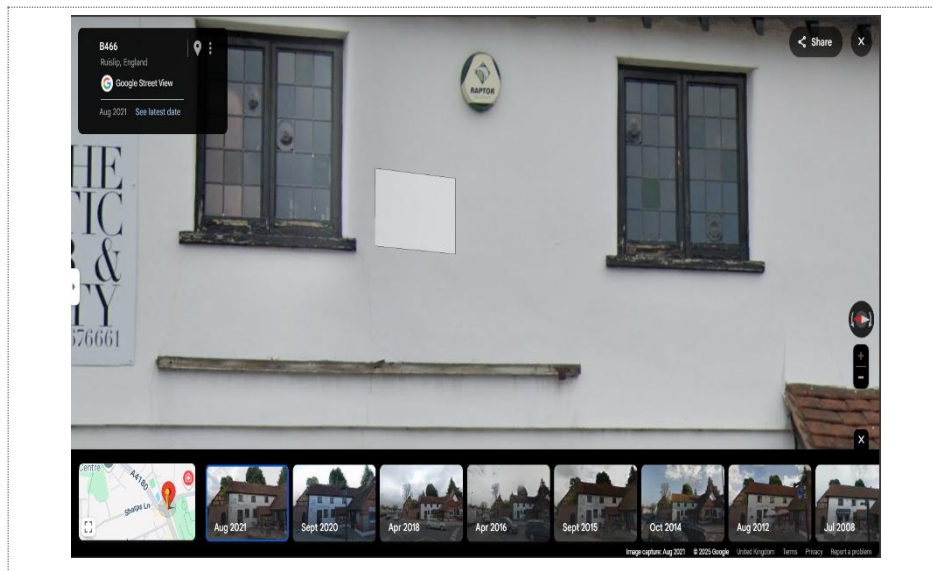
- 3.23 Shortly after our site visit, we reviewed images available on the Google Maps, which for this property went from July 2008 to August 2024.
- 3.24 It became apparent when reviewing the images between 2022 and 2024, that the cracks seen below the windows at the front elevation of property 1 have been present since ~2021
- 3.25 We also noticed that part of the masonry seen on the left-hand side elevation of property 1a has been repointed over time with a Portland cement mortar, despite the original mortar joints being lime mortar.

Plate 14. Image showing crack seen on google maps in August 2021.

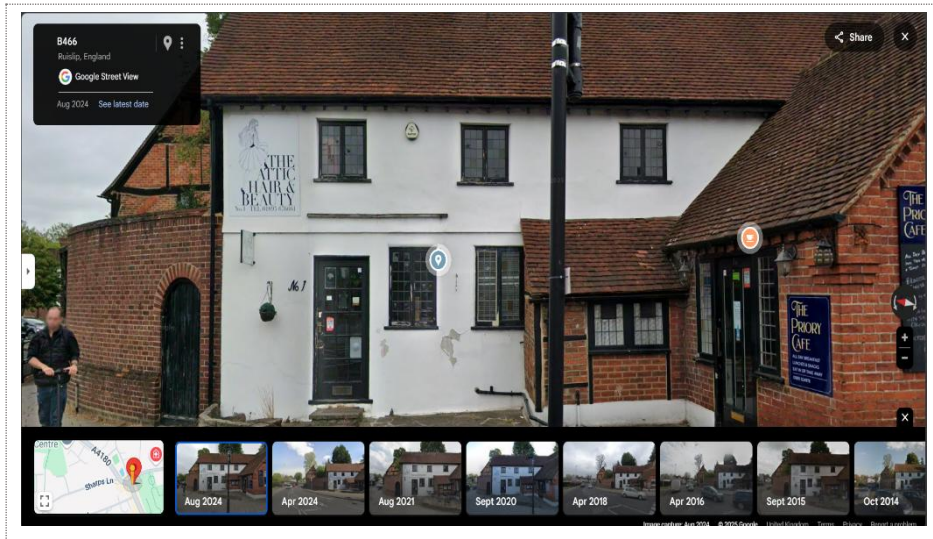
Plate 15. Showing crack seen on google maps in August 2024.
