## SITE INVESTIGATION FACTUAL REPORT

Report No: 509700  
Client: Cunningham Lindsey - Maidstone  
Site: 15 Mallard Way,  
Client Ref: 6757279-  
Date of Visit: 30/05/18

Investigation  
Layout Plan

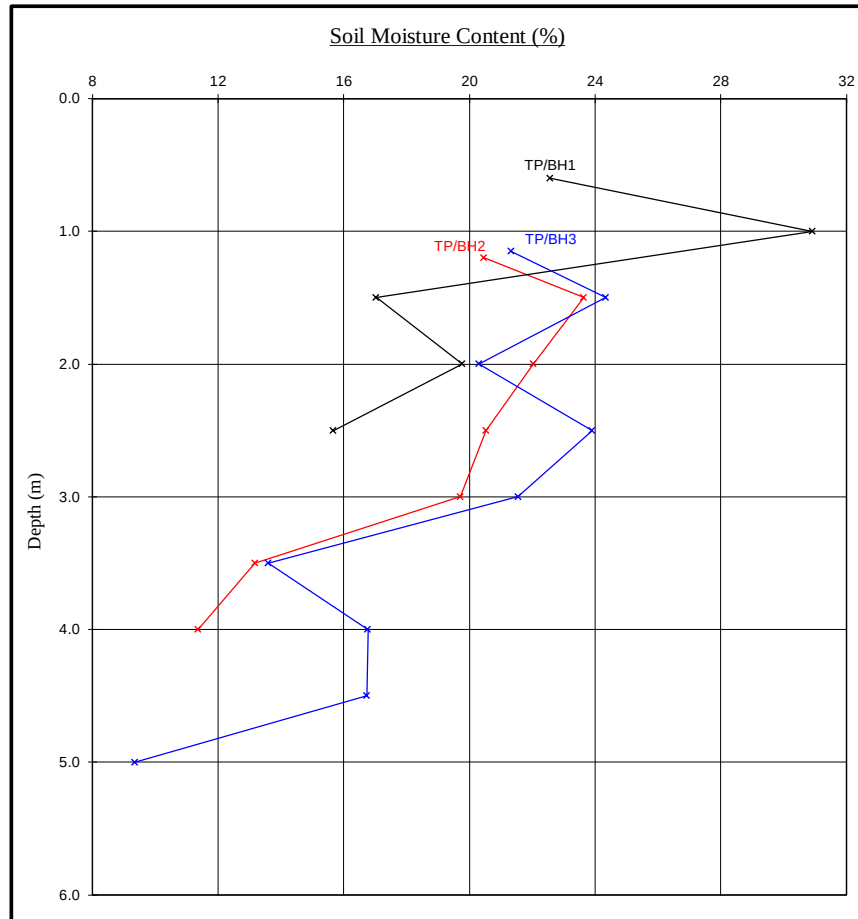
# Moisture Content Profiles

1. If plotted, 0.4 LL and PL+2 ( after Driscoll, 1983 ) should only be applied to London Clay ( and similarly overconsolidated clay) at shallow depths.
2. Unless specifically noted the profiles have not been related to a site datum.

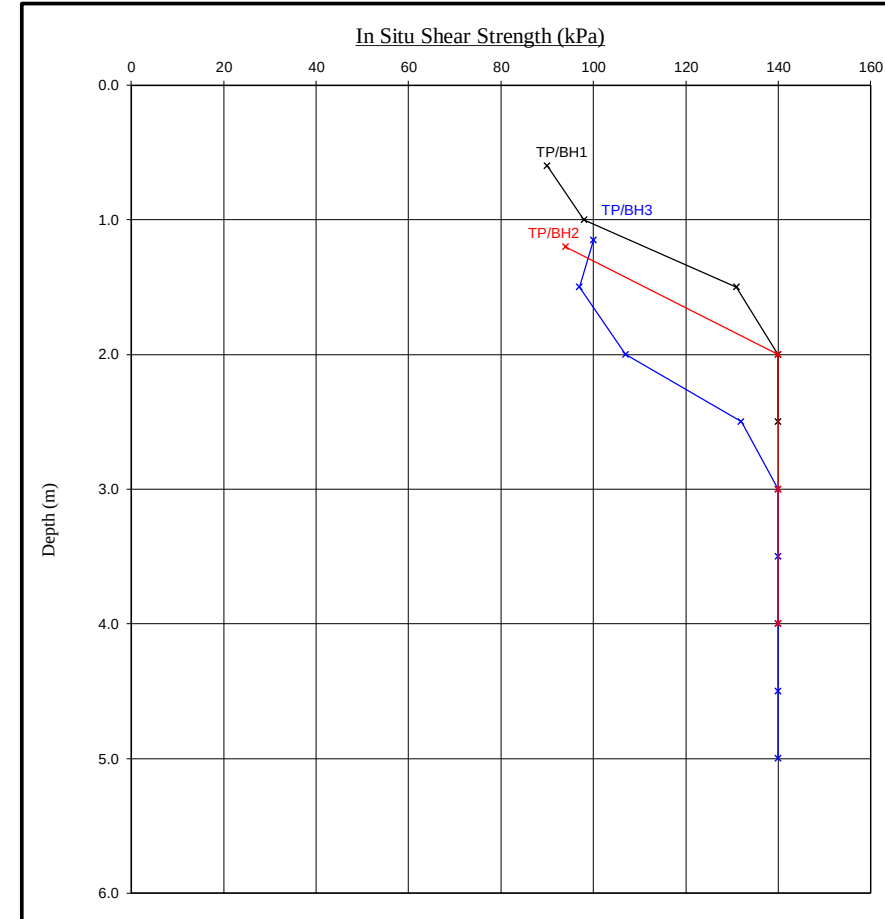
# Shear Strength Profiles

1. Unless otherwise stated, values of Shear Strength were determined in situ by CET using a Pilcon Hand Vane the calibration of which is limited to a maximum reading of 140 kPa.
2. Unless specifically noted the profiles have not been related to a site datum.
