Windows - Ground Floor

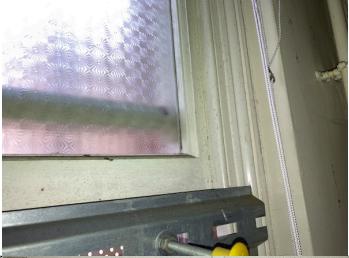
| WG14 | Year2 WC2 | W (yard) | B | Timber sash window with brickwork surrounds. Not original. Obscured, patterned glass to sashes. Reasonable condition. Secondary fire-resistant glazing to be installed on reception face. Otherwise general restoration and repainting only | | |

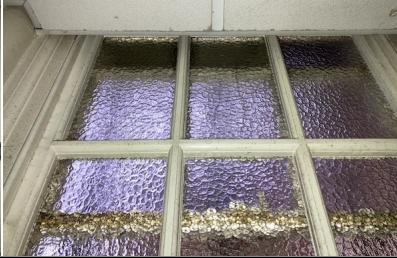
| WG15 | Year2 WC1 | W (yard) | B | Timber sash window with brickwork surrounds. Obscured, mottled glass to sashes. Metal chains, original fixtures. Reasonable condition. Secondary fire-resistant glazing to be installed on reception face. Otherwise general restoration and repainting only | | |

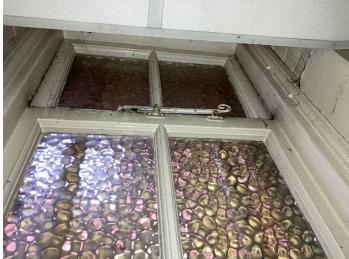
| WG16 | Year2 WC1 | W (yard) | H | Fixed timber window with opening fanlight over. Brickwork surrounds. Obscured, mottled glass panes. Unexceptional condition. Secondary fire-resistant glazing to be installed on reception face. Otherwise general restoration and repainting only | | |

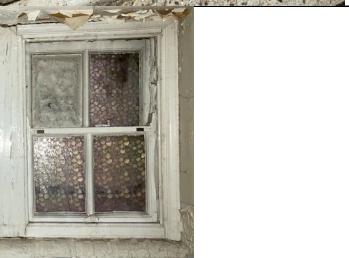
| WG18 | Sensory rm/Store | SE (L-well) | B | Pair timber sash windows in timber frame, obscured mottled glass although some panes missing. To be become internal wall. Therefore to be rubbed down and repainted, glazed with mirrors on sensory room side and blocked on store side | | |
