First Floor

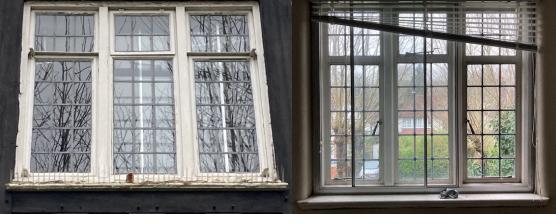
Window number	Location	Elevation	Type	Notes/Works	Photo
First Floor					
WF01	Preschool Rm 1	NW	C	Three part window. Open casements to outer units with fixed lights over. Fixed central window with opening fanlight over. Steel frames in timber sub-frames with leaded panes. Some original, some replacement fittings. Timber boarding around facing brickwork surround. Generally in good condition Secondary glazing already installed. Restore and repaint as necessary

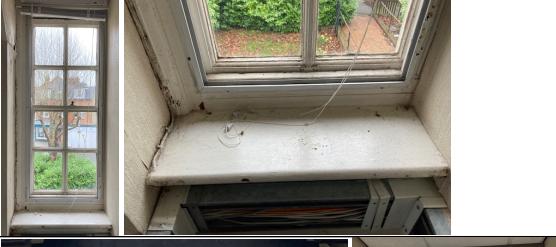
WF02	Preschool Rm 1	NE	B	Single sash window in timber frame - part of triple window. Plain glass. Metal chains, original fixtures. Stone cill, brickwork flanks, timber lintel over. Reasonable condition, but mould to LH side. General restoration and repainting only required

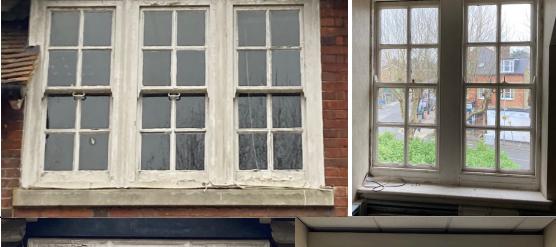
WF03	Preschool Rm 2	NE	B	Double sash window in timber frame - part of triple window. Plain glass. Metal chains, original fixtures. Stone cill, brickwork flanks, timber lintel over. Reasonable condition, but mould to LH side. General restoration and repainting only required

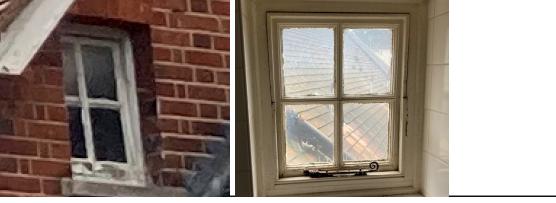
WF05	Preschool WC	SE	J	Timber horizontally pivoting window, poorly fitting. Brickwork surround, stone cill In reasonable condition, but requires repair and refitting Install double glazing

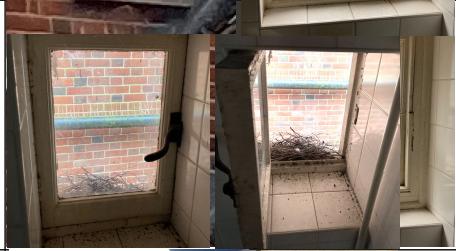
WF06	Preschool WC	SW (L-well)	K	Single timber casement, internally opening with steel water bar. Pigeon's nest on sill. In good condition, rub down and repaint. Fit with anti bird spikes Install double glazing

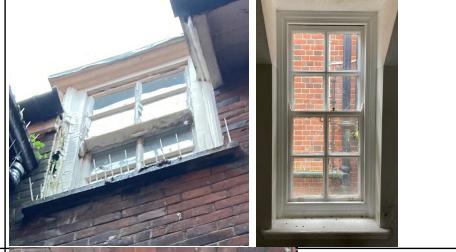
WF07	Preschool WC	SW (L-well)	B	Single timber sliding sash window in part dormer, stone sill. Not all fittings original Good condition internally, externally suffering from overflowing gutter. Restore, rub down and repaint

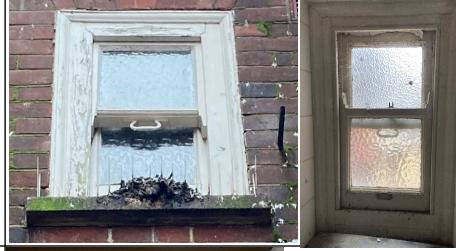
WF08	Store	SE (L-well)	B	Single timber sliding sash window in brickwork surround and stone sill. Good condition generally, paintwork peeling badly. Rub down and repaint

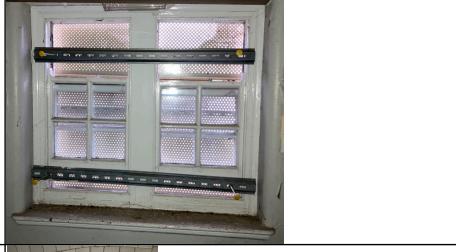
WF09	Stair-corridor	SE (yard)	B	Double sash window in timber frame. Plain glass. Metal chains, some original and some new fixtures. Stone sill, brickwork arch and flanks Reasonable condition General restoration and repainting only required

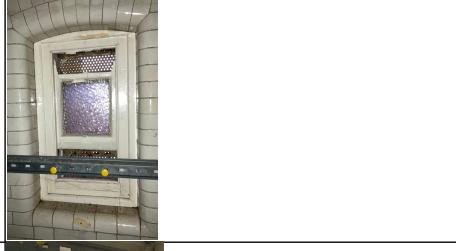
WF10	Store	SE (L-well)	B	Single timber sliding sash window in brickwork surround, stone sill. Good condition internally. Rub down and repaint

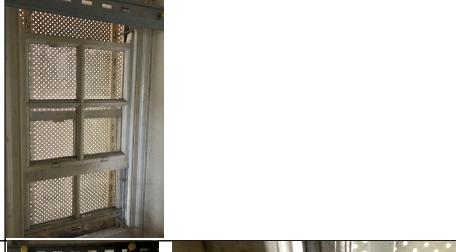
WF11	Corridor	NE (L-well)	B	Single timber sliding sash window in brickwork surround, stone sill. Good condition internally. Rub down and repaint

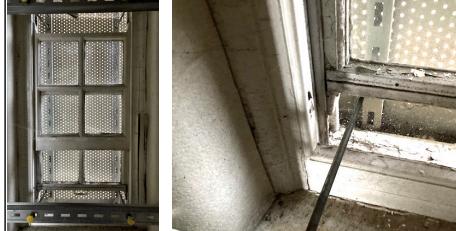
WF12	Corridor	NE (L-well)	B	Single timber sliding sash window in brickwork surround, stone sill. Good condition generally. Rub down and repaint

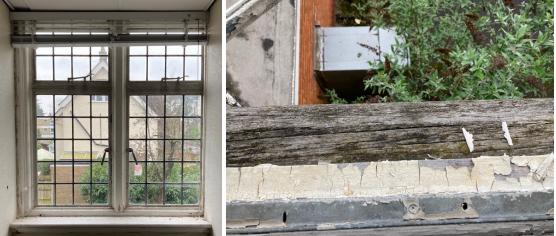
WF16	Year 3 Rm 1	SW	C	Two parts of triple window. Open casements with opening fanlights over. Steel frames in timber sub-frames with leaded panes. Some original, some replacement fittings. Timber boarding around facing brickwork surround. Timber cill in poor condition and paintwork peeling to outside but otherwise in good condition. Make good or replace cill. Restore and repaint window as necessary

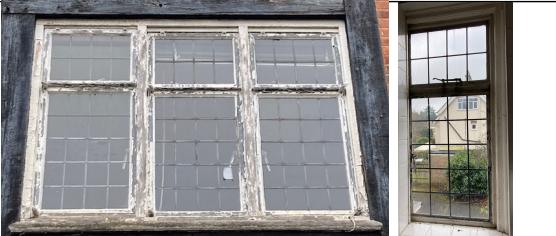
WF17	Year 3 WC	SW	C	One part of triple window. Open casements with opening fanlights over. Steel frames in timber sub-frames with leaded panes. Some original, some replacement fittings. Timber boarding around facing brickwork surround. Timber cill in poor condition and paintwork peeling to outside but otherwise in good condition. Make good or replace cill. Restore and repaint window as necessary

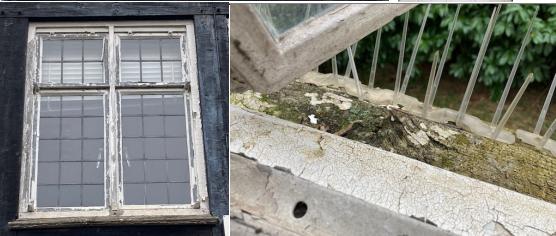
WF18	Year 3 Rm 2	SW	C	Double window. Open casements with opening fanlights over. Steel frames in timber sub-frames with leaded panes. Some original, some replacement fittings. Timber boarding around facing brickwork surround. Timber cill in poor condition and paintwork peeling to outside but otherwise in good condition. Make good or replace cill. Restore and repaint window as necessary

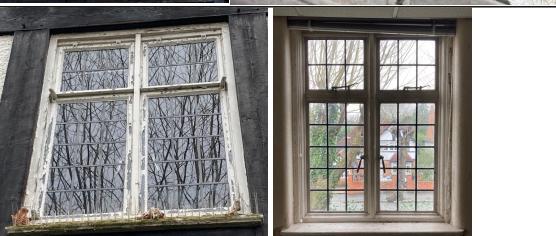
WF19	Year 3 Rm 2	NW	C	Double window. Open casements with opening fanlights over. Steel frames in timber sub-frames with leaded panes. Some original, some replacement fittings. Timber boarding around facing brickwork surround. Paintwork peeling to outside but otherwise in good condition. Restore and repaint window as necessary
