## Draft Claim Assessment Report

On behalf of **Aviva**

**Our Reference:** IFS-AVI-SUB-18-0076236

**Risk Address:** 29 Nicholas Way, North Wood, HA6 2TR

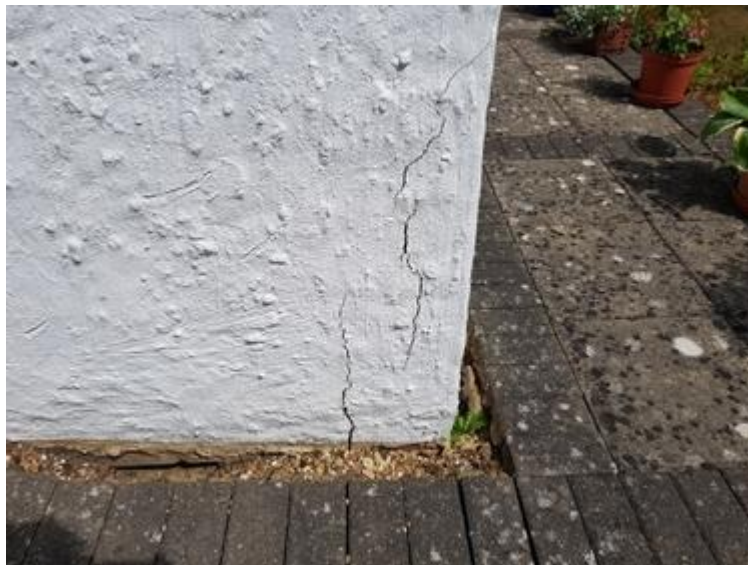
A vertical 10mm crack was present to the right hand rear corner, extending from ground level and diminishing with height.

FIGURE 03 Extension right hand elevation rear corner

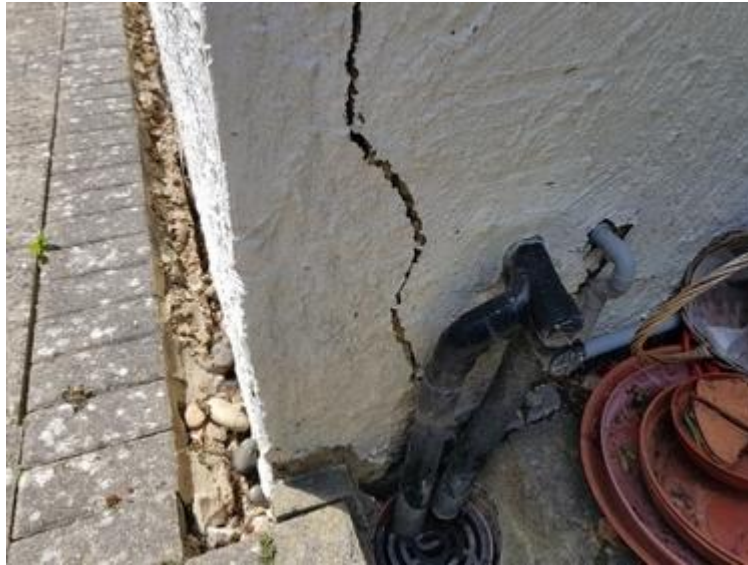
A vertical 5mm crack was present to the left hand elevation rear corner, extending from ground level and diminishing with height.

FIGURE 04 Extension left hand elevation rear corner

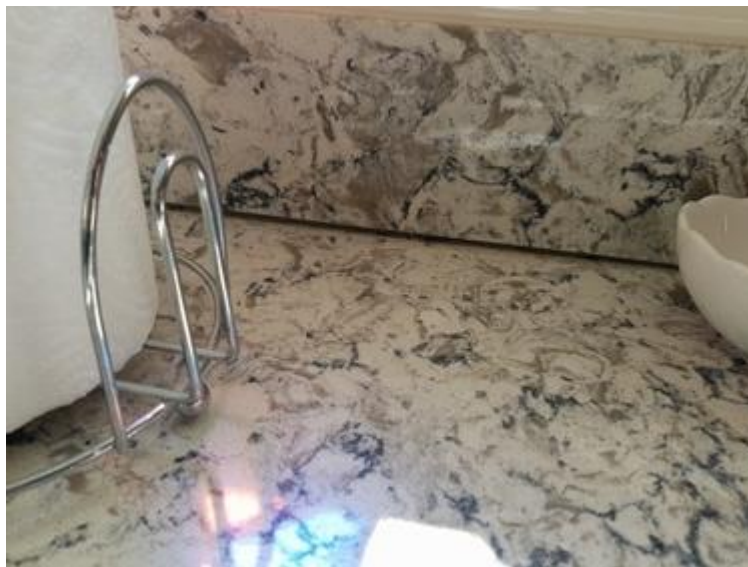
FIGURE 05 Kitchen gap to work top
