## TREE SURVEY - HEALTH & SAFETY

Proj. No <b>9298</b>	<b>49 St Martins Approach, Ruislip, London, HA4 7QH</b>
Client:	Mr Sam Robbins
Date of Report:	01/02/2022

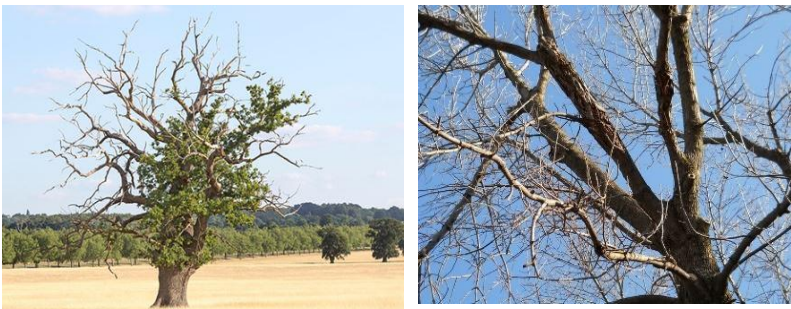
<b>Name: Deadwood</b>	
<b>Symptoms/damage type and cause:</b>	This relates to dead branches in the crown of the tree. In most cases, this is caused by the natural ageing process of the tree or shading due to its proximity to neighbouring trees. However, in some situations, it may be related to fungal, bacterial or viral infection.
<b>Consequence:</b>	Depending upon the location and mass of dead wood removal of the affected tissue may be necessary to prevent harm to persons or property as the wood will become unstable as it decays and in some circumstances is likely to fall from the tree with little or no warning.
<b>Control:</b>	Detailed monitoring should be undertaken on those trees showing signs of excessive deadwood production to identify the underlying cause.
<b>Species affected:</b>	Most tree species.
<b>Images:</b>

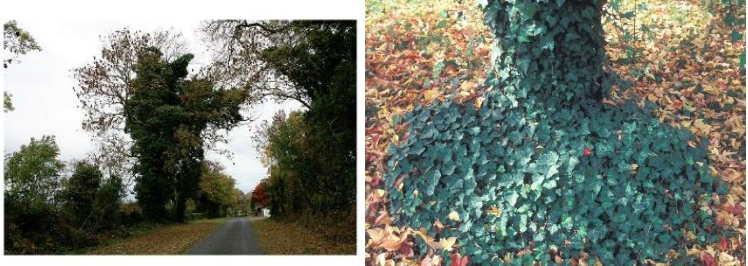
<b>Name:</b> <i>Hedera helix</i> (Ivy)	
<b>Symptoms/damage type and cause:</b>	Ivy may grow to varying degrees on all areas of a tree from the base to the upper crown. It is possible that in doing so it will out-compete the host tree for available light thereby suppressing the host.
<b>Consequence:</b>	This is generally only harmful to the tree on already unhealthy specimens which may be constricted by large ivy stems around the trunk or may have their top growth suppressed by a mass of flowering shoots in the crown. Ivy can also mask potentially dangerous faults on a tree.
<b>Control:</b>	Ivy should only be removed if necessary because it provides abundant cover to wildlife and then by severing twice close to the ground and removing a length of stem thereby causing the gradual dying away of the aerial parts of the plant providing extended benefit to wildlife whilst relieving the pressure on the tree.
