Subsidence Damage at: 16 Deerings Drive, Pinner, HA5 2NZ

# Arboricultural Consultancy for Aviva / Barclays / Woolwich

Insured	Mr Amit Karia	Address	16 Deerings Drive, Pinner, HA5 2NZ		
Client	Subsidence Management Services	Contact	Ian Domigan	Claim No.	IFS-AVI-SUB-22-0101567
ES Ref	SA-250316	Consultant	Giles Mercer	Contact No.	0330 380 1036
Report Date	26/09/2022

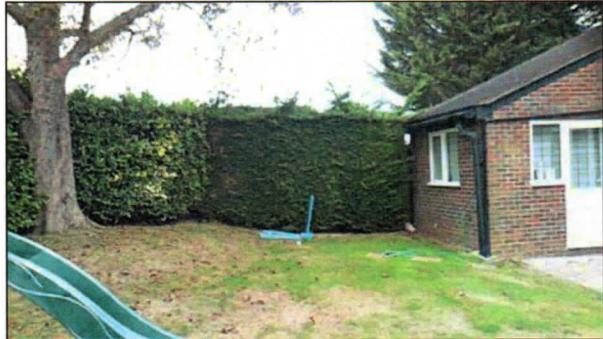
H1 - Mixed species hedge

With due regards to species profile, size and proximity, the Red Oak (T3 & T4), the Horse Chestnut (T1) and the mixed species hedge (H1) are considered the dominant features proximate to the focal area(s) of movement and accordingly, where vegetation is confirmed as being causal, we have identified them as the primary cause of the current subsidence damage.

Consequently, we have advocated the complete removal of, the Red Oak (T3 & T4) and the Horse Chestnut (T1) in conjunction with management, to include partial removal of a section of the mixed species hedge H1 (as detailed) as it will offer the most certain arboricultural solution likely to restore long-term stability.
