# WAR MEMORIAL REPORT

## Summary of The Polish War Memorial

Q 00209

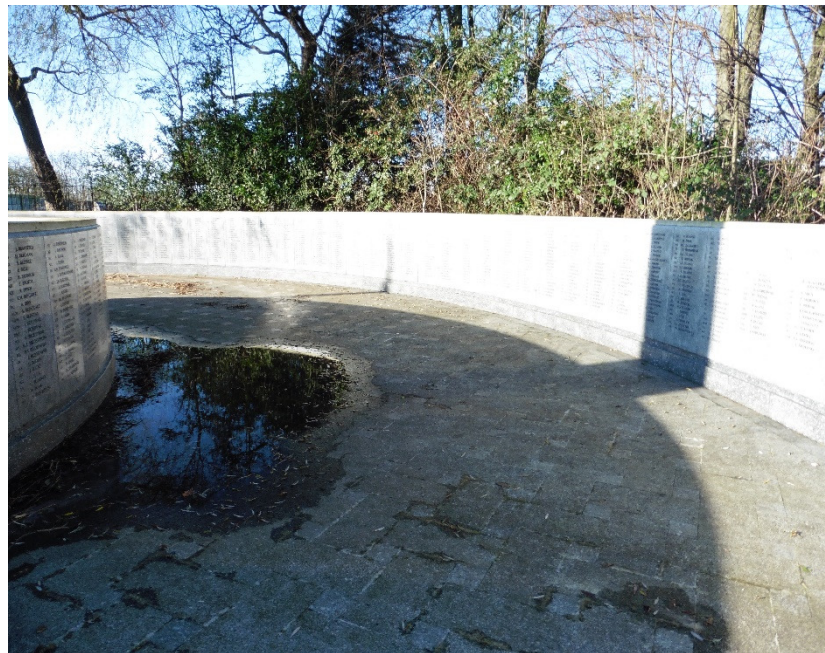
**Picture 2. Granite section showing ponding**

Granite section with roll of hour is in good condition apart from the drain seems to be slow or blocked, as there is a large area of ponding after rains, also sand and gravel run off from the path up to the garden of remembrance, is running across the granite paving into the drain channel, some parts of the paving have open joints.

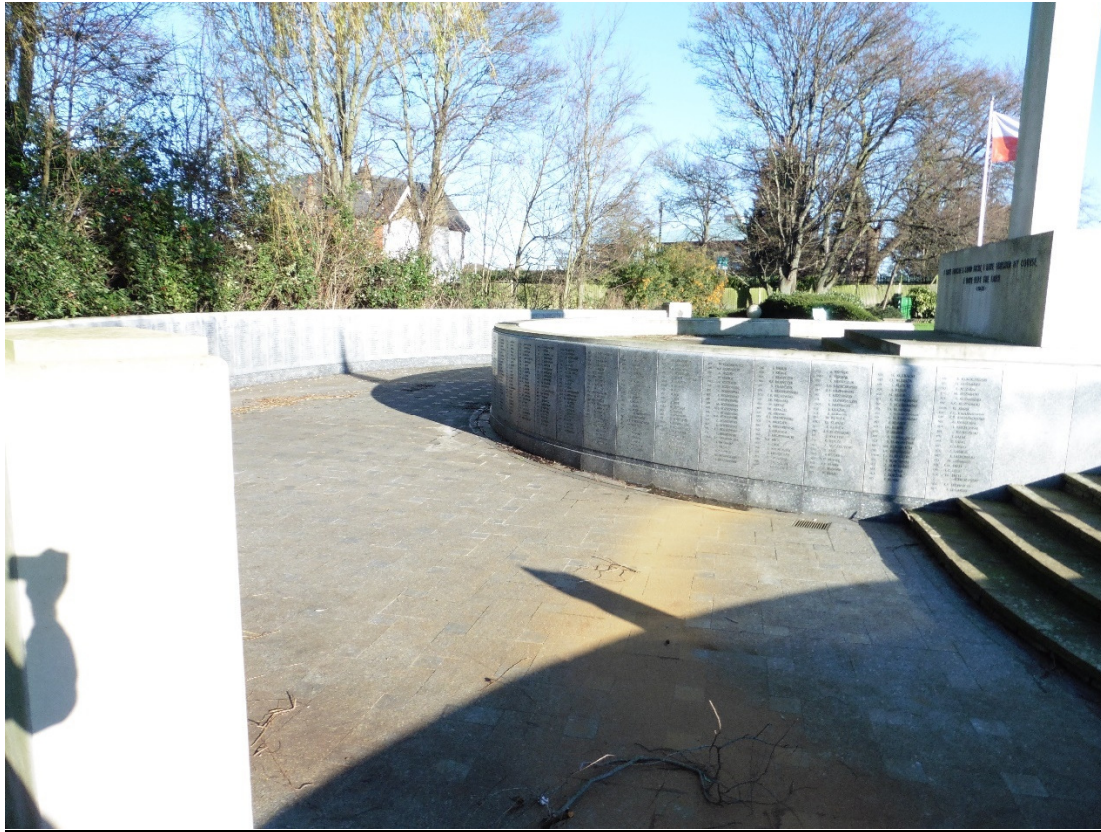
Picture 3. Showing granite paving with run off from path to remembrance garden

The granite section collects leaves and these lead to staining and with the orange sand wash off of the path also causing staining cleaning recommended

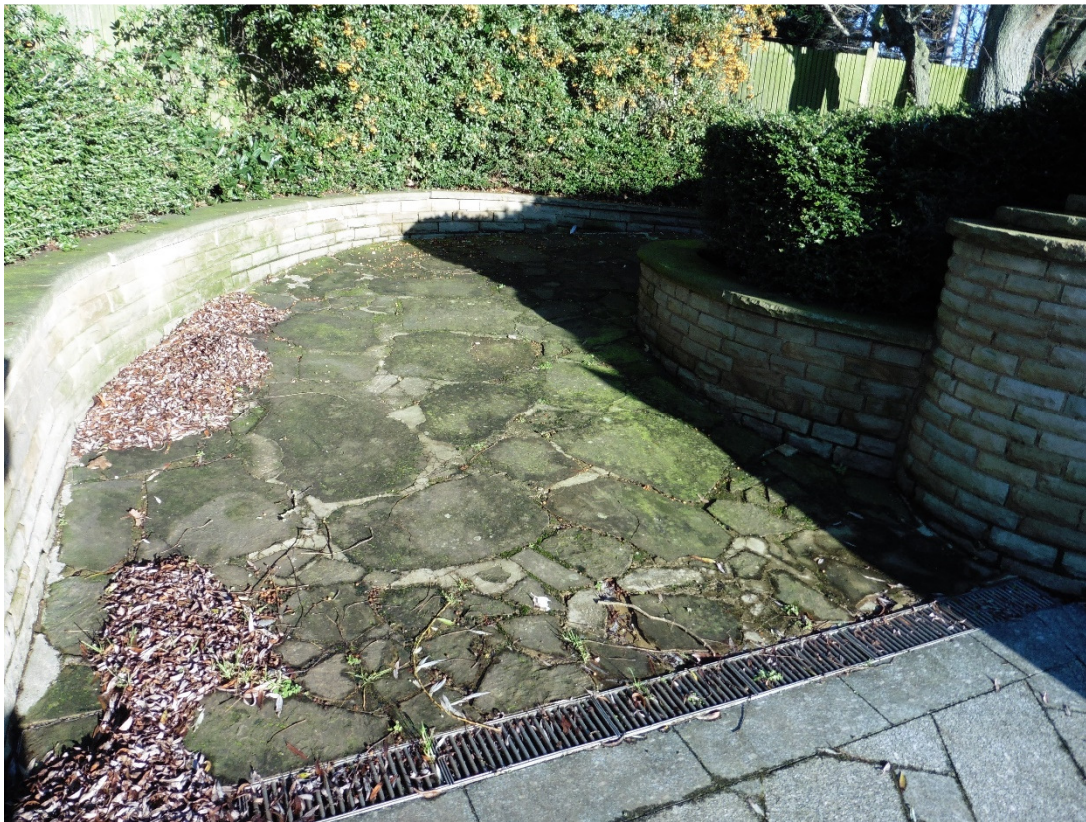
Picture 4. Showing previous patching and further deterioration to York paving

York crazy paving and walling, the crazy paving is the largest area, this is the part of the memorial that is in the worst condition, the crazy paving requires a lot of re-pointing and the York stone has broken up so trip hazards have been formed. (position shown in pictures 4-7)

The problem with re-pointing the crazy paving is that all the joints would need cutting out and re-pointing to a reasonable depth to avoid frost from causing them to fail again. The problem with that is the stones might become loose dependant on how the stones where fixed. It might be worth taking up a section at a time and re-bedding it and re-pointing, and doing this over a period of years, this way trip hazards can be reduced.

York crazy paving has got sections of jointing that has failed and some is missing completely and requires re-pointing, the crazy paving is the worst area and the largest, it requires a lot of re-pointing and the York stone has broken up so trip hazards have been formed.

The problem with re-pointing the crazy paving is that all the joints would need cutting out and re-pointing to a reasonable depth to avoid frost from causing them to fail again. The problem with that is the stones might become loose dependant on how the stones were fixed. It might be worth taking up a section at a time and re-bedding it and re-pointing, and doing this over a period of years, this way trip hazards can be reduced.

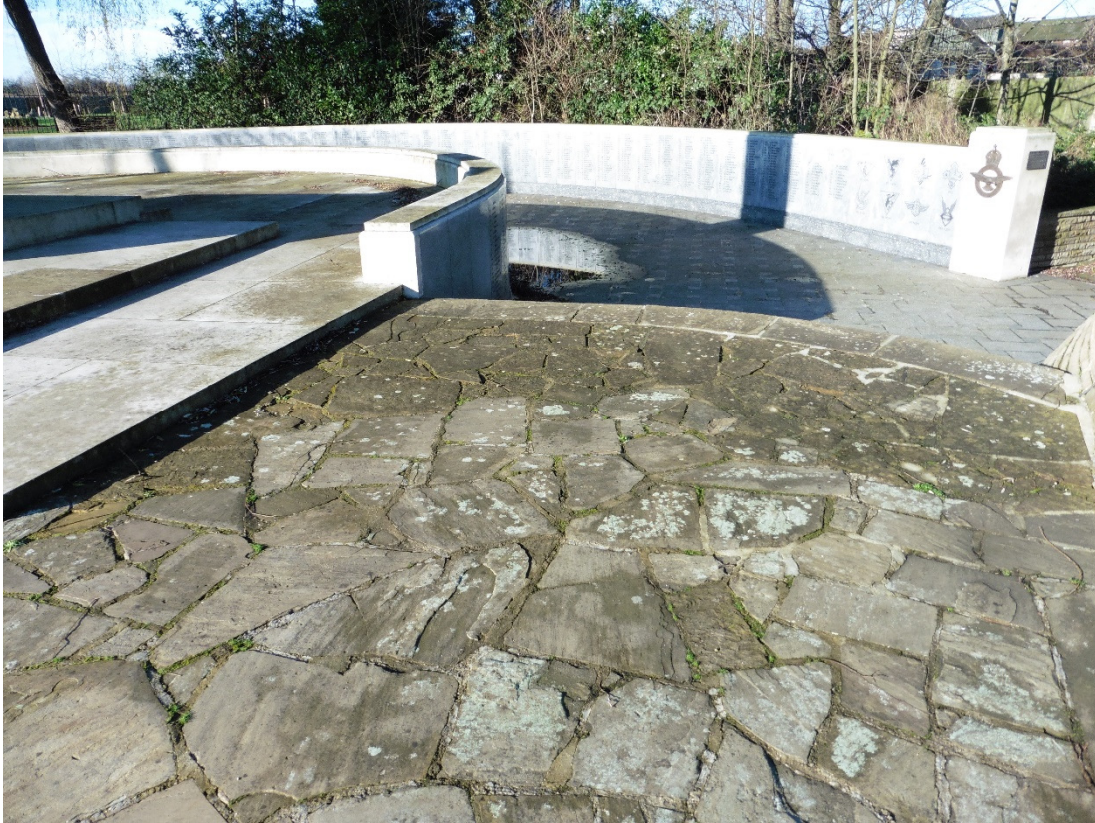
Picture 5. Showing York paving with open joints and with some vegetative growth

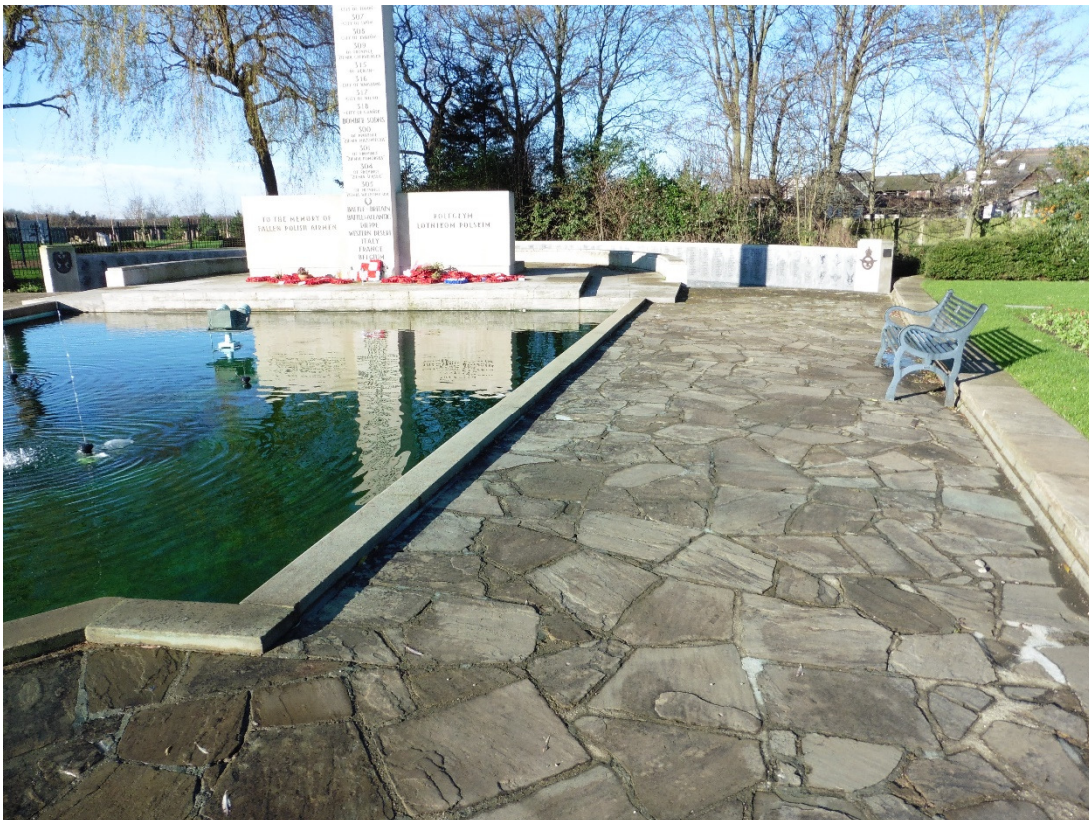
Picture 6. Open joints to York paving with previous patching

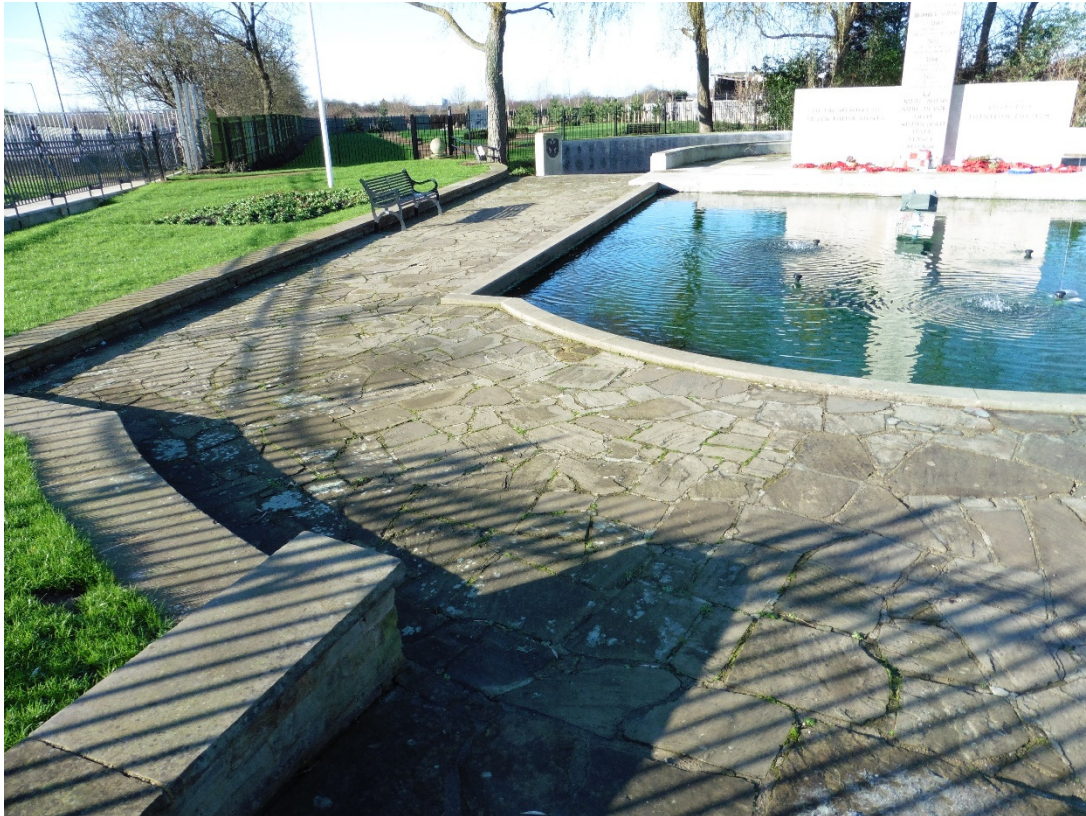
Picture 7. Open joints to York paving and copings

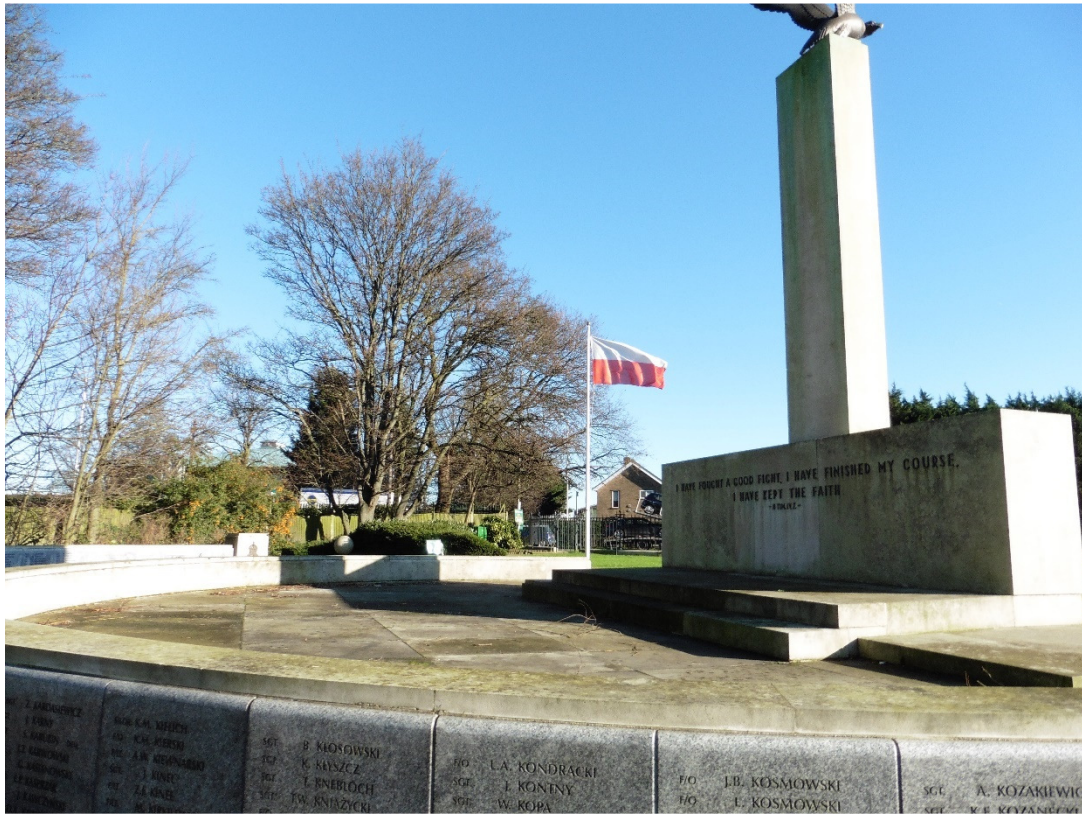
Picture 9. Portland paving and back of memorial showing signs of ageing and algal growth

The Portland stone Cenotaph and surrounding paving again is green with algal growth especially the back (north side) suggest cleaning

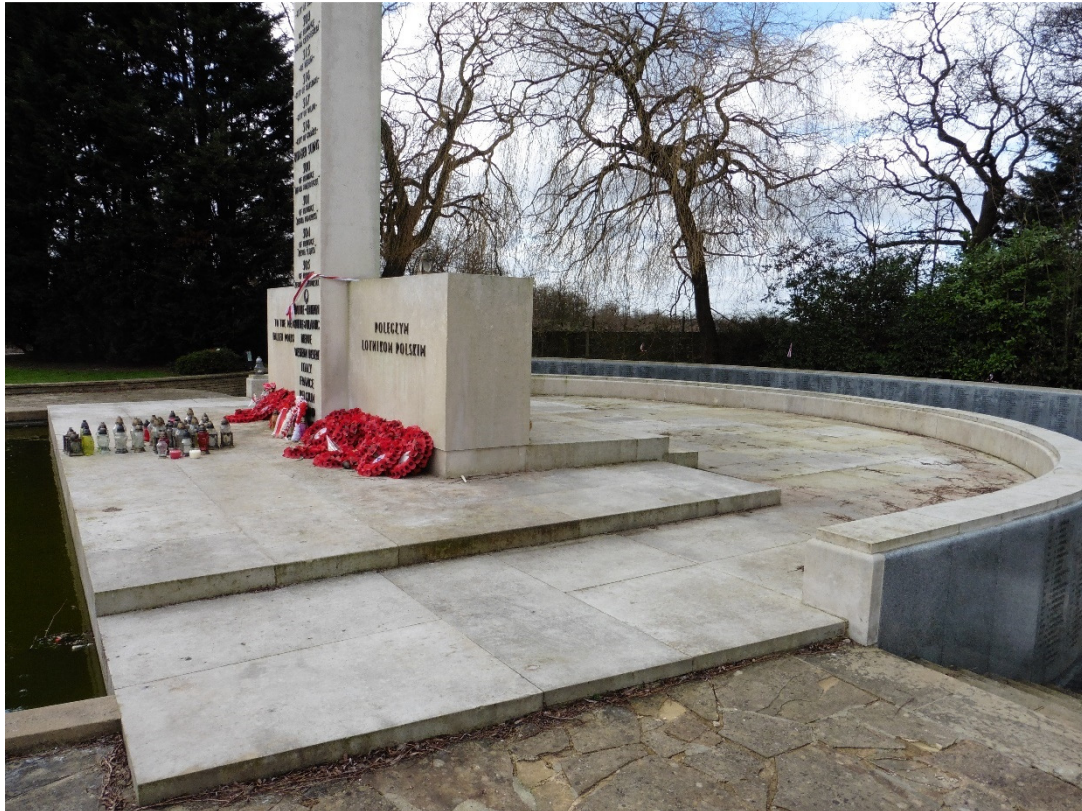
Picture 10. Showing position of damage in close up in picture 11

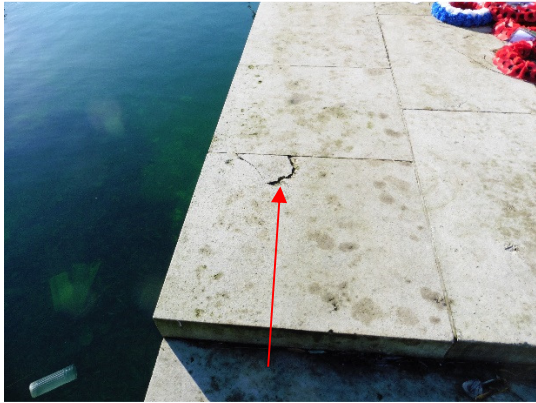
Picture 11. Damage to stone

There are two damaged stones, one has cracked (position shown in picture 12) and the other has spalled face (position shown in picture 11)

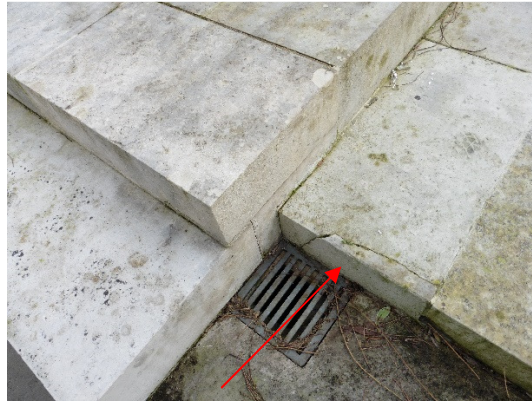
Picture 12. Damage to stone

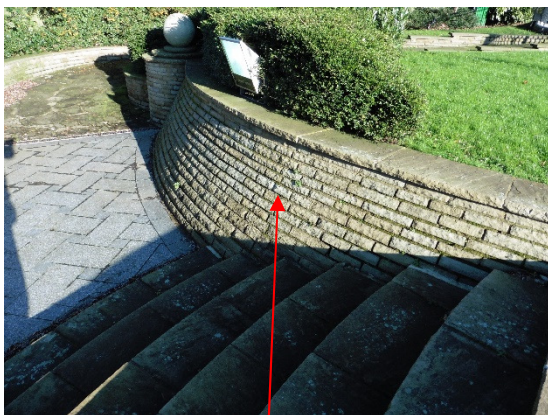
Picture 13. Showing open jointing to walling

The walling has got several sections of jointing that has failed and some is missing completely and requires re-pointing, with the removal of vegetation that has taken advantage of the open joints. (position shown in picture 13)

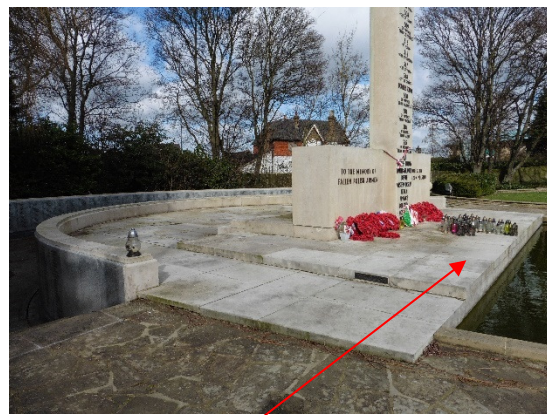
Picture 14. Showing position of rocking stone

Portland memorial and paving, this part of the memorial is in relatively good condition, with some open joints, one loose stone (position shown in picture 14)
