Please find below the results of your Infiltration testing. The information contained below is a summary of the site works carried out on 15<sup>th</sup> November 2022.

Location	30-32 Chester Road, Northwood, Middlesex, HA6 1BQ
Date	November 15, 2022
Project Reference	YEX4848

## Soakaway Test

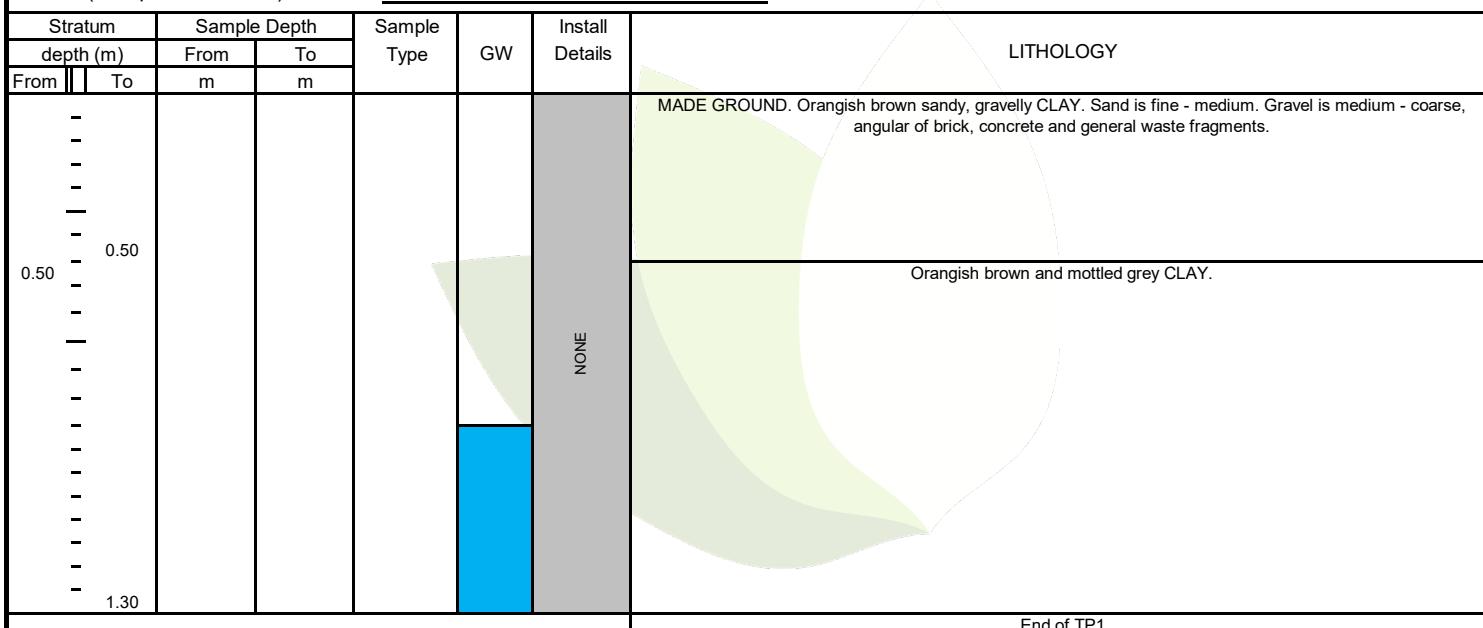
Width	<u>0.4</u>	m
Length	<u>1.1</u>	m
Depth	<u>1.3</u>	m

## Method (Trial pit, window etc)      Trial Pit - Machine Excavation

End of TP1

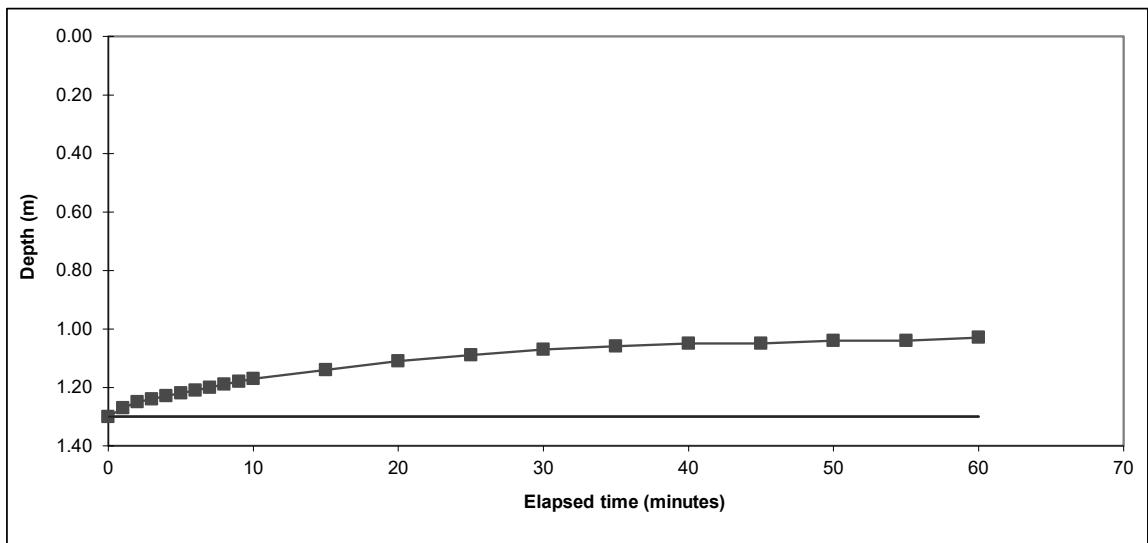
Soil infiltration rate (m/s):	Test incomplete as 25% effective depth not achieved. Unable to reliably determine soil infiltration rate.
Remarks	Results processed following BRE 365 (2007).
