Please find below the results of your Infiltration testing. The information contained below is a summary of the site works carried out on 15th November 2022.

Location	30-32 Chester Road, Northwood, Middlesex, HA6 1BQ
Date	November 15, 2022
Project Reference	YEX4848

Soakaway Test

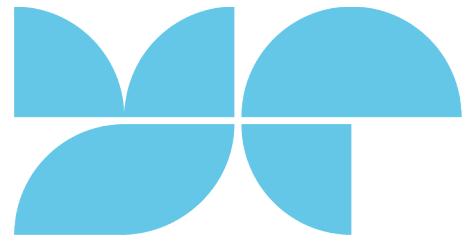
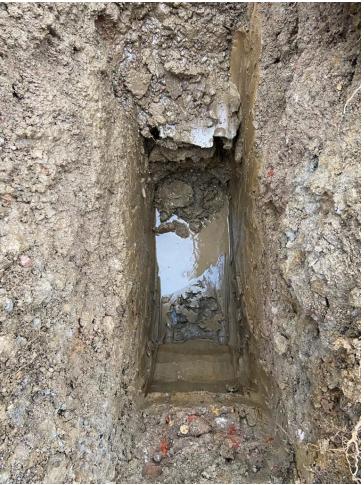
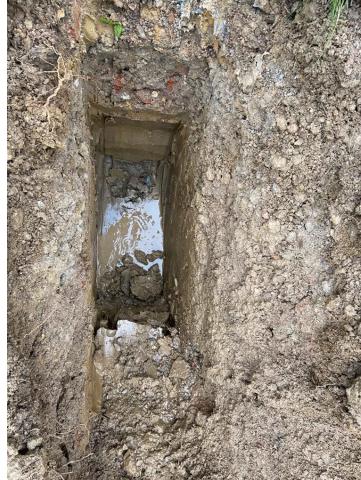
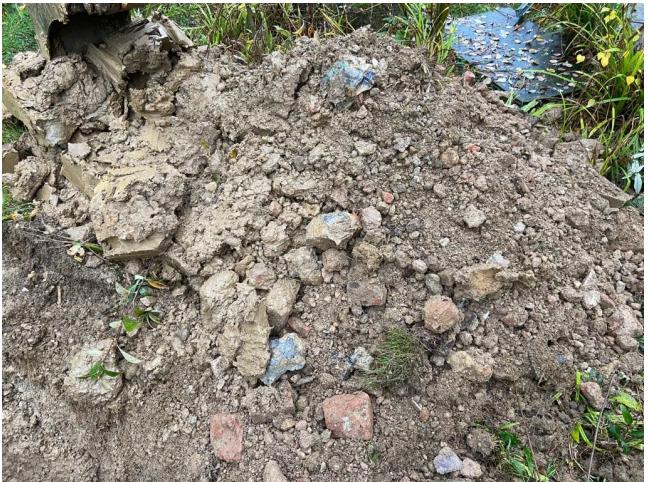
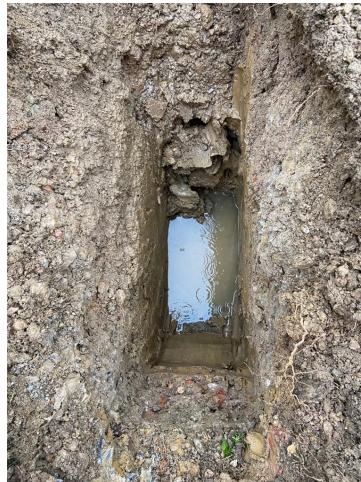
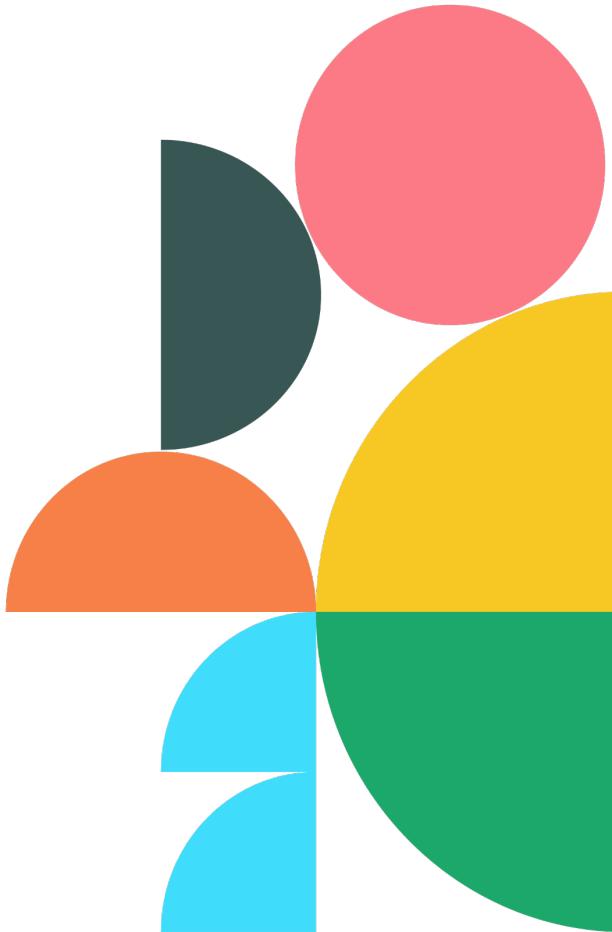
TP01 Photos

During the excavation of the trial pit, ground or perched water started to enter the pit at a depth of 1.30mbgl. The excavation was halted and monitored for approximately sixty minutes in which the water level rose to approximately 1.00mbgl. The results obtained from the soakaway tests are summarised below:

The soils encountered beneath the site were found to be predominantly CLAY. Given the ground / perched water levels and data from the test, it is considered that soakaways are not suitable for this site.
