Elite Designers Structural Engineers

Structural Defects to The Countess of Derby's Almshouses, Church Hill, Harefield, UB9 6DU

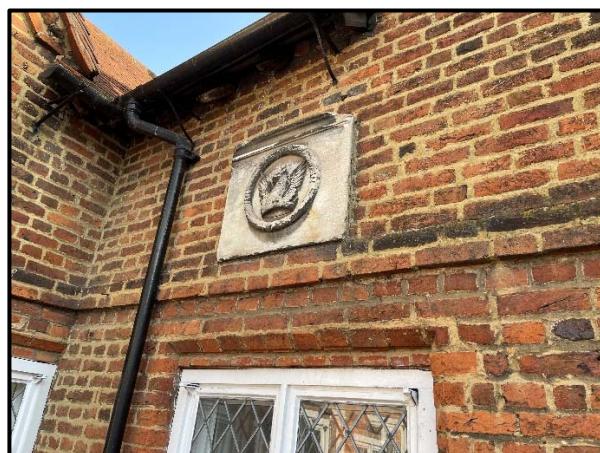
Figure 1 – North Plaque

The western façade of the building consists of a large central door opening with a flat brick arch above and two-pane casement windows either side, each with flat brickwork above. Above each of these windows and the central door is an ornate stone plaque, set into purpose-built recesses in the wall. The plaque above the southernmost window has fallen out, revealing the substrate to be comprised of a single skin of brickwork to the internal skin, a skin of brickwork on edge in front of this and mortar dabs in front of this to set the plaque in place. There is evidence of the central and south plaques having been reset into place previously. There is evidence of previous repairs to the panel between the south window and plaque recess above, where the flat brick opening has deformed and the subsequent cracking repointed. The central door opening has experienced similar deformations, with the central brick arch having dropped and the panel above cracking at the corners of the door opening.

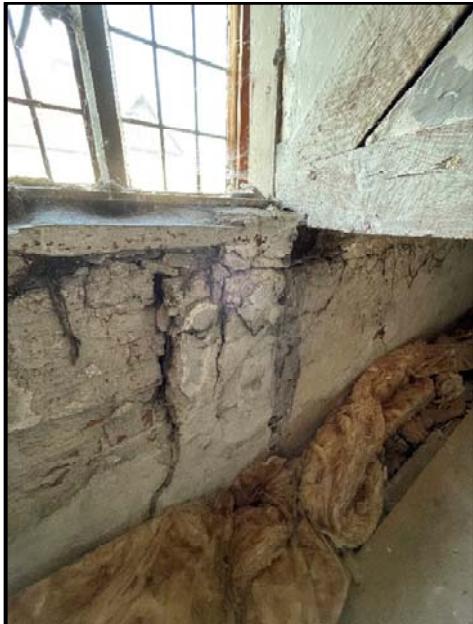
Figure 4 – Cracking at Location of Truss Bearing

Internally, there is a large timber truss forming the ridge of the gable to the façade in question – the truss bears onto a wall plate that forms the sill for a central four-pane casement window in the centre of the gable. This wall plate is in very poor condition and has completely rotted away in places. There is a low 9" wall below this wall plate which is comprised of the top section of the main façade wall above the door and window openings below. There is a full height crack in this wall to the south side of the truss location, and the brick wall has crushed and moved inwards directly below the truss. The wall either side of this region is generally plumb and free of significant defects.

The gable truss to the centre of the building is presently causing significant structural damage to the west façade. This deterioration of the wall plate has resulted in a substantial concentrated load being imposed directly onto the brickwork below, which has subsequently experienced a shear crack, localised crushed and lateral deformation of the wall panel in this area. This is likely to be the cause of the historic cracking in evidence and the dropping of the brick arch over the doorway. It is not clear whether this defect also resulted in the cracking to the south window opening – the most likely explanation is that the deformation of the wall panel generally has resulted in the flat brick reveal dropping in this area. It is recommended that the gable truss be supported in the temporary condition, the wall locally rebuilt over the door opening and a timber wall plate to match the existing dimensions reinstated to restore the capability of the brick panel to spread the load more evenly. It is recommended that a steel PFC150x90x24 spreader beam is also installed below the wall plate on the inner skin to avoid overloading the brick arch below, extending past the width of the door opening onto the panels of brickwork either side.
