**Church Gardens  
Church Hill  
Harefield  
Middx. UB9 6DU**

**Orchard Wall Repair & Restoration**

**Photographic Record  
&  
Schedule of Works**

**Home Plans  
July 2020**

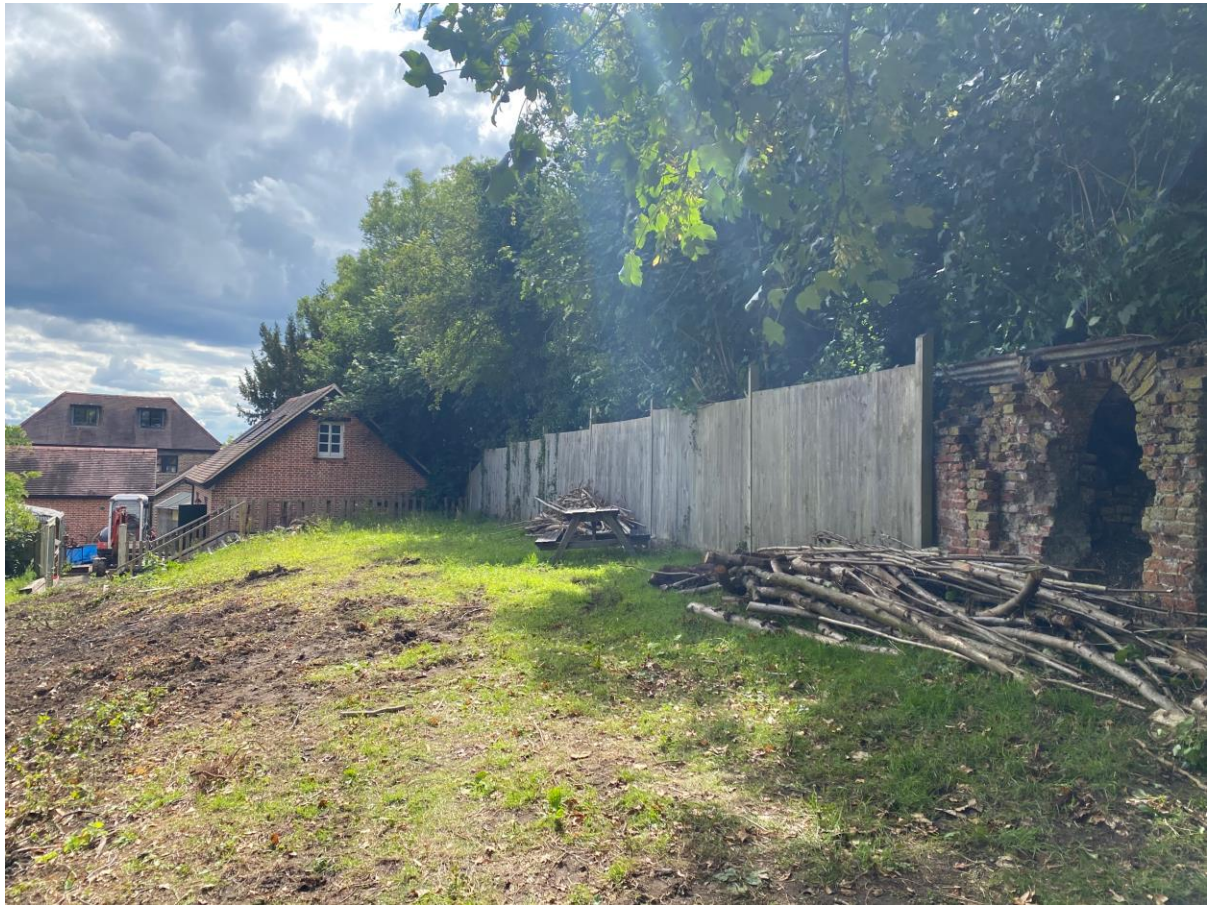
P1

### **WALL 3 – Orchard Area**

**Description** - Remains of original brick boundary wall now approx. 0.8m – 0.9m high retaining earth behind but leaning inwards – wall 380mm thick with plinth increasing to 520mm.

**Proposed Works required** - Existing wall to be completely removed to foundation level. Wall to be carefully demolished by hand and all salvaged brickwork to be stacked and stored safely on site for reuse. Excavate and provide new concrete strip foundation with retaining wall element to support existing ground, all to Structural Engineer's design and detail.

Rebuild wall to full height in matching 50mm handmade stock bricks in 1:4 Lime mortar mix. Wall to be 360mm thick with bricks laid in English Garden bond to match existing. Connect new brickwork to existing at each end. Provide chamfered brick detail to top of wall with brick on edge coping.

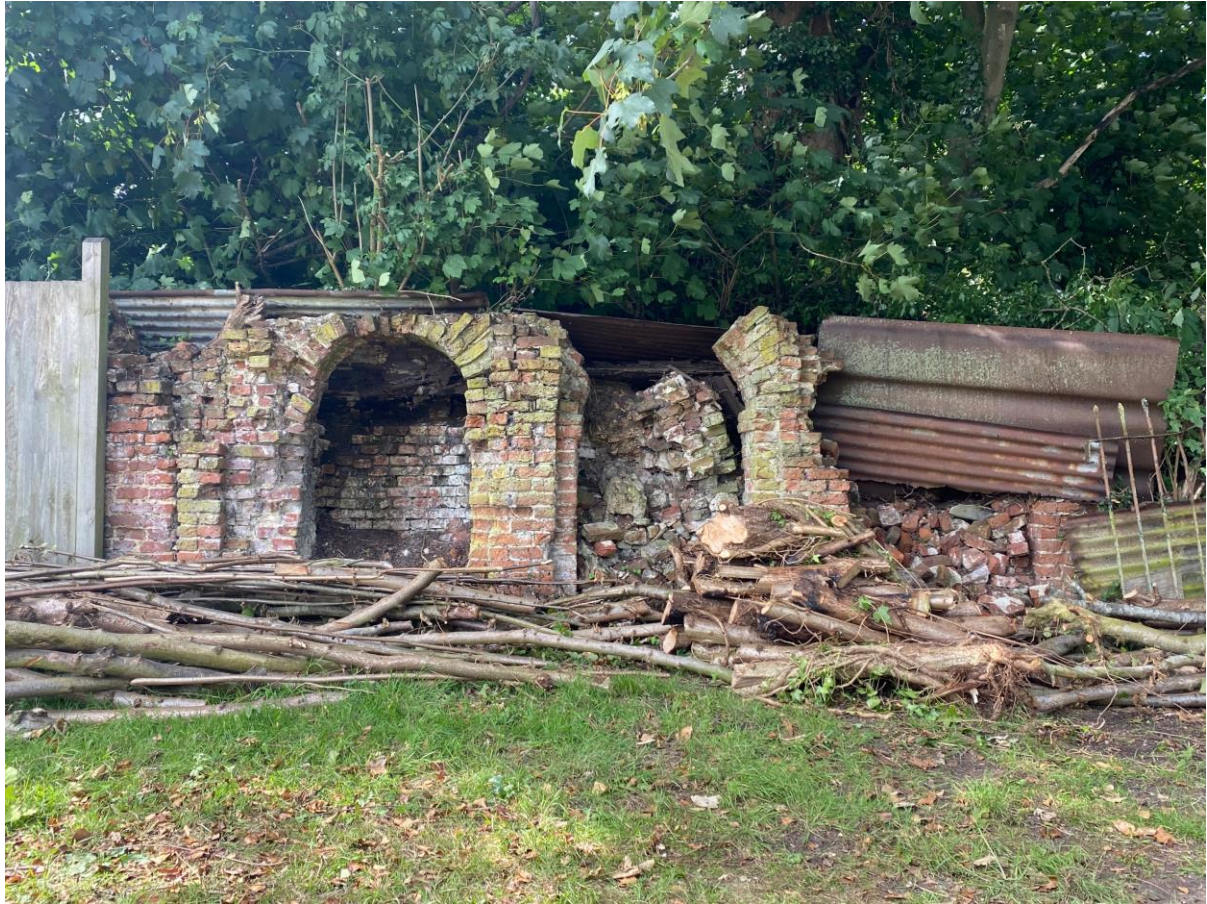
### Wall 3 – Arches 1, 2 & 3

**Description** - Remains of original brick feature boundary wall comprising of 33 arches and niches. Wall is approx. 2.5m high and retaining earth behind to full height in most areas. It is understood that there would originally have been a walkway along the top and it is assumed that there would have been a protective barrier of some form along the front edge.

| <b>Arch No. 1</b> | <b>% Remaining</b> | <b>Existing Condition</b> | <b>Repair requirements:<br/>Fabric to add</b> | <b>% pointing required</b> |
|---|---|---|---|---|
| <b>Arch</b> | 85 | Front course missing | | 50 |
| <b>West Pilaster</b> | 30 | Most missing | 10% toothed in to existing | 60 |
| <b>Niche</b> | 85 | Most in place | | 100 |

| <b>Arch No. 2</b> | <b>% Remaining</b> | <b>Condition As Found</b> | <b>Repair requirements:<br/>Fabric to add</b> | <b>% pointing required</b> |
|---|---|---|---|---|
| <b>Arch</b> | 10 | Sound East end – remainder collapsed | Repair East end – rebuild arch | 5 |

**Proposed Works required** - The proposed works involve all necessary repairs and rebuilding works to restore this feature wall to as close to it's original condition as possible with all arches and recessed niches reformed to match the existing. All repair and rebuilding works will be completed in matching 50mm handmade stock bricks in 1:4 Lime mortar mix. With feature detailing along the parapet edge. It is intended that the upper level walkway will be reinstated on completion of the restoration works with a selected metal protective balustrade along the front edge.

| <b>Arch No. 1</b> | <b>% Remaining</b> | <b>Existing Condition</b> | <b>Repair requirements:<br/>Fabric to add</b> | <b>% pointing required</b> |
|---|---|---|---|---|
| <b>Summary:</b> | Remove all collapsed brickwork from opening by hand. Clean and store all existing bricks to be reused. Excavate spoil within niche to ground level. Build over the arch top with mortar and tile. Replace mortars in front of arch. Left hand arch springer brick required. Consolidate pilaster column with new brick and rebuild niche to full height. Repoint most of exposed brickwork. Backfill ground to rear. | | | |

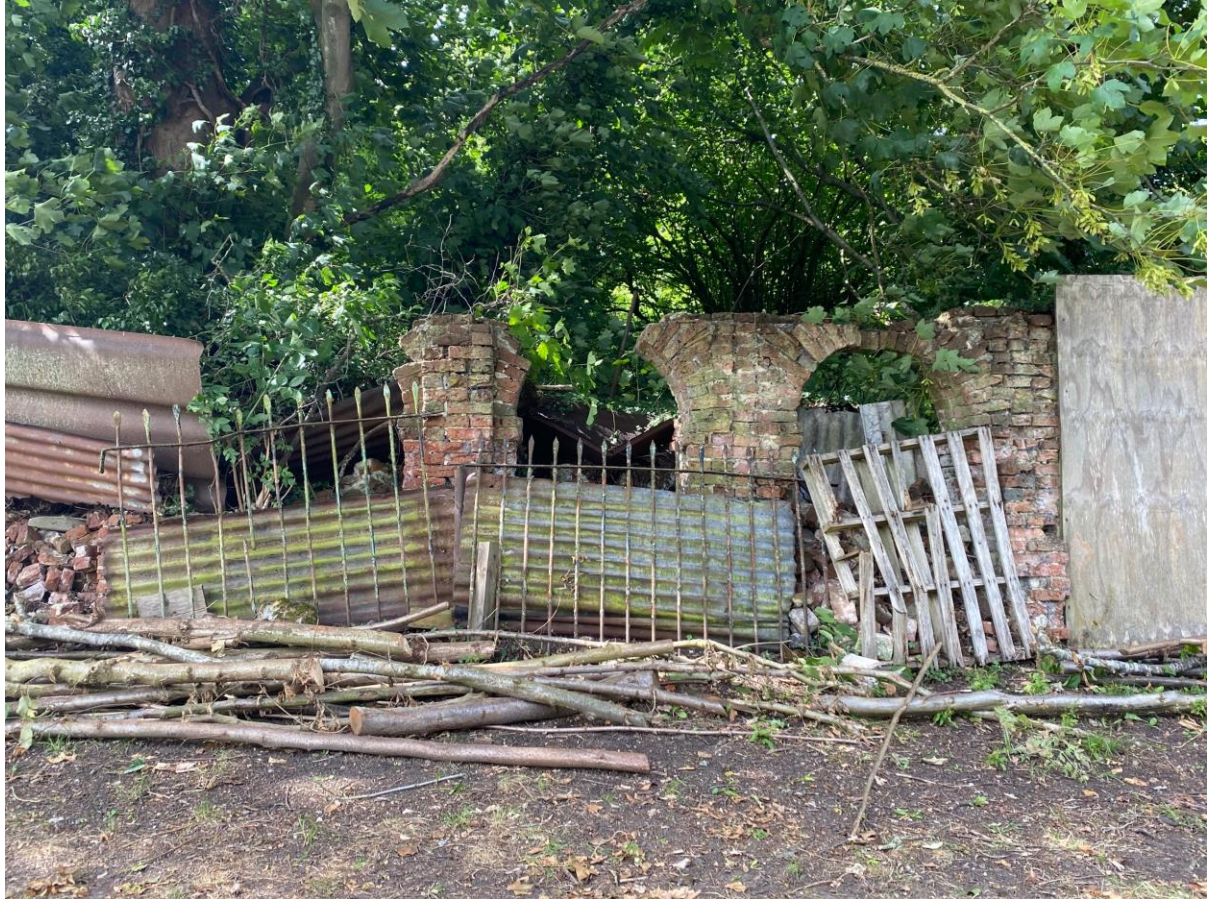
**Wall 3 – Arches 4, 5 & 6**

| Arch No. 6 | % Remaining | Condition As Found | Repair requirements:<br>Fabric to add | % requiring pointing |
|---|---|---|---|---|
| Arch | 80 | Sound | Repair to face and cap | |

| Arch No. 4 | % Remaining | Condition As Found | Repair requirements:<br>Fabric to add | % requiring pointing |
|---|---|---|---|---|
| <b>Summary:</b> | Remove all existing metal sheeting and collapsed brickwork and debris within opening and excavate spoil withing niche to ground level. Rebuild West pilaster to full height. Repair arch base on East side and rebuild arch with capping. Rebuild niche completely from existing base. Backfill ground to rear. | | | |

| Arch No. 5 | % Remaining | Condition As Found | Repair requirements:<br>Fabric to add | % requiring pointing |
|---|---|---|---|---|
| <b>Summary:</b> | Remove all existing metal sheeting and collapsed brickwork and debris within opening and excavate spoil withing niche to ground level. Repair face and top of West pilaster. Repair arch base on East side and rebuild arch with capping. Rebuild niche completely from existing base. Backfill ground to rear. | | | |

| Arch No. 6 | % Remaining | Condition As Found | Repair requirements:<br>Fabric to add | % requiring pointing |
|---|---|---|---|---|
| <b>Summary:</b> | Remove all existing sheeting and collapsed brickwork and debris within opening and excavate spoil withing niche to ground level. Repair face and top of West pilaster. Repair arch base on East side and rebuild | | | |

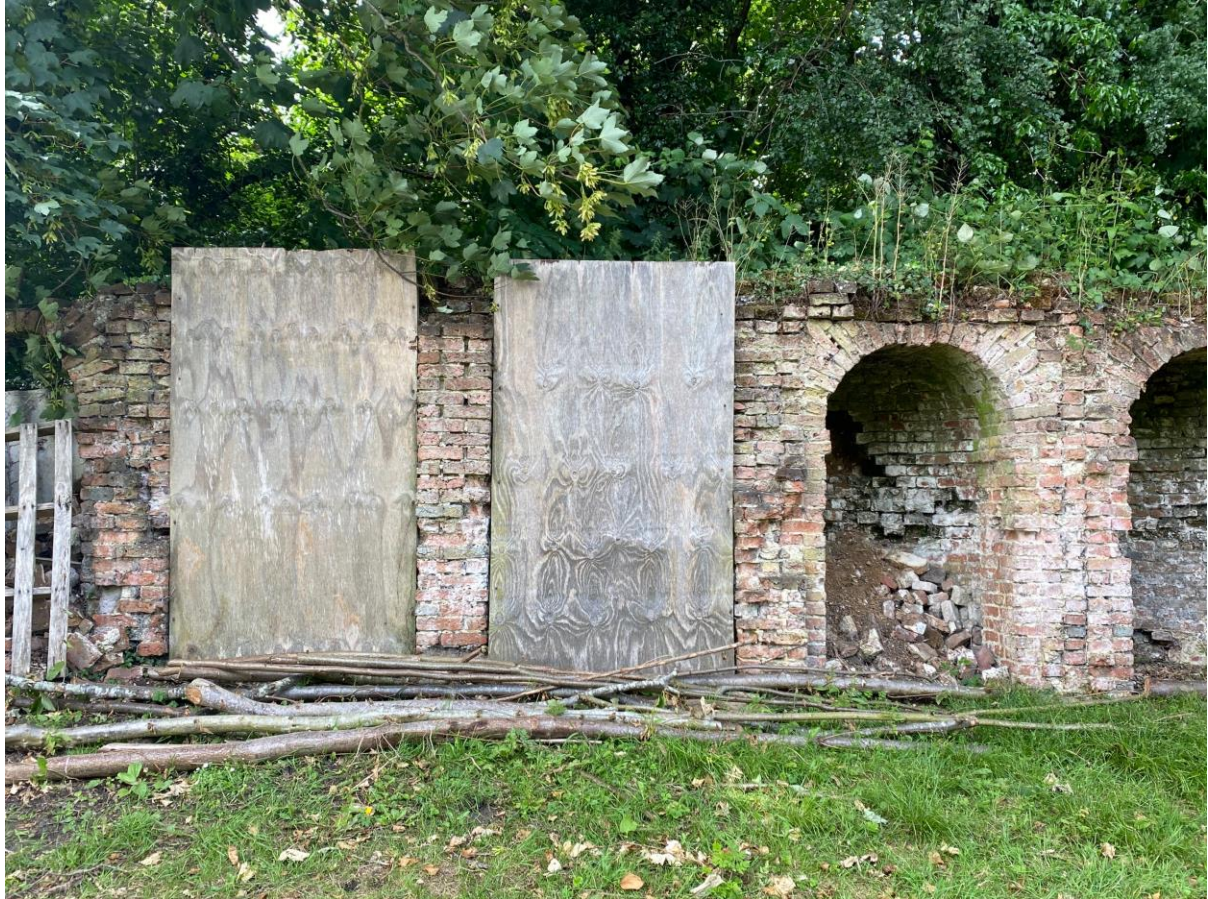
**Wall 3 – Arches 7, 8 & 9**

| Arch No. 7 | % Remaining | Condition As Found | Repair requirements:<br>Fabric to add | % requiring pointing |
|---|---|---|---|---|
| Arch | 80 | Sound | Repair to face and cap | |

| Arch No. 9 | % Remaining | Condition As Found | Repair requirements:<br>Fabric to add | % requiring pointing |
|---|---|---|---|---|
| Arch | 80 | Sound | Repair to face and cap | |
| Niche | 80 | Presume sound | Repair all areas. | 50 |

| Arch No. 7 | % Remaining | Condition As Found | Repair requirements:<br>Fabric to add | % requiring pointing |
|---|---|---|---|---|
| <b>Summary:</b> | Remove all existing boarding and collapsed brickwork and debris within opening and excavate spoil withing niche to ground level. Repair face and top of West pilaster. Repair arch base on East side and repair arch with capping. Rebuild niche to full height. Backfill ground to rear. | | | |

| Arch No. 9 | % Remaining | Condition As Found | Repair requirements:<br>Fabric to add | % requiring pointing |
|---|---|---|---|---|
| <b>Summary:</b> | Remove all collapsed brickwork and debris within opening and excavate spoil withing niche to ground level. Repair face and top of West pilaster. Repair arch with capping. Repair niche. Backfill ground to rear. | | | |

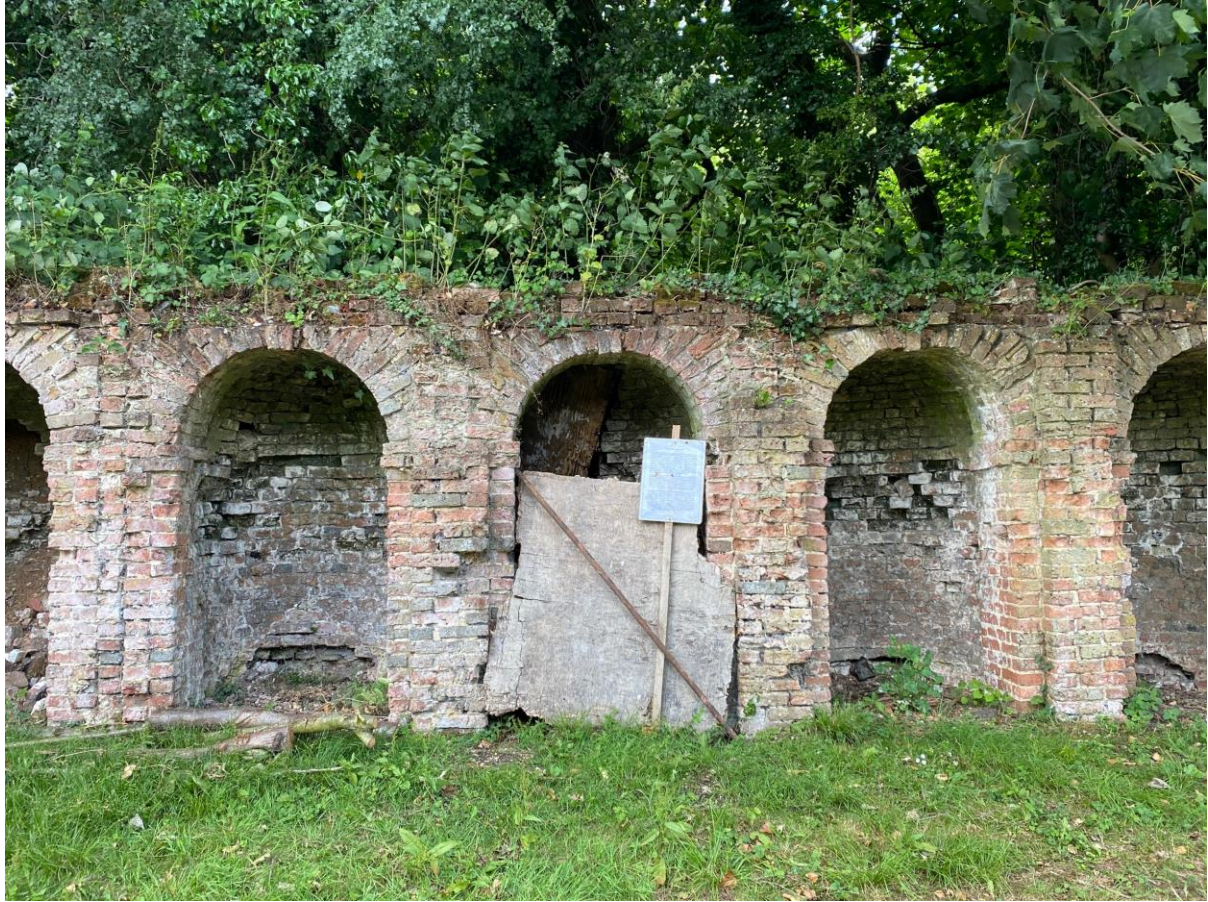
**Wall 3 – Arches 10, 11 & 12**

| <b>Arch No. 10</b> | <b>%<br/>Remaining</b> | <b>Condition As Found</b> | <b>Repair requirements:<br/>Fabric to add</b> | <b>%<br/>requiring<br/>pointing</b> |
|---|---|---|---|---|
| <b>Arch</b> | 80 | Sound | Repair to face and cap | |
| <b>Niche</b> | 80 | Presume sound | Repair all areas. | 50 |
| <b>Dome</b> | 60 | | Repair all areas. | 50 |

| <b>Arch No. 11</b> | <b>%<br/>Remaining</b> | <b>Condition As Found</b> | <b>Repair requirements:<br/>Fabric to add</b> | <b>%<br/>requiring<br/>pointing</b> |
|---|---|---|---|---|
| <b>Arch</b> | 90 | Sound | Repair to face | |

| <b>Arch No. 12</b> | <b>%<br/>Remaining</b> | <b>Condition As Found</b> | <b>Repair requirements:<br/>Fabric to add</b> | <b>%<br/>requiring<br/>pointing</b> |
|---|---|---|---|---|
| <b>West Pilaster</b> | 90 | Sound | Repairs to East face and front | 50 |

| <b>Arch No. 10</b> | <b>%<br/>Remaining</b> | <b>Condition As Found</b> | <b>Repair requirements:<br/>Fabric to add</b> | <b>%<br/>requiring<br/>pointing</b> |
|---|---|---|---|---|
| <b>Summary:</b> | Remove all collapsed brickwork and debris within opening and excavate spoil withing niche to ground level. Repair face and top of West pilaster. Repair arch with capping. Repair niche. Backfill ground to rear. | | | |

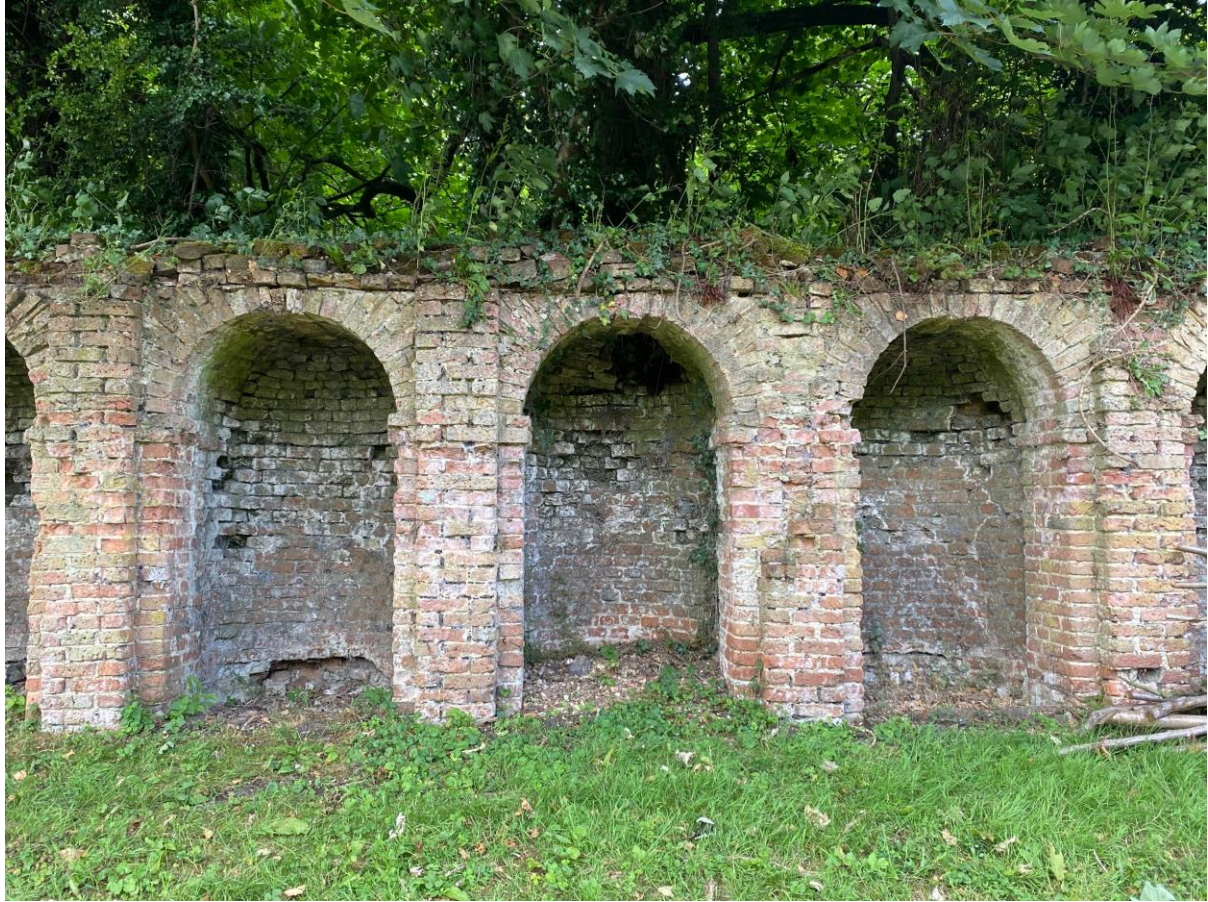
**Wall 3 – Arches 13, 14 & 15**

| <b>Arch No. 13</b> | <b>%<br/>Remaining</b> | <b>Condition As Found</b> | <b>Repair requirements:<br/>Fabric to add</b> | <b>%<br/>requiring<br/>pointing</b> |
|---|---|---|---|---|
| <b>Arch</b> | 90 | Sound | Repair to face | |
| <b>West Pilaster</b> | 90 | Sound | Repairs to face. | 50 |
| <b>Niche</b> | 80 | Presume sound | Repair all areas. | 50 |

| <b>Arch No. 13</b> | <b>%<br/>Remaining</b> | <b>Condition As Found</b> | <b>Repair requirements:<br/>Fabric to add</b> | <b>%<br/>requiring<br/>pointing</b> |
|---|---|---|---|---|
| <b>Summary:</b> | Remove all collapsed brickwork and debris within opening and excavate spoil withing niche to ground level. Repair face and top of West pilaster. Repair arch with capping. Repair niche. Backfill ground to rear. | | | |

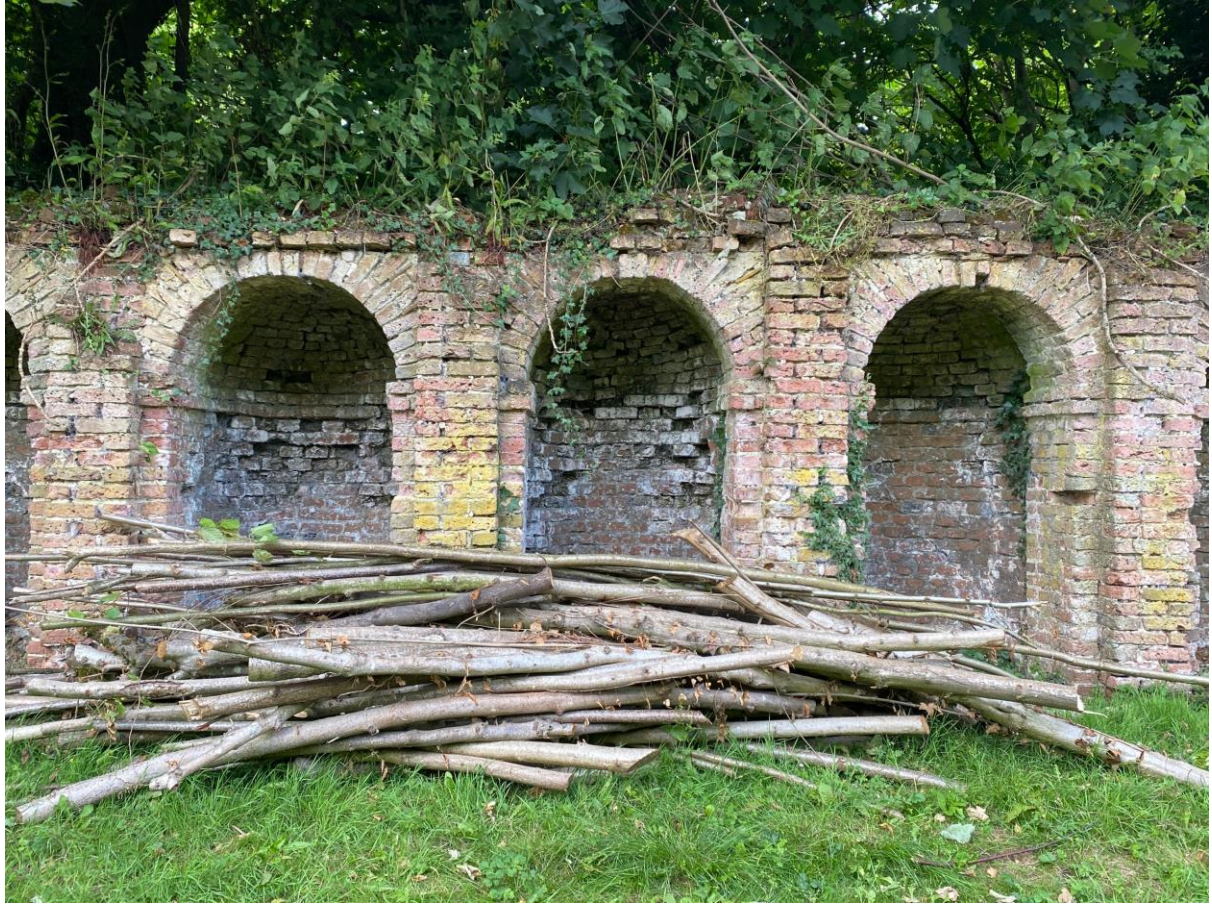
**Wall 3 – Arches 16, 17 & 18**

| <b>Arch No. 16</b> | <b>% Remaining</b> | <b>Condition As Found</b> | <b>Repair requirements:<br/>Fabric to add</b> | <b>% requiring pointing</b> |
|---|---|---|---|---|
| <b>Arch</b> | 90 | Sound | Repair to face | |
| <b>West Pilaster</b> | 90 | Sound | Repairs to front | 50 |
| <b>Niche</b> | 80 | Presume sound | Repair all areas. | 50 |

| <b>Arch No. 16</b> | <b>% Remaining</b> | <b>Condition As Found</b> | <b>Repair requirements:<br/>Fabric to add</b> | <b>% requiring pointing</b> |
|---|---|---|---|---|
| <b>Summary:</b> | Remove all collapsed brickwork and debris within opening and excavate spoil withing niche to ground level. Repair face and top of West pilaster. Repair arch with capping. Repair niche. Backfill ground to rear. | | | |

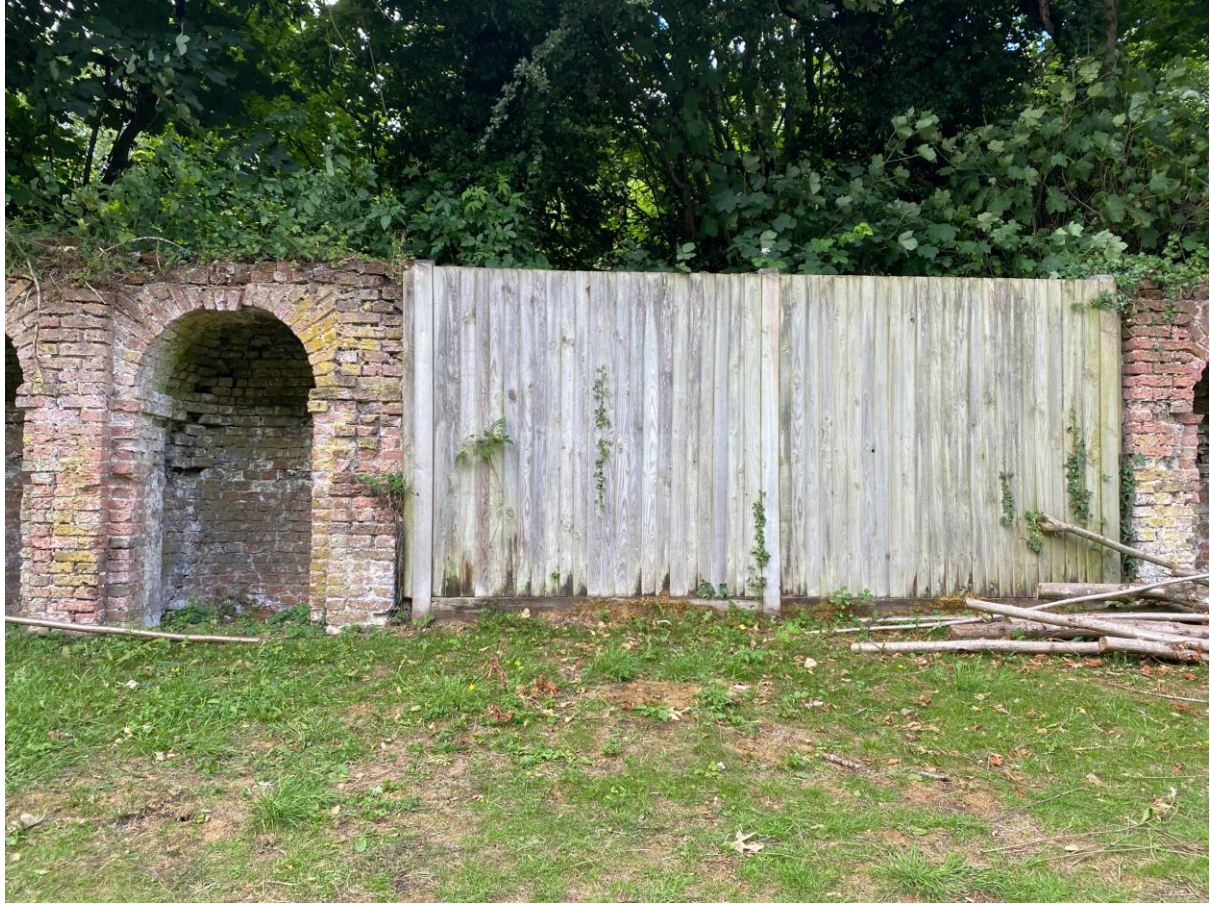
**Wall 3 – Arches 19, 20, 21 & 22**

| <b>Arch No. 19</b> | <b>% Remaining</b> | <b>Condition As Found</b> | <b>Repair requirements:<br/>Fabric to add</b> | <b>% requiring pointing</b> |
|---|---|---|---|---|
| <b>Arch</b> | 90 | Sound | Repair to face | |
| <b>West Pilaster</b> | 90 | Sound | Repairs to front and East face | 50 |

| <b>Arches No. 20 &amp; 21</b> | <b>% Remaining</b> | <b>Condition As Found</b> | <b>Repair requirements:<br/>Fabric to add</b> | <b>% requiring pointing</b> |
|---|---|---|---|---|
| <b>West Pilaster</b> | 10 | Sound | Repairs to front and East face | 50 |

| <b>Arch No. 22</b> | <b>% Remaining</b> | <b>Condition As Found</b> | <b>Repair requirements:<br/>Fabric to add</b> | <b>% requiring pointing</b> |
|---|---|---|---|---|
| <b>West Pilaster</b> | 20 | Sound | Repairs to front and East face | 50 |

| <b>Arch No. 19</b> | <b>% Remaining</b> | <b>Condition As Found</b> | <b>Repair requirements:<br/>Fabric to add</b> | <b>% requiring pointing</b> |
|---|---|---|---|---|
| <b>Summary:</b> | Remove all collapsed brickwork and debris within opening and excavate spoil withing niche to ground level. Repair face and top of West pilaster. Repair arch with capping. Repair niche. Backfill ground to rear. | | | |

| <b>Arch No. 22</b> | <b>% Remaining</b> | <b>Condition As Found</b> | <b>Repair requirements:<br/>Fabric to add</b> | <b>% requiring pointing</b> |
|---|---|---|---|---|
| <b>Summary:</b> | Remove all collapsed brickwork and debris within opening and excavate spoil withing niche to ground level. Rebuild pilaster, arch, niche and dome to full height and cap over. | | | |

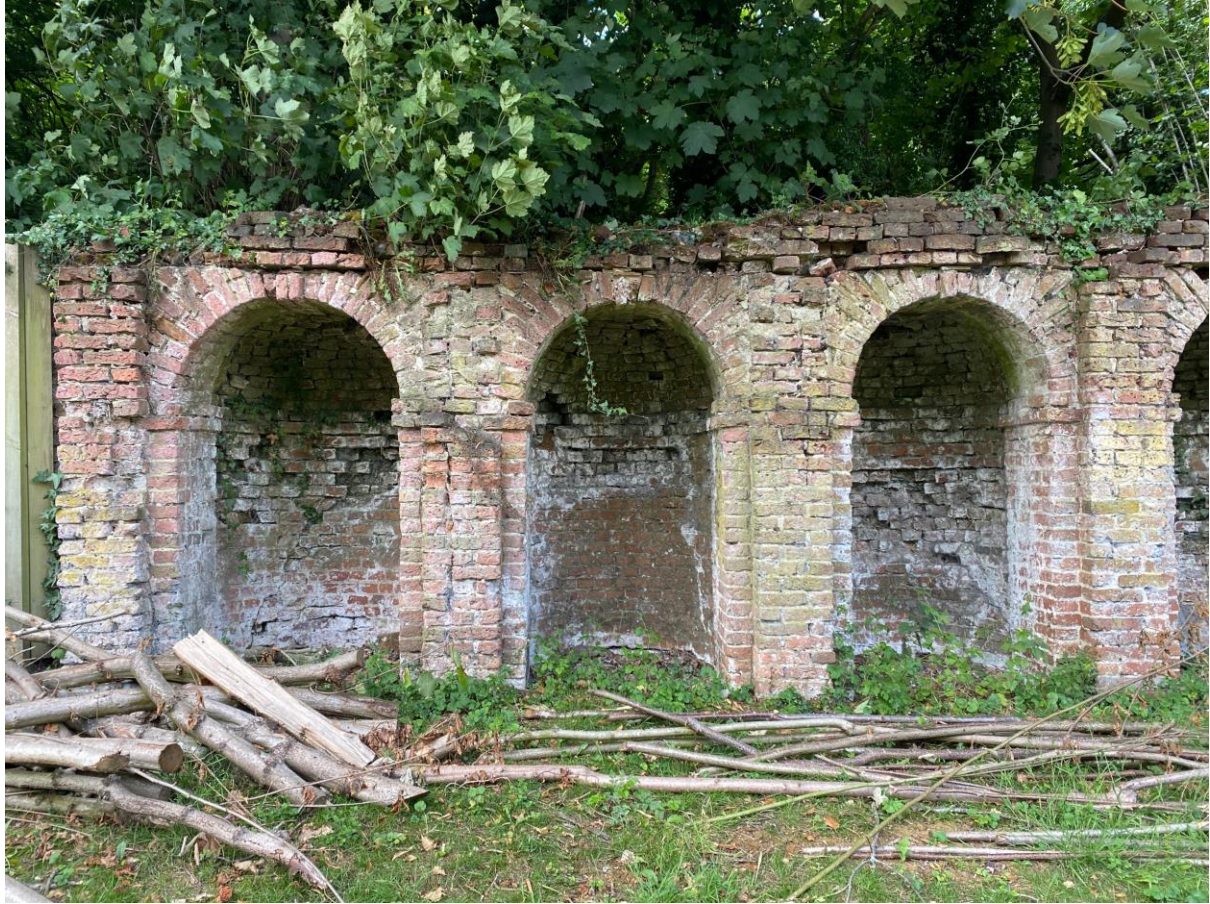
**Wall 3 – Arches 23, 24 & 25**

| <b>Arch No. 23</b> | <b>%<br/>Remaining</b> | <b>Condition As Found</b> | <b>Repair requirements:<br/>Fabric to add</b> | <b>%<br/>requiring<br/>pointing</b> |
|---|---|---|---|---|
| <b>Arch</b> | 90 | Sound | Repair to face | |
| <b>West Pilaster</b> | 90 | Sound | Repairs to front and East face | 50 |
| <b>Niche</b> | 80 | Presume sound | Repair all areas. | 50 |

| <b>Arch No. 23</b> | <b>%<br/>Remaining</b> | <b>Condition As Found</b> | <b>Repair requirements:<br/>Fabric to add</b> | <b>%<br/>requiring<br/>pointing</b> |
|---|---|---|---|---|
| <b>Summary:</b> | Remove all collapsed brickwork and debris within opening and excavate spoil withing niche to ground level. Repair face and top of West pilaster. Repair arch with capping. Repair niche. Backfill ground to rear. | | | |

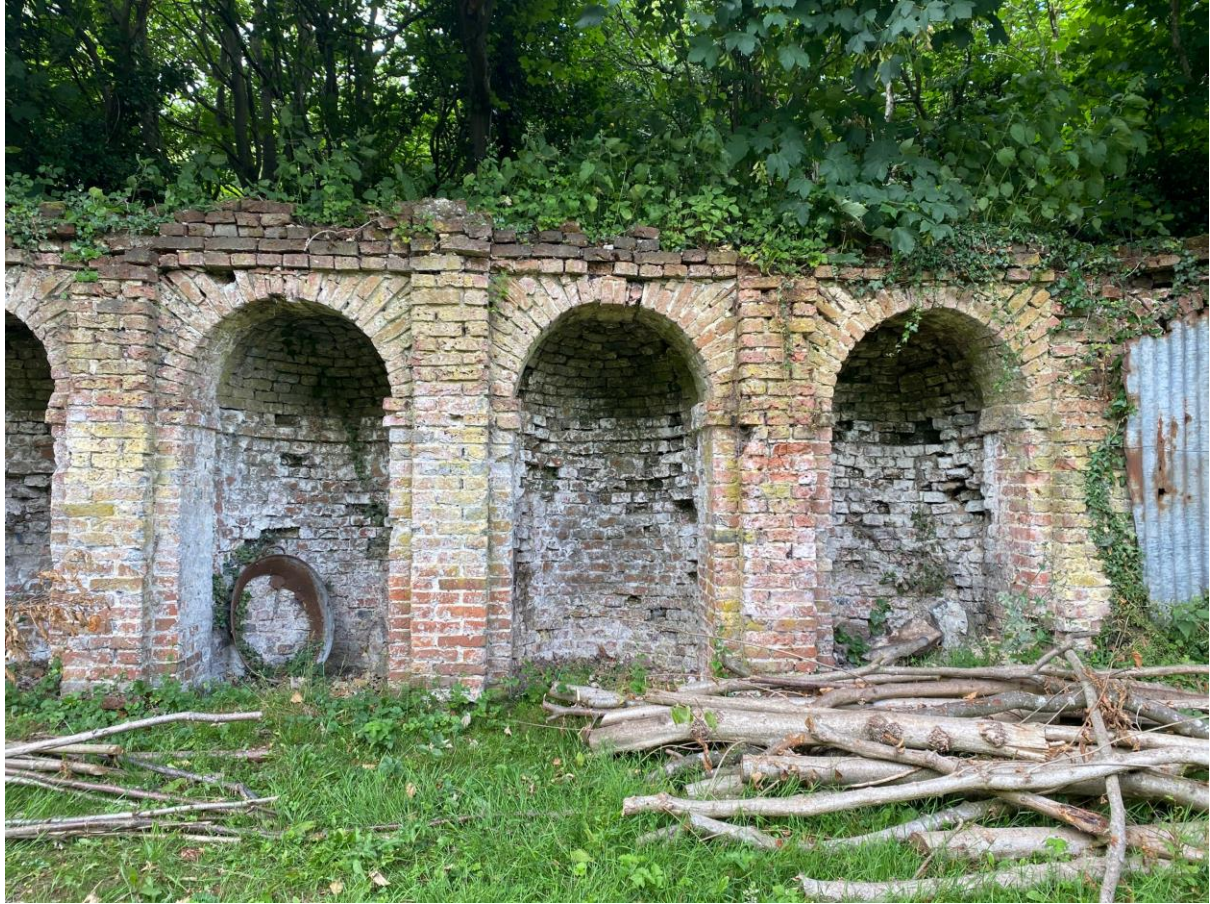
**Wall 3 – Arches 26, 27 & 28**

| Arch No. 26 | % Remaining | Condition As Found | Repair requirements:<br>Fabric to add | % requiring pointing |
|---|---|---|---|---|
| Arch | 90 | Sound | Repair to face | |
| West Pilaster | 90 | Sound | Repairs to front and East face | 50 |
| Niche | 80 | Presume sound | Repair all areas. | 50 |

| Arch No. 26 | % Remaining | Condition As Found | Repair requirements:<br>Fabric to add | % requiring pointing |
|---|---|---|---|---|
| <b>Summary:</b> | Remove all collapsed brickwork and debris within opening and excavate spoil withing niche to ground level. Repair face and top of West pilaster. Repair arch with capping. Repair niche. Backfill ground to rear. | | | |

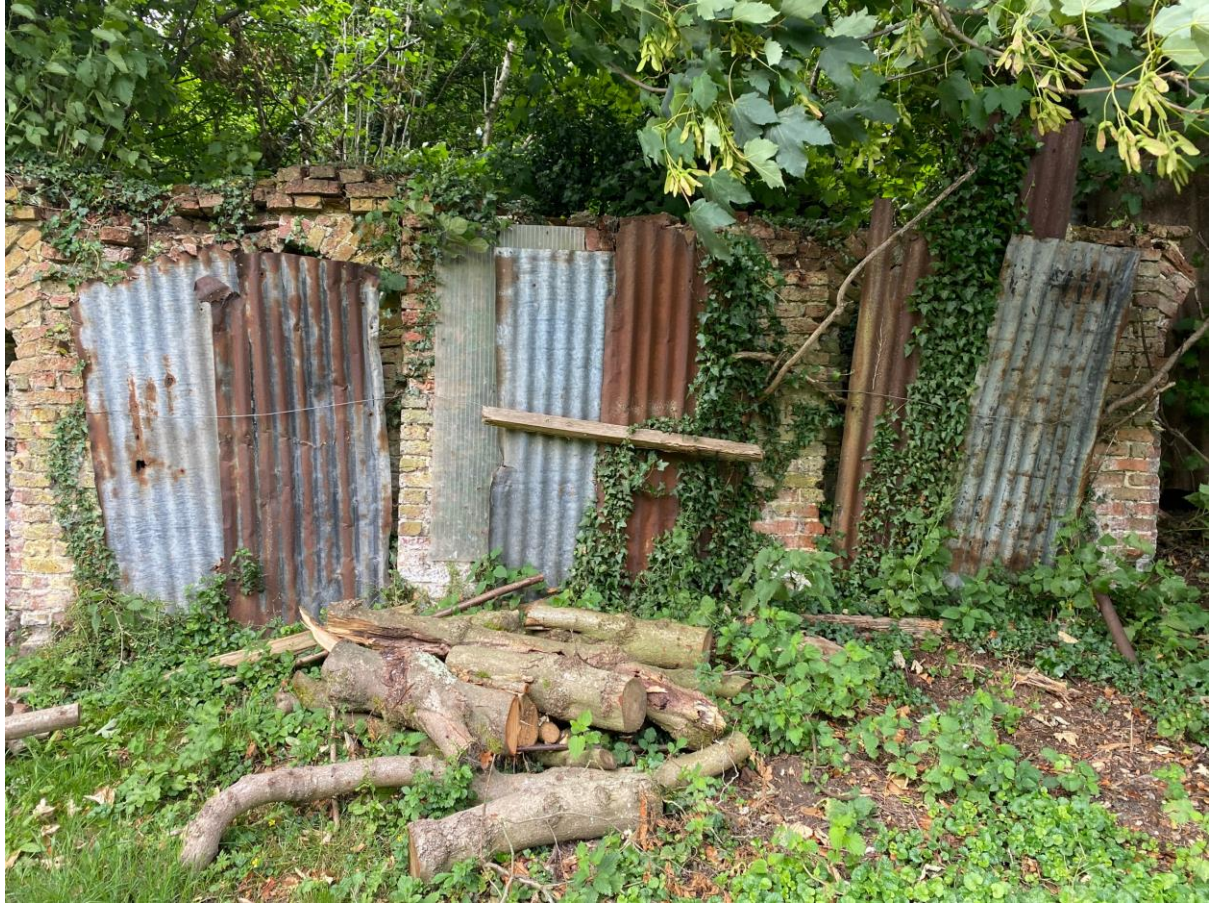
**Wall 3 – Arches 29, 30 & 31**

| Arch No. 29 | % Remaining | Condition As Found | Repair requirements:<br>Fabric to add | % requiring pointing |
|---|---|---|---|---|
| Arch | 75 | Sound | Repair to head | |

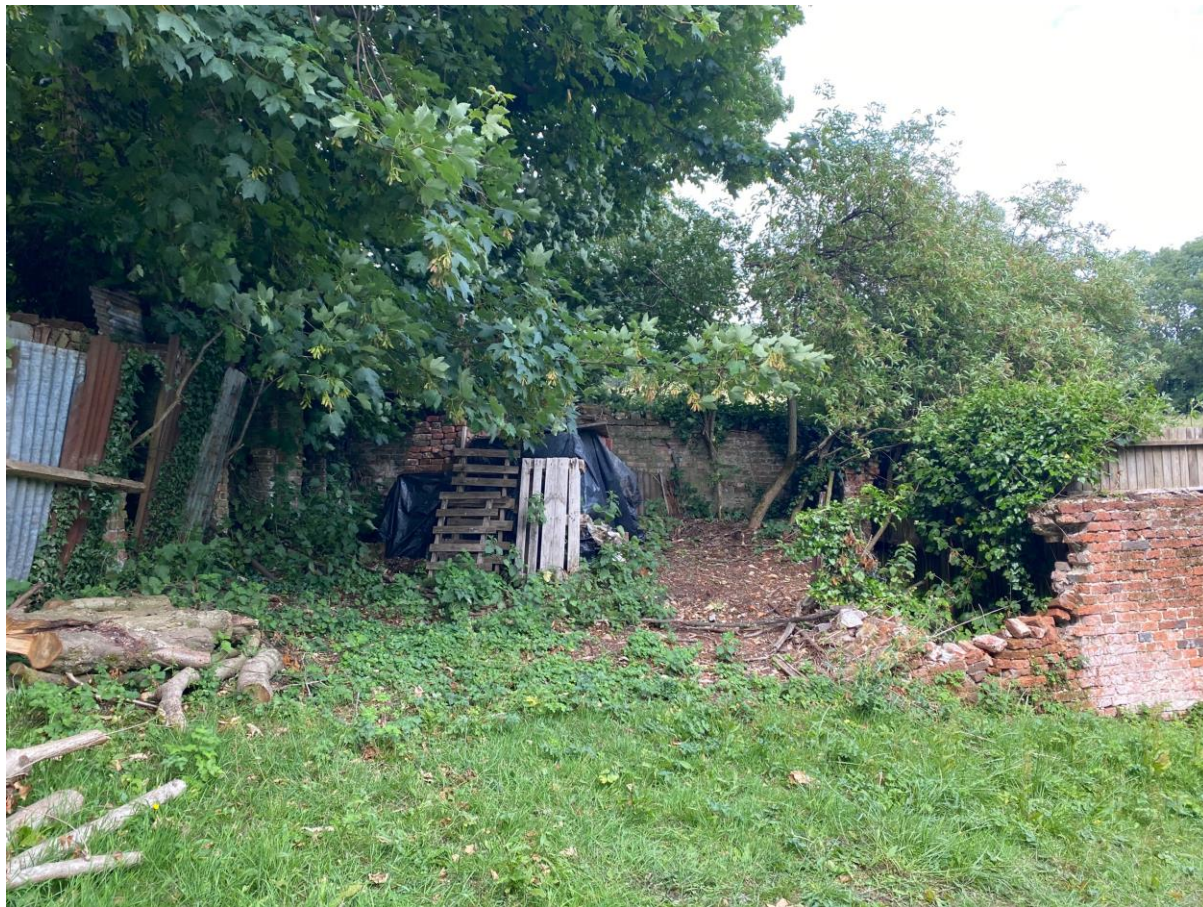
**Wall 2 – East wall Section enclosing recessed area.**

**Description** – Original brick wall approx. 2.0m high and 0.35m thick with brick on edge coping.

**Proposed Works required-** Remove all loose brickwork to top of remaining wall and consolidate to receive new work. Rebuild wall in new brickwork to match existing with chamfered detail to top and brick on edge coping. Salvaged bricks to be selectively mixed in with new work. Brickwork laid in 1:4 Lime mortar mix in bond to match existing.

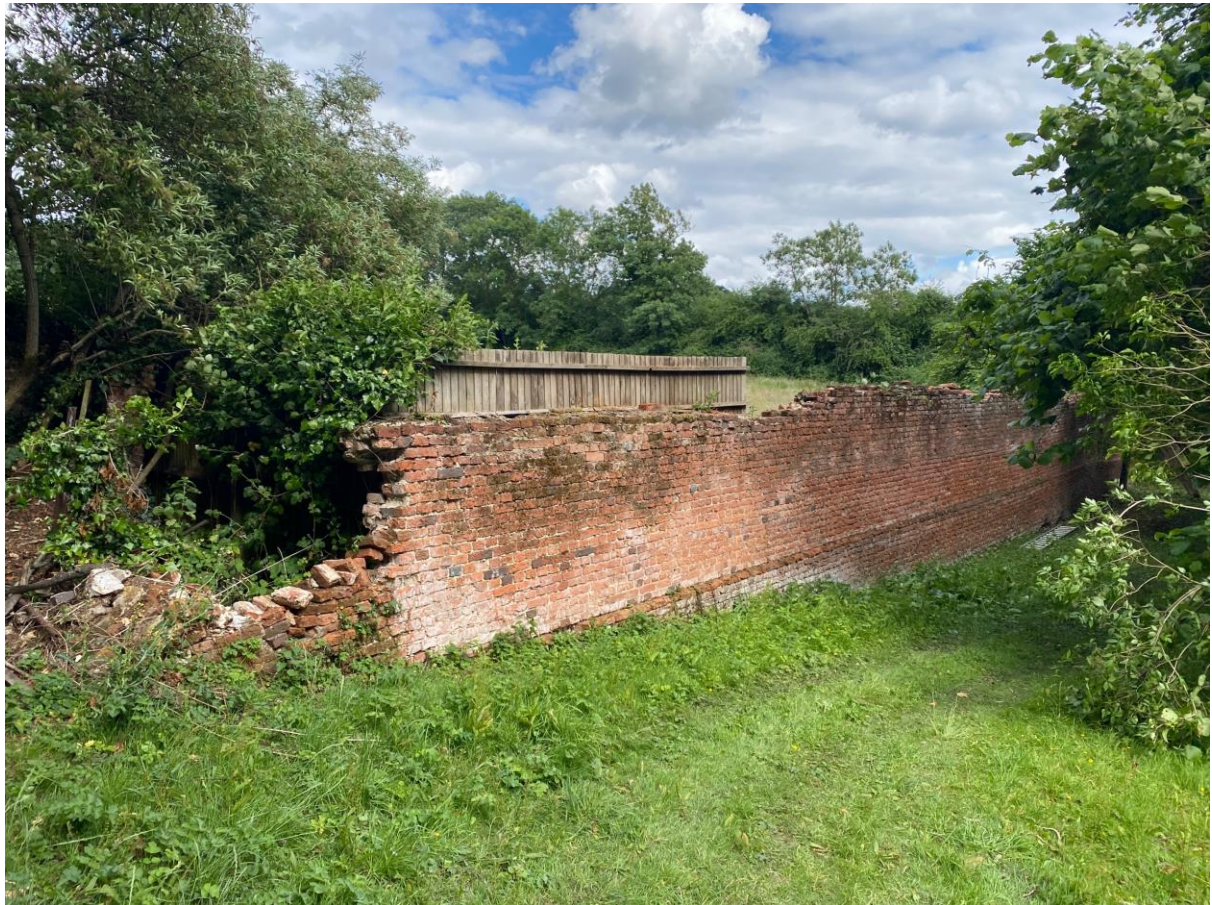
### **Wall 2 – Northern End**

**Description** - Original brick boundary wall reasonably plumb with standing section in relatively good condition. Northern end of wall missing to ground level and top 10 -12 courses missing.

**Proposed works required** - Remove all vegetation to outside face of wall. Remove timber fencing. Take off any loose bricks at base to missing section and along top of wall. All bricks to be removed by hand and where possible bricks to be clean and stored safely for reuse. Repair and consolidate top of wall to receive new work. Rebuild wall in new brickwork to match existing with chamfered detail to top and brick on edge coping. Salvaged bricks to be selectively mixed in with new work. Brickwork laid in 1:4 Lime mortar mix in bond to match existing.

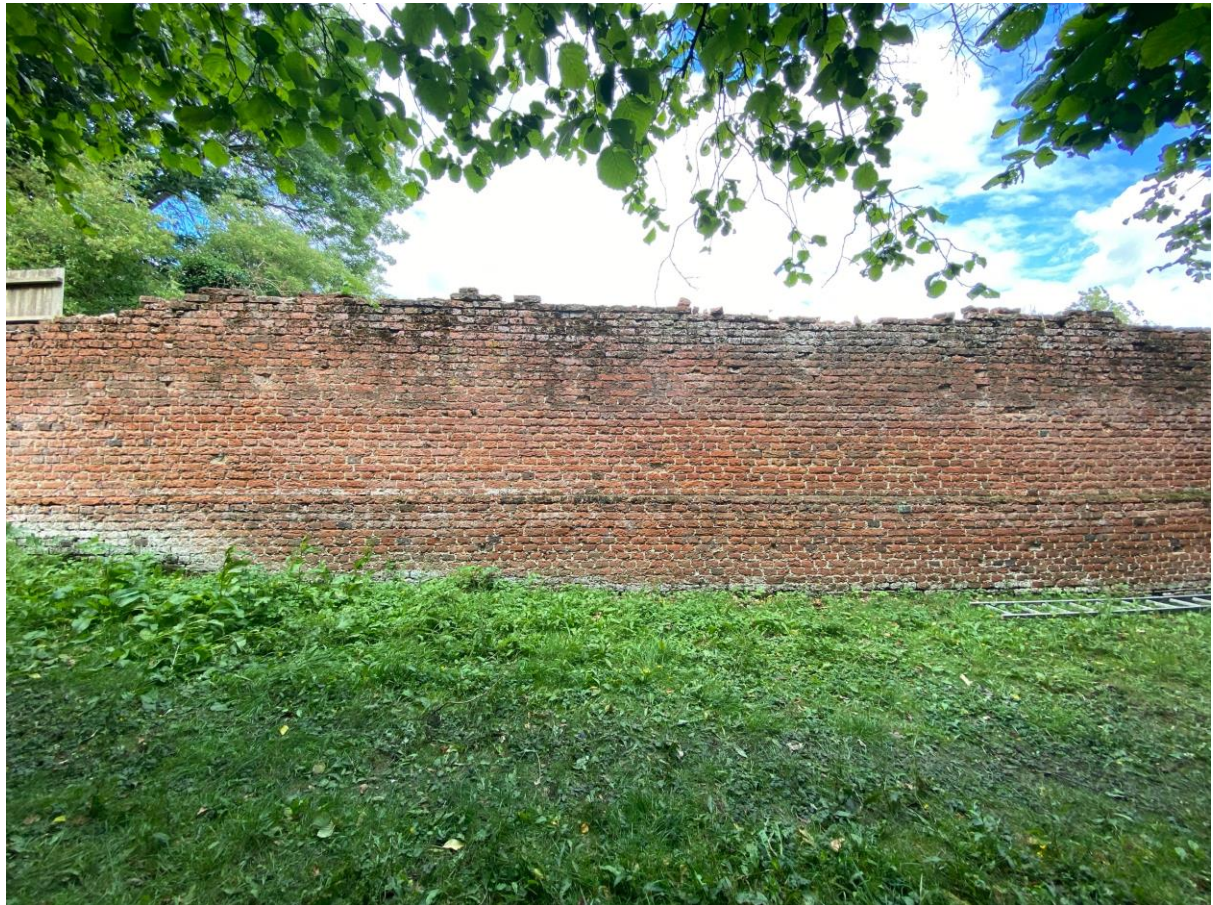
### **Wall 2 – Northern End**

**Description** - Original brick boundary wall reasonably plumb with standing section in relatively good condition with top 10 -12 courses missing.

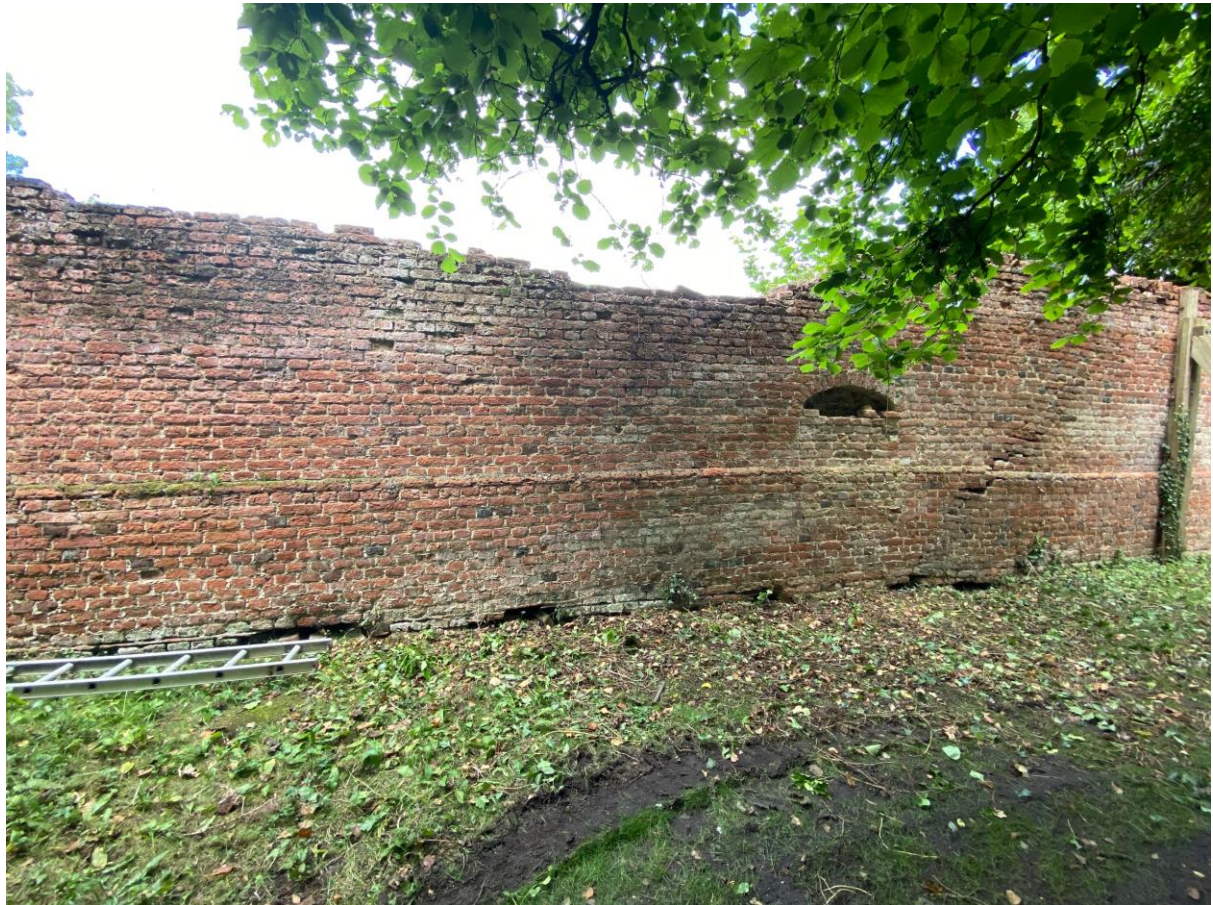
### Wall 2 – Centre Section

**Description** - Original brick boundary wall reasonably plumb with standing section in relatively good condition with top 6 - 7 courses missing.

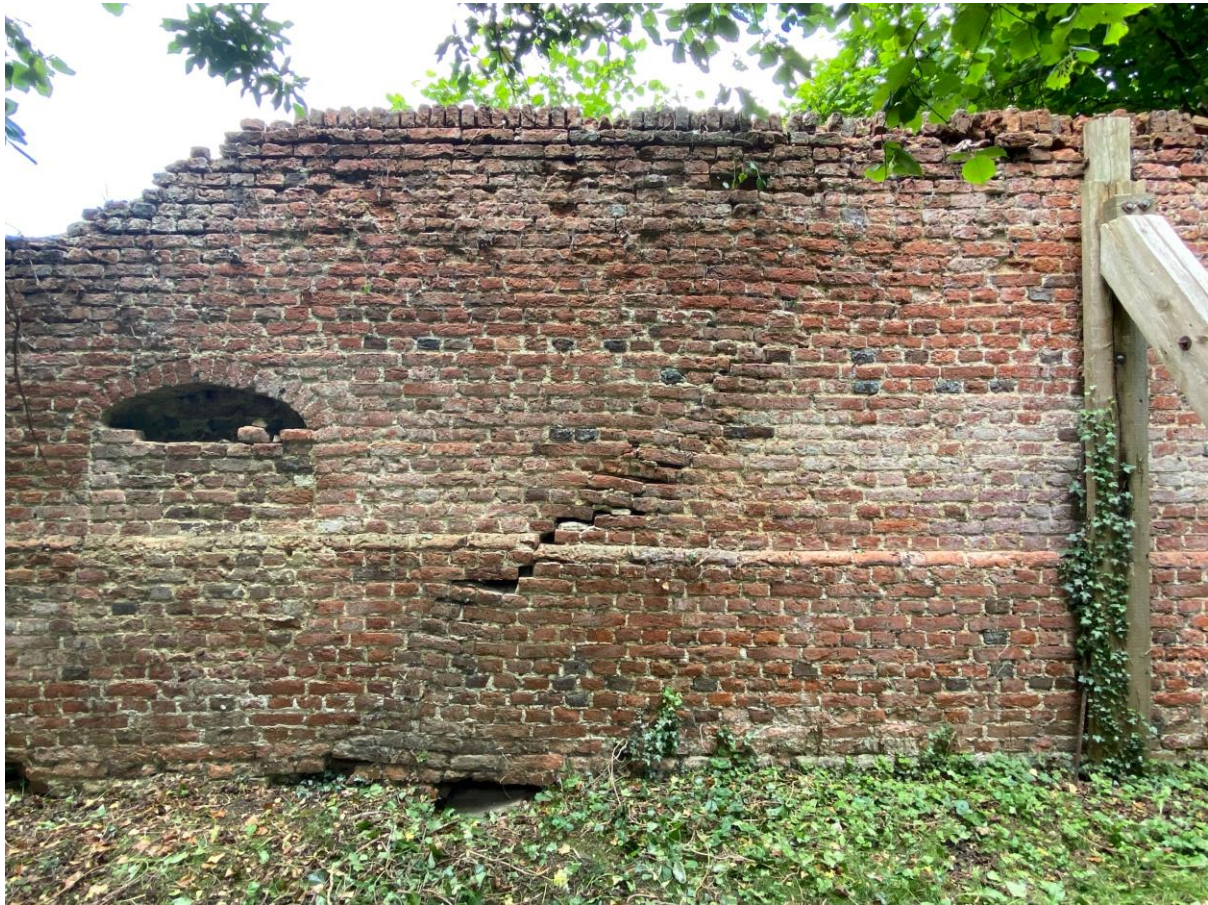
### Wall 2 – Centre Section

**Description** - Original brick boundary wall reasonably plumb with standing section in relatively good condition with original coping still largely in place.

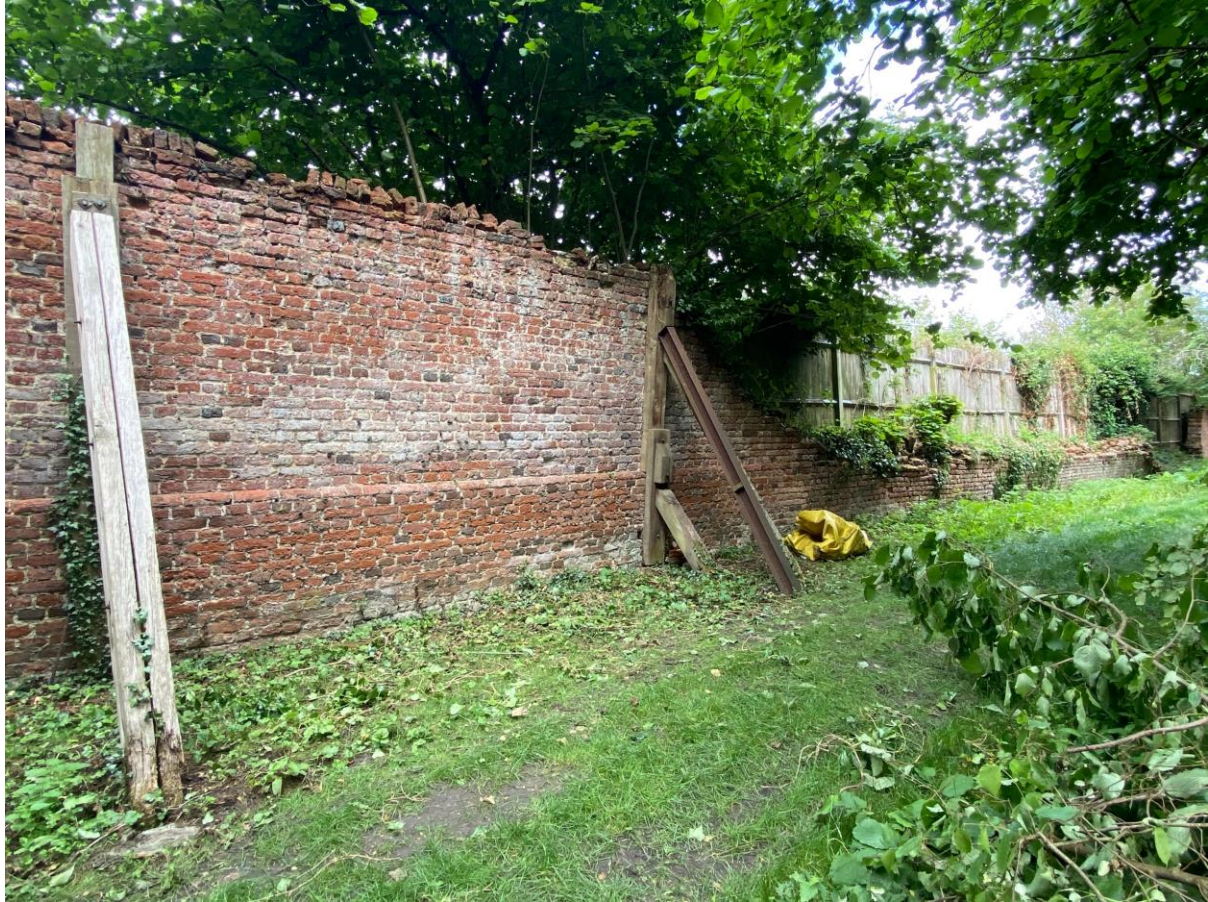
### Wall 2 – Centre Section

**Description** - Original brick boundary wall leaning into garden with temporary steel and timber props.
