**Church Gardens  
Church Hill  
Harefield  
Middx. UB9 6DU**

**Orchard Wall Repair & Restoration**

**Photographic Record  
&  
Schedule of Works**

**Home Plans  
July 2020**

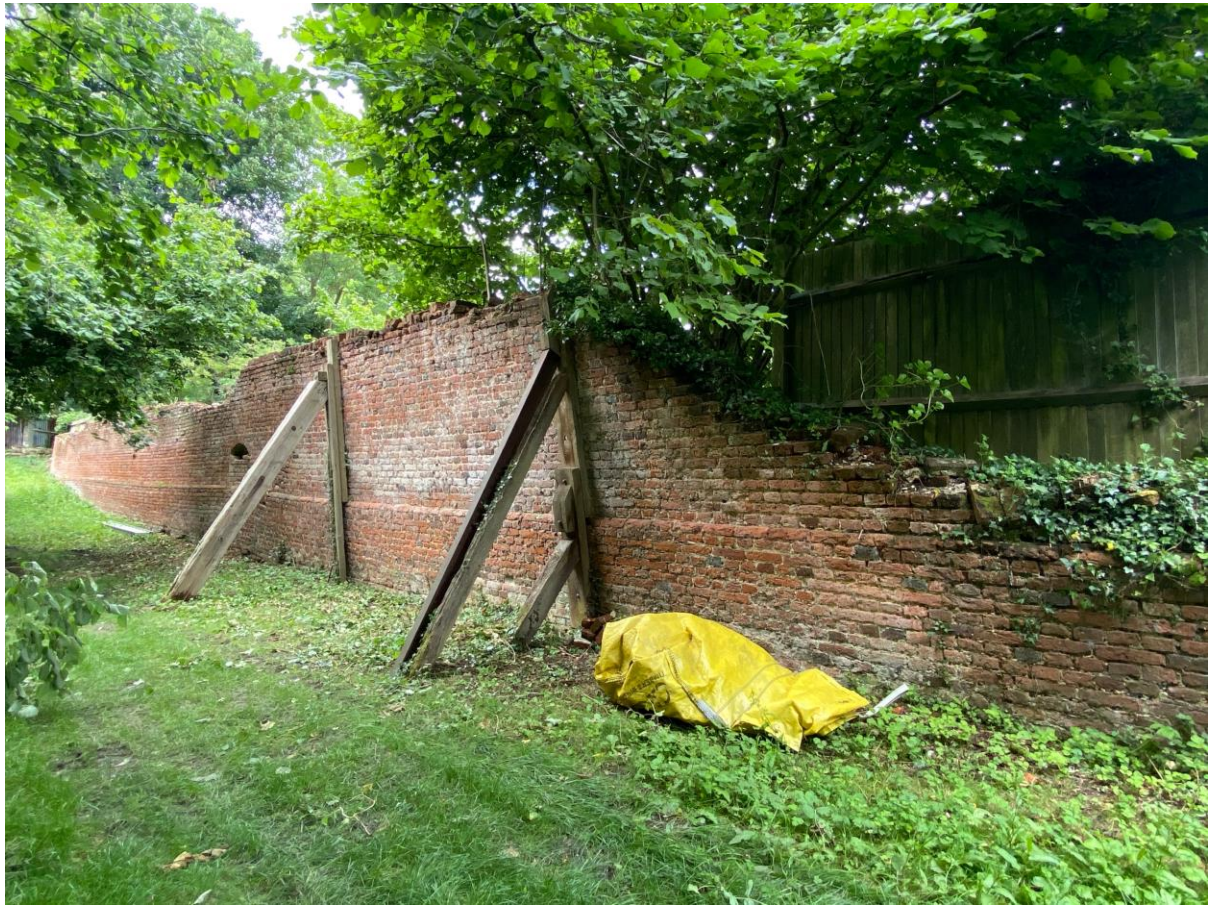
### Wall 2 – Centre Section

**Description** - Original brick boundary wall seriously leaning into garden with temporary steel and timber props.

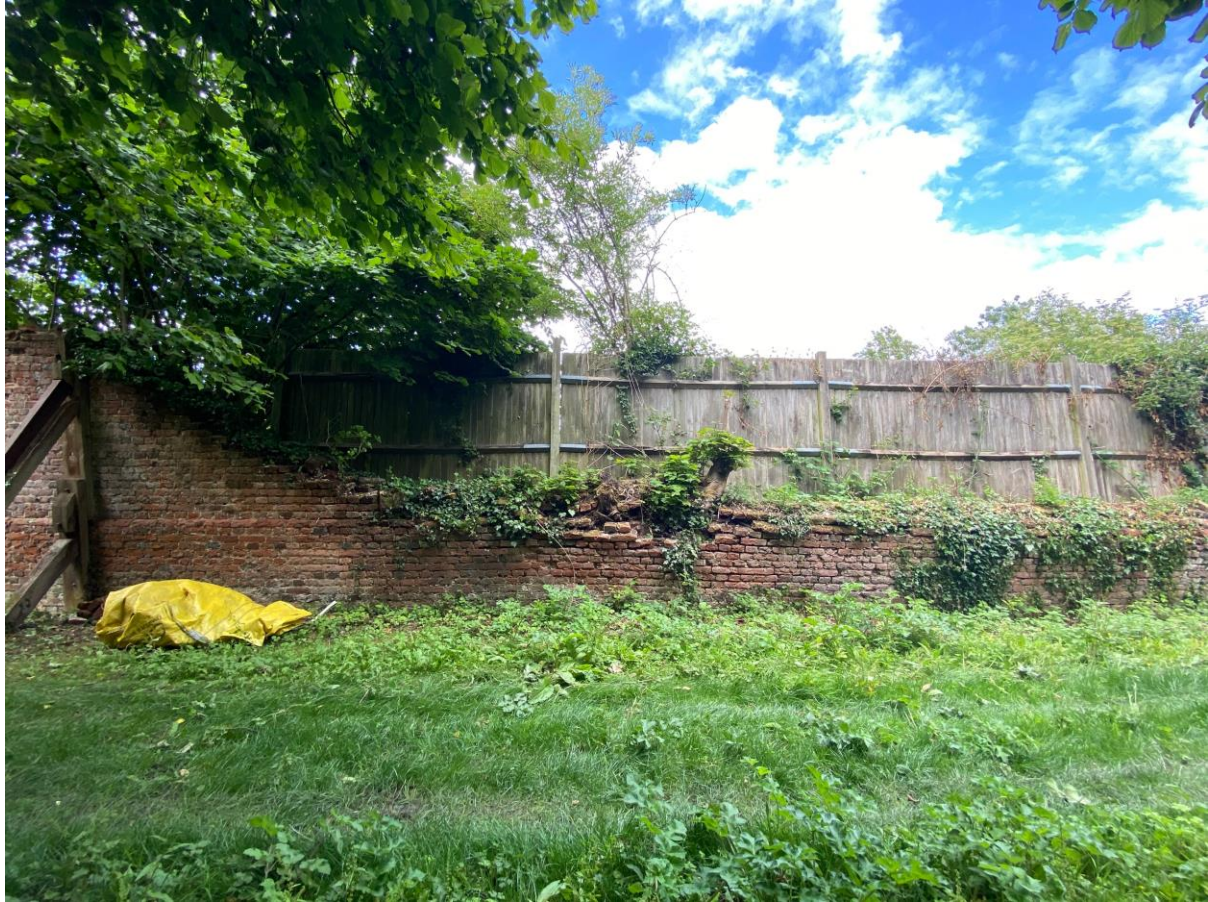
### Wall 2 – Centre Section

**Description** - Original brick boundary wall seriously leaning into garden with temporary steel and timber props.

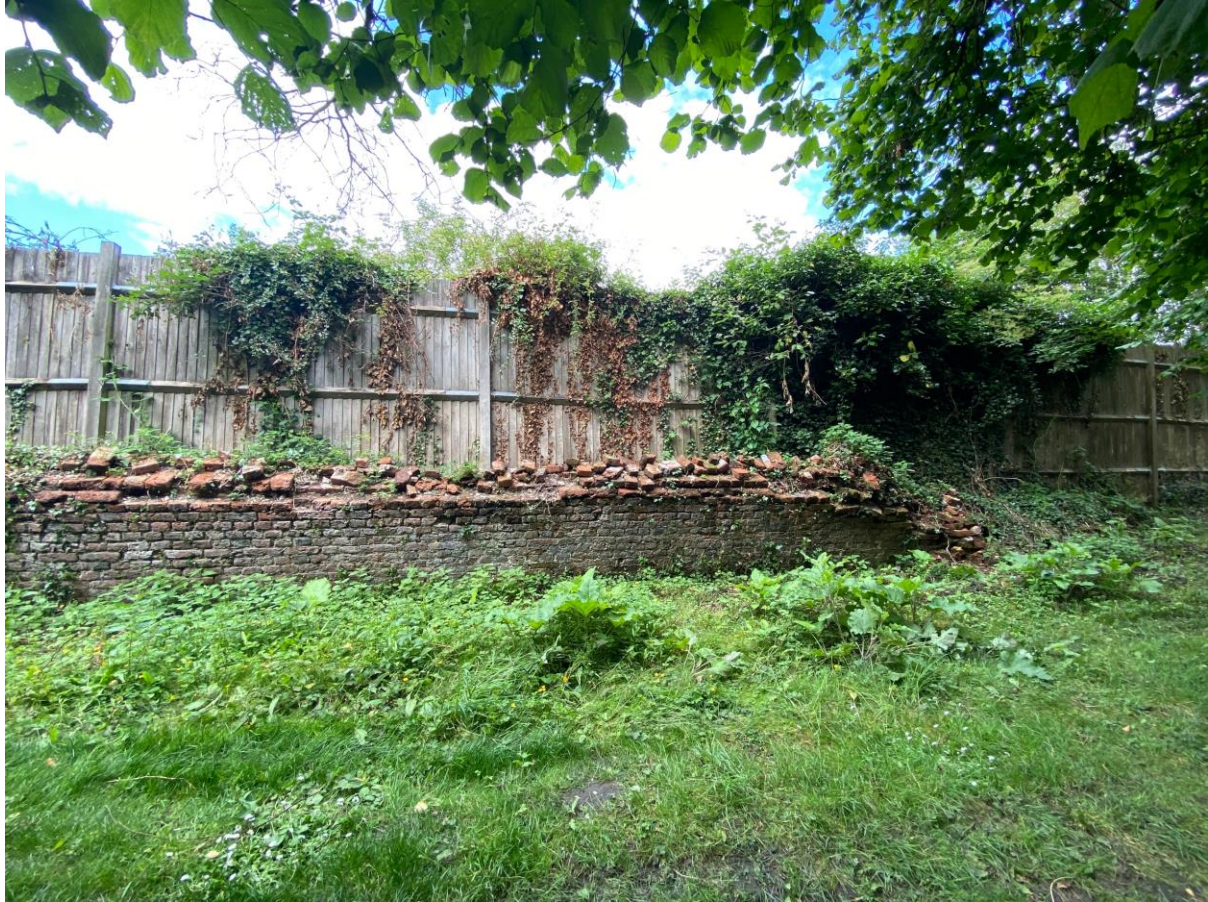
## Wall 2 – Southern Section

**Description** - Remains of original brick boundary wall seriously leaning into garden.

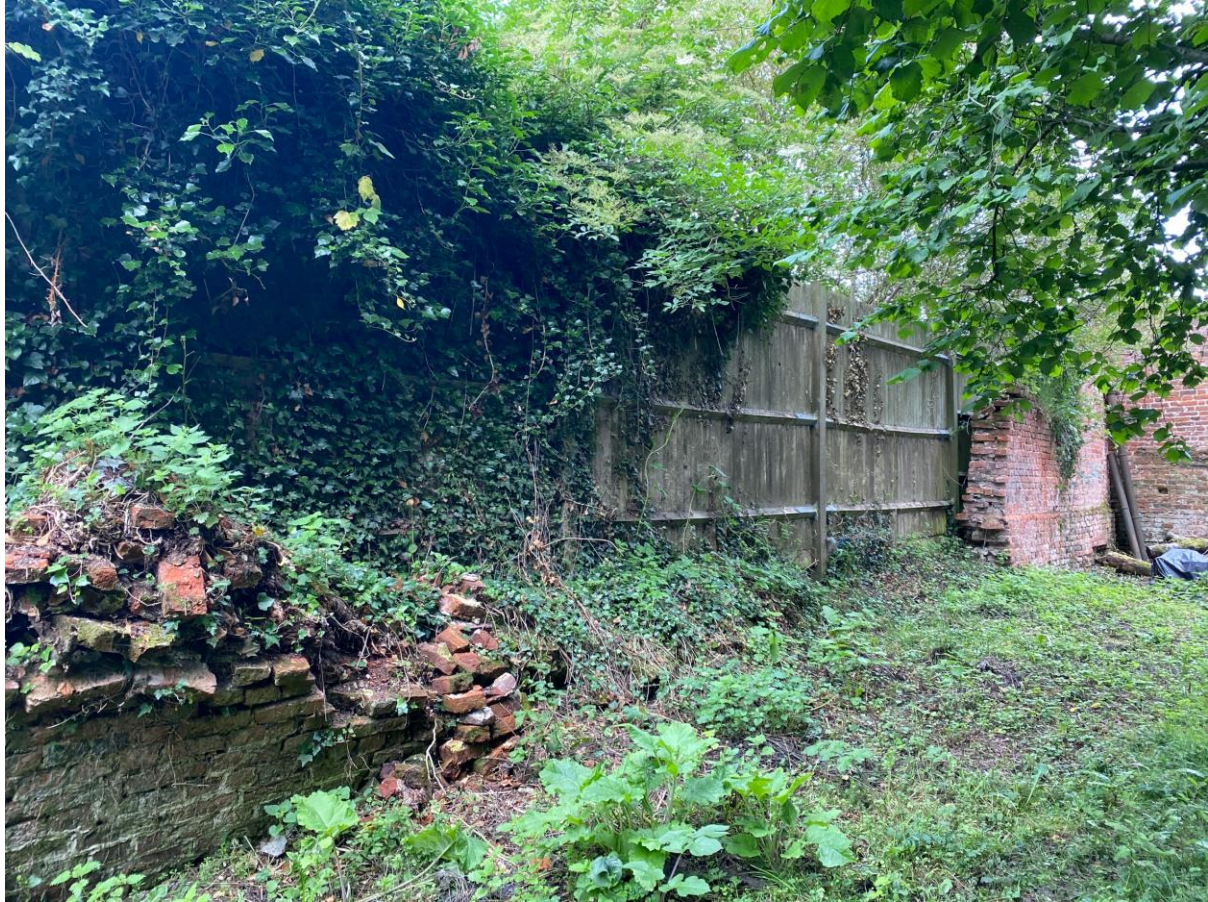
### Wall 2 – Southern Section

**Description** - Remains of original brick boundary wall seriously leaning into garden.

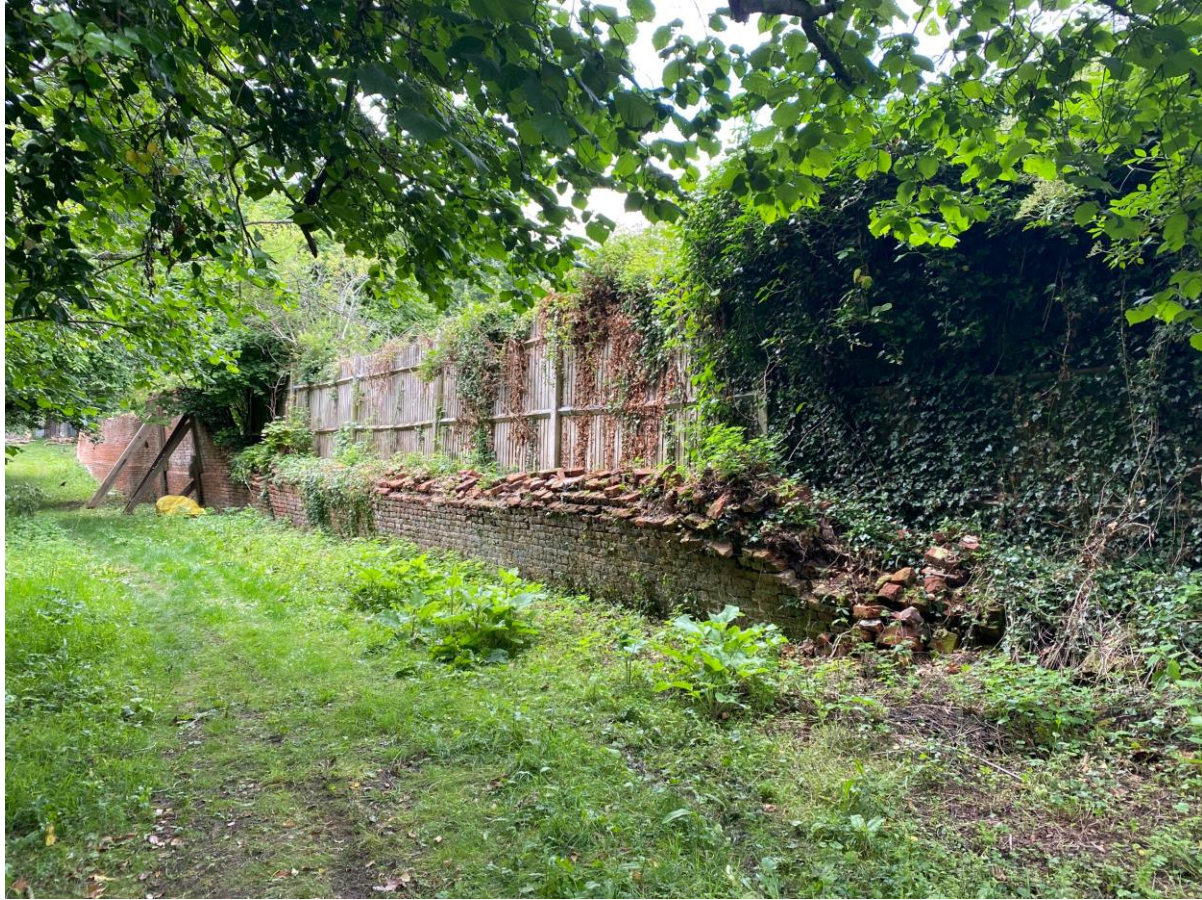
### Wall 2 – Southern Section

**Description** - Remains of original brick boundary wall seriously leaning into garden.

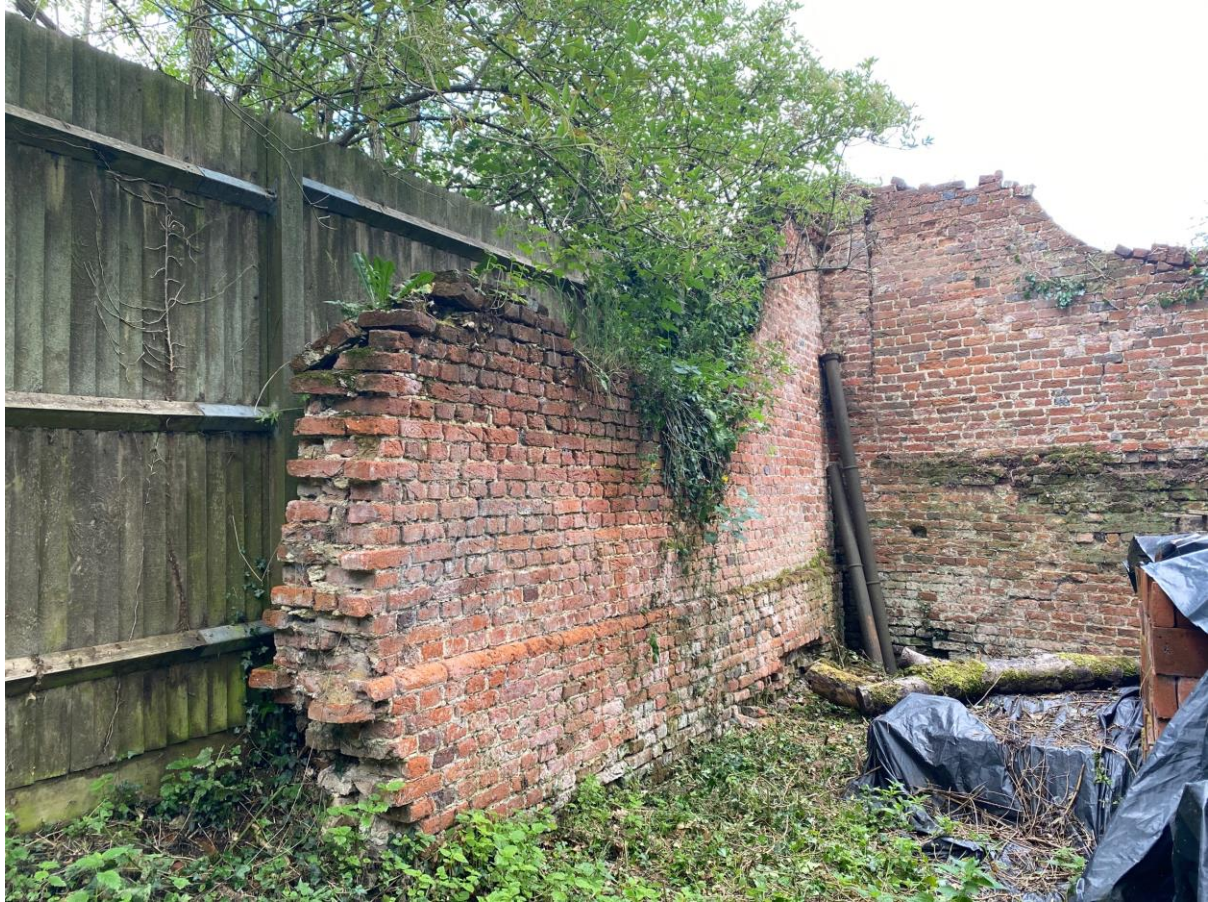
## Wall 2 – Southern Section

**Description** - Remains of original brick boundary wall slightly leaning into garden.

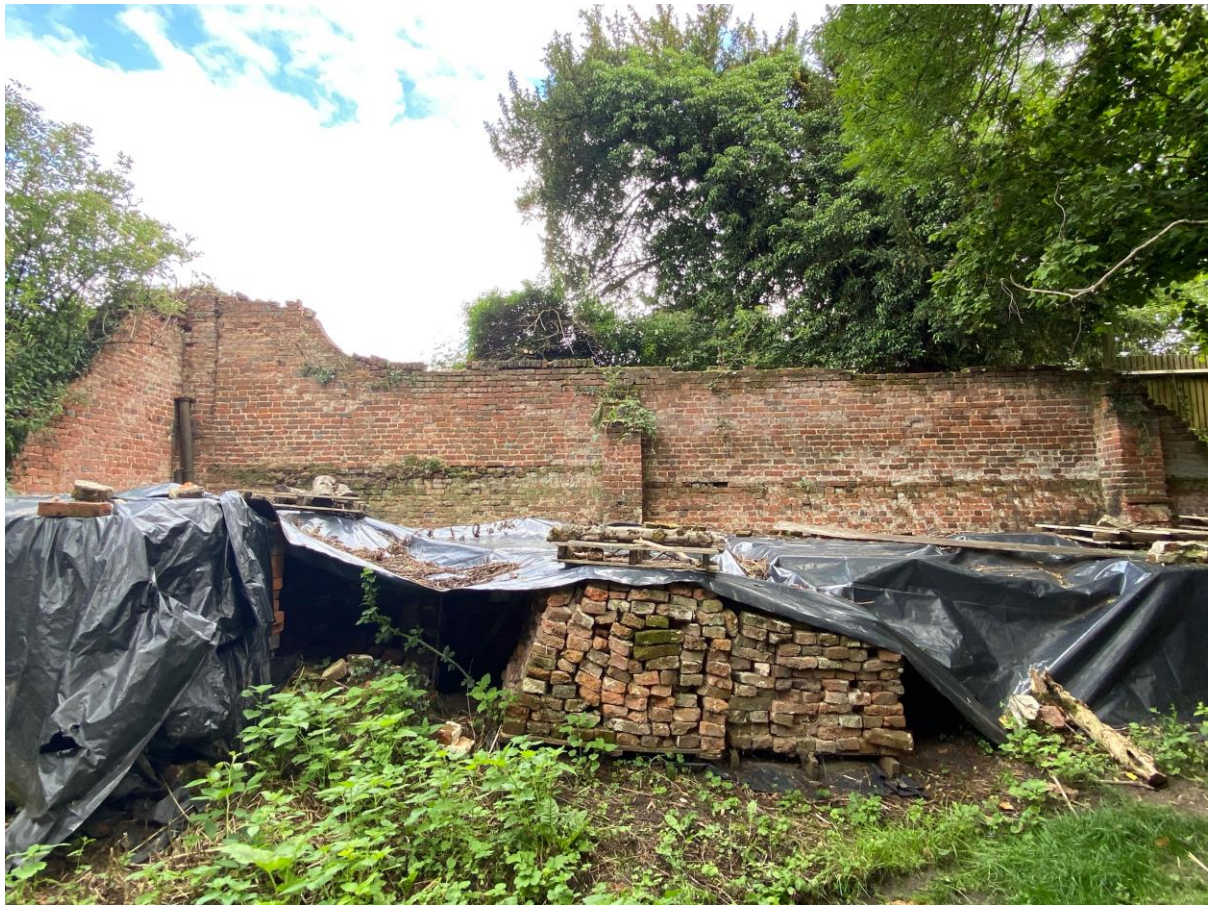
### Wall 1 – Eastern End

**Description** - Original brick wall enclosing Orchard Area, retaining higher ground behind. Wall in reasonably good condition with some vegetation growth at plinth level.

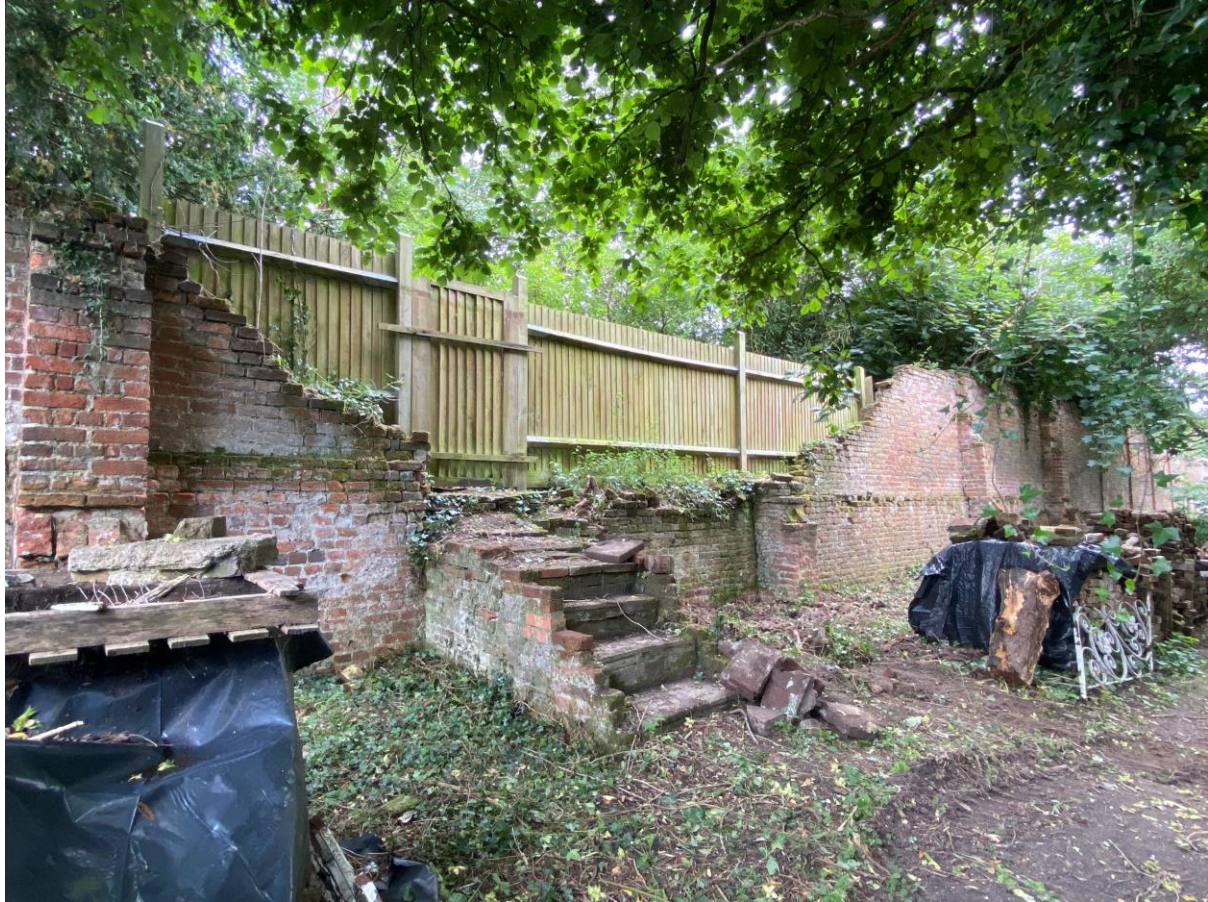
### Wall 1 – Eastern End

**Description** - Original brick wall enclosing Orchard Area, retaining higher ground behind. Area each side of original gate opening missing but standing sections appear sound.

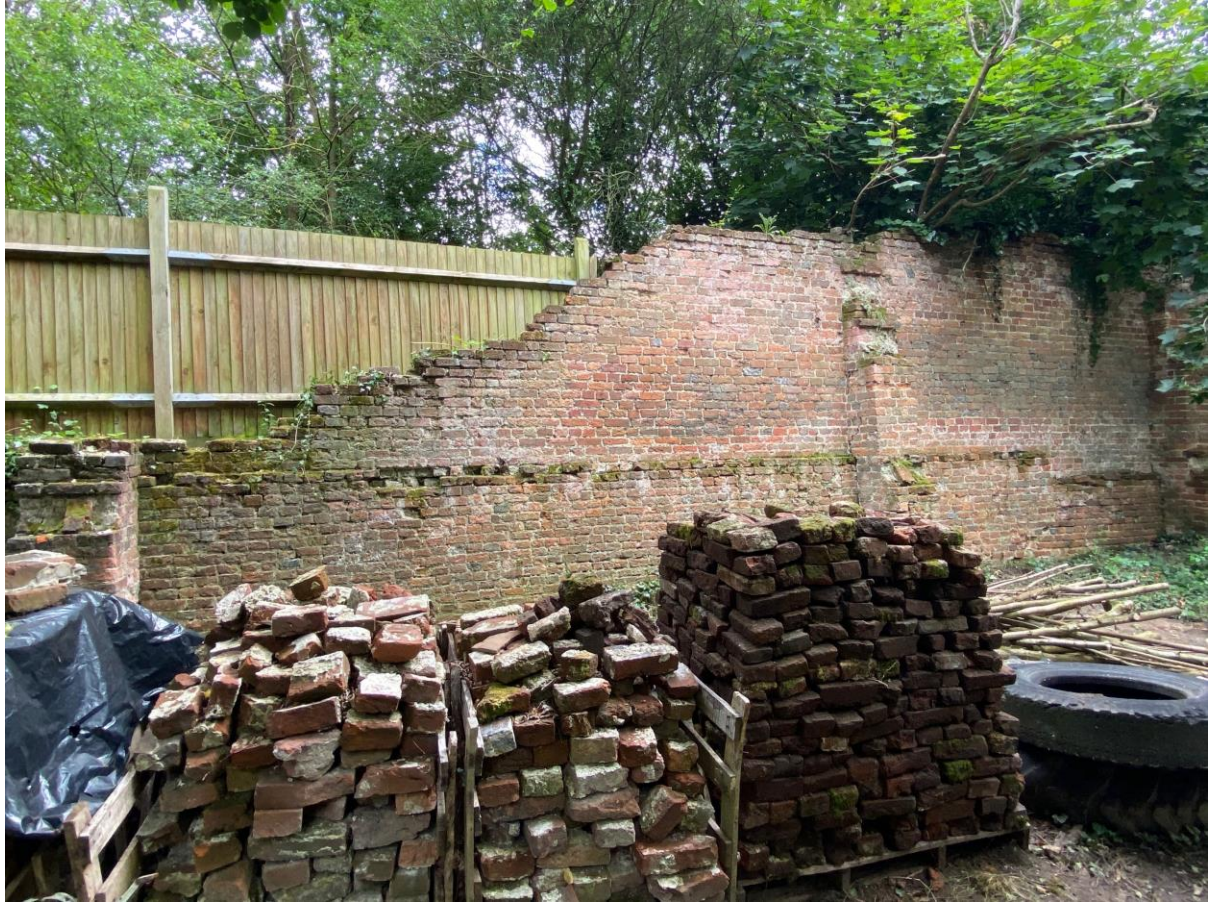
### Wall 1 – Eastern End

**Description** - Original brick wall enclosing Orchard Area, retaining higher ground behind. Area each side of original gate opening missing but standing sections appear sound.

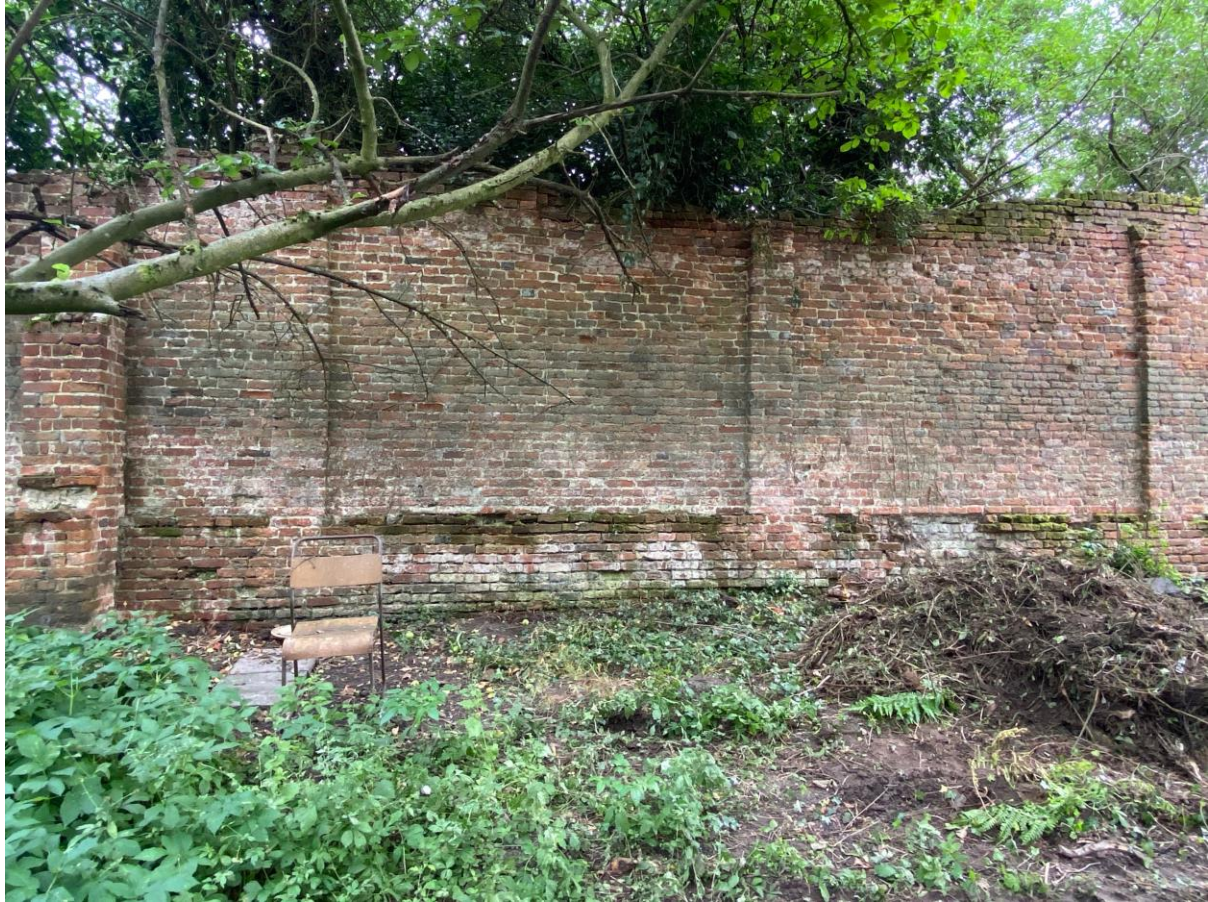
### Wall 1 – Centre Section

**Description** - Original brick wall enclosing Orchard Area, retaining higher ground behind. Standing sections appear sound.

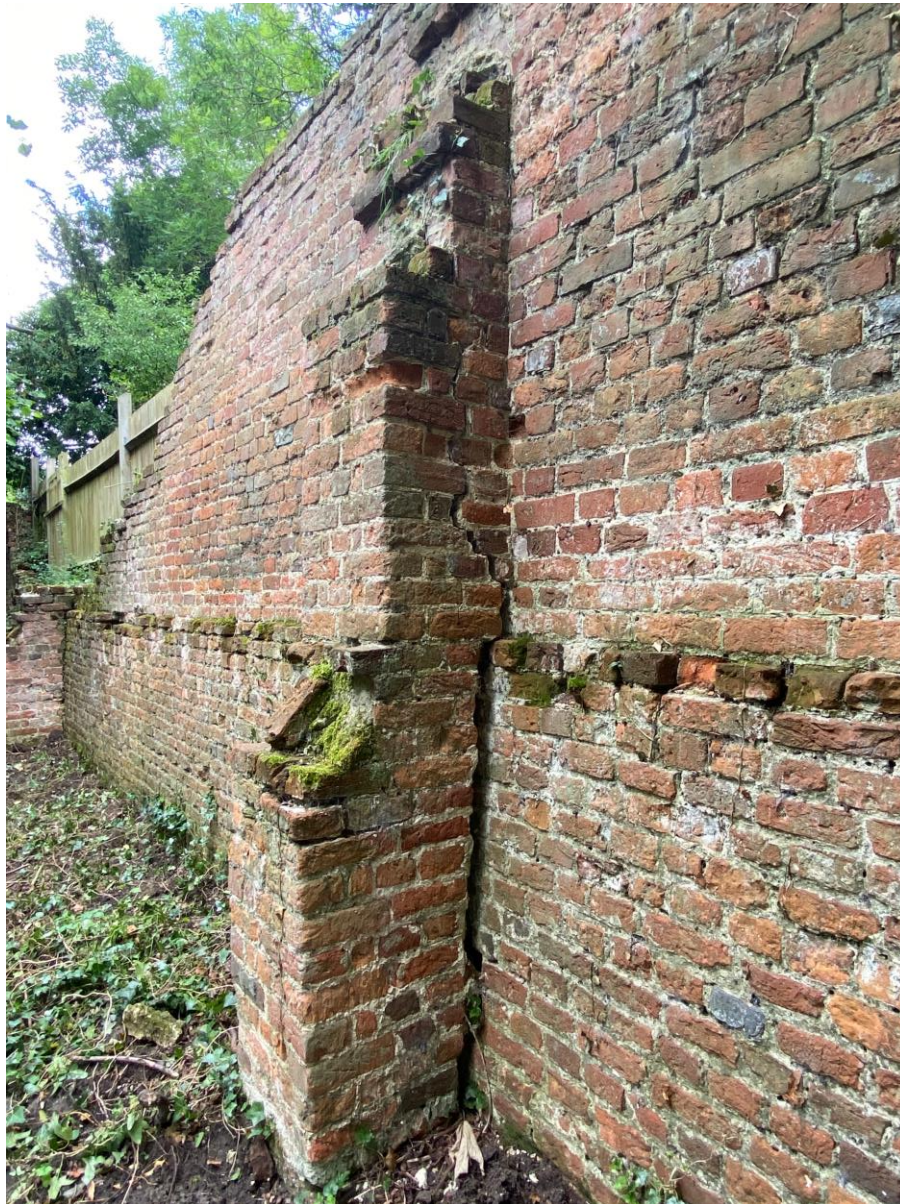
### Wall 1 – Centre Section

**Description** - Original brick wall enclosing Orchard Area, retaining higher ground behind. Standing sections appear sound but slightly leaning outwards. Original brick pier buttress pier has become disconnected from main wall..

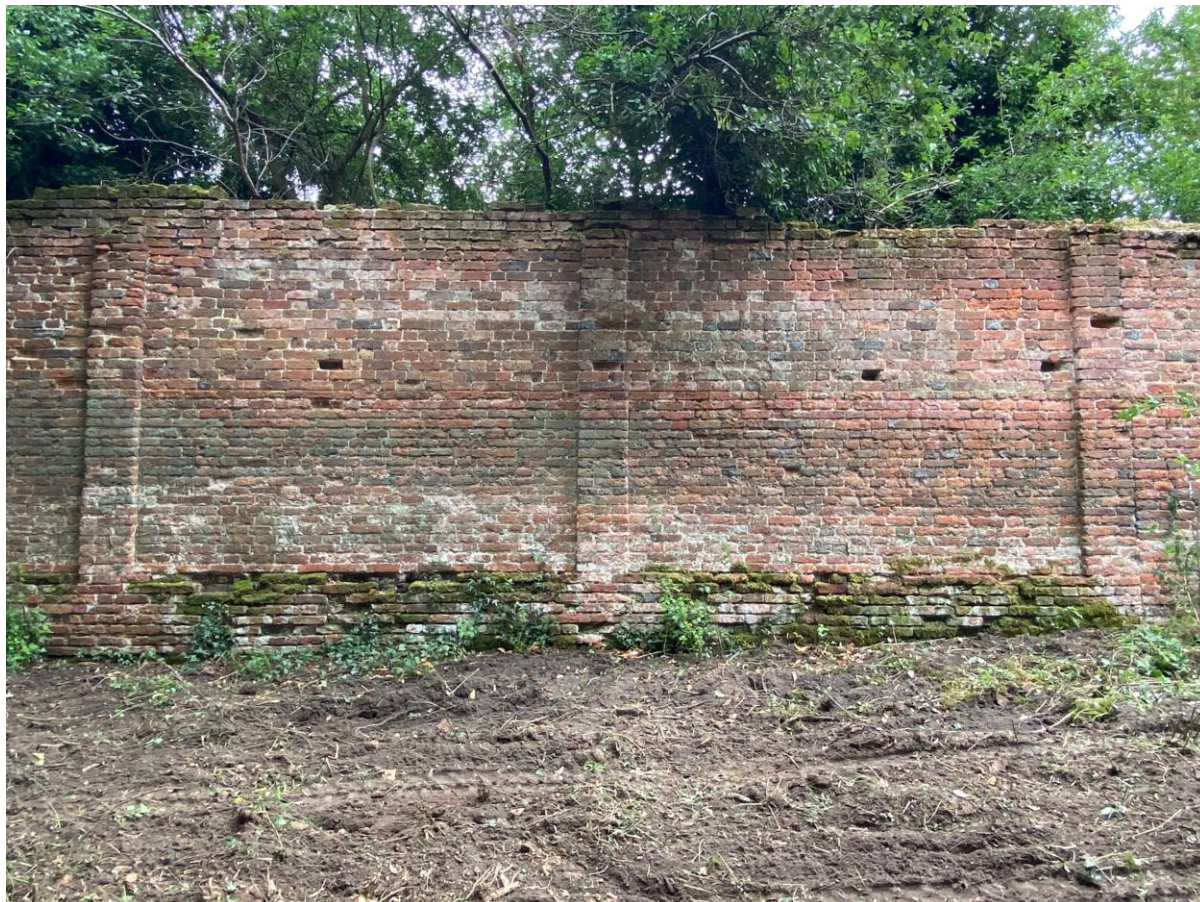
### Wall 1 – Centre Section

**Description** - Original brick wall enclosing Orchard Area, retaining higher ground behind. Standing sections appear sound.

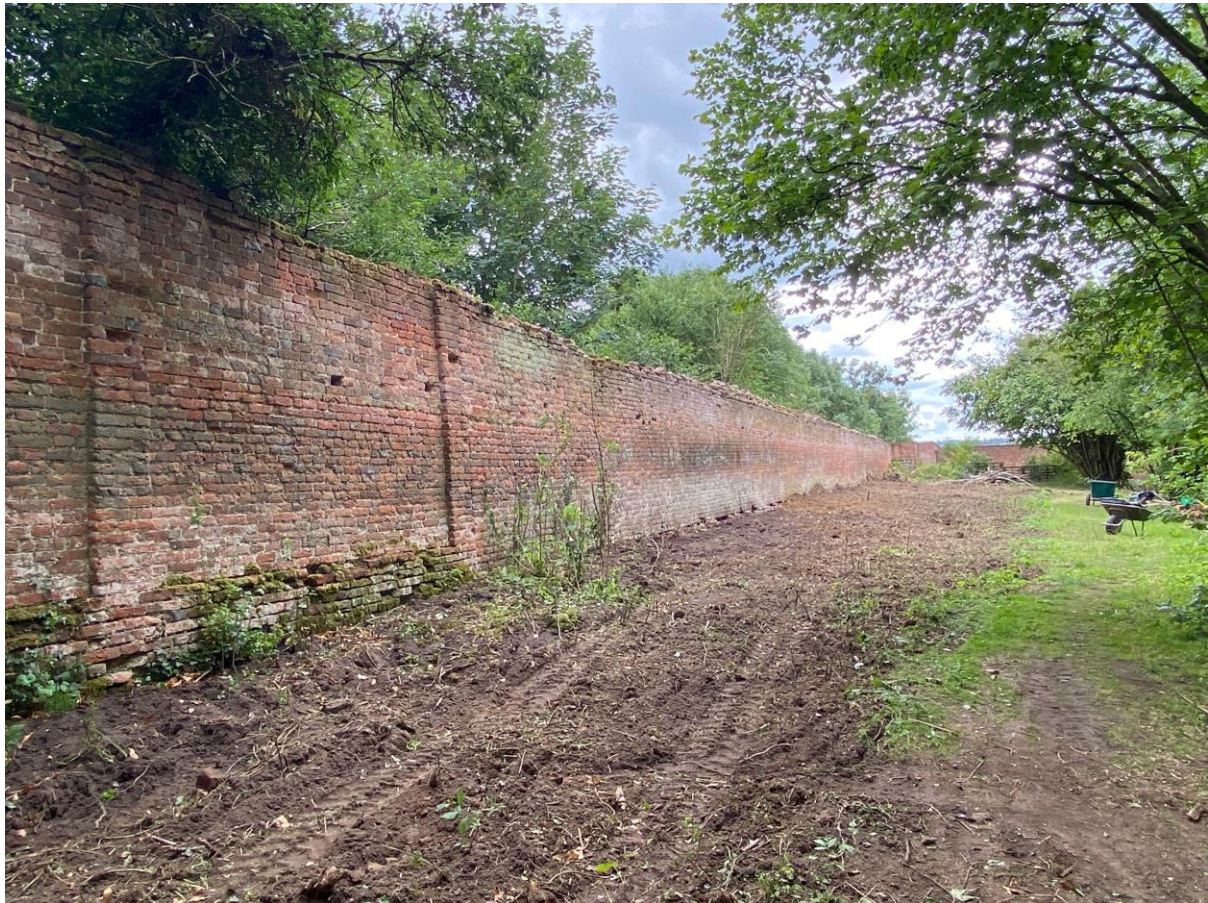
### Wall 1 – Centre Section

**Description** - Original brick wall enclosing Orchard Area, retaining higher ground behind. Standing sections appear sound.

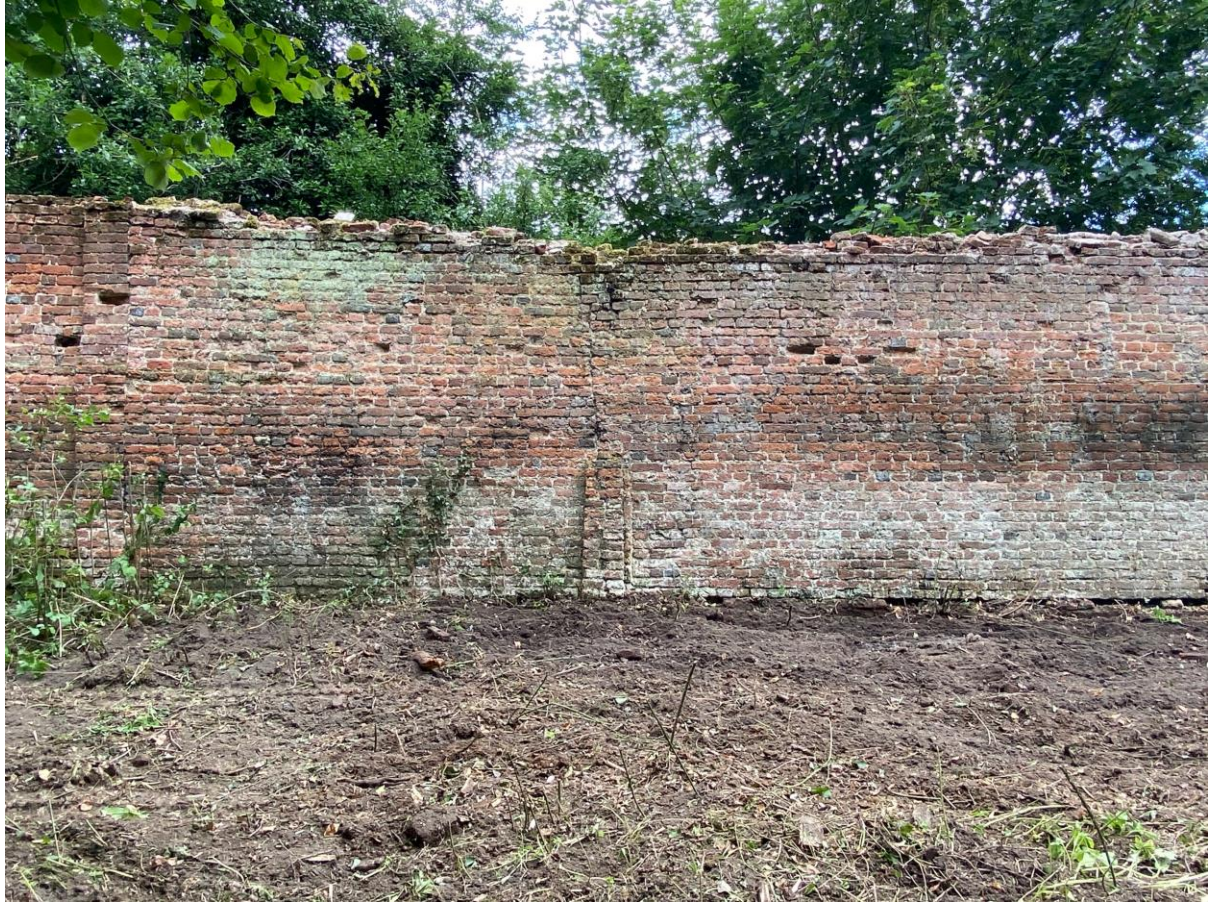
### **Wall 1 – Centre Section**

**Description** - Original brick wall enclosing Orchard Area, retaining higher ground behind. Standing sections appear sound.

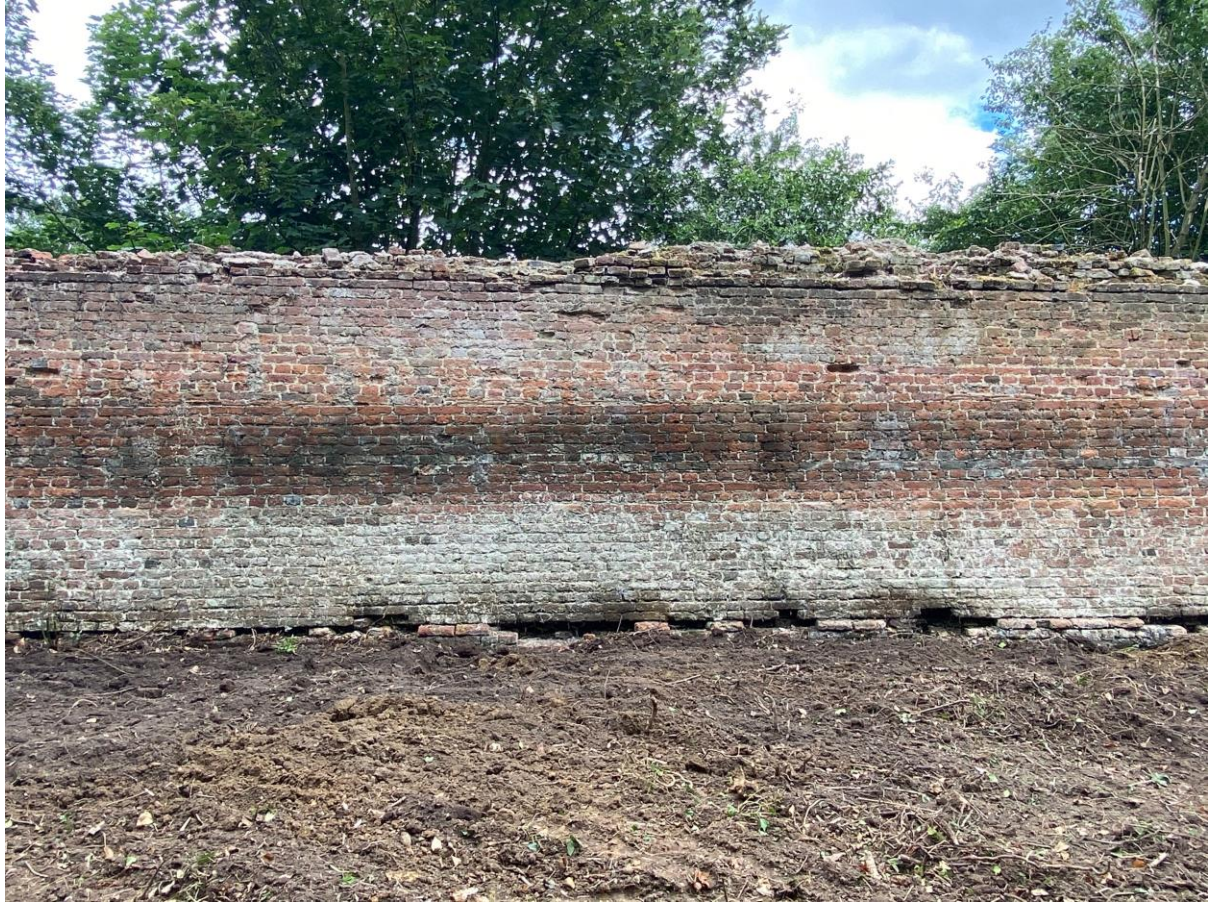
### Wall 1 – Centre Section

**Description** - Original brick wall enclosing Orchard Area, retaining higher ground behind. Standing sections appear sound.

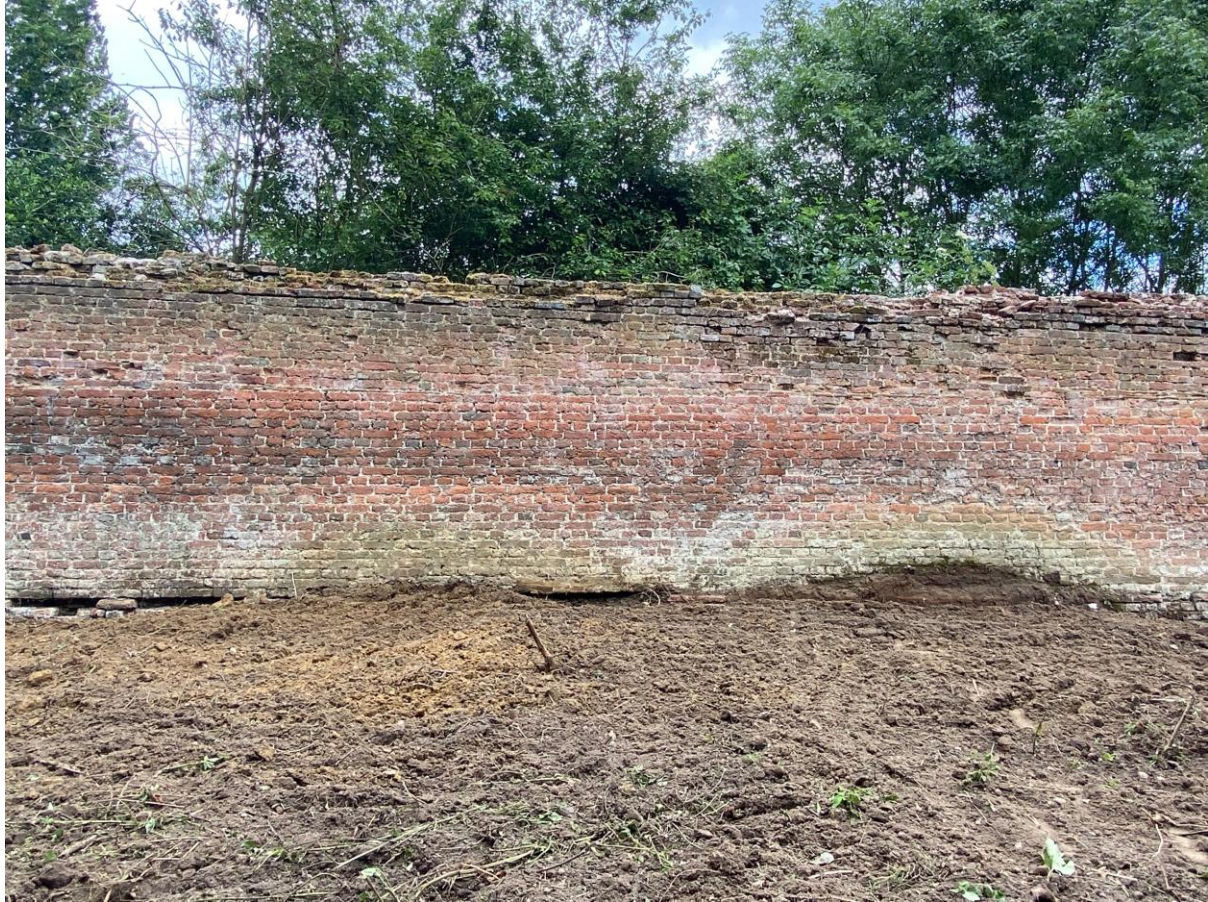
### Wall 1 – Centre Section

**Description** - Original brick wall enclosing Orchard Area, retaining higher ground behind. Standing sections appear sound.

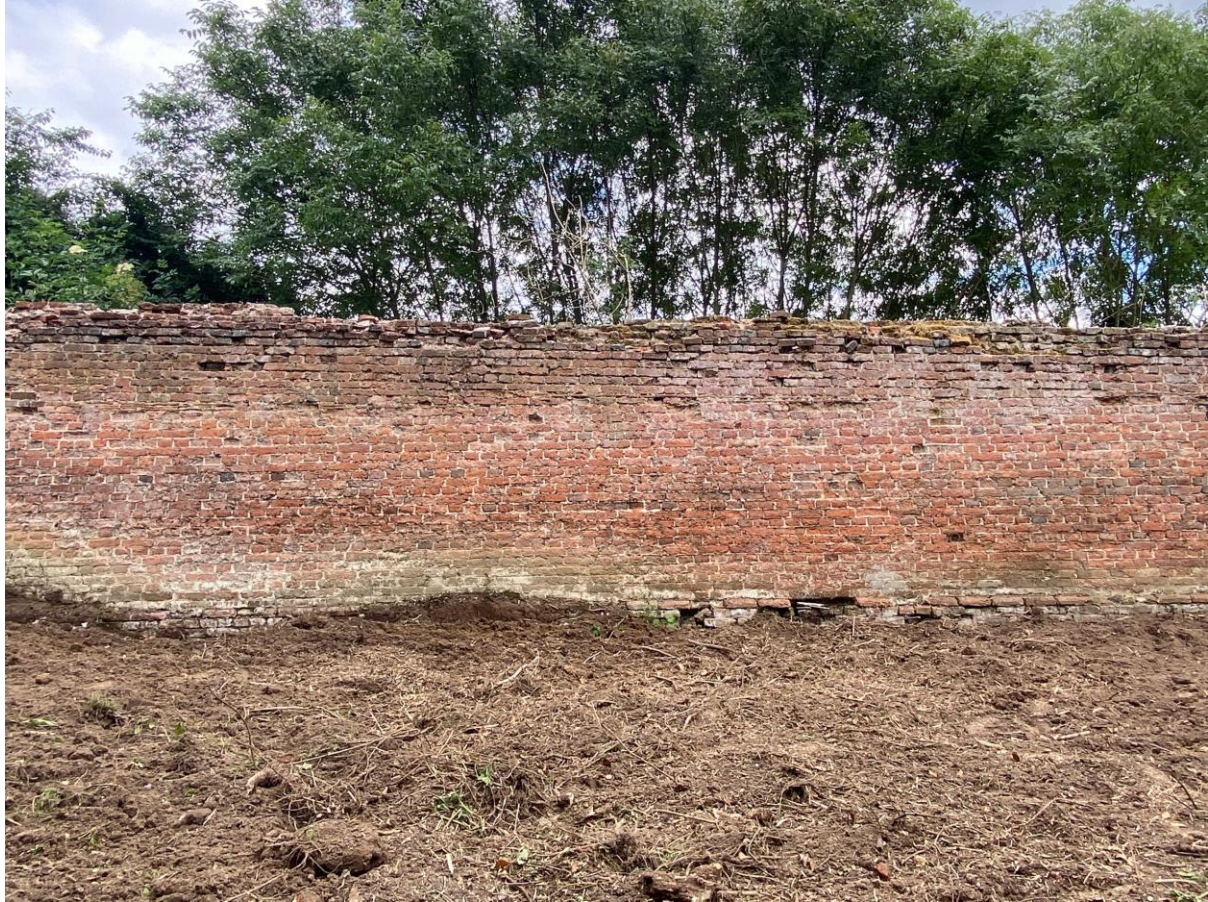
### Wall 1 – Centre Section

**Description** - Original brick wall enclosing Orchard Area, retaining higher ground behind. Standing sections appear sound.

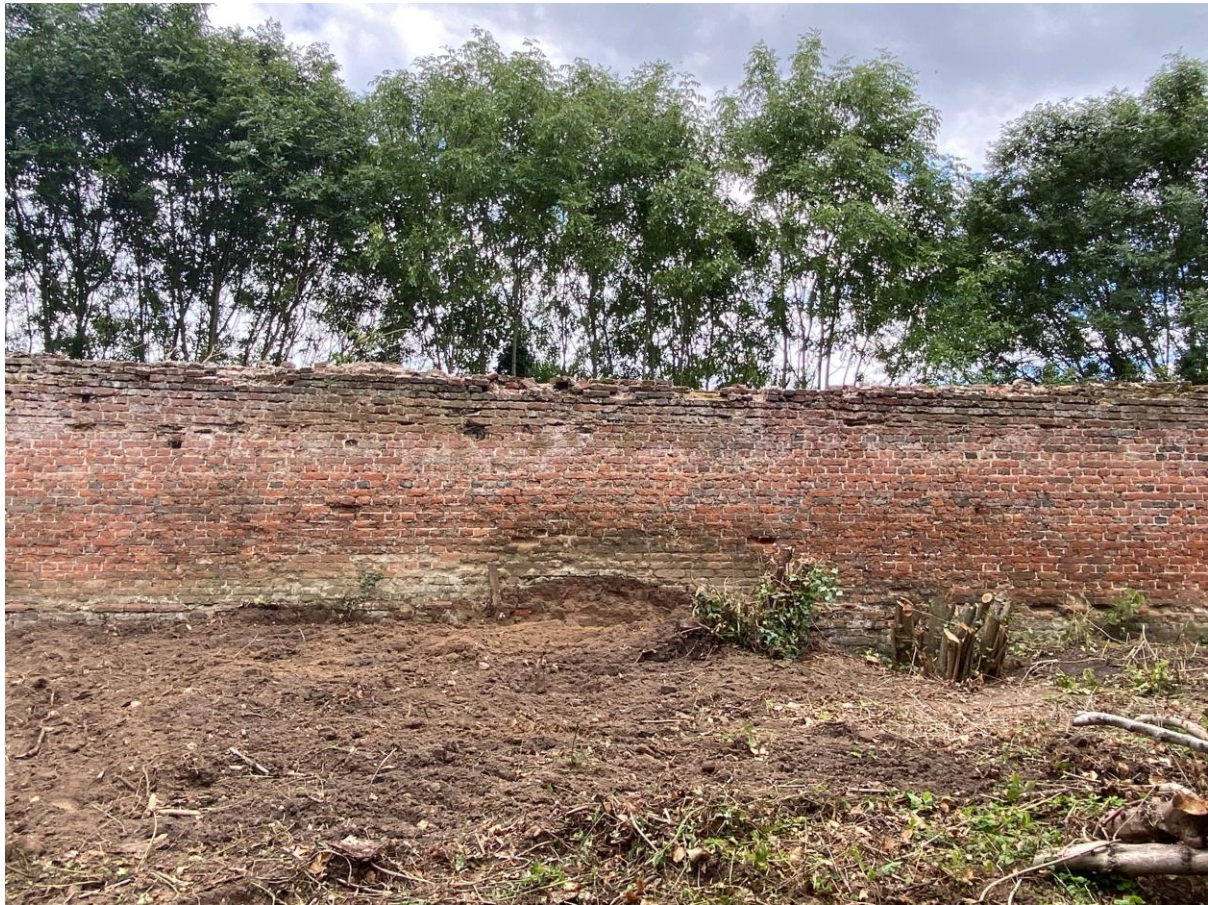
### Wall 1 – Centre Section

**Description** - Original brick wall enclosing Orchard Area, retaining higher ground behind. Standing sections appear sound.

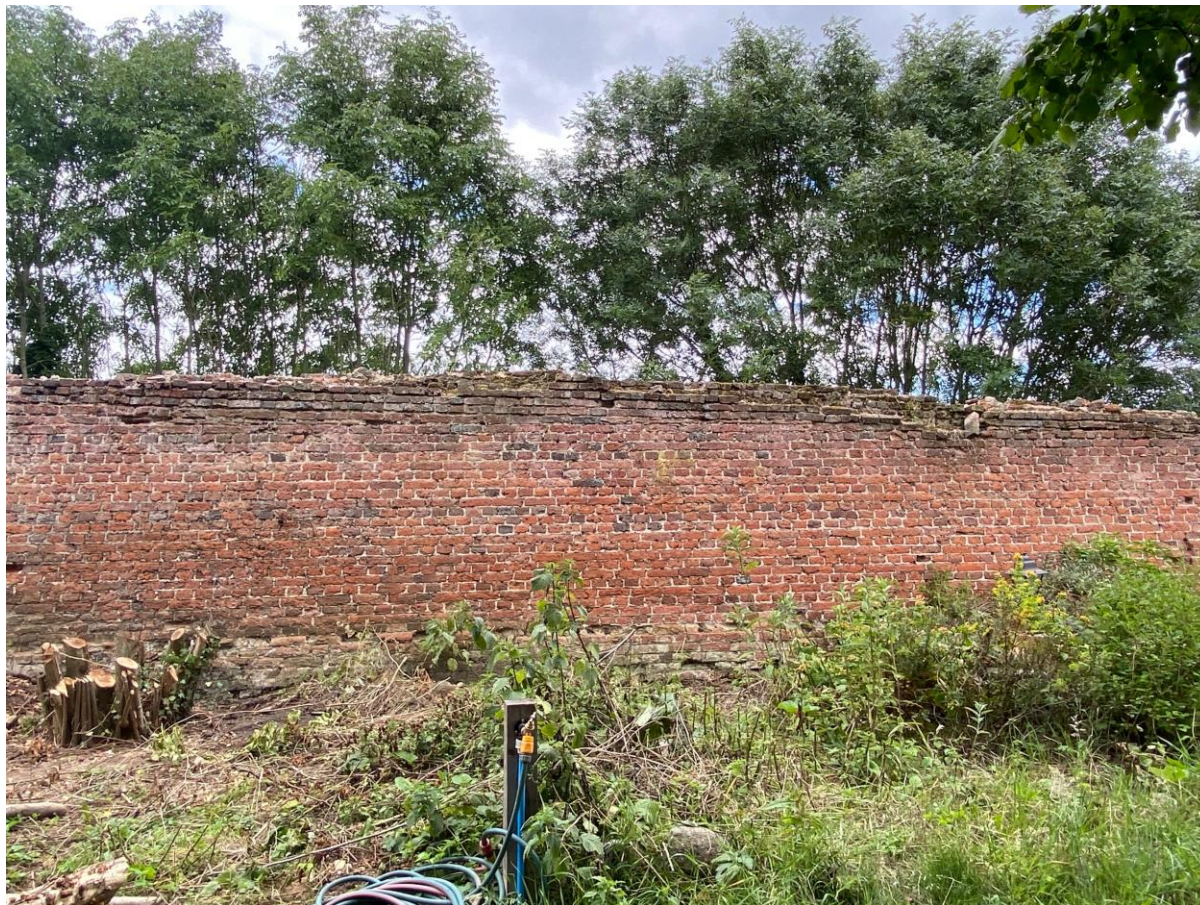
### Wall 1 – Western Section

**Description** - Original brick wall enclosing Orchard Area, retaining higher ground behind. Standing sections appear sound.

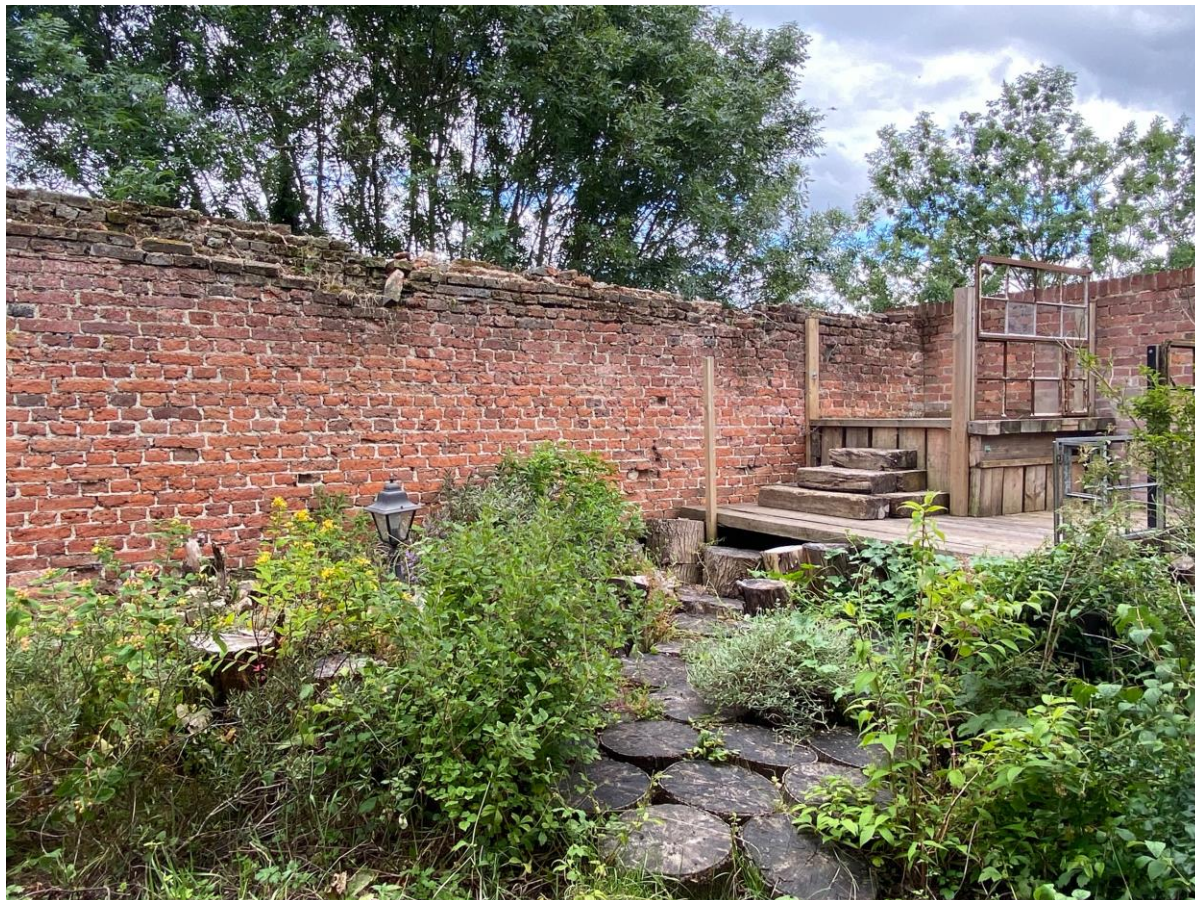
### Wall 1 – Centre Section

**Description** - Original brick wall enclosing Orchard Area, retaining higher ground behind. Standing sections appear sound.

Complete repairs to lower section of wall in salvaged and new bricks to match all as above.
