RE: Trees at 9 Linksway, Northwood, HA6 2XA

Below: excerpt from tree survey updated December 2024:

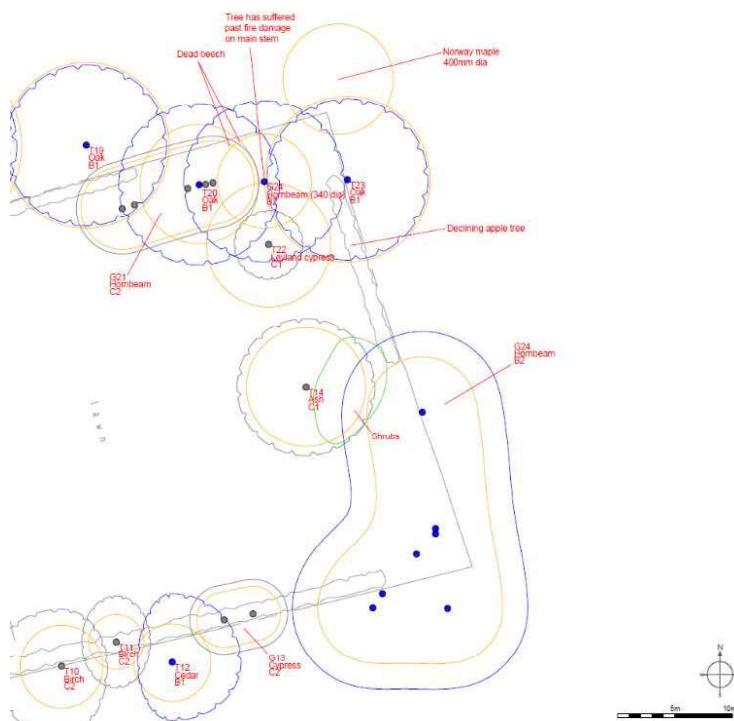
Having reviewed the DDA landscape plan (ref: 1363/P/7F) I note that trees G21 and the northern standalone hornbeam from G24 require removal. Please note that T14 and T22 have already been removed as these trees were not covered by the Tree Preservation Order (TPO).

G21 is a lapsed hedge and was previously graded as C category. Whilst these trees are covered by the TPO, they are suppressed low value trees with little prospect of ever developing into fully formed trees given the other nearby trees and their tightly packed stems.

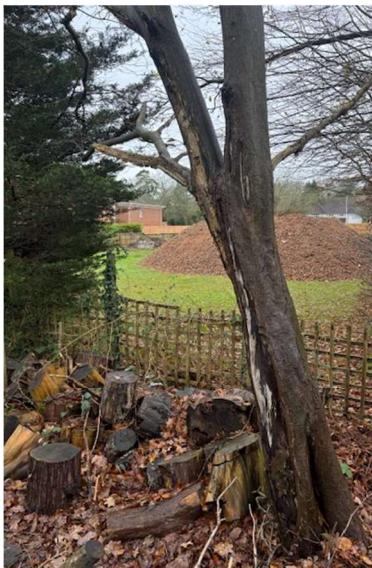
The northern tree of G24 has suffered from historic fire damage as can be seen on the photo below. This tree is also of limited visual amenity given its rear garden location and the presence of T20 and T23, oak trees which are either side of this tree and which will be retained.

Below: tree in G24 proposed for removal:

In conclusion, the trees proposed for removal are either of low value or are compromised due to their condition. The loss of these trees will not adversely impact the local or wider landscape, especially when considering the substantial number of new trees proposed for planting.
