## structural letter report

**1 Hillman Cl  
Uxbridge  
UB8 1QA**

**ref# 24092-DVP-R01**

**Re: 1 Hillman Cl, Uxbridge UB8 1QA**

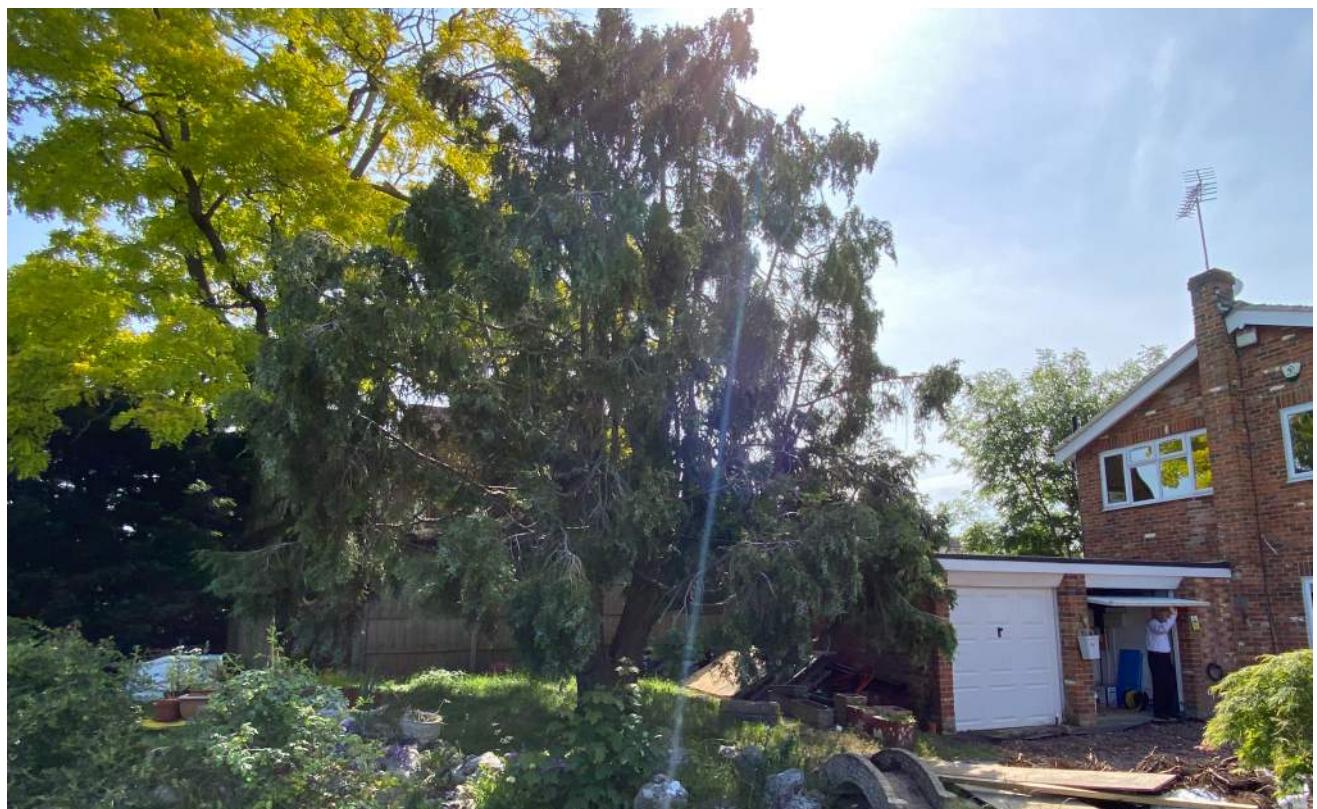
FIG. 2

T002 is multi-stemmed and growing at an angle, leaning precariously over the garage. This structural inclination poses a significant risk of splitting and falling onto the garage. The risk of splitting is heightened by the tree's multi-stemmed nature and the visible inclusion at the base where the stems converge, which can weaken the overall structural integrity, especially under the strain of adverse weather conditions (such as heavy snow or winds) or the weight of the tree itself. The tree's sparse crown and fair physiological and structural condition further suggest that it is not thriving, which may contribute to its vulnerability. Given its position and current health, the future risks include potential structural failure, leading to substantial damage to the garage and surrounding property, and possibly posing a safety hazard to the occupants.

Given the significant risks associated with Tree T002, including its precarious lean over the garage, multi-stemmed structure, and visible base inclusion that increases the likelihood of splitting, it is recommended that the tree be removed. The removal of Tree T002 will mitigate the substantial risk of structural failure, which could result in severe damage to the garage and surrounding property, as well as potential safety hazards to the occupants. Proactively removing the tree will prevent future maintenance challenges and eliminate the ongoing threat posed by its compromised structural integrity. This recommendation should be discussed and agreed upon with the arboriculturist to ensure all considerations are addressed.

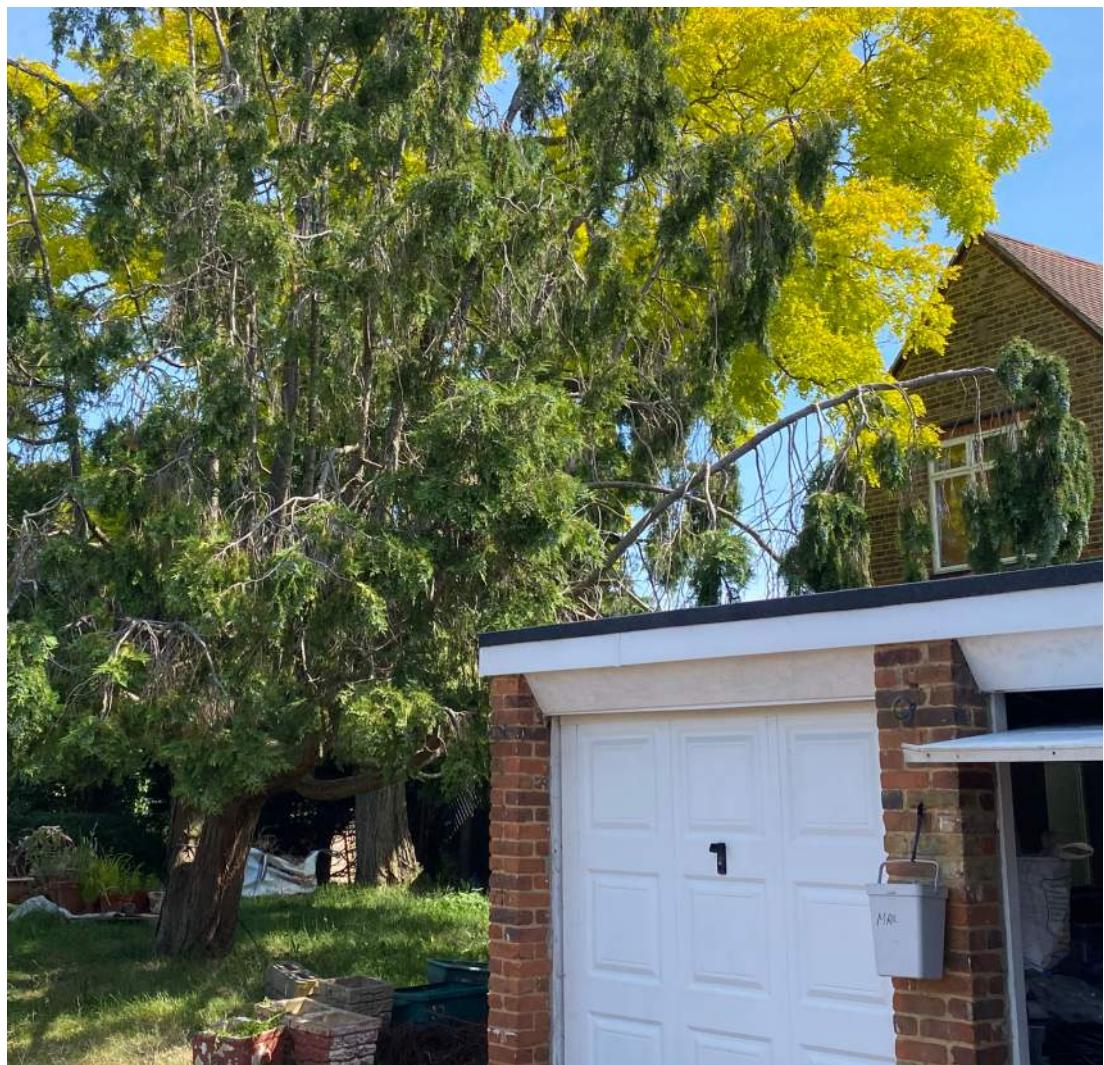
FIG. 4

T002 is located approximately 4m from the face of the existing garage. No cracks were noted on the face of the garage walls that may indicate structural movement induced by the tree roots. Minor cracks were noted on the garage concrete floor, which were likely affected by the existing tree to some extent.
