Tree Structural Integrity Report

5 Kewferry Road
Northwood
Middlesex
HA6 2NS

GD/220497

5th October 2022

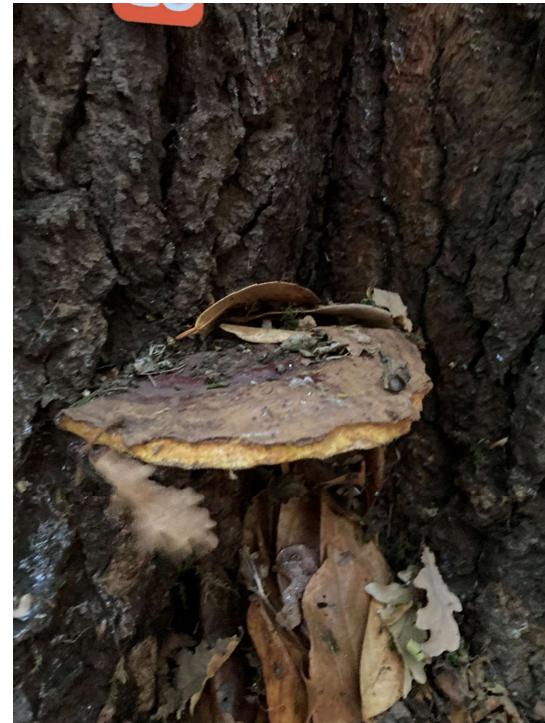
The presence of a fungal fruiting body identified to be *Ganoderma pfeifferi* is found to be developing at the base of the Common Oak.

Figure 2: Beeswax Fungus fruiting body attached to the south-western quadrant of the Oak Tree

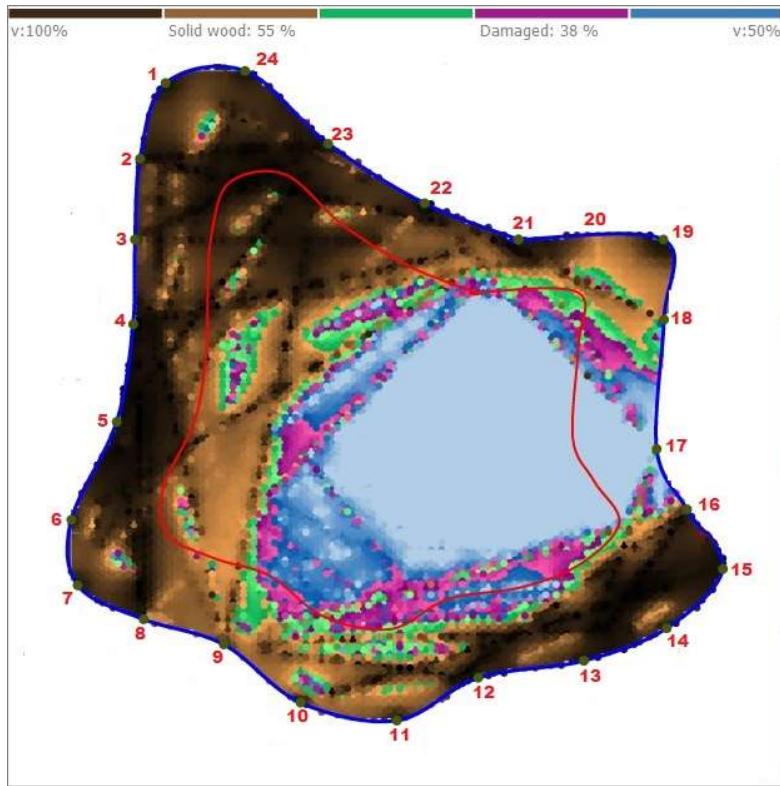
Figure 4: Image of PiCUS® Sonic Tomograph at 53 Centimetres Ht. on Common Oak at 5 Kewferry Rd

The Tomogram depicts that at 53 centimetres above ground level 38% of the wood as indicated by the blue/pink colours returned the slowest rate of soundwave transmittance, whilst 55% as indicated by the brown colour returned the fastest transmittance. The remaining 7% as indicated by the green coloured areas of the image is considered to have moderate rate of soundwave transmittance.

The blue / pink areas with the slowest soundwaves are interpreted as regions where wood is possibly decayed. As can be seen in Figure 4, the blue area has a bias to the southern quadrant. This corresponds with the locations of the fungal fruiting bodies previously attached between sensors 9-10 & 17-18 with very little in way of intact wood within these areas

The surrounding “belt” of green depicted on the image indicate areas of the stem which we interpret as incipient decay.

At the conclusion of the advanced assessment using the sonic tomography at the base of the main stem, the results are interpreted as advanced levels of wood decay and degradation with an asymmetrical bias to the south, falling outside the circumferential red line (notional representation of the "t/R ratio").

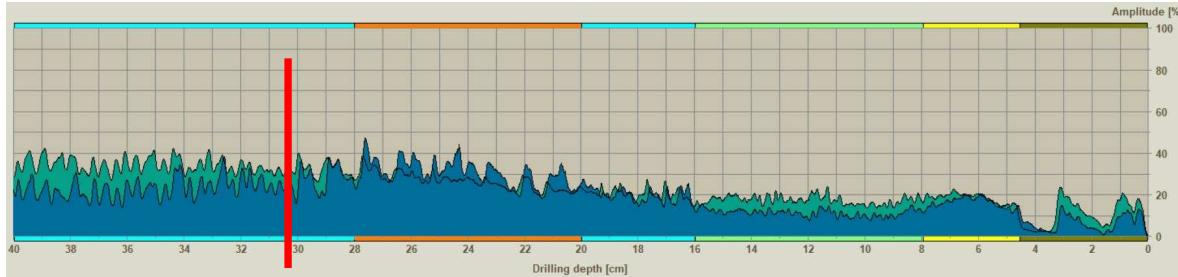
Test No.1 – At Sensor 4

Increasing wood density through the initial sapwood profile, with a noticeable drop in amplitude beyond 8cm and a reduction of the peaks and troughs indicating early stage decay up to 16cm. This profile fails to satisfy the 0.33 Mattheck's t/R ratio.

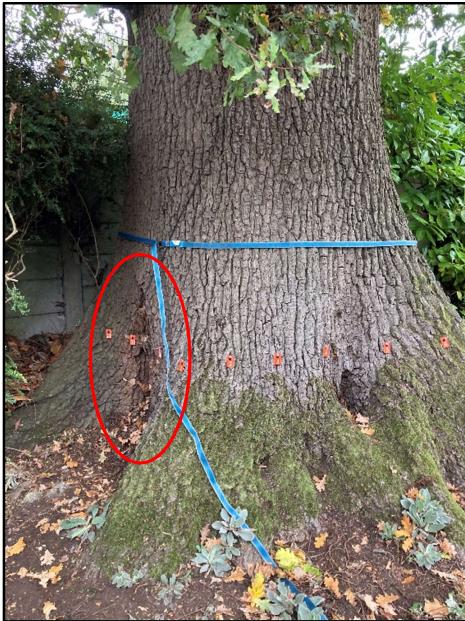
Figure 9: Image showing prominent buttressing to the east and western quadrant & location of Fungal Brackets to the south-east highlighted

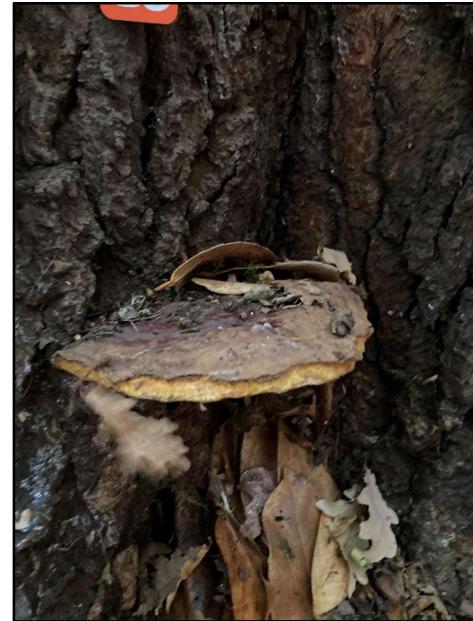
Figure 10: Image of fungal bracket attached to the south-western quadrant
