**12 Fringewood Close  
Northwood  
HA6 2TB**

## **Tree Health and Condition Survey**

**(Ref. 101 639)**

**Date: 03/08/2021**

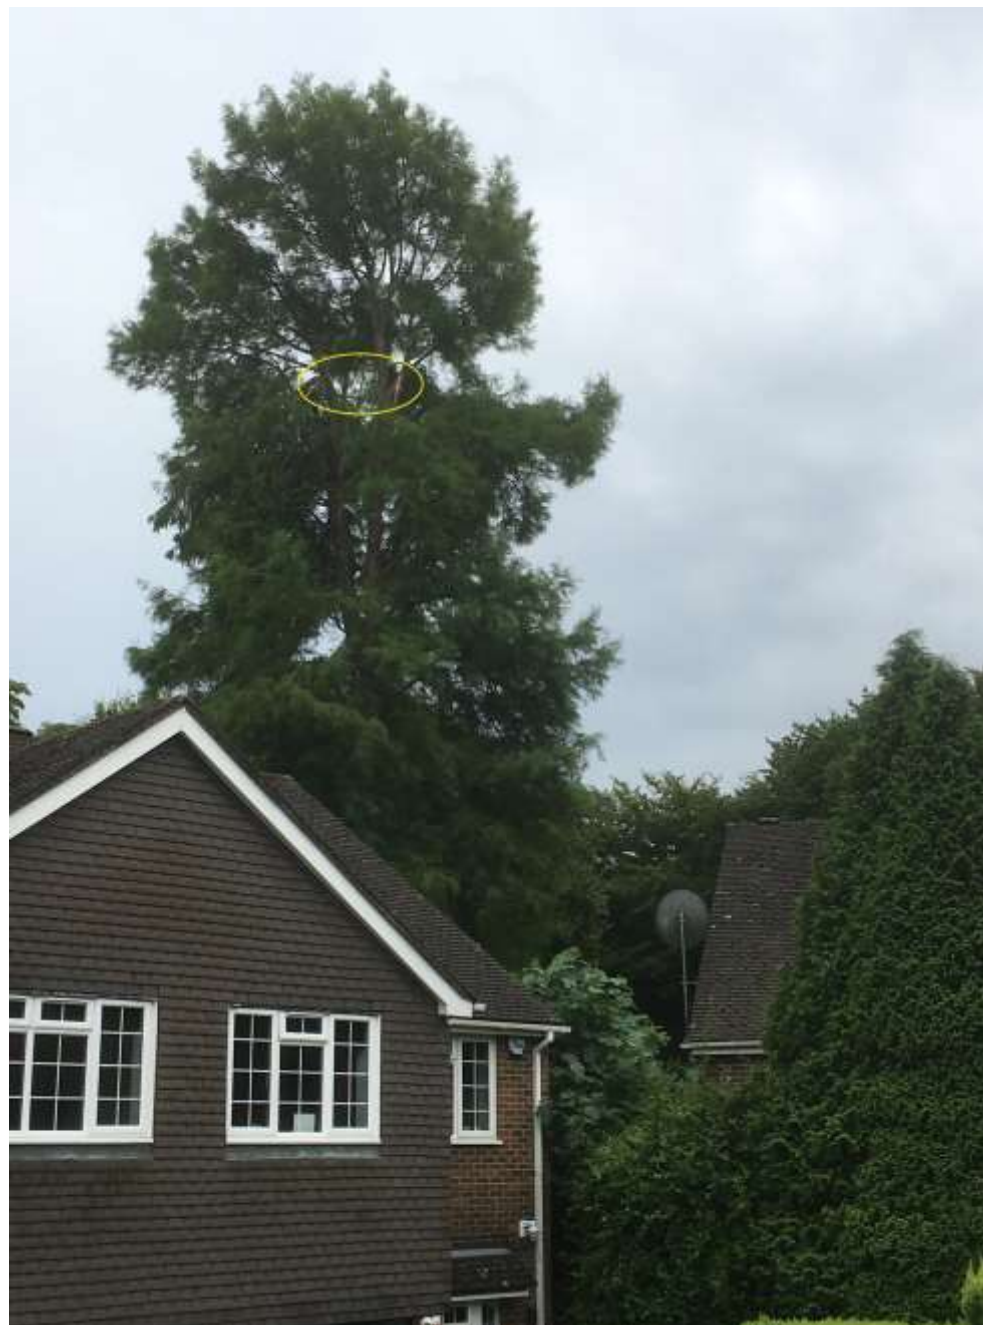
Photo no. 1 to show within the yellow oval, the torn upright scaffold limb (with pale heartwood exposed) on right-hand side and the 2 x branch hangers on the left-hand side

- (1) Remove the upper crown hangers (x 2) and the low crown lodged branch (x 1). Even though T1 is subject to a TPO these tree works can be carried out without Hillingdon Council permission. During these works the contractor should carry out a climbing inspection to note and report back on any branch defects (e.g. cracks, splits or weak unions). *Timeframe:* As we have recommended that the garden not be used until these branch removals are carried out, these tree works should be carried out as soon as possible.
- (2) Apply to Hillingdon Council to prune back the crown to the previous pruning points i.e. the crown reduction of 2016. This will reduce the branch end weight and mitigate any branch failures in the short-medium term. This may also include the removal of any defective branches noted during the aforementioned climbing inspection. *Timeframe:* within the three months.

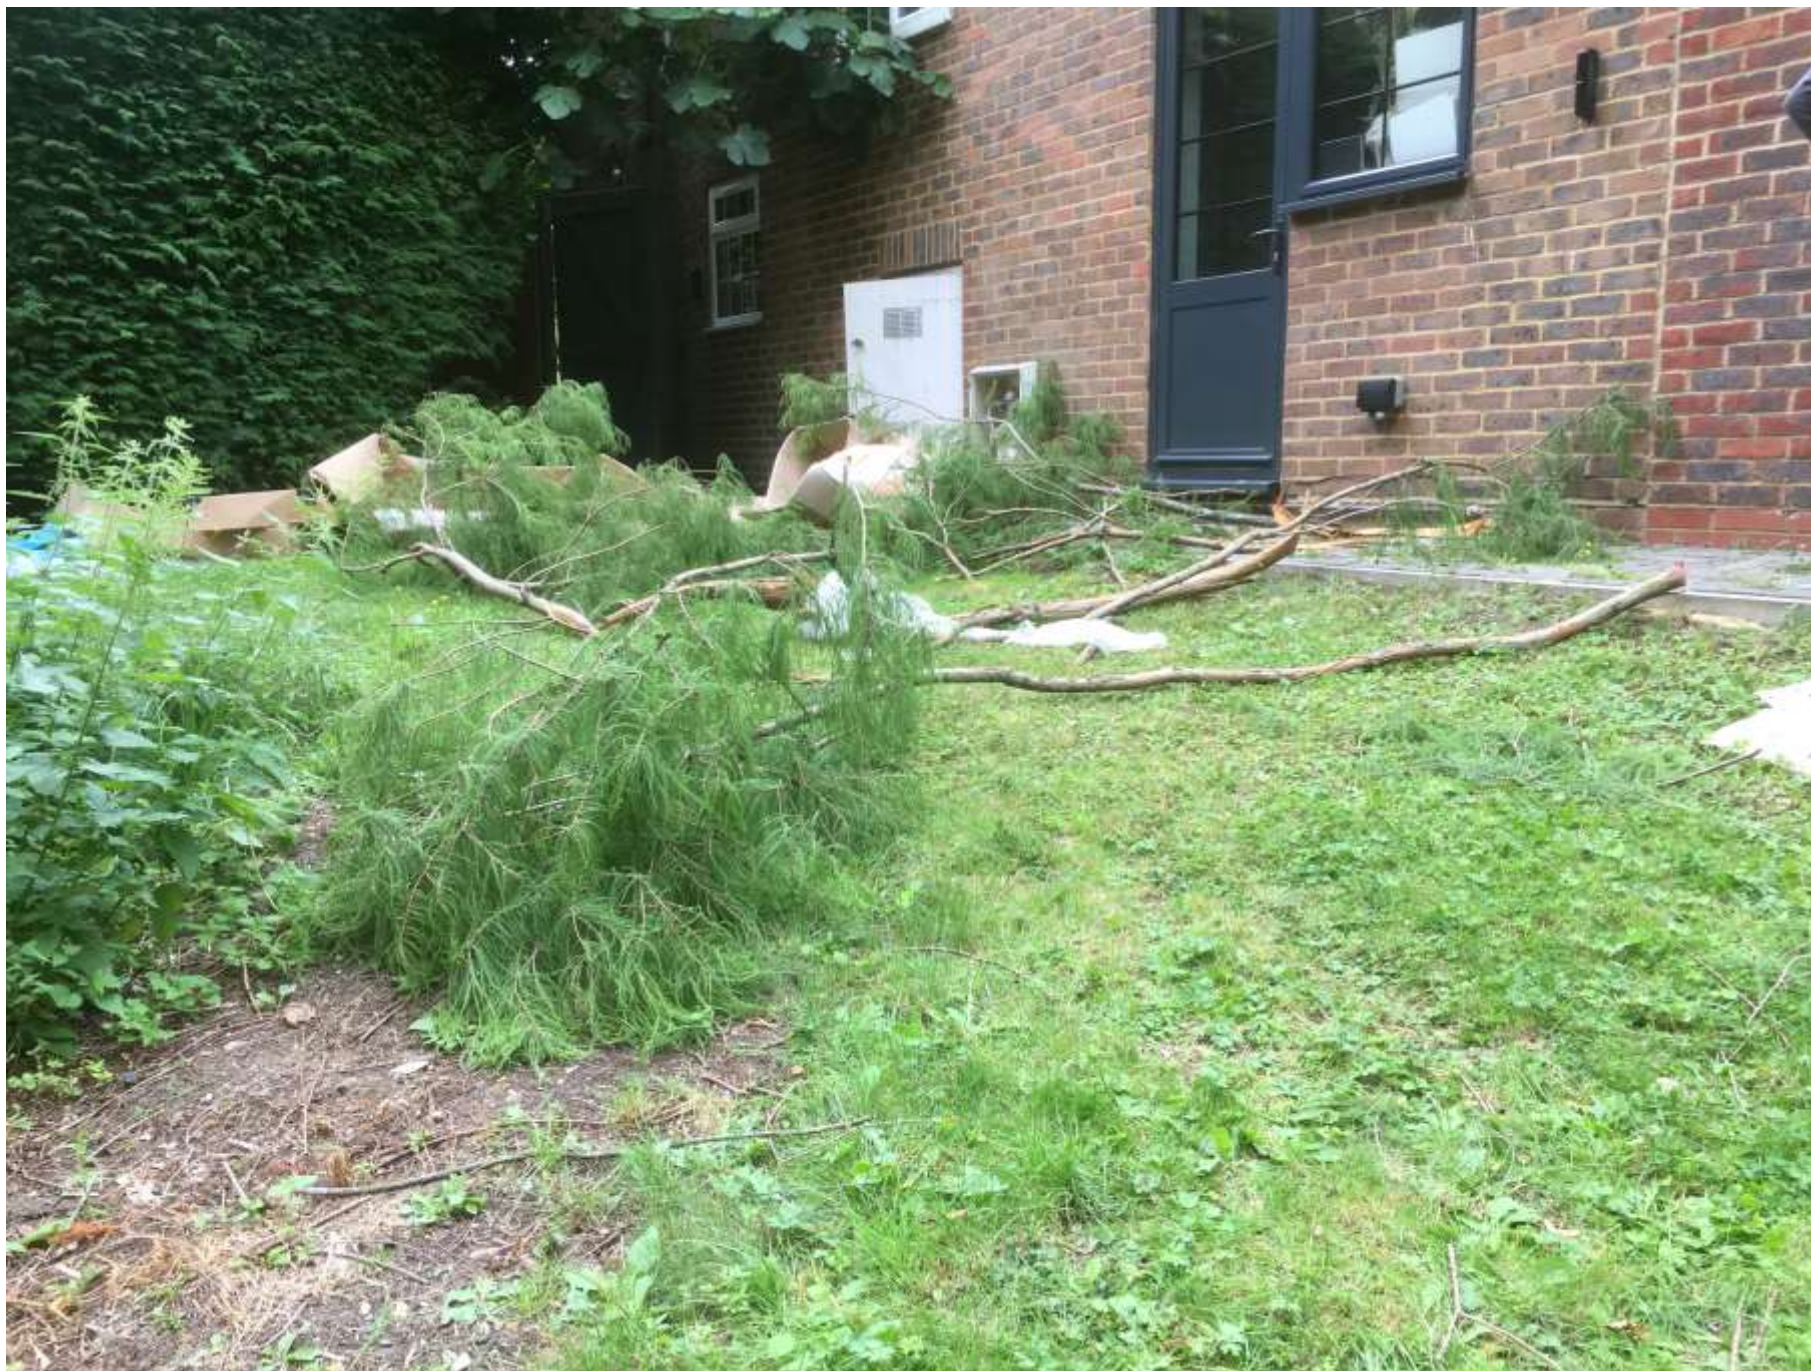
**Initial Conclusion:** The recently failed branches were not diseased, nor did they have horizontal splits or decay issues. Also they could not be described as heavy over-extended limbs with long-lever arms. As such we cannot be conclusive regarding the mechanism of failure though high winds could have been a contributing factor. As a possibility: Summer Branch Drop (SBD) occurs with long large diameter primary scaffold branches and the usual suspects are, amongst other tree species, beech, oak and eucalyptus. Typically, SBD is associated with limb water content rather than being a structural defect. In our experience however SBD is not an issue with swamp cypress and importantly in regard to T1, it does not have long heavy primary scaffold branches. The role of SBD as a causal agent to the T1 branch failures is therefore questionable.

Photo no. 2 to show the 4 x recently failed braches  
**NB** Door included for scale and note small branch diameters

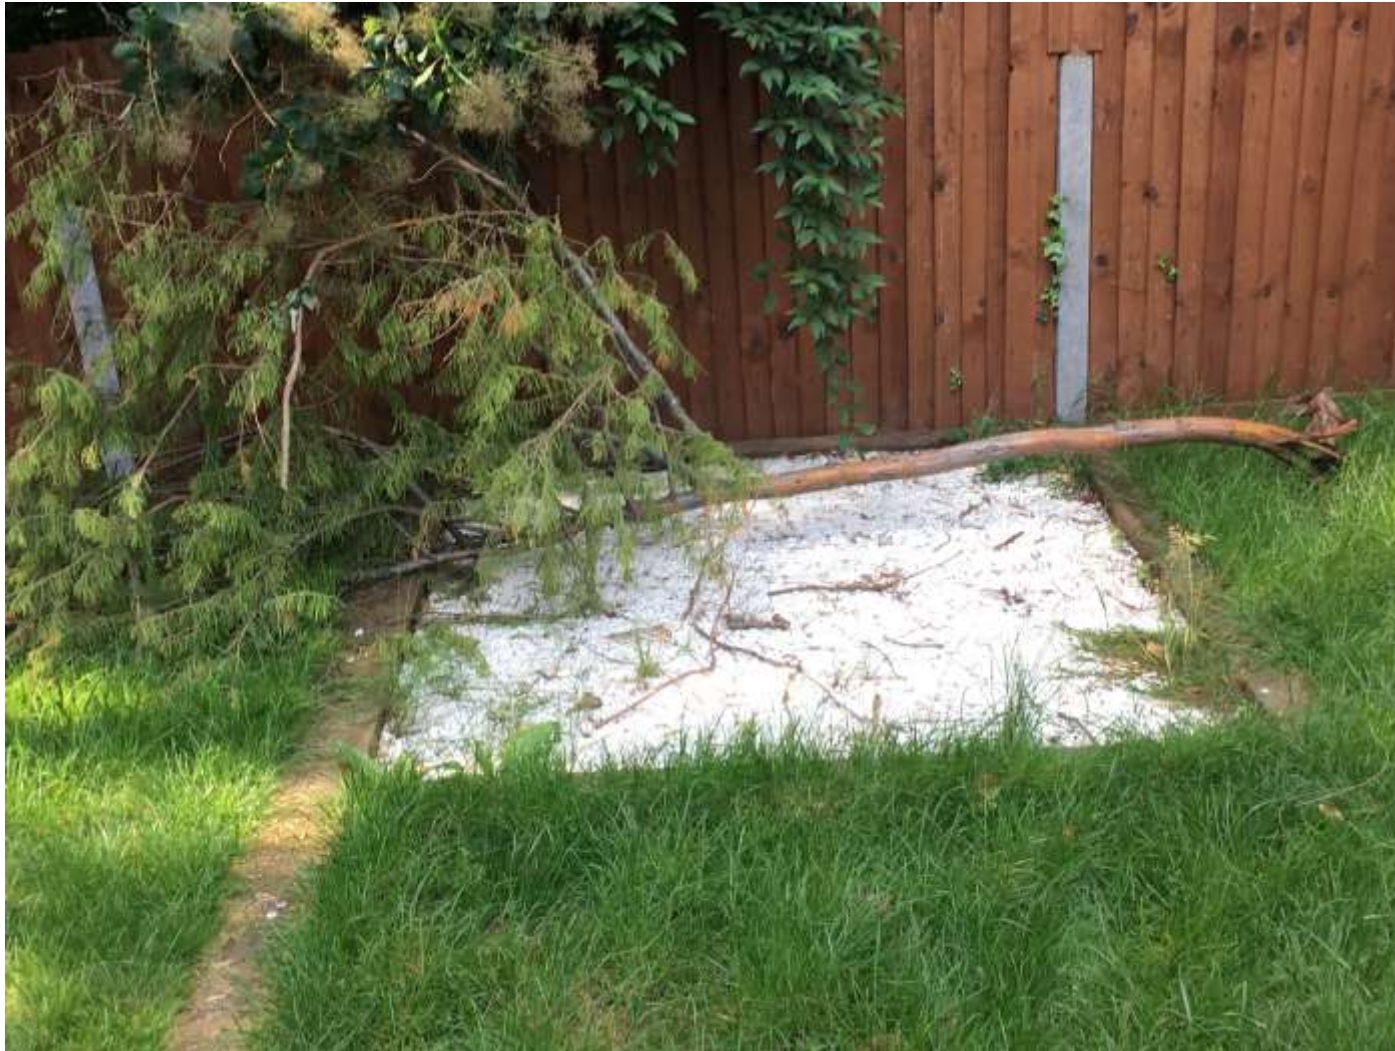
Photo no. 3  
Supplied photo of branch that failed in 2017

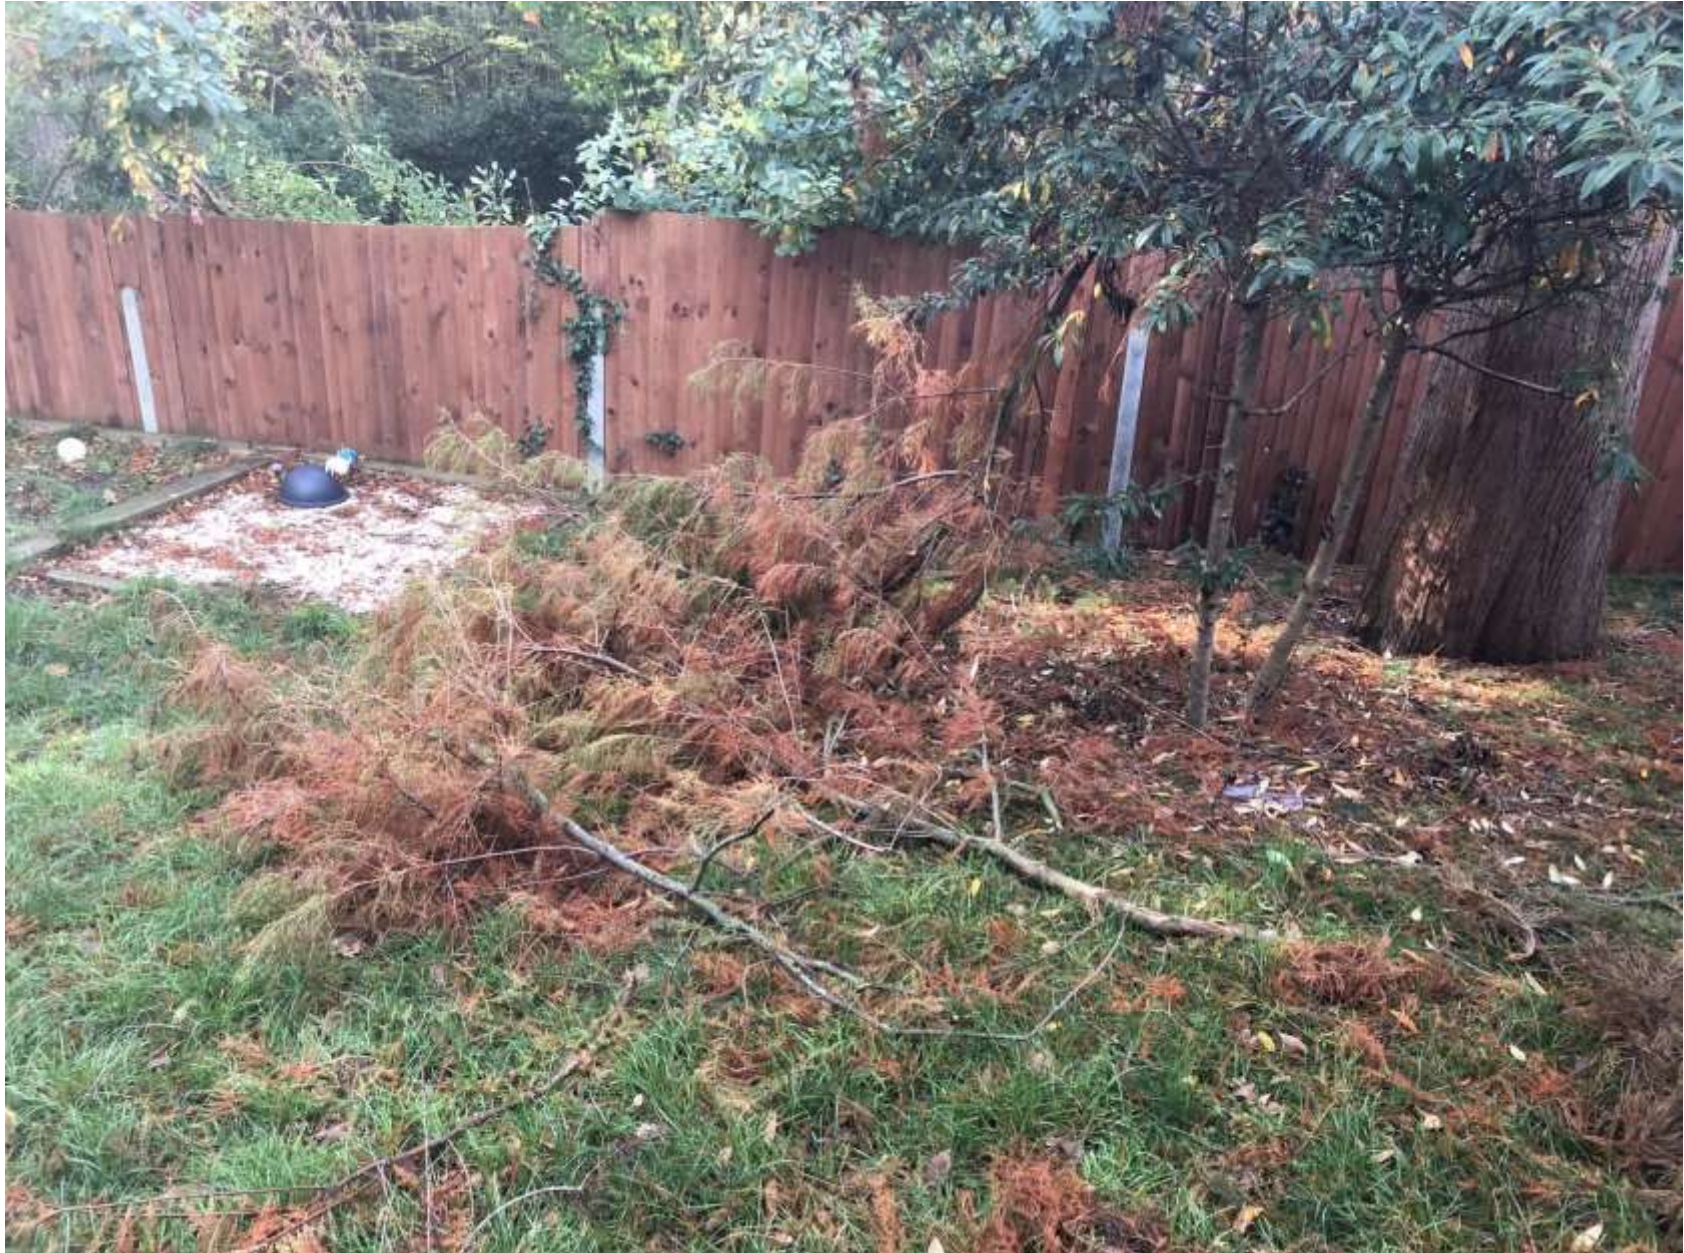
Photo no. 4  
Supplied photo of 3 x branches that failed in 2017
