TREE CONDITION REPORT PERTAINING TO ONE SWAMP CYPRESS TREE

**No. 12 Fringewood Close,
Northwood, Middx HA6 2TB**

CLIENT:	Mr Chirag Shah
CLIENT REF:	CS/FCNM
AAAL REF:	SAL/KMA/12008
AAAL CONSULTANT:	Shane A Lanigan
REPORT DATE:	7 th May 2024

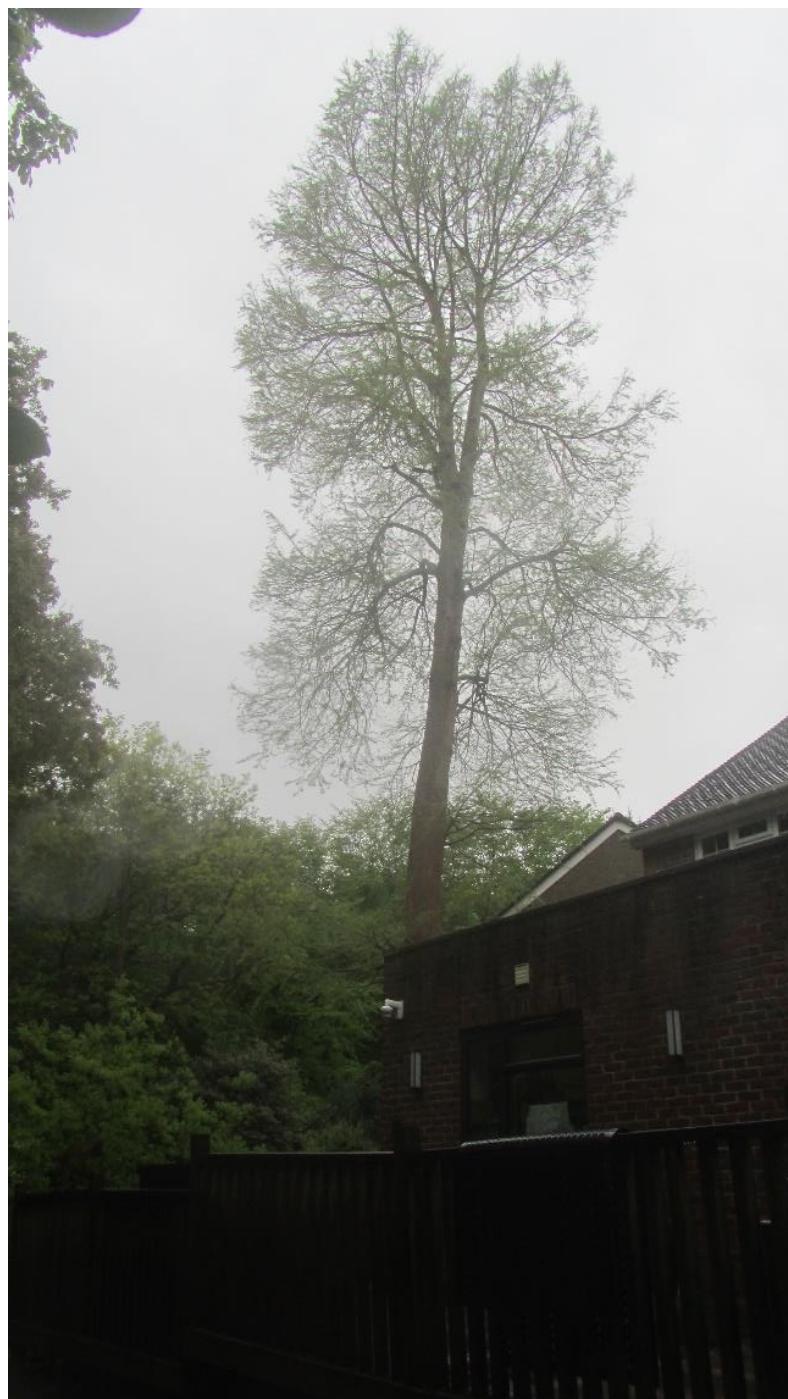
PHOTOGRAPH NO. 1 – T1 – Swamp cypress – viewed from the northeast

5.1 **T1 – Swamp cypress** – fell to ground level.

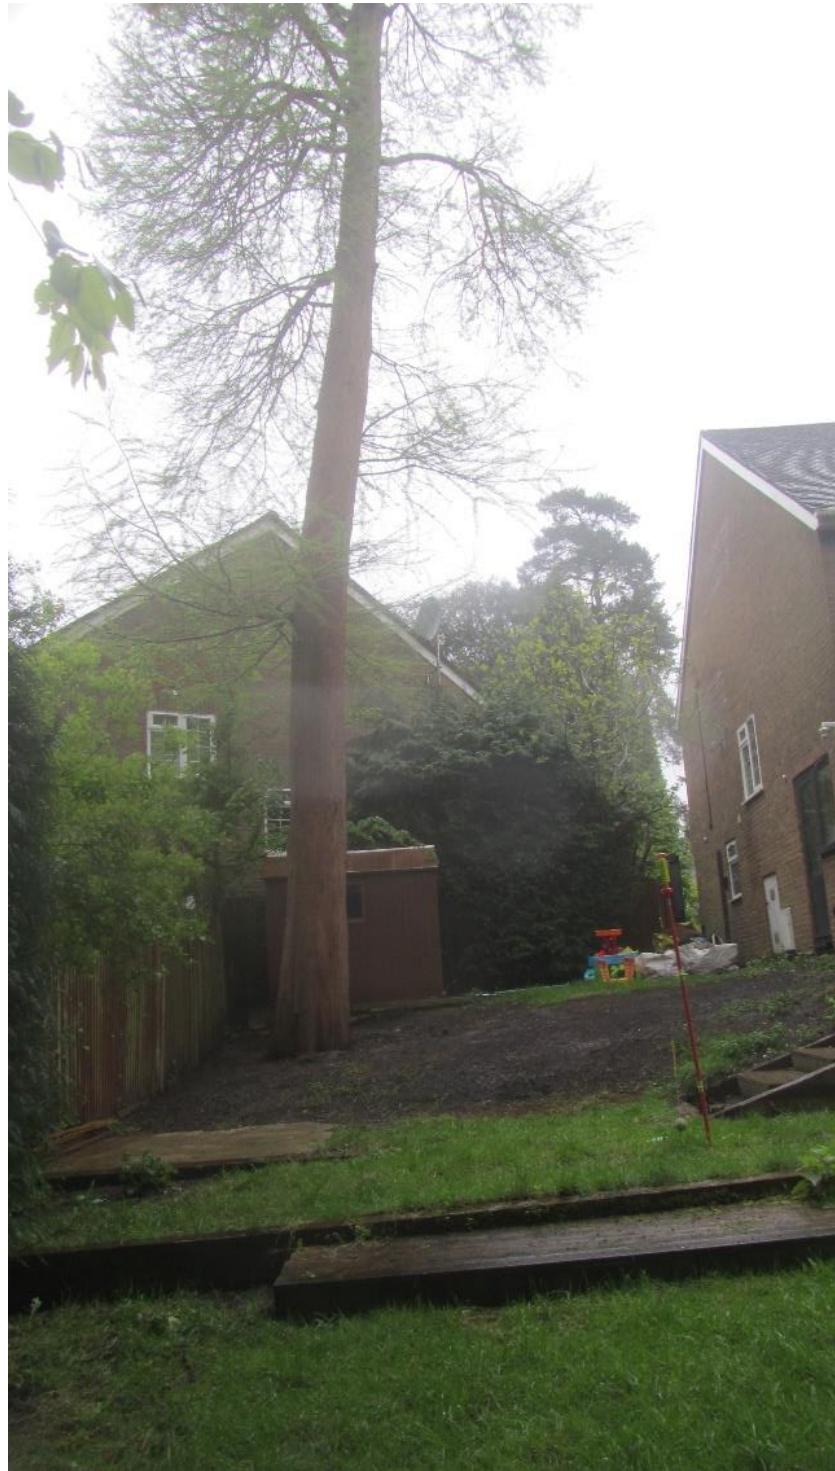
PHOTOGRAPH NO. 2 – Base and lower trunk of T1 viewed from the east and showing the favourable growth disposition to the north

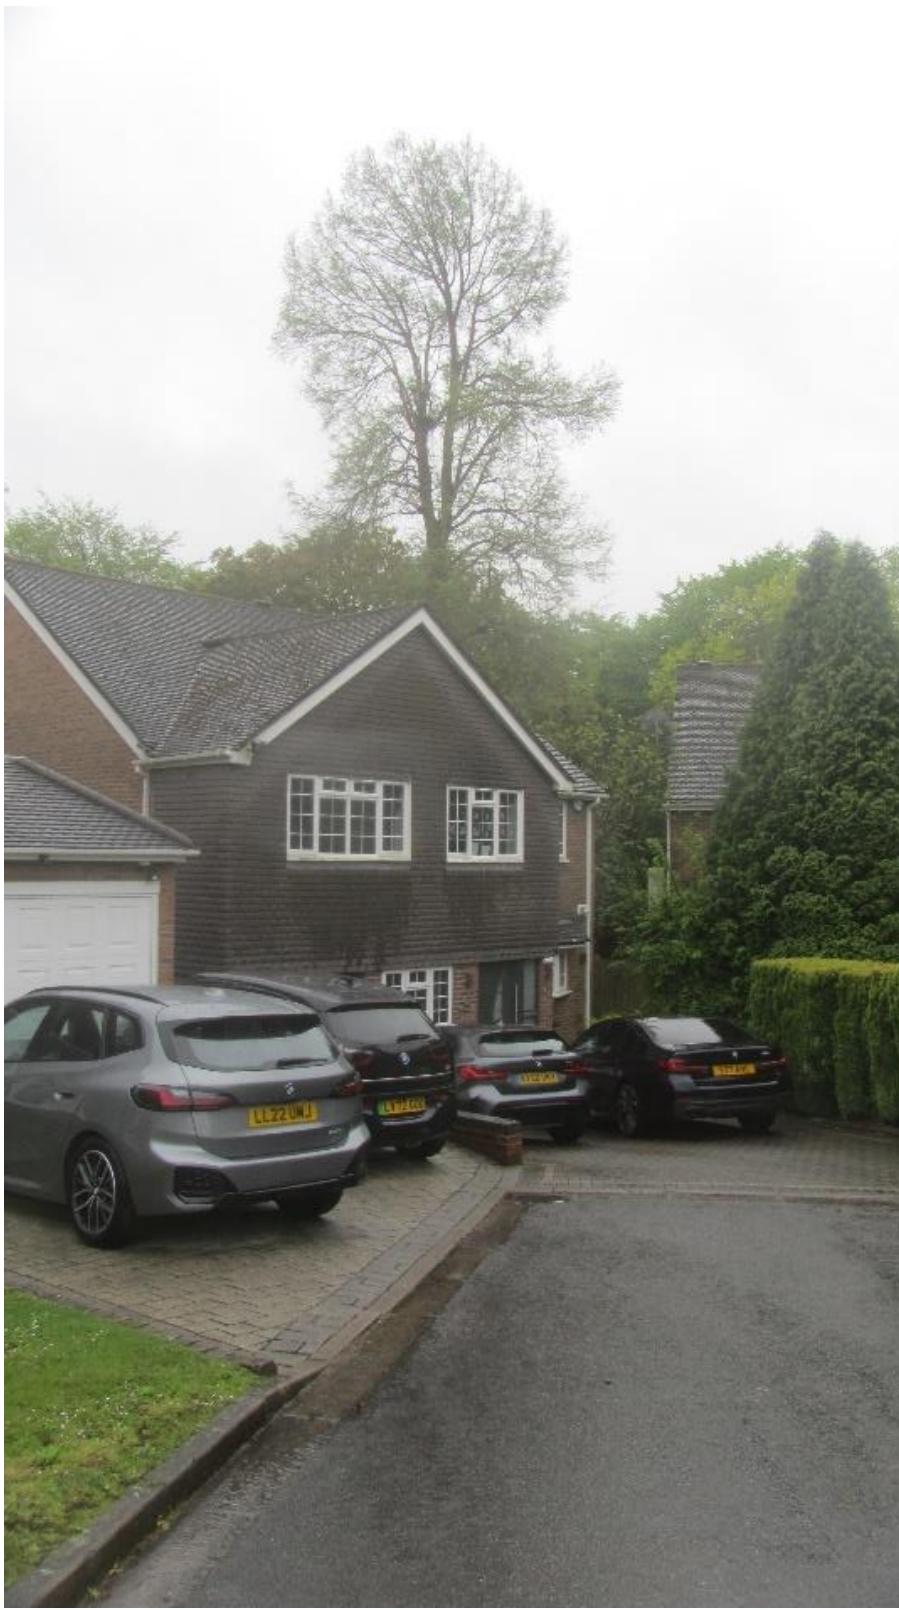
PHOTOGRAPH NO. 3 – T1 – Swamp cypress viewed from the northwest within Fringewood Close

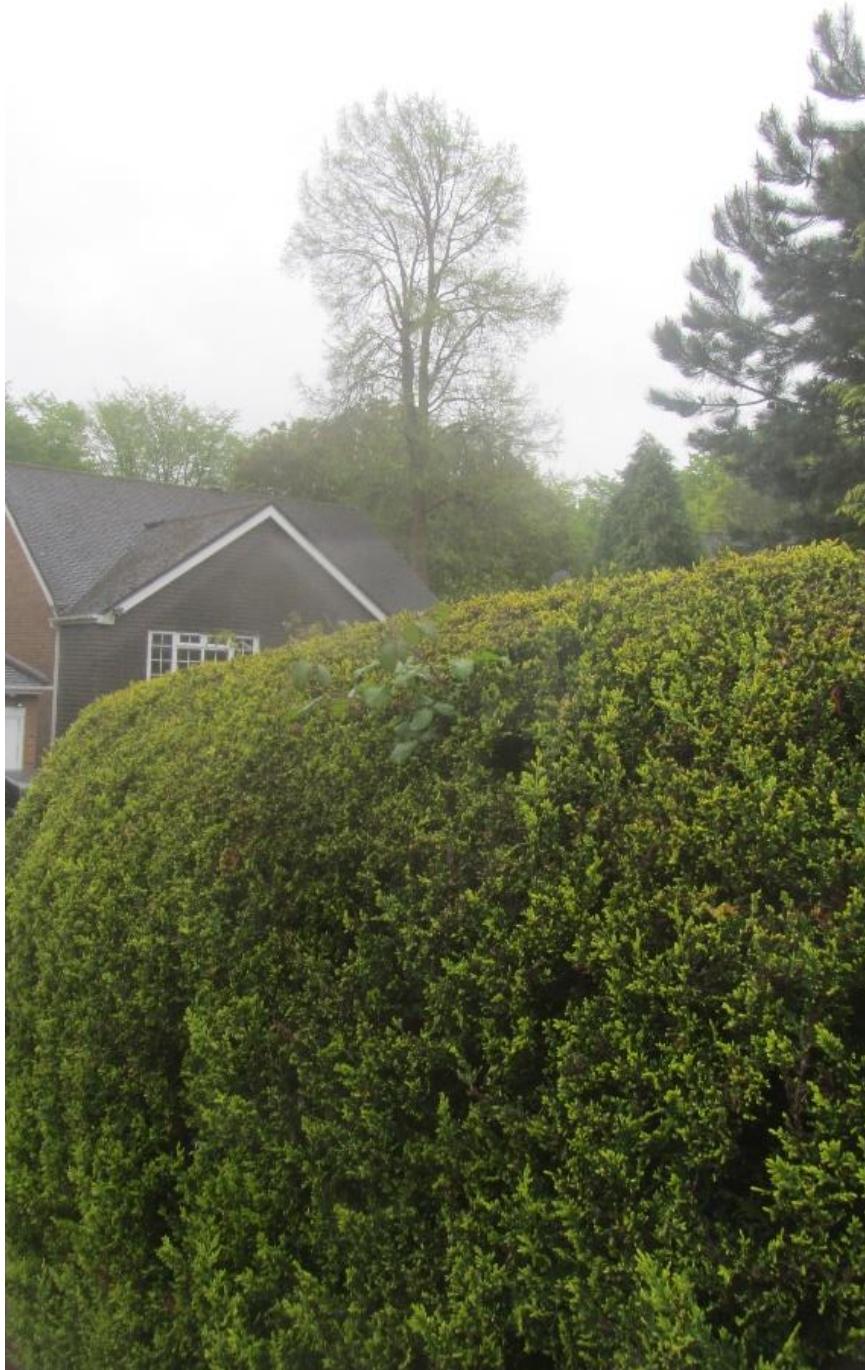
PHOTOGRAPH NO. 3 – T1 – Swamp cypress viewed from the west while within Fringewood Close

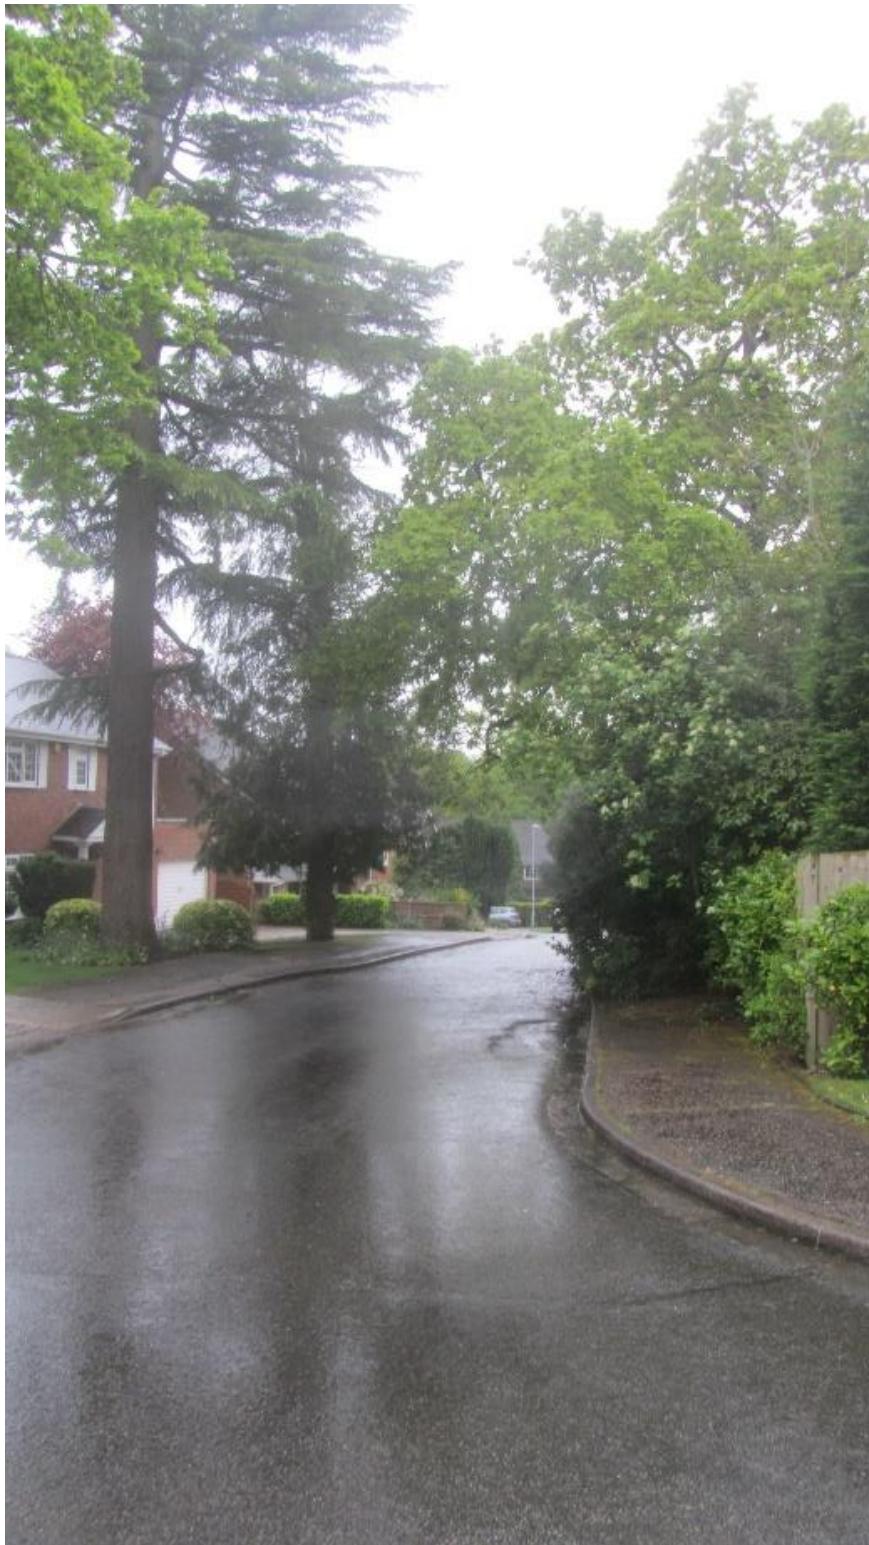
**PHOTOGRAPH NO. 5 – T-junction of Fringewood Close showing that T1
cannot be seen from points to the northwest other than from points
near to No. 11**

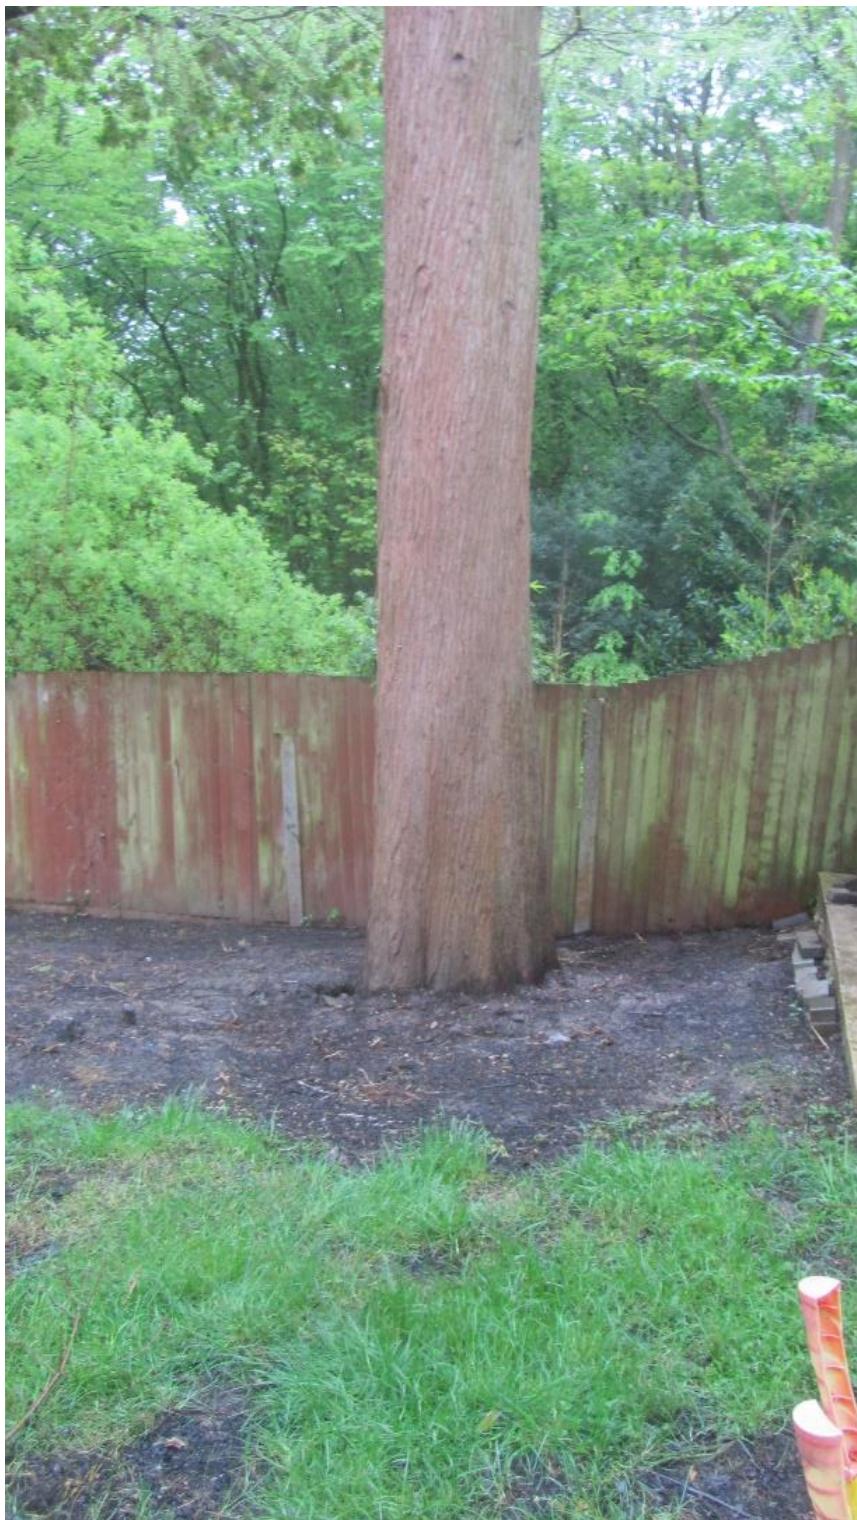
<p>Photograph 3 of the Arbol Euro Consultancy report) and again in 2019 (see Photographs 2 & 3 of that report). Other sporadic failures have occurred throughout this seven-year time period. The tree base shows minimal trunk buttressing which contradicts the usual tree form: there are however, no signs of decay or dysfunction in this region.</p>
<p>Comment:</p>	<p>Tree one is significantly taller than the trees growing in Ruislip Woods to the southeast, and there are no other large trees growing nearby. It stands in isolation, with most of its live crown above the trees within Ruislip Woods. Accordingly, it has no companion cover from wind-forces and being so exposed to these has undergone the incidences of branch break referred to above.</p>

PHOTOGRAPH NO. 6 – Base of T1 showing a lack of root buttressing

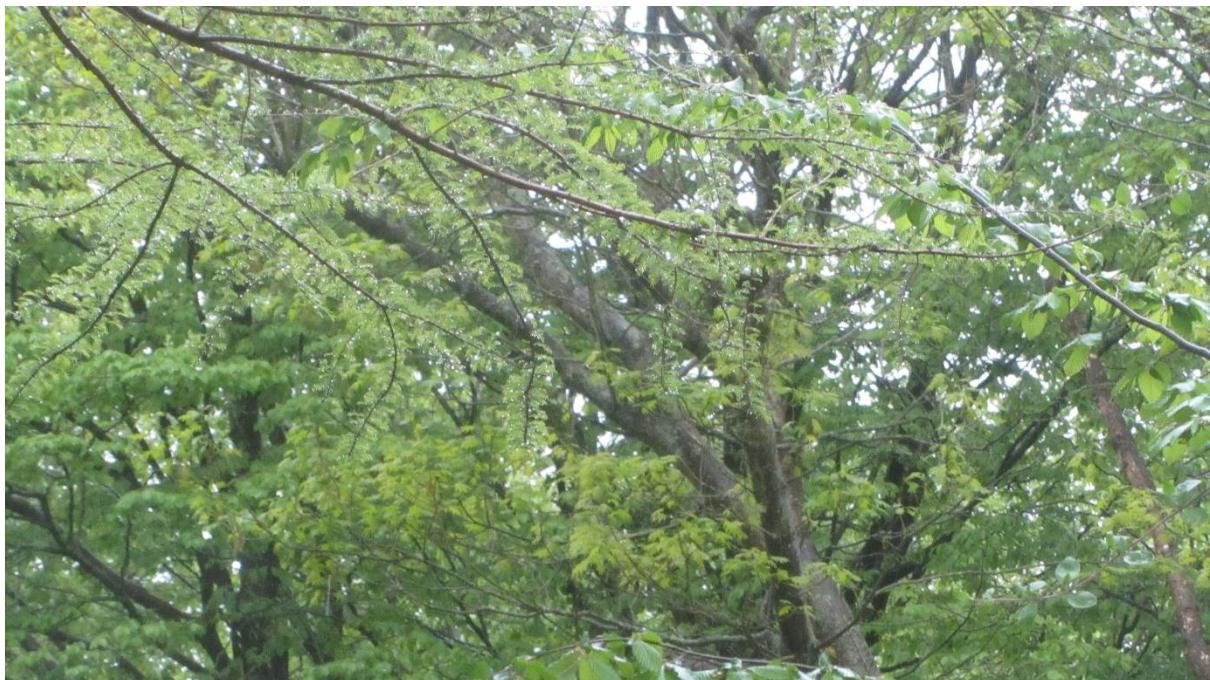
PHOTOGRAPH NO. 7 – Foliage of T1 viewed to confirm that it is a swamp cypress

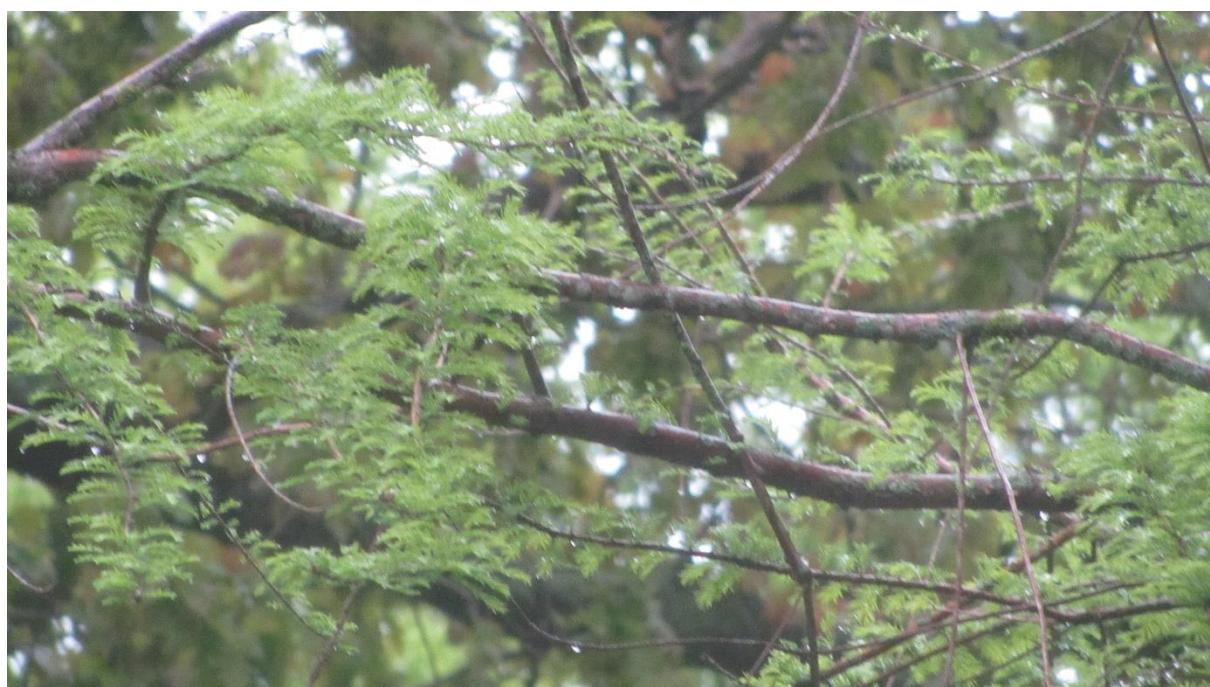
PHOTOGRAPH NO. 8 – Foliage of T1 viewed to confirm that it is a swamp cypress

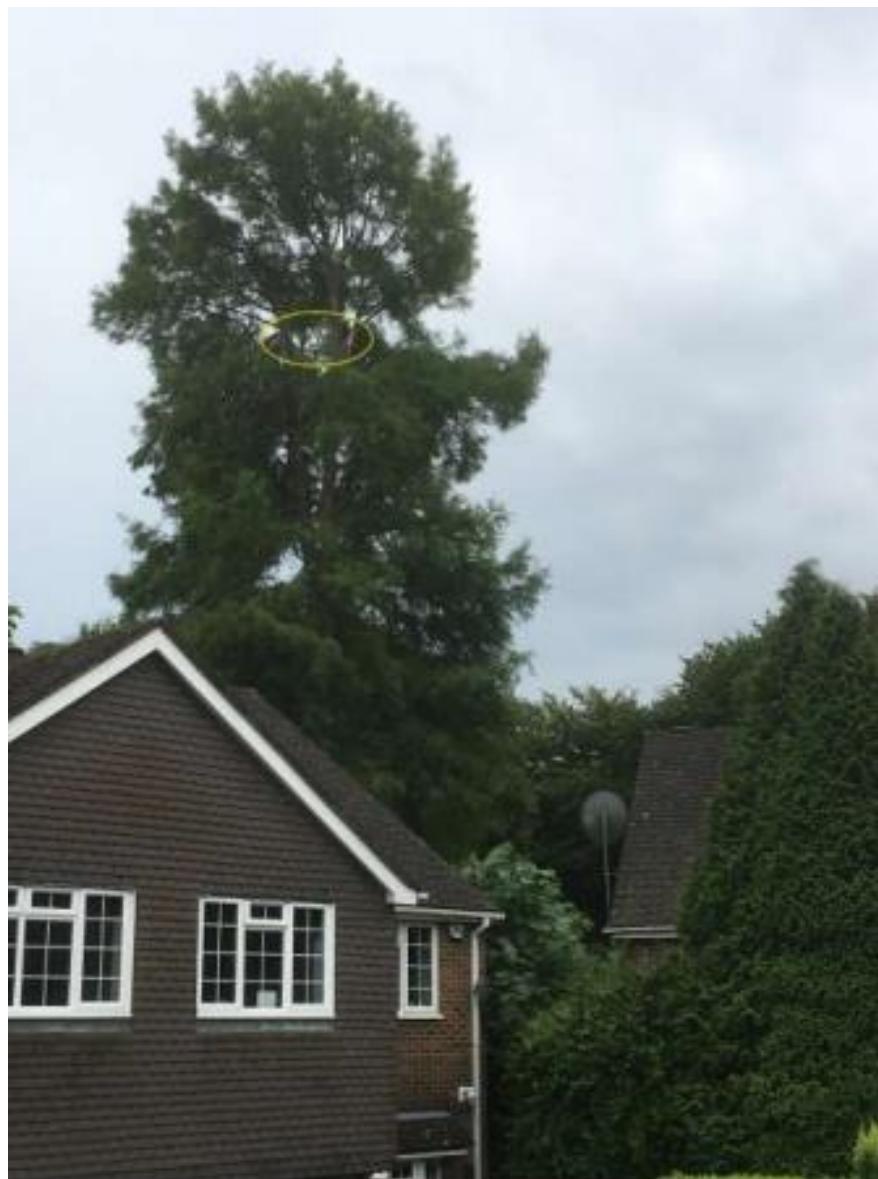
PHOTOGRAPH 1

3.2 Physiological condition: The earlier arboricultural report which was undertaken in 2021 refers to this condition as “Health” and advises that T1 has normal vitality and crown density. Photograph 1 of that report, which was taken in August with the tree in full leaf confirms this (see Appendix 1). My Photograph 1, taken in May 2024 and with due allowance made for the leaves being only partially opened, shows a marked decline in physiological condition. The leaves are presently around 50% of their probable eventual size while the tree canopy density is probably less than 20% of that shown in Photograph 1 of the first report (see Appendix 1). Nonetheless and even having given due consideration to this I do not believe the canopy condition in August this year will equate to that detailed in the photograph taken in August 2021.
