**Site Observation Report Form**

| <b>SITE:</b> | <b>Southall Western Access</b> | <b>JOB NO:</b> | <b>CG/28308</b> |
| <b>SVR 93</b> | | | |

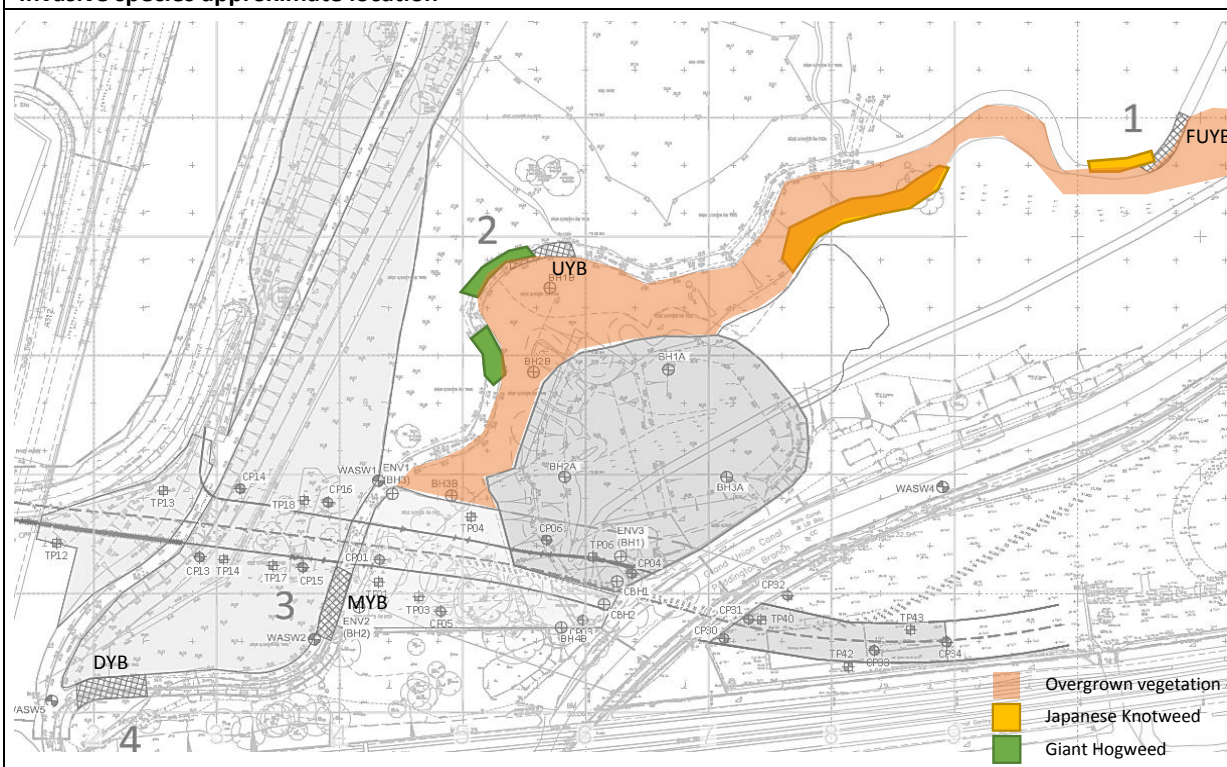
**Correspondence requested by FMC/CGL****Correspondence received from FMC****Invasive species approximate location**

| <p><b>Yeading Brook reed bed installation</b></p> <p>Dredging slit/clay from Yeading Brook and installing reed beds. Dredged material containing deleterious material (general litter, wood, plastic piping, tree branches and roots) stockpiled adjacent to the brook. No visual or olfactory hydrocarbon contamination was observed. The Brook water was visually cloudy from the silt disturbance though coarse suspended sediment appeared to be retained by the fish capture netting that cross the channel.</p> <p><b>Invasive species</b></p> <p>A full groundwater and surface water monitoring round was completed (round 31), access to some borehole (BH1B, BH2B) and surface water sample locations (FUYB, UYB) outside of the lagoon hoarding were restricted with dense overgrown vegetation. Additionally, invasive species such as Giant Hogweed and Japanese Knotweed were in full bloom near some locations. It is imperative that safe, clear access is maintained throughout the monitoring regime and invasive species are clearly identified, quarantined and workers are informed of their location, extent and the possible risk. I've included a rough sample location plan showing the approximate location of Giant Hogweed and Japanese Knotweed species.</p> | |

- Embankment toe drainage or surface runoff management should be implemented to impede the direct pathway of entrained silt into Yeading Brook.
- Invasive species in full bloom such as Giant Hogweed and Japanese Knotweed should be fenced off and construction workers should be notified of the personal dangers and risk of spread around the site from vehicle and pedestrian movements.
- Two of Environ's damaged boreholes have been replaced though it appears the redundant boreholes have not been suitably decommissioned. One redundant location is positioned directly in the Yeading Brook channel providing a direct pathway to groundwater and natural underlying strata. The redundant borehole is unsealed with open slotted pipe protruding above ground surface exposing it to possible cross-contamination, particularly with silt washout flowing into its proximity from the zone 4 embankment.
