## Site Observation Report Form

| <b>SITE:</b> | <b>Southall Western Access</b> | <b>JOB NO:</b> | <b>CG/28308</b> |
| <b>Date and time:</b> | <b>12/09/2018</b><br>09:20 to 16:45 | <b>VISIT BY:</b> | <b>CRG</b> |
| <b>SVR 113</b> | | | |

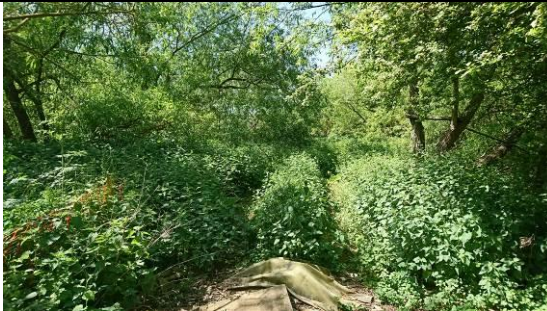
Overgrown and restricted access to some borehole sample locations (BH1B, BH2B, FUYB and UYB)

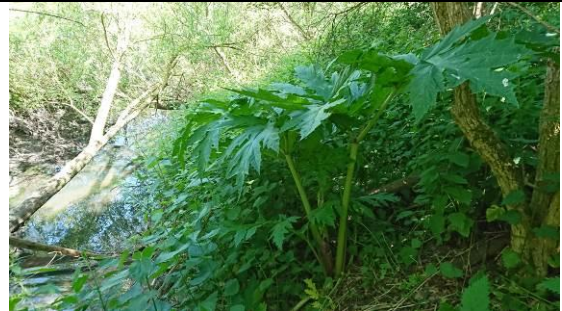
Giant Hogweed in full bloom near Yeading Brook bank

- Embankment toe drainage or surface runoff management should be implemented to impede the direct pathway of entrained silt into Yeading Brook.
- Invasive species in full bloom such as Giant Hogweed and Japanese Knotweed should be fenced off and construction workers should be notified of the personal dangers and risk of spread around the site from vehicle and pedestrian movements.
- Two of Environ's damaged boreholes have been replaced though it appears the redundant boreholes have not been suitably decommissioned. One redundant location is positioned directly in the Yeading Brook channel providing a direct pathway to groundwater and natural underlying strata. The redundant borehole is unsealed with open slotted pipe protruding above ground surface exposing it to possible cross-contamination, particularly with silt washout flowing into its proximity from the zone 4 embankment.

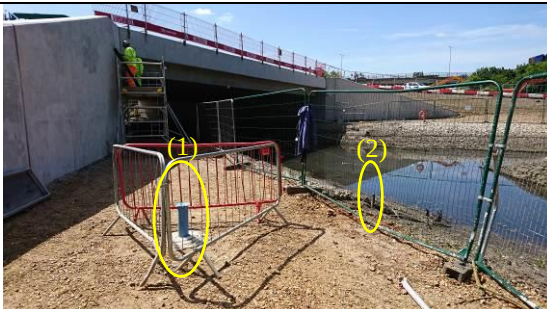
Replacement Environ borehole (1) and exposed open redundant borehole in Yeading Brook channel (2)

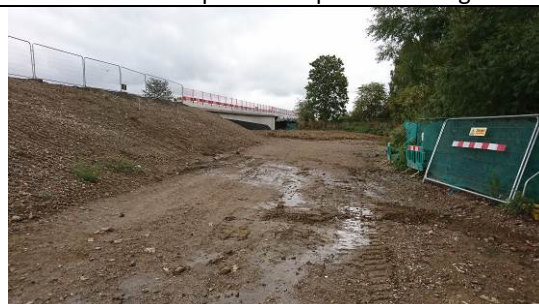
Water is emerging / standing at the toe of the embankment and may, locally, compromise the long-term stability. Given the recent extended dry weather conditions and elevation of the embankment toe, it is unlikely to be attributed to groundwater conditions or ingress from the canal. A shallow hand pit was excavated to approximately 0.5m below ground level at the embankment toe and no groundwater ingress was observed. The soils exposed below the surface were dry and comprised of a dark grey brown slightly clayey very silty GRAVEL. Some water ingress was observed from ponding water on saturated fine slurry deposits at the toe of

Water emerging/ standing at south embankment toe

the embankment. This appeared to be a combination of the surface material composition and method of installation. The embankment surficial material comprises a poorly graded loose coarse gravel, combined with very silty fine sand. It appears that, during high winds and precipitation, the fines are easily separated from the gravel and entrained in surface runoff downslope and deposited at the toe, this has caused an accumulation of fines at the embankment toe, where underlying soils are relatively impermeable, causing localised ponding. Additionally, the embankment has been compacted with tracked vehicles, which have caused grooves parallel with the slope gradient, which appear to have accelerated surface runoff during the more recent wet weather conditions. Localised rills, brading and gullies are forming on the embankment surface as fines continue to be washed downslope. As a result, the surface soil on the embankment predominantly consist of loose gravel with much of the finer fraction no longer present. This has contributed to the embankment surface becoming exclusively loose gravel and the finer material is completely removed. This process was previously identified on the north embankment and is also notable along the FCA embankments. As there is a risk of fines flowing directly into controlled waters. It is recommend that landscaping, topsoil placement and seeding is completed as soon as possible to amour the exposed embankment surface and mitigate further erosion.

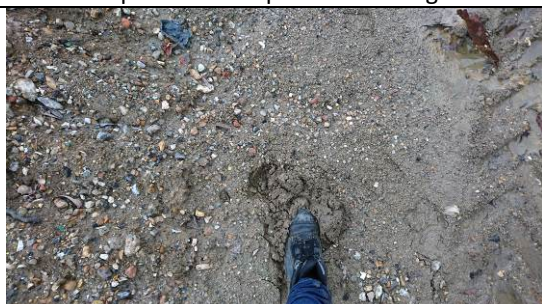
Fines washout accumulating at the embankment toe

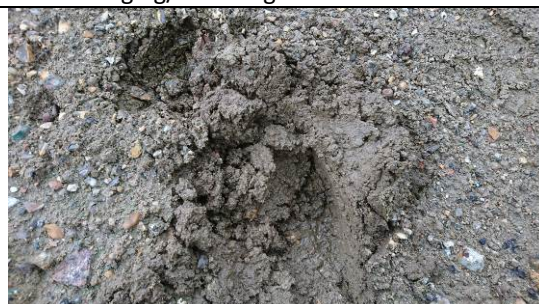
Fines slurry saturated with ponding surface water

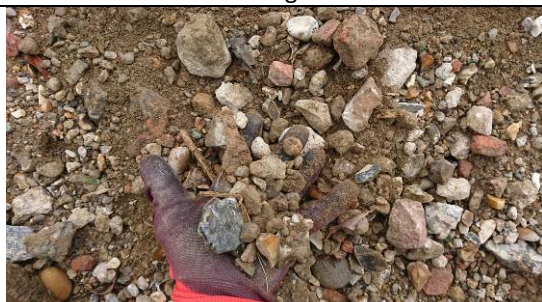
Surface of embankment becoming exclusively gravel as fines are stripped away

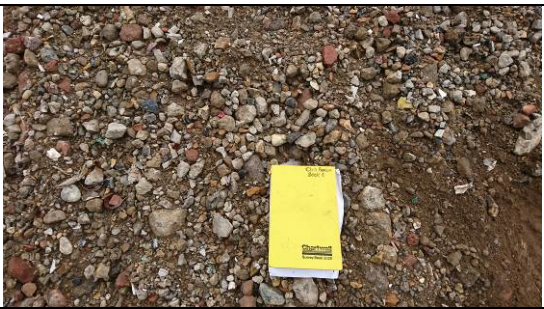
| <p>Surface of embankment becoming exclusively gravel as fines are stripped away</p> | <p>Grooves from tracked vehicles create preferential drainage channels for surface runoff and fines</p> |

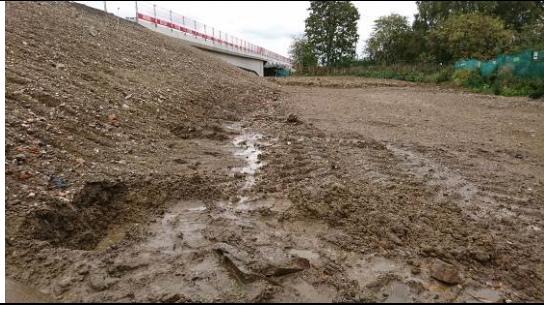
| <p>Hand pit at south embankment toe</p> | <p>Water ingress only from standing surface water</p> |

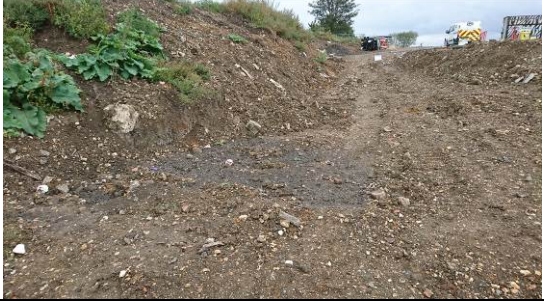
CGL inspected the northern embankment, including an area that was already fenced off, and identified several fragments of what appeared to be asbestos cement board. The fragments appeared damp following overnight rain and contained within the cordoned off area and will need to be removed by a specialist contractor. No works should be undertaking in this area until it has been fully inspected and potential ACM fragments removed. Damping down, using a suitable spray with surfactant, sound be maintained, whilst the fragments are still present, where dry weather conditions are forecast, to limit the risk of airborne fibres.

| <p>Section of north embankment fenced off where possible ACMs identified</p> | <p>Identification of multiple Chrysotile (white) cement board fragments identified</p> |

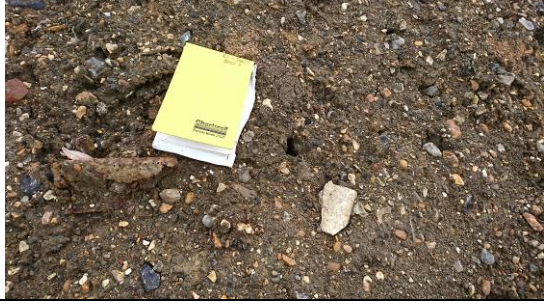
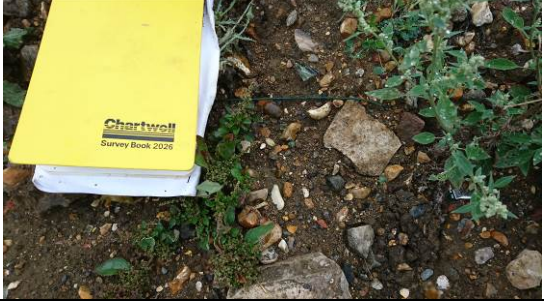
| <p>Identification of multiple Chrysotile (white) cement board fragments identified</p> | <p>Overview of contaminated AMC area</p> |

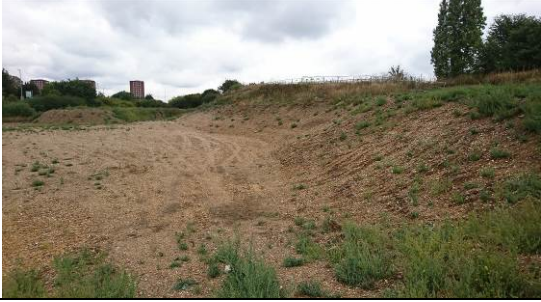
| Overview of FCA topsoil stockpile (FCAE) | Gullying and rills forming on FCA embankment with fines accumulating at the toe. |

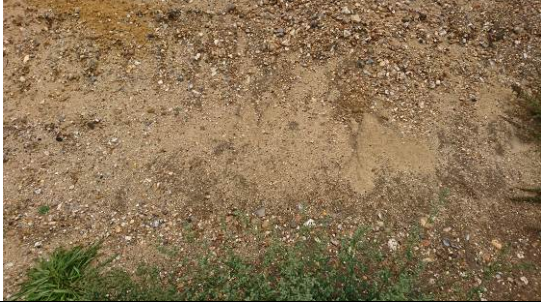
| Fines washout at embankment toe | Overview of pedestrian pathway compaction |

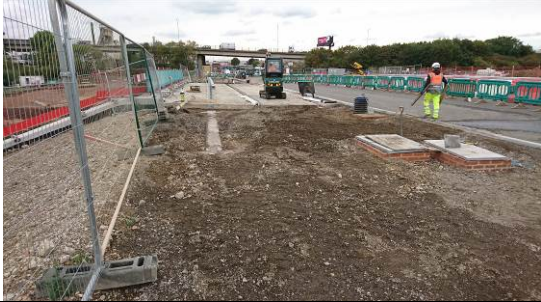
Soft ground was previously observed during a site walkover on 6<sup>th</sup> September at the surface on the pedestrian pathway in the transition zone between the GUC bridge deck and embankment. The softer ground was comprised of a sandy material. This had evidently been removed and a new suitable material was being placed during CGLs attendance.

| Area where soft spots identified, sandy material removed and replaced | Advised to remove remaining sand used around service duct and replace |

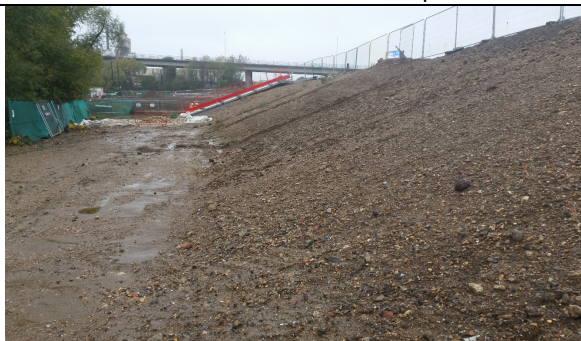
Overview of EYB south slope. Note fines washout and softened material at toe of slope

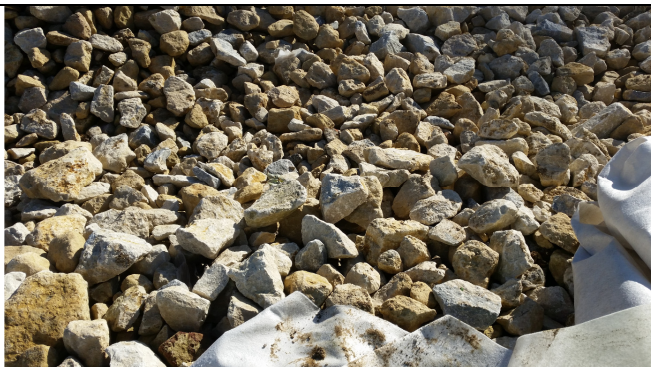
- i) Confirm the levels of the basin and toe level of the embankment and wing walls tied in with the levels as shown on the design drawings;
- ii) identify if there is a requirement to install scour protection to the south wester wing wall (adjacent to the Detention Basin).
- iii) visually inspected the grading rock fill which had been imported for the scour protection to assess the grading. The stone appeared to be graded towards the lower bound specified particle size of Dn50 150mm and the material may therefore not be graded as specified. It is understood FMC are having difficulties sourcing material for the grading specified by CGL.

Scour protection material.

- i) CGL have confirmed the levels of the detention basin and embankment and wingwall of the southern side of the Central Embankment (Zone 4) as constructed, are in accordance with the design levels;
- ii) CGL have confirmed that scour protection is not required at west YB southern wingwall as the presence of the detention basin at this location should prevent scour occurring at the end of this wing wall;
- iii) CGL have revised the scour protection specification and drawing to enable FMC to source and place more suitable rockfill.
