# Site Observation Report Form

| <b>SITE:</b> | <b>Southall Western Access</b> | <b>JOB NO:</b> | <b>CG/28308</b> |
| <b>Date and time:</b> | <b>05/11/2018</b><br>09:30 to 12:30 | <b>VISIT BY:</b> | <b>ALC</b> |

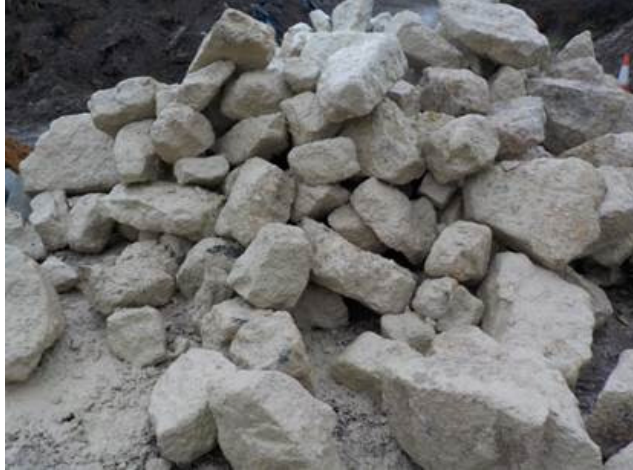
The newly imported larger stone for the scour protection appears to be between 300mm and 600mm in size (Photo 1). FMC breaking the larger pieces so that the average size is around 200mm to 300mm and constructing the scour protection to East Yeading Brook north wing wall.

Photo 1. Scour Protection – imported large stone (prior to breaking)

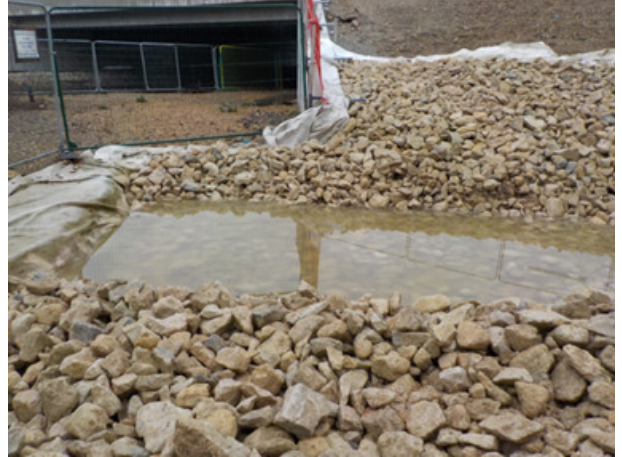
- overlap Terram at top of stone on slope prior to placing topsoil on the upper half of the slope. Terram to be cut once topsoil is placed. This will prevent migration of fines into the rockfill;
- anchor the Terram in a trench around the scour protection at ground level. Trench to be backfilled with arisings;
- rockfill to be placed such that the smaller stone at the toe of the slope is buttressed by the larger stone at the base. Pack gaps in between larger stone with smaller stone;
- Smaller rockfill already placed on East YB southern embankment to remain but replaced with larger stone size 3.0m from toe of slope (Photo 2).

Photo 2 East YB south scour protection. Larger stone to be placed at slope toe.

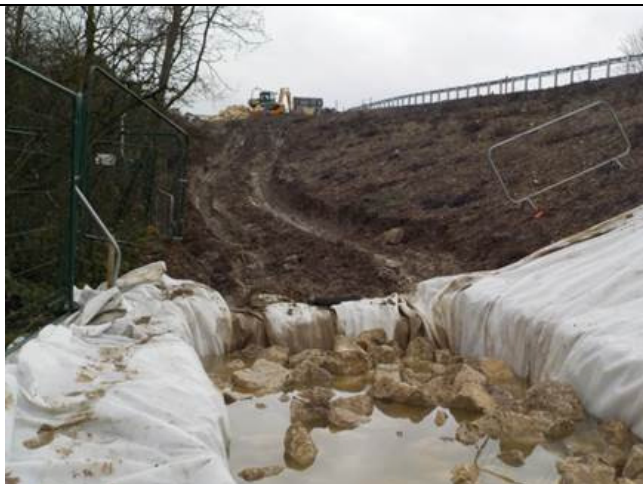
- Standing water within the scour protection excavation, and ponding at the toe of slope. There is no embankment toe drainage in this area;
- Along the full length of the EYB north embankment FMC have levelled the ground, effectively undercutting the toe with a 0.5m high vertical cut (Photo 3). This has been done so plant can access the scour protection area. The fill needs to be reinstated as soon as possible, particularly as heavy and persistent rainfall could exacerbate the potential risk of instability. The plant can't currently access the scour protection working area as the ground is too soft, so the slope is unlikely to be reinstated this week.

Photo 3 East YB north scour protection and undercut slope toe

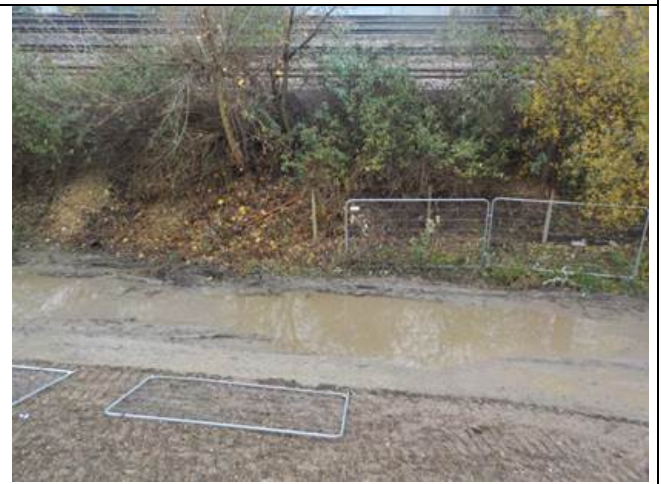
FMC are proposing to extend the landscape fill in front of the East GUC wing wall to 3.0m offset from the toe of the railway embankment (Photo 4). There are at least two drainage pipes visible in the railway embankment but it is not known if these are redundant; no toe drainage to the railway embankment was visible. The fill extension will also limit access to the bridge for maintenance.

Photo 4 Proposed East GUC south landscape fill in front of wing wall to 3.0m offset from toe of railway embankment

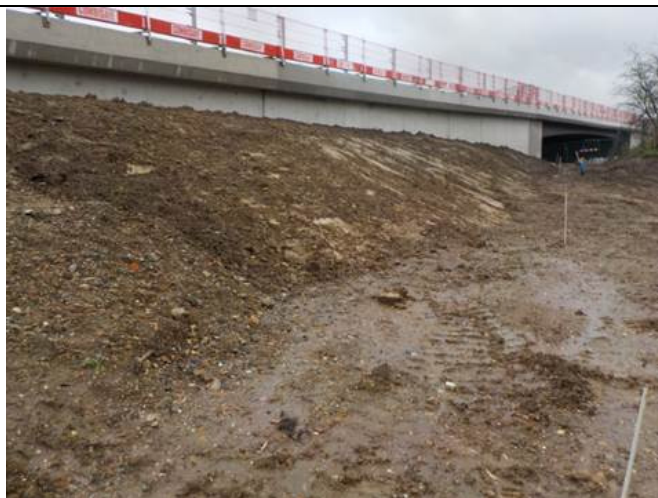
| <p><b>West GUC south landscape fill</b></p> <p>FMC have placed landscape fill against the front of the West GUC south wing wall at the request of Berkley who wanted the black waterproofing to be covered over (Photo 5). The fill is to be extended further out. No geoenvironmental testing has been undertaken on this material. The fill has just been tracked in. ALC advised FMC that the new fill is to be benched in.</p> |

Photo 5 Newly placed landscape fill to West GUC south wing wall

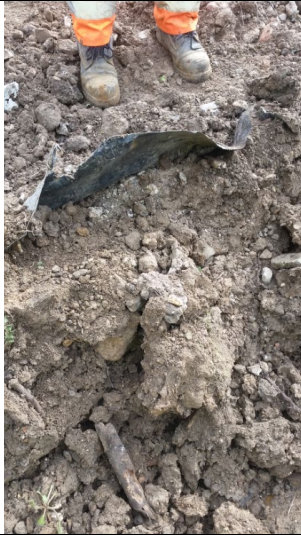
**Photo 1. Example of material sampled beneath liner in lagoon.**

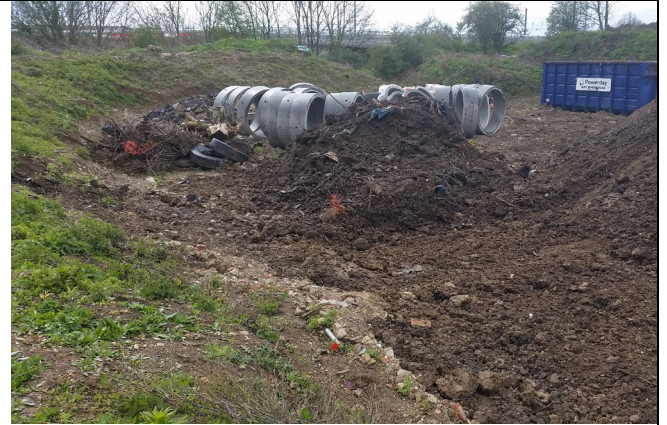
**Photo 2 Location of trial pitting and sampling beneath liner in lagoon.**

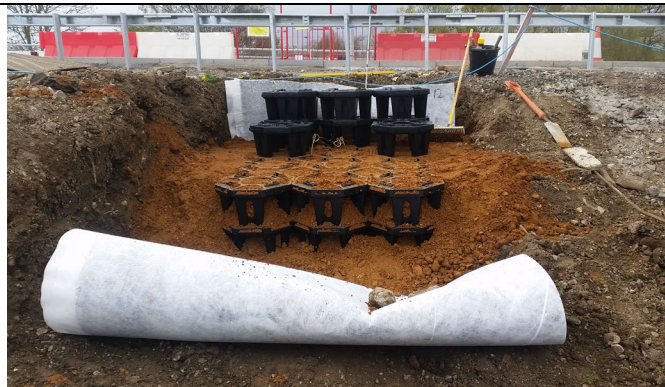
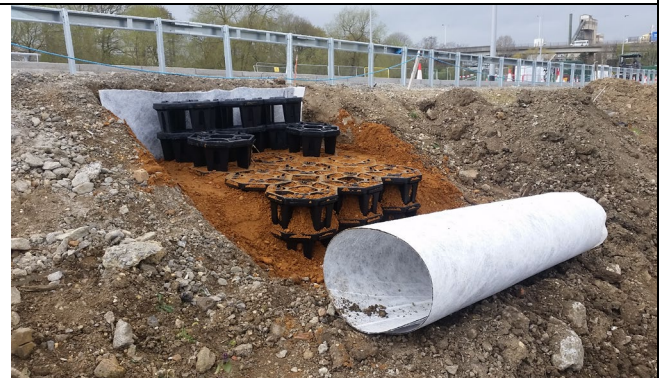
| <b>Other comments and observations (ecological concerns? Water observations? Anticipated issues?)</b><br><p>Construction of tree pit installations was observed to be in accordance with the construction drawing previously approved by TFL.</p> | |

**Photo 3 Tree pit installation in Zone 4.**

**Photo 4 Tree pit installation in Zone 4.**

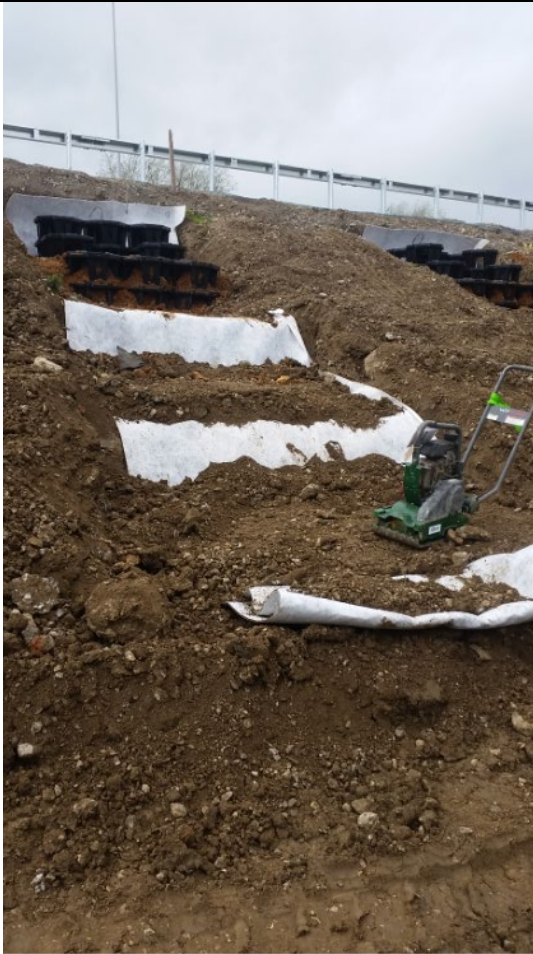
**Photo 5 Compacting fill on geotextile and benching following tree pit installation.**

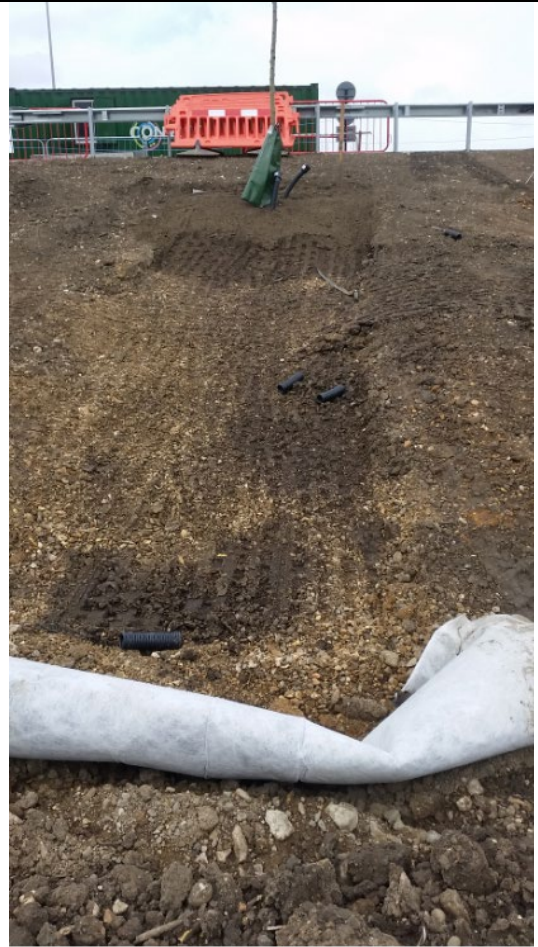
**Photo 6 Completed installation and backfilling of tree pits.**

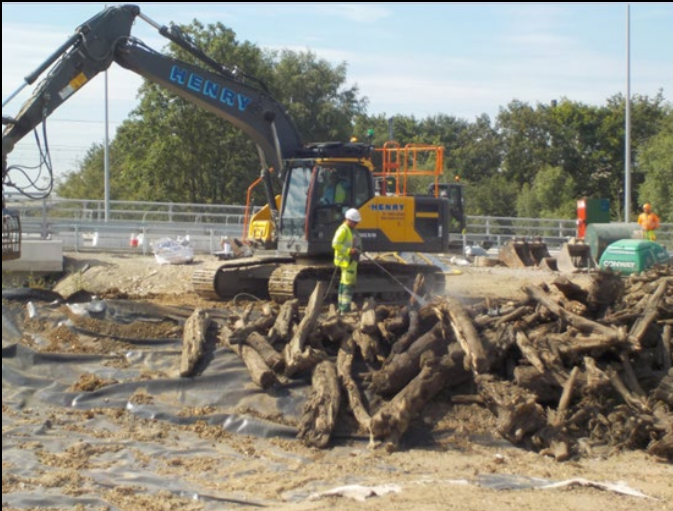
Jet washing timber from stockpile SP2 to remove invasive species spores prior to disposal off site.

**Photo 1. Jet washing timber from stockpile SP2 to remove invasive species spores prior to disposal off site.**

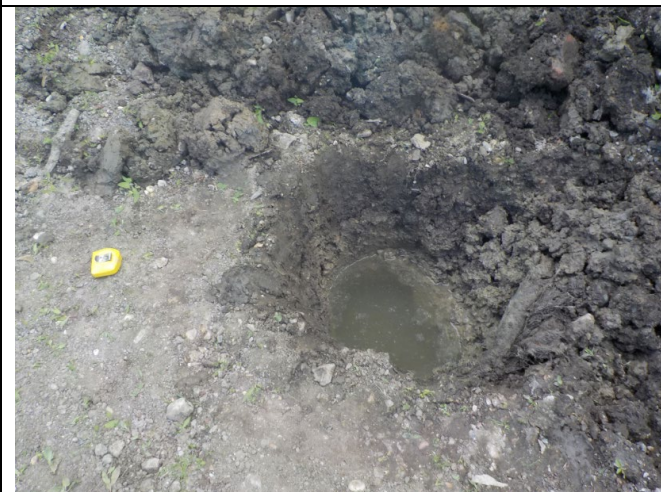
Standing water was recorded between 0.3m and 0.6m bgl, beneath the topsoil or within clayey gravel beneath the topsoil. Water seepage was noted in HP4 and HP7 along the southern boundary – this appeared to tie in with the areas where vegetation is becoming established. No seepage was observed in HP5, also located along the southern boundary, however a woven geotextile was encountered at 0.3m bgl in HP5, and the overlying topsoil was damp. Two pits were excavated at the toe of the embankment.

From these observations the source of the standing water does not appear to be originating from the embankment fill, or from beneath the embankment. Historically, the 'triangle' has always been prone to soft ground and it is most likely the source of the water is from the canal, due to leakage. A. Curtis recommended further machine excavation to confirm the exact extent of the 'soft' area and standing/shallow water. T. Cole suggested constructing a small cut off 'bund' along the boundary perimeter however it is likely that water will still find a way around or beneath this, having a natural tendency to 'flow' towards Yeading Brook. A. Curtis advised a grip drain may be more appropriate to allow it to drain more freely to reduce standing water. No final decision was made. T. Cole to consider options over next few days.

**Photo 3 High groundwater encountered in hand dug pits within 'Railway Triangle' area**

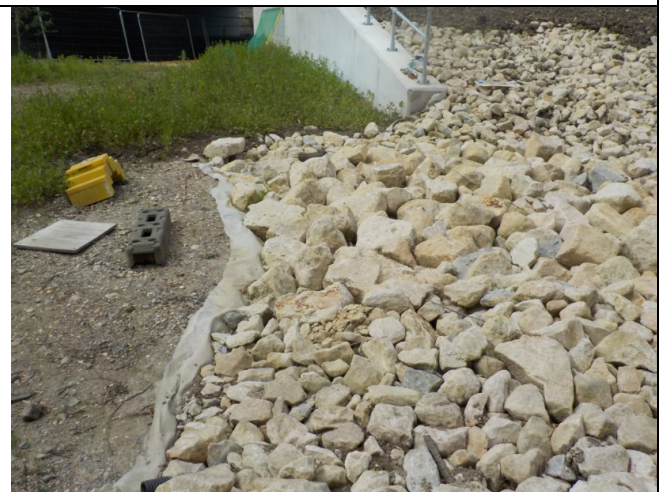
A. Curtis conducted a walkover of all three areas of the scour protection placed to Yeading Brook wingwalls. The scour protection appeared to be satisfactorily installed on top of a non-woven geotextile Terram liner which extended up the sides of the rockfilled excavations. Topsoil has been placed satisfactorily to all embankment side slopes level with the top of the scour protection. Some topsoil has yet to be placed around the toe of the rockfill at the northwest and southeast wingwalls.

**Photo 4 Completed rock scour protection on Terram geotextile separator**

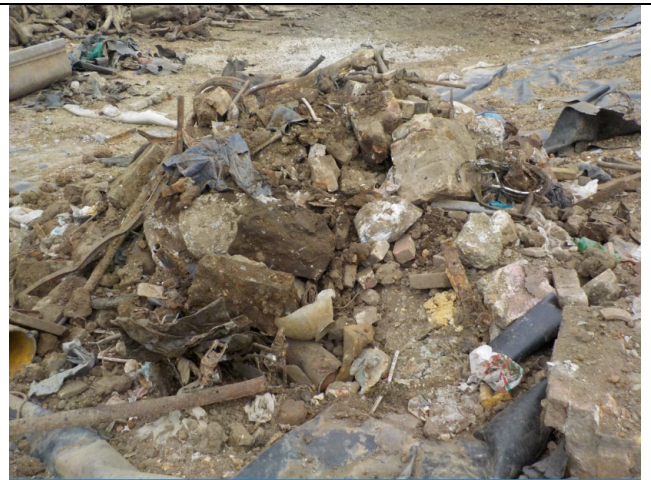
Photo 4 Deleterious material riddled from Minet Tip/Lagoon Bund Wall

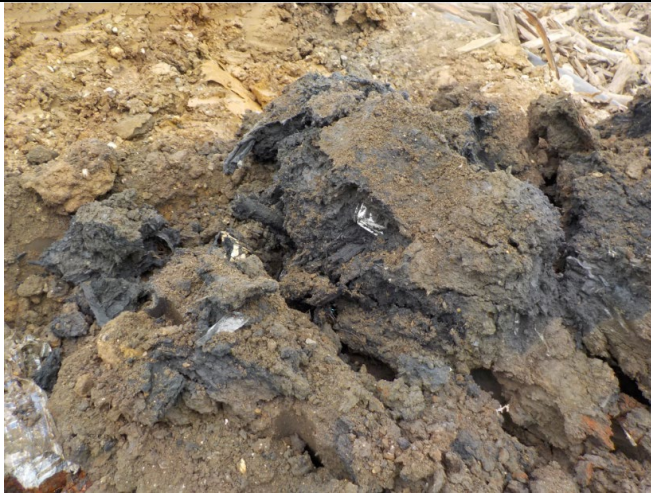
| <b>Observations</b> <p><b>1. Lagoon bund wall (Minet Tip) watching brief and sampling</b><br/>Three trial pits were excavated in the lagoon bund wall (Minet Tip) to the proposed excavation toe level of the level for the relocated bund wall. A layer of hydrocarbon impacted soil (clay) was encountered in all three trial pits at the base of the excavations such that the bund excavation will expose between 0.3m and 1.1m of the impacted material. The material above this layer comprised sandy gravelly clay or clayey sand and gravel with much deleterious material (metal, plastics, glass bottles, wood, cables, fibre glass boarding, ash etc). No perched water was encountered. T.Cole (FMC)/A.Curtis (CGL) discussed the potential impact of the contaminated material becoming exposed. A. Curtis advised the requirements for cover soils and/or other protection measures or reuse of the hydrocarbon impacted soils would be dependent on the concentrations and type of contaminants.</p> <p><b>2. Railway Triangle Standing Water</b><br/>Machine dug trial slit trenches/holes were excavated in the railway triangle to attempt to identify the extent and source of standing/shallow water. The pits exposed an area of hardcore beneath the topsoil, on three layers of woven geotextile, in the central area. Water seepage was observed from beneath and on top of the hard core, between 0.3m and 0.7m bgl. This hardcore is the remains of a haul road constructed for the works.</p> <p>Based on the observations it is considered that the hardcore is hindering the seepage of water leaking from the canal, finding its way to Yeading Brook. FMC placing additional topsoil across the area to improve the aesthetics of the area.</p> | |

**Photo 5 Hydrocarbon impacted soil in Minet Tip/Lagoon Bund Wall**

| <b>Other comments and observations (ecological concerns? Water observations? Anticipated issues?)</b><br><p>FMC to consider reducing the dig level of lagoon bund wall to limit the excavation of hydrocarbon impacted material.</p> | |

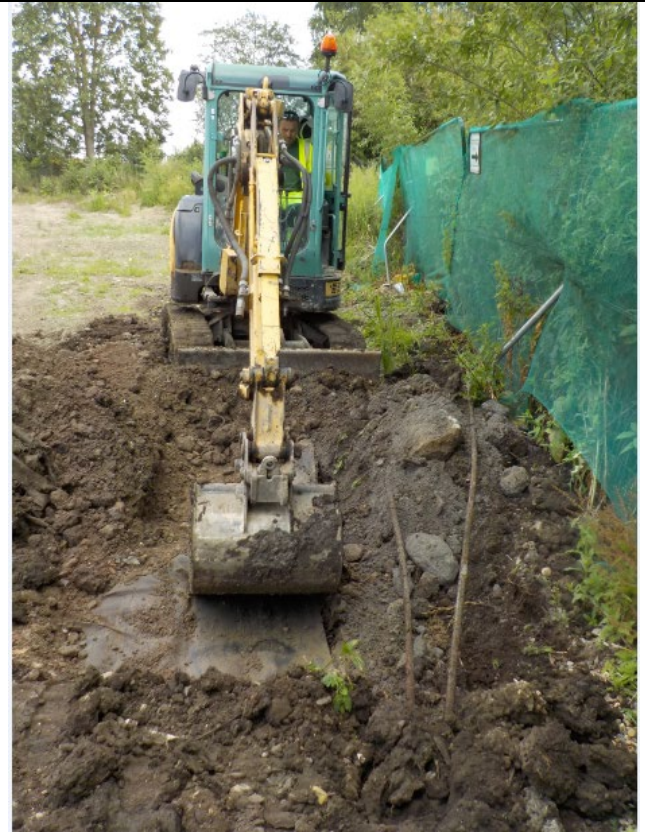
**Photo 6 Railway triangle slit trenches exposing hardcore and geotextile placed to form hardstanding during construction works.**
