## Record of Site Visit No. 021

| <b>Site:</b> Southall Western Access | <b>Job No:</b> | CG/28308 |
| <b>Client:</b> FM Conway | <b>Date:</b> 25/08/2017 | |

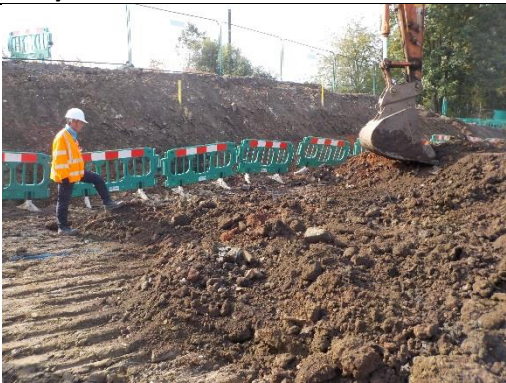
| Summary Photos: | |
|---|---|
| UXO supervision as loose material was sieved in search of the second potential UXO device in the West GUC pile mat base. | Second potential UXO device identified by Environ was found and confirmed to be an industrial engine/ component, not UXO |

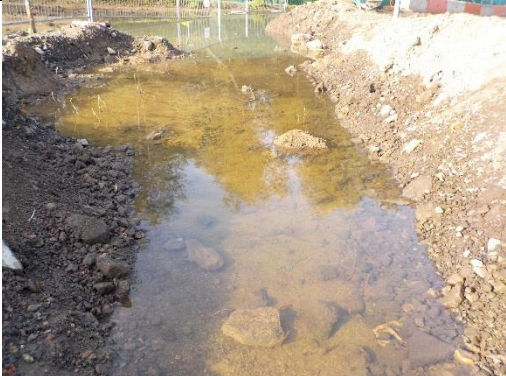
| <p>Surface rainwater provided no visual or olfactory indication of contamination</p> | <p>Pump used to drain surface rainwater directly onto ground surface</p> |

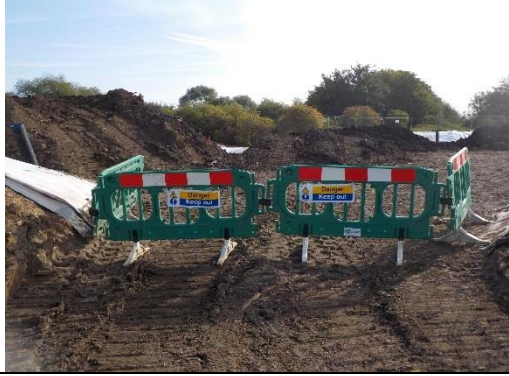
| <p>Layer of imported 6F5 crush added to the base of Lagoon 2</p> | <p>Lagoon 1 remained closed and inaccessible until second potential UXO device was found</p> |

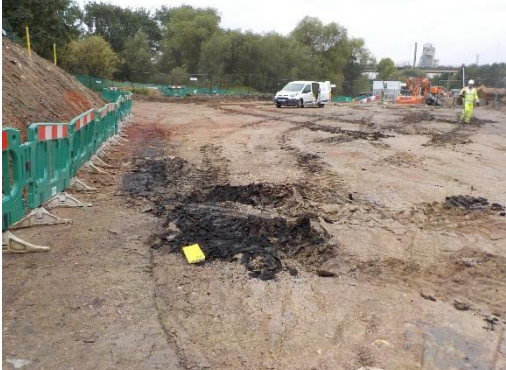
| <p>Isolated sections of soft dredged/ alluvium material at base of West GUC pile mat</p> | <p>Lower western section of West GUC pile mat to be filled up to base level</p> |

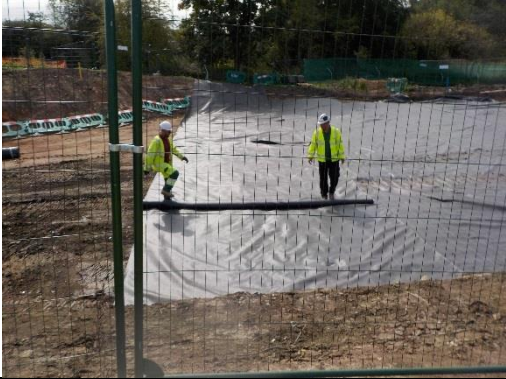
| <p>Type B gravel installed in Lagoon 2 trench burying drainage pipe and securing vertical extraction pipe</p> | <p>Geotextile added to base of west GUC pile mat, four layers added to sections with low CBR values</p> |

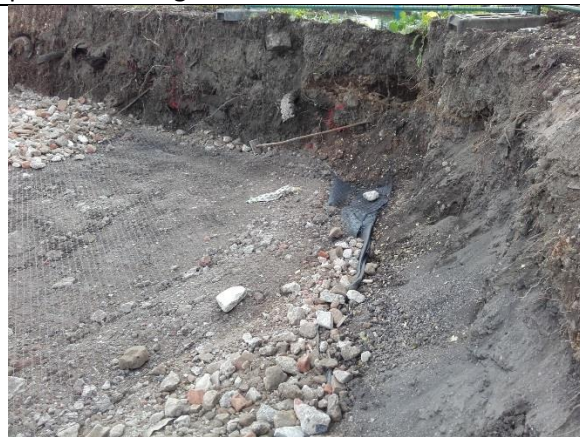
Pile mat 3 excavation – granular Made Ground

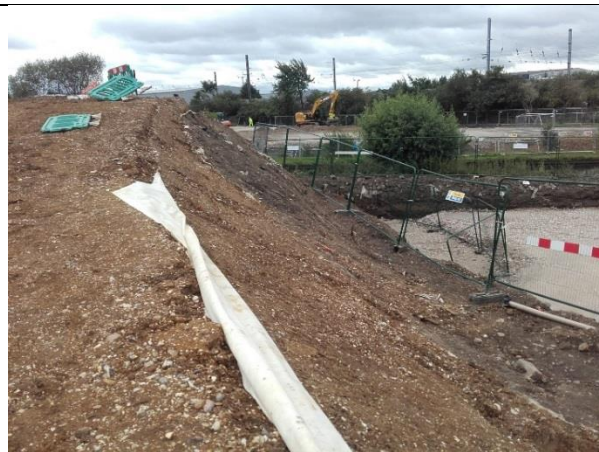
Lagoon bank stability – Bank inspected. No signs of major instability i.e. tension cracks, slumping. Some minor undercutting and ravelling at crest as previously noted.

Lagoon bund crest – no signs of major instability
