# Merewood

**Arboricultural survey to British  
Standard B.S. 5837: 2012 'Trees in  
relation to design, demolition and  
construction - Recommendations'  
at  
Heathrow Medical Centre  
1 St Peter's Way  
Harlington**

05/01/2016

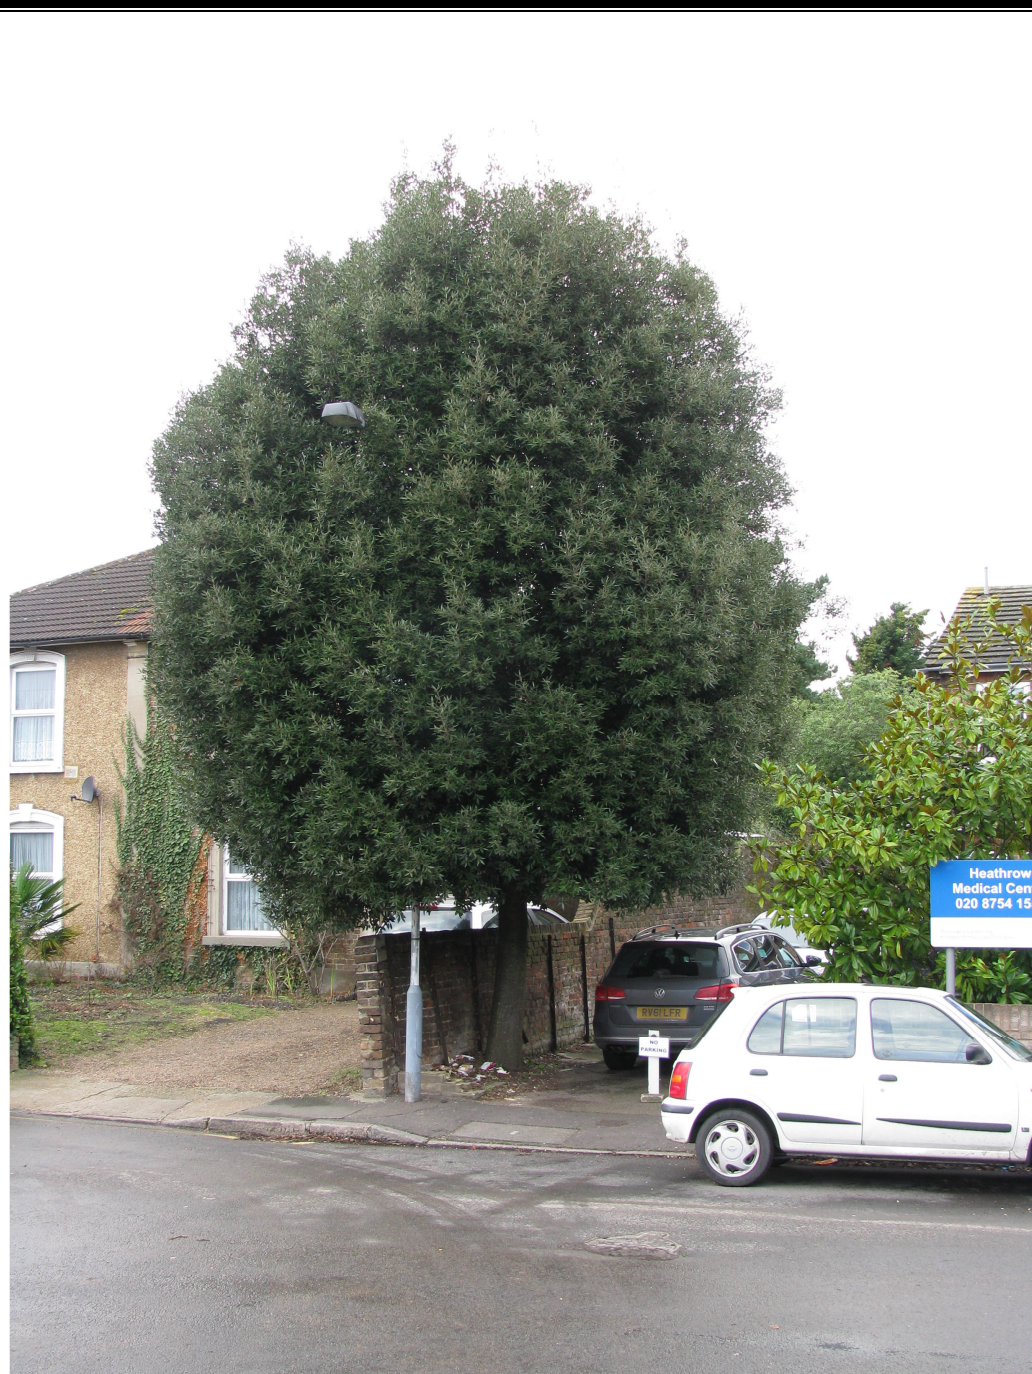
adjacent to the front wall surrounded by the parking, whilst to the south west corner of the plot, near to the driveway entrance, there is a holm oak (T5) (fig.1).

Fig: 1 The holm oak (T5) at the front of the site is close to the entrance of the medical centre

| Tree no | Species | Height | Stem diameter | Crown spread | | | | Height to 1st main branch | Height of canopy | Age | General observations | Life expectancy | Category |
|---|---|---|---|---|---|---|---|---|---|---|---|---|---|
| T5 | Holm Oak | 9 | 310 | 3 | 3 | 3 | 3 | | | M/A | | 40+ | B1 + B2 |

- 5.10 During construction work, it is proposed that the driveway entrance to the south, adjacent to the holm oak (T5) should be sealed off, affording the holm oak maximum protection. The tree protection plan (appendix 3) shows how that can be achieved.

- 6.3 The trees at the front can be satisfactorily protected by simply closing off that side of the access drive during building works.
- 6.4 It is concluded that a re-development of the site can take place without harming the trees to be retained. These can be protected using barriers as detailed by British Standard B.S. 5837: 2012 'Trees in relation to design, demolition and construction - Recommendations' and in line with best practice procedures.
