Arboricultural Appraisal Report

CTC Reference: 14477

Property: 2 Heythrop Drive,
Uxbridge,
UB10 8DT

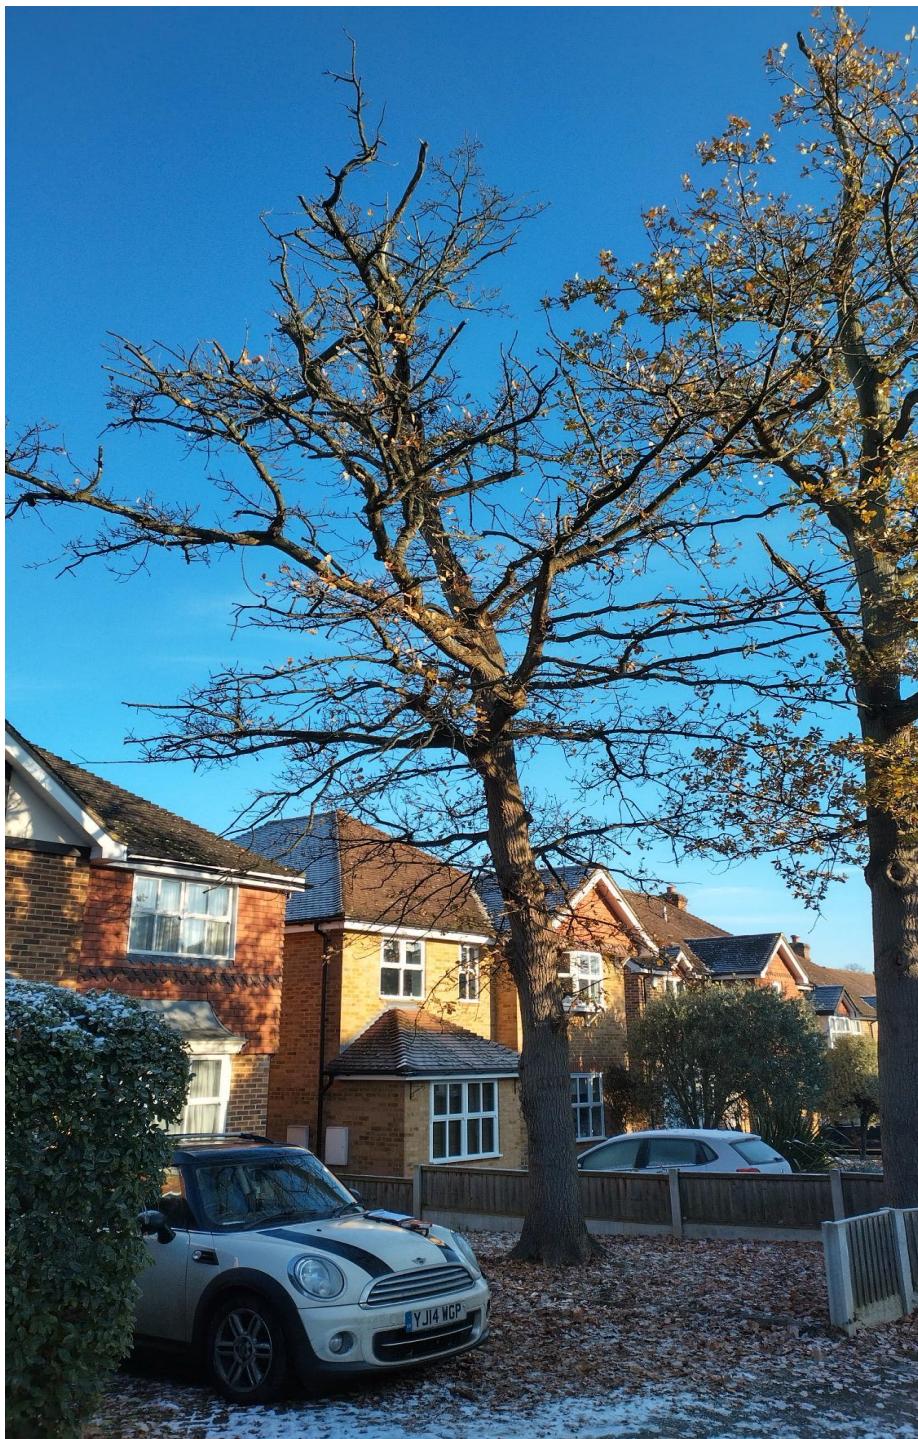
Tree No.	Species	Age Class	Approx. Height (m)	Dia. (DBH)	Condition	Growth Potential	Life Expectancy (category)
T1	English oak /Quercus robur (App 1 - Photo 1)	M	14	48	Poor	Medium	U (less than ten years)
Distance to built structures:		586 cm from the house (number 2)					
Targets:		House, road, fence, garden,					
Defects:		Roots: Bark damage to buttress roots, change in colour, Stem: leaning towards house, wounds, Crown: die back (60%), major dead wood, asymmetric crown,

I believe the risk of indirect physical damage is low. Although the house is within the zone of influence of the oak trees it was constructed in the 1990s when the risk of subsidence would have been known and it is assumed the foundation depths/design would have taken this risk into consideration. There is no sign of damage despite a very dry summer. Although both trees are not fully grown their poor physiological condition means that their rate of growth (if there is any) must be slow. It would also mean reduced rates of transpiration.

Photo 1 – T1 (Die back and lean evident).

My recommendation is that both trees are removed T2 should be removed because of the large cavity and T1 because it is in decline. Once T2 is removed it is likely to have a negative effect on T1 which will be exposed and lose part of the shared root system.

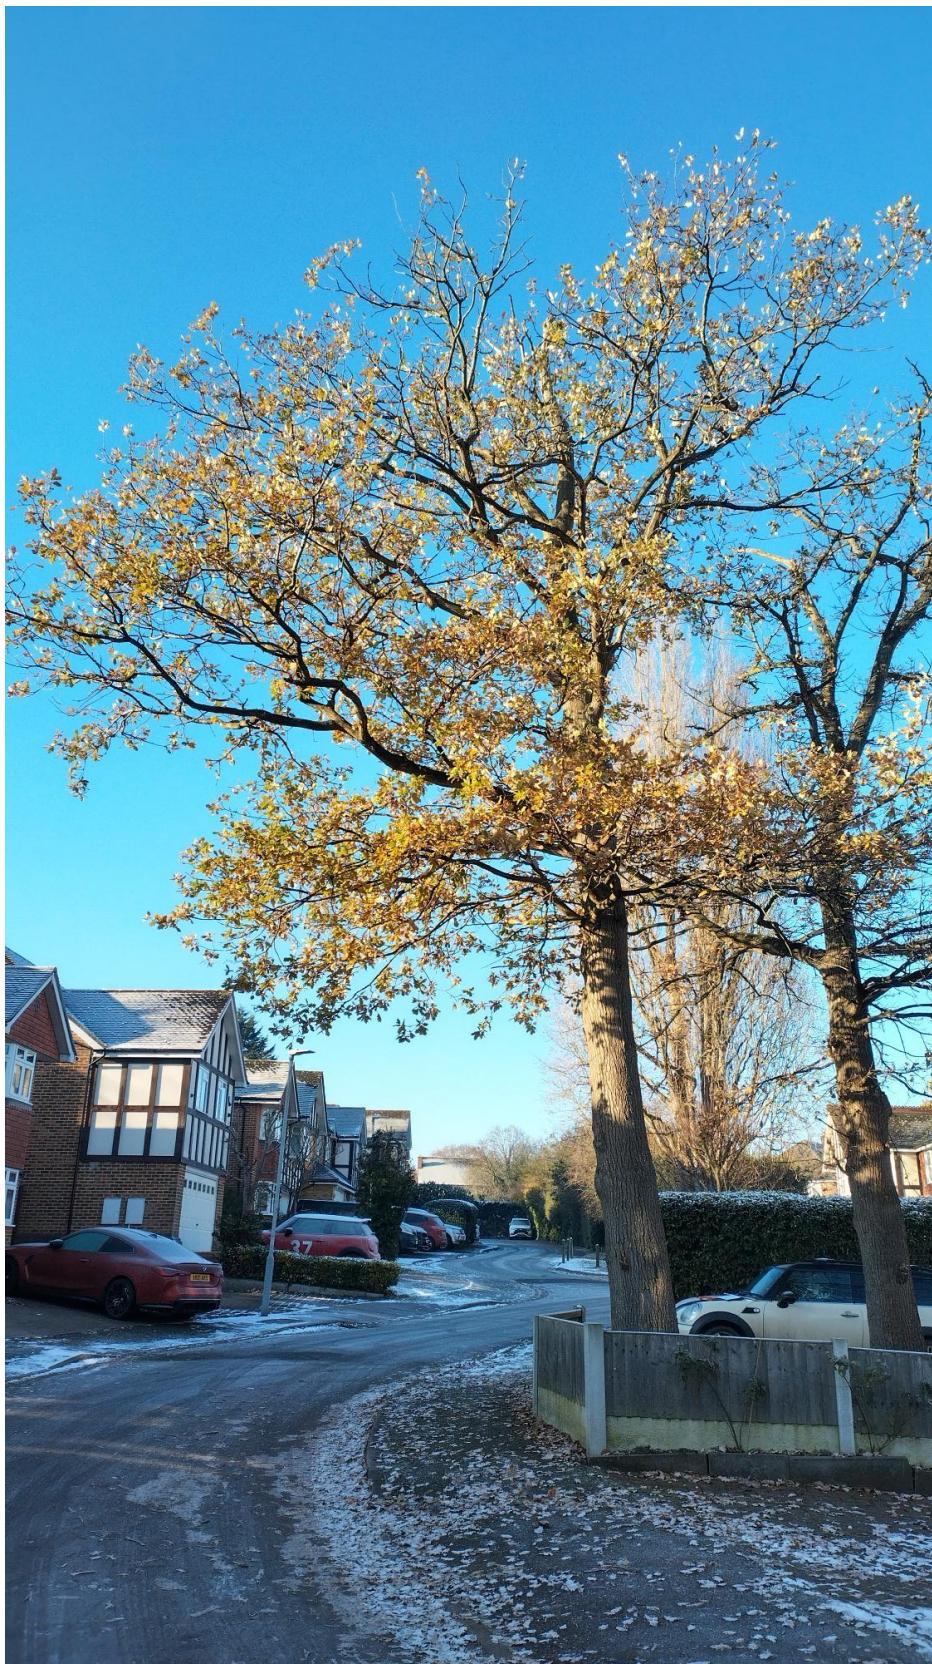
Tree No.	Species	Age Class	Approx. Height (m)	Dia. (DBH)	Condition	Growth Potential	Life Expectancy Category)
T2	English oak /Quercus robur (App 1 - Photo 2)	M	16	58	Poor	Medium	U (less than ten years)
Distance to built structures		810cm from the house (number 2)					
Targets:		House, road, fence, garden,					
Defects:		Roots: Bark damage to buttress roots, change in colour, Stem: leaning towards road, wounds, cavity at base of 32cm deep and 40cm high, white rot, Crown: major dead wood, asymmetric crown,

Crown/Stem: there is a high risk of damage or injury from the aerial parts of both trees since they have significant defects and high value targets. There is major dead wood in the crowns including the leader of T2. This is likely to fail. There is a large basal cavity in T2 which exceeds two thirds of the radius and is surrounded by white rot. It includes the buttresses across one side of the tree. The client has advised this is progressive. There is a significant risk of whole tree failure. The client has also advised that there were yellow/brown fruiting bodies near to the base of T1 in the Autumn. There is a possibility this is *Armillaria mellea* since T1 is stressed and in poor physiological condition.

I believe the risk of direct physical damage is high. T2 has a very significant defect that is progressive. This represents an unacceptable risk of damage or injury and the landowner has a duty of care to remediate this. Both trees are in poor physiological condition (T1 has 60% die back) and so I do not think that crown reducing the trees is appropriate since it would further stress them and accelerate any decline.

Photo 2 – T2 (major dead wood and dead leader visible)

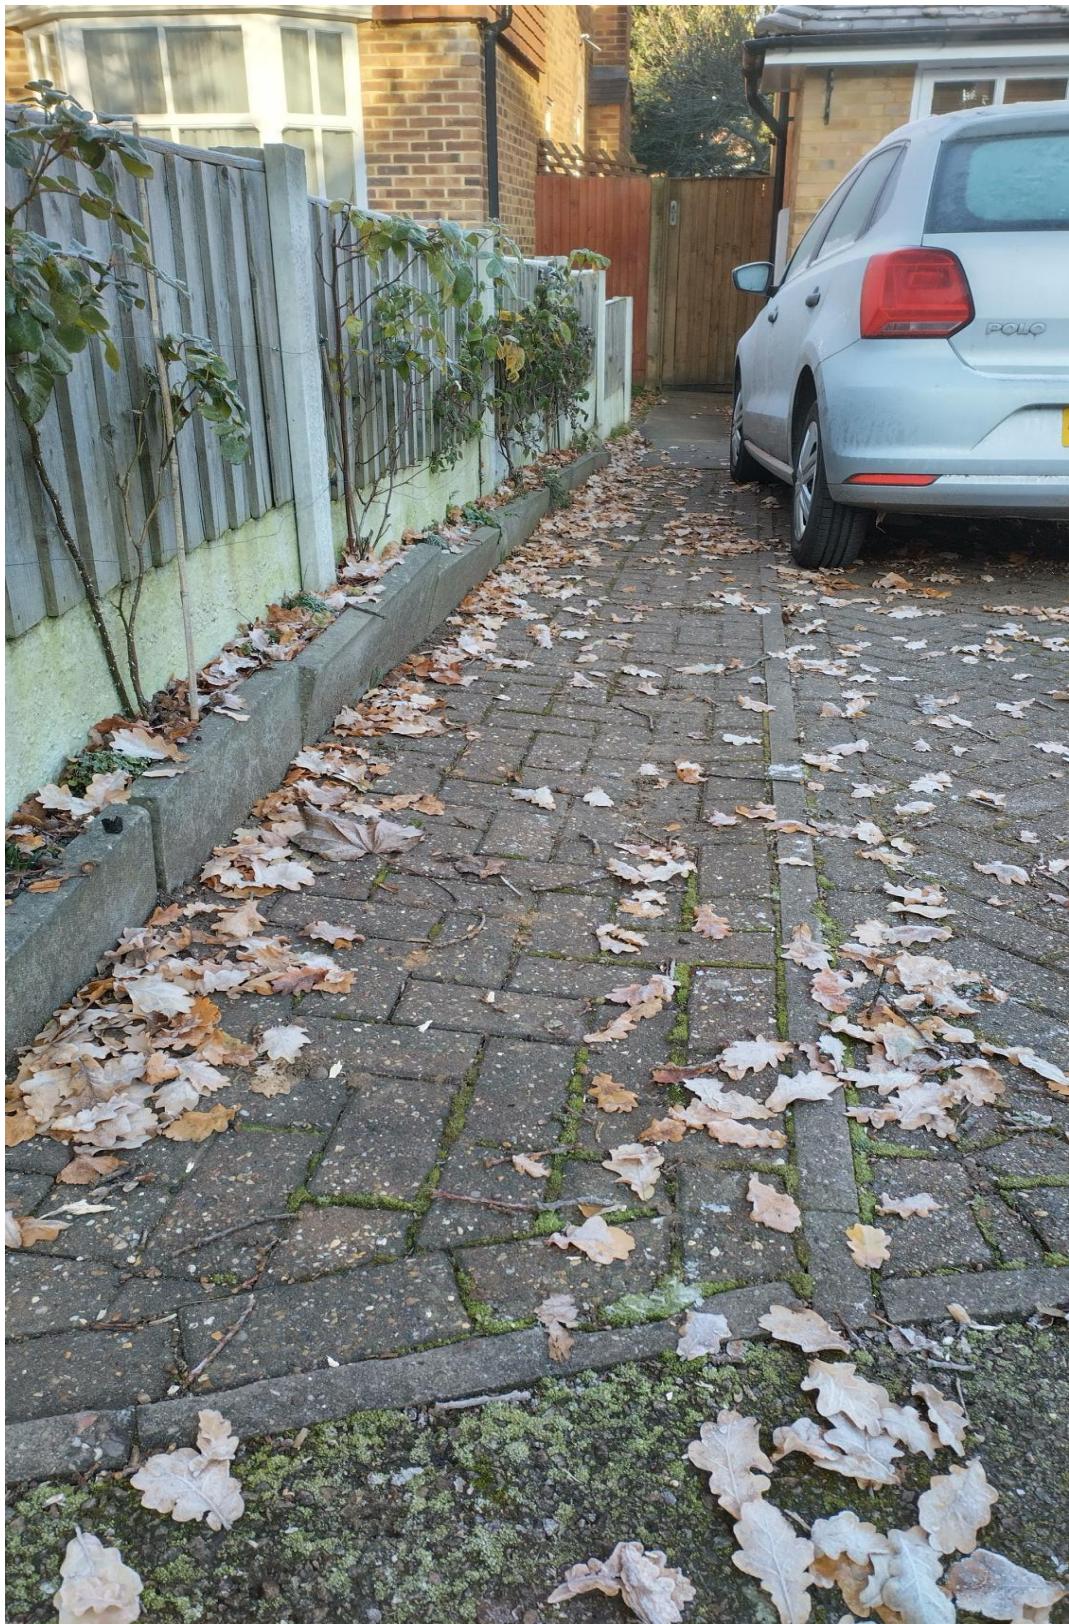
There was no visible damage to the house. There was some minor damage to the neighbour's path (Appendix 1 – Photo 3), where the path had sunk and the gravel boards of the boundary fence were deflected.

Root damage: near T2 there is minor physical damage to the boundary fence (number 3) caused by the roots. There is no damage to the house. Both trees are a sufficient distance from the house not to represent a risk of physical damage to it from their roots.

Photo 3 – Damage to boundary fence

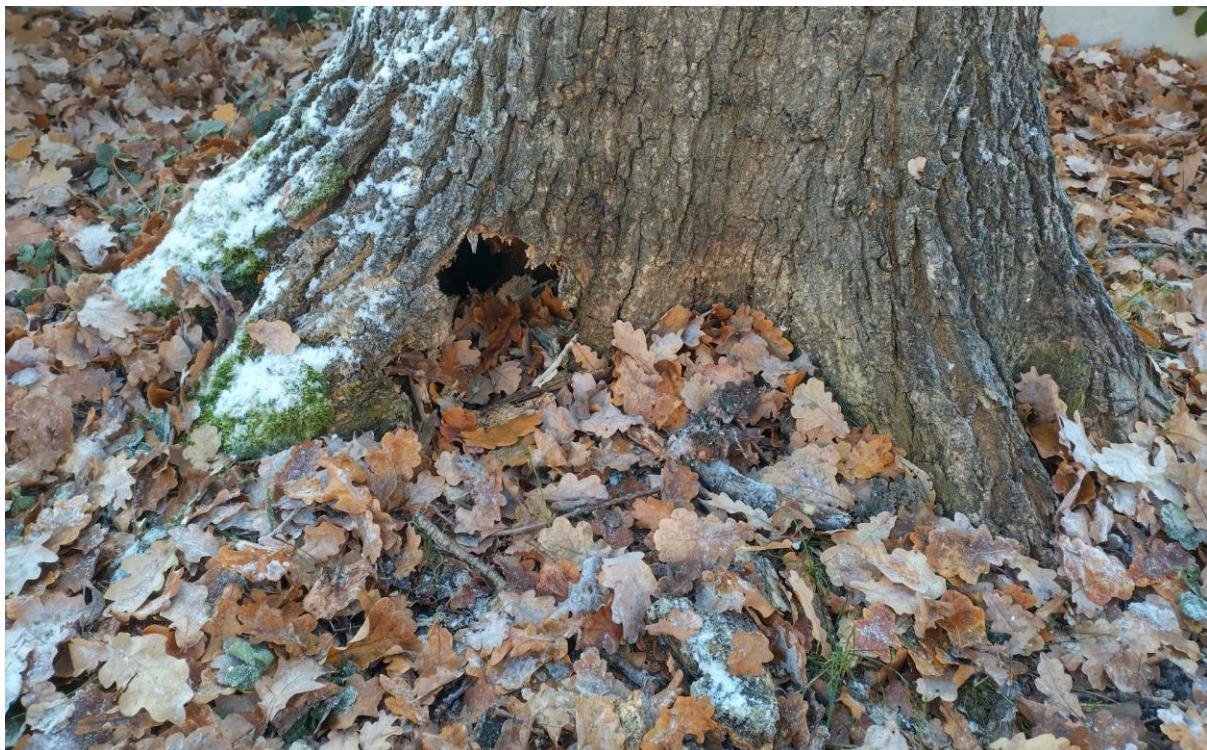
Photo 4 – T2 Basal cavity
