# Arboricultural Consultancy for Lloyds Bank

| Insured | Dr Sundaramani Kumari | Address | 19 Woodgate Crescent, Middlesex, HA6 3RB | | |
| Client | Subsidence Management Services | Contact | Kevin Phillips | Claim No. | IFS-LBG-SUB-20-0088871 |
| Report Date | 17/12/2020 | | | | |

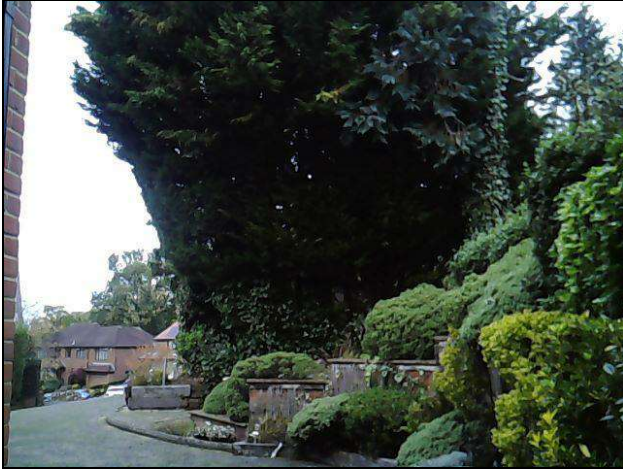
H1 - Mixed coniferous group

| Tree No. | Species | Age Cat | Approx. Height (m) | Distance to Building (m) * | Ownership | Action | Requirement |
|---|---|---|---|---|---|---|---|
| H1 | Mixed coniferous group | 3 | 10 | 8.7 | C - Insured | Action to avoid future risk | Maintain at broadly current dimensions by way of regular pruning. |

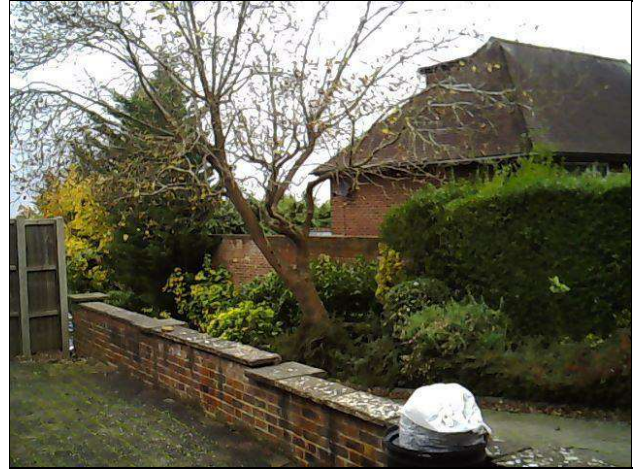
T2 - Indian Bean Tree

| Tree No. | Species | Age Cat | Approx. Height (m) | Distance to Building (m) * | Ownership | Action | Requirement |
|---|---|---|---|---|---|---|---|
| T2 | Indian Bean Tree | 3 | 8.8 | 8.8 | A - Third Party | Action to avoid future risk | Maintain at broadly current dimensions by way of regular pruning. |

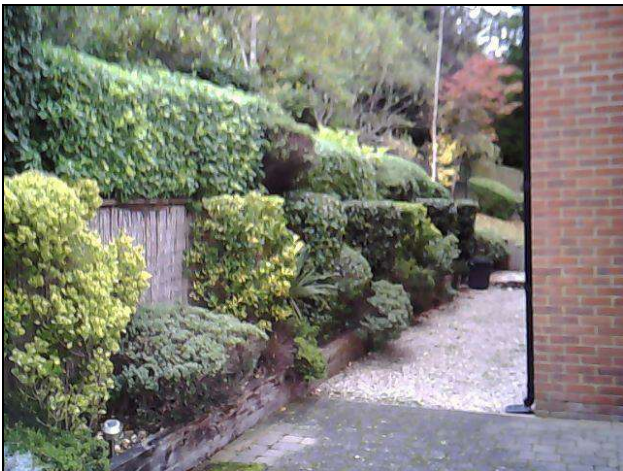
SG1 - Mixed species shrubs

| Tree No. | Species | Age Cat | Approx. Height (m) | Distance to Building (m) * | Ownership | Action | Requirement |
|---|---|---|---|---|---|---|---|
| SG1 | Mixed species shrubs | 1 | 1.8 | 2.6 | C - Insured | Action to avoid future risk | Maintain at broadly current dimensions by way of regular pruning. Includes Euonymus, Hebe, Bay, Fatsia and Buddleia |

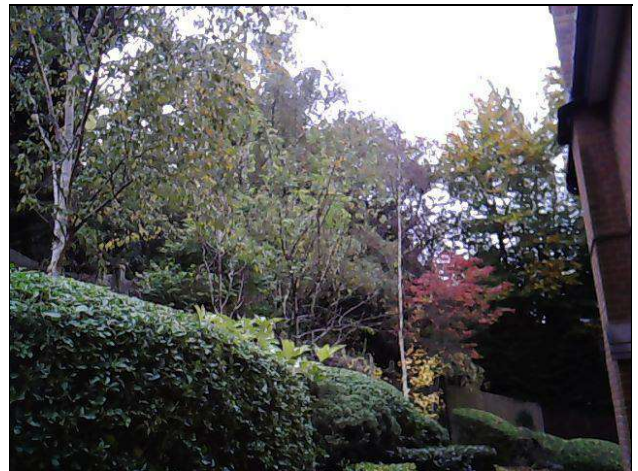
TG1 - Mixed species group

| Tree No. | Species | Age Cat | Approx. Height (m) | Distance to Building (m) * | Ownership | Action | Requirement |
|---|---|---|---|---|---|---|---|
| TG1 | Mixed species group | 1 | 7.2 | 4.5 | C - Insured | Action to avoid future risk | Maintain at broadly current dimensions by way of regular pruning. Situated 2m above ground level. Birch x 2, Rowan x 2, Apple and Prunus. |

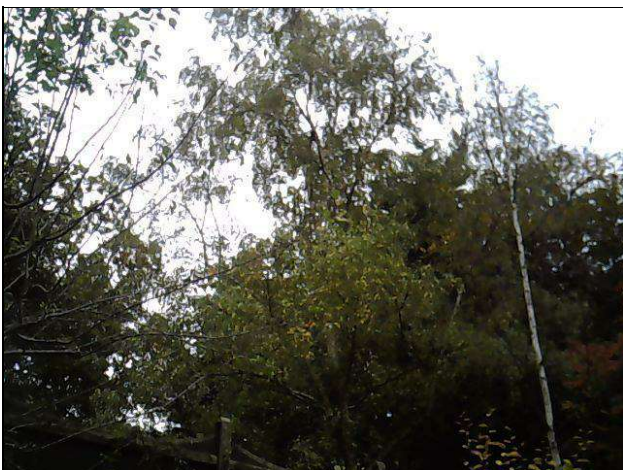
T1 - Birch

| Tree No. | Species | Age Cat | Approx. Height (m) | Distance to Building (m) * | Ownership | Action | Requirement |
|---|---|---|---|---|---|---|---|
| T1 | Birch | 3 | 15 | 12 | A - Third Party | Action to avoid future risk | Maintain at broadly current dimensions by way of regular pruning. Situated 4m - 5m above ground level of property. |

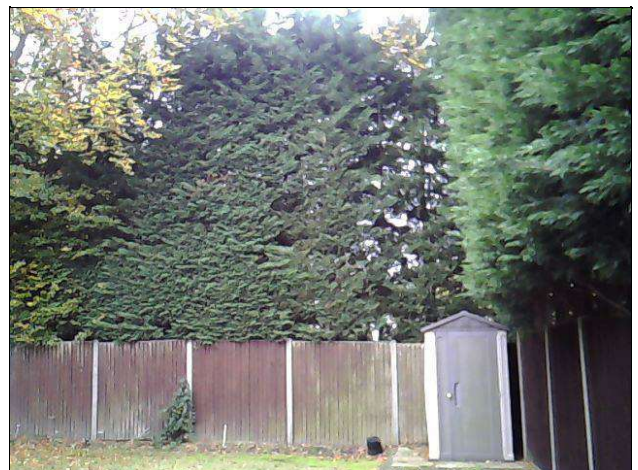
H2 - Cypress (Leyland)

| Tree No. | Species | Age Cat | Approx. Height (m) | Distance to Building (m) * | Ownership | Action | Requirement |
|---|---|---|---|---|---|---|---|
| H2 | Cypress (Leyland) | 2 | 9.2 | 9.5 | E - Boundary Veg (ownership to be confirmed) | Action to avoid future risk | Reduce hedge to height of 6m and maintain at reduced dimensions by way of regular pruning. |

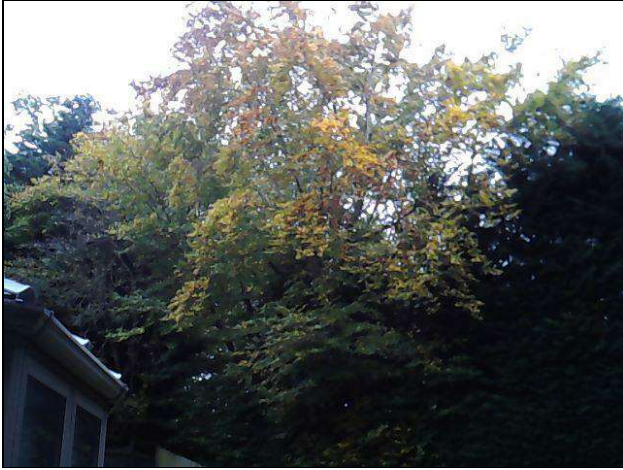
TG2 - Beech

However, whilst not positively implicated by root analysis, TG2 (Beech) cannot be discounted as contributing to the overall level of soil drying proximate to the area of damage and is therefore also considered to retain a contributory influence, albeit in a secondary capacity when compared to H3.

| Tree No. | Species | Age Cat | Approx. Height (m) | Distance to Building (m) * | Ownership | Action | Requirement |
|---|---|---|---|---|---|---|---|
| TG2 | Beech | 3 | 16.4 | 10.8 | A - Third Party | Remove | Remove close to ground level. |

Consequently, complete removal of H3 & TG2 will offer the most certain arboricultural solution likely to restore long-term stability.

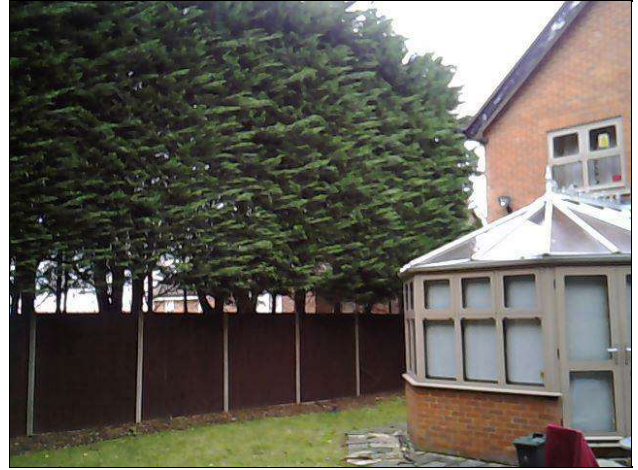
H3 - Cypress (Leyland)

Our survey of the site identified Cypress hedge (H3), given its position relative to the damage it is our opinion that the roots identified will emanate from this vegetation and accordingly we have identified it as a significant cause of the subsidence damage.

| Tree No. | Species | Age Cat | Approx. Height (m) | Distance to Building (m) * | Ownership | Action | Requirement |
|---|---|---|---|---|---|---|---|
| H3 | Cypress (Leyland) | 2 | 9.5 | 3.7 | A - Third Party | Remove | Remove close to ground level. |

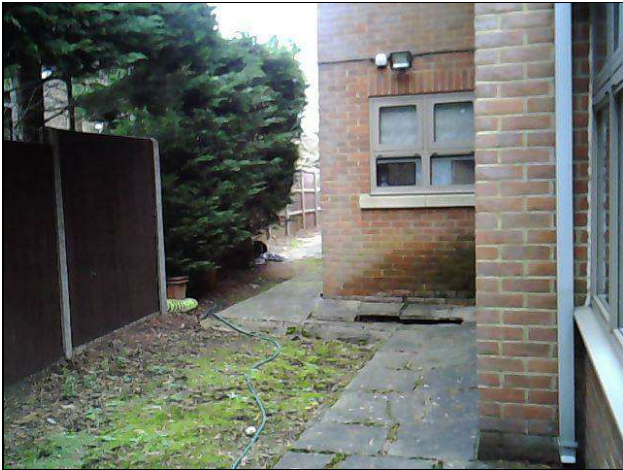
H4 - Cypress (Leyland)

| Tree No. | Species | Age Cat | Approx. Height (m) | Distance to Building (m) * | Ownership | Action | Requirement |
|---|---|---|---|---|---|---|---|
| H4 | Cypress (Leyland) | 2 | 4 | 2.3 | C - Insured | Action to avoid future risk | Do not allow to exceed current dimensions by way of regular pruning. |

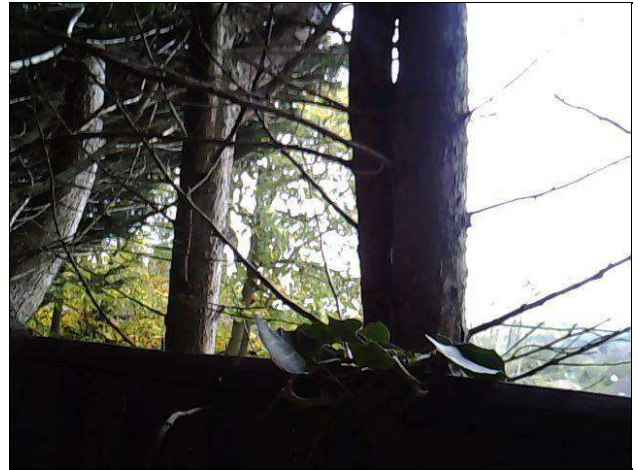
TG3 - Beech

| Tree No. | Species | Age Cat | Approx. Height (m) | Distance to Building (m) * | Ownership | Action | Requirement |
|---|---|---|---|---|---|---|---|
| TG3 | Beech | 3 | 15 | 14 | A - Third Party | Action to avoid future risk | Do not allow to exceed current dimensions by way of regular pruning. |

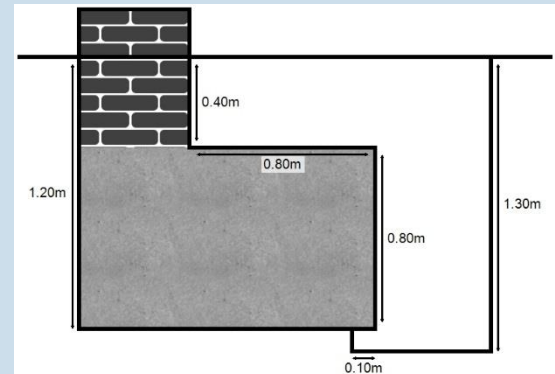
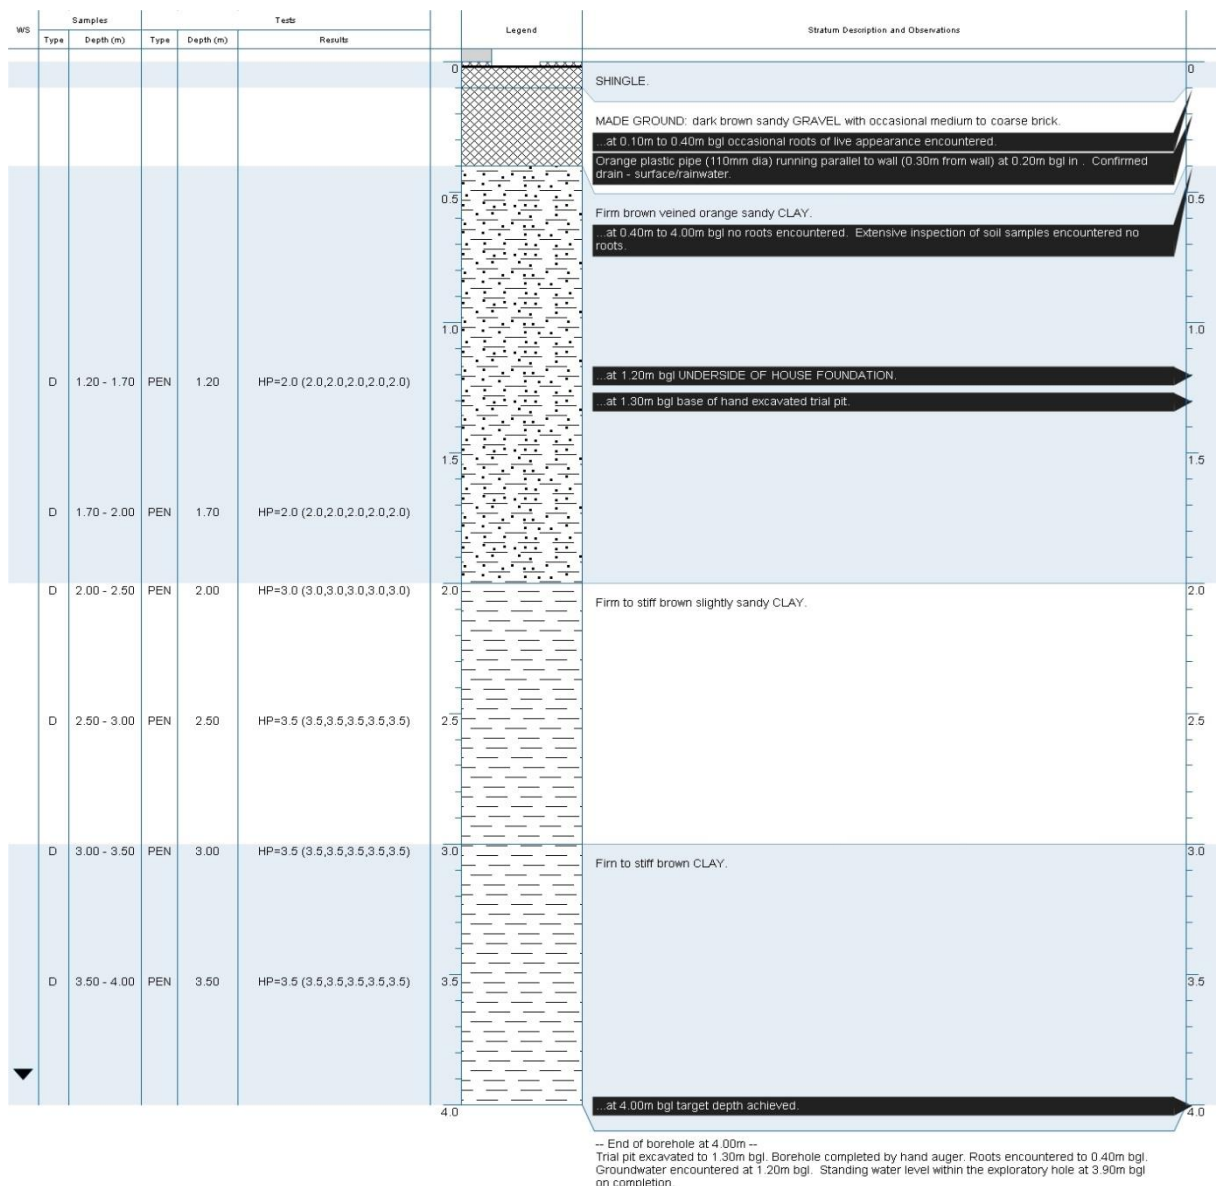
## TP/BH1 Foundation Detail and Borehole Log

House foundation comprised of brick wall to 400mm bgl, bearing on concrete to 1200mm bgl, with a total projection of 800mm from the elevation. Underside of foundation (USF) was exposed to 100mm back from the face of the foundation and probed 400mm back from the face of the foundation.

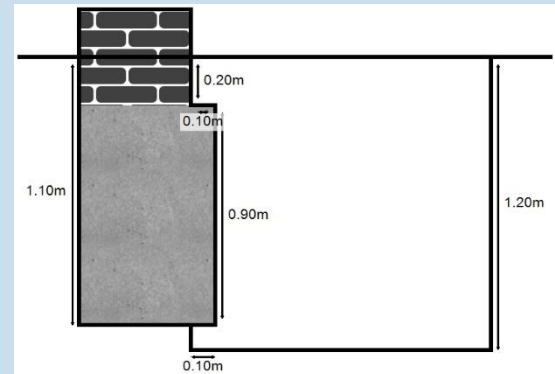
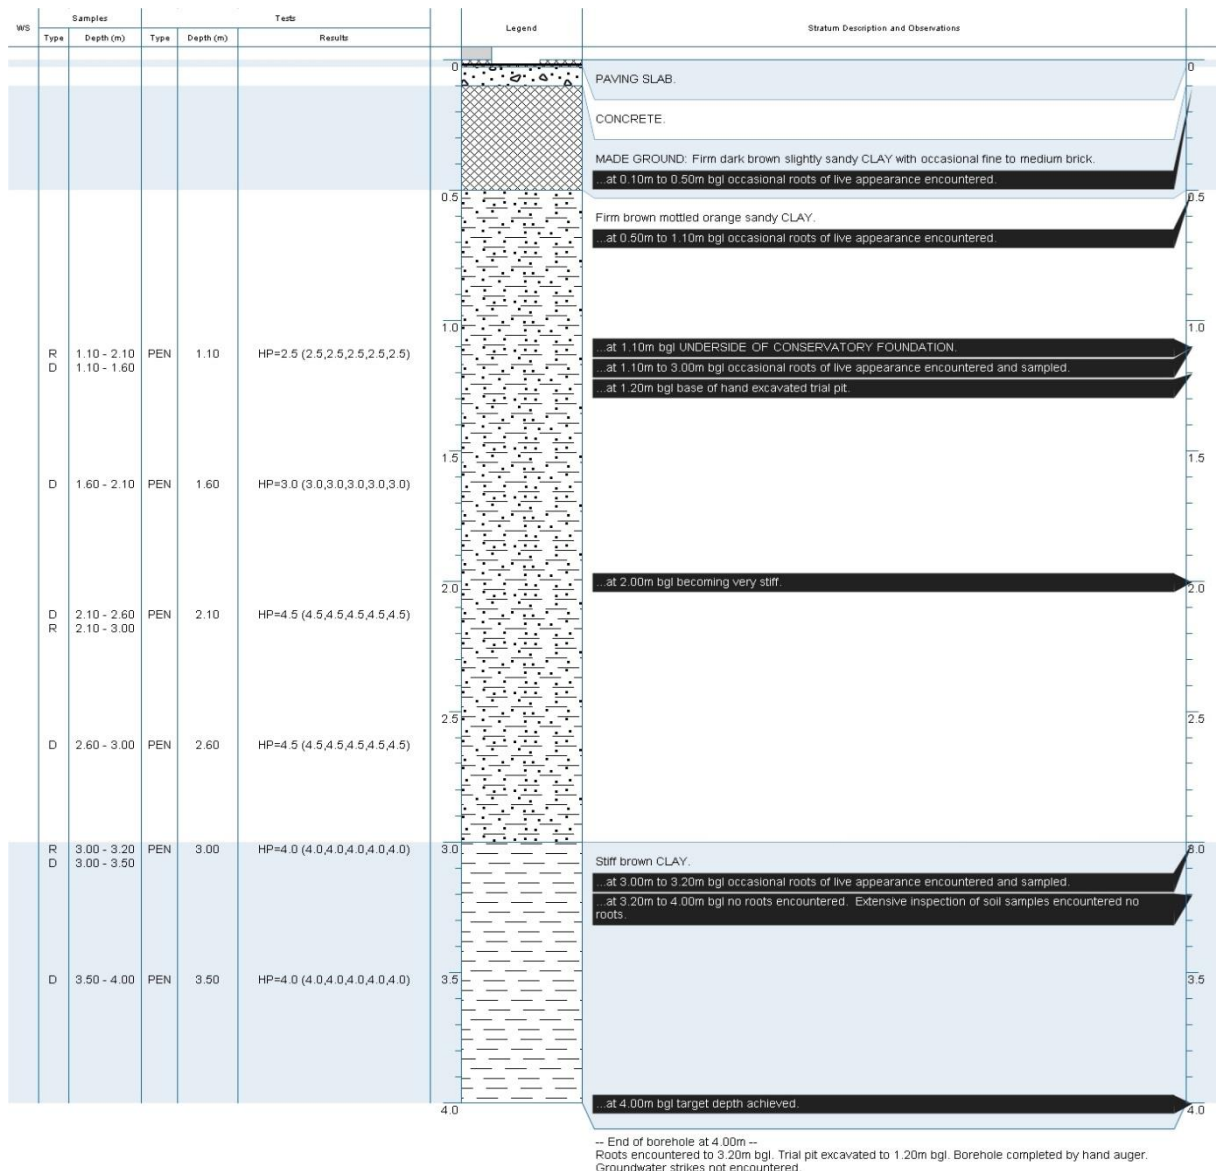
## TP/BH2 Foundation Detail and Borehole Log

Conservatory foundation comprised of brick wall to 200mm bgl, bearing on concrete to 1100mm bgl, with a total projection of 100mm from the elevation. Underside of foundation (USF) was exposed to 100mm back from the face of the foundation and probed 300mm back from the face of the foundation.
