**Demolition Survey for**  
Toureen Contractors Ltd  
**at**  
North Hyde Garden  
Hayes,  
UB3 4QQ

Project Number: J054862

## Executive Summary

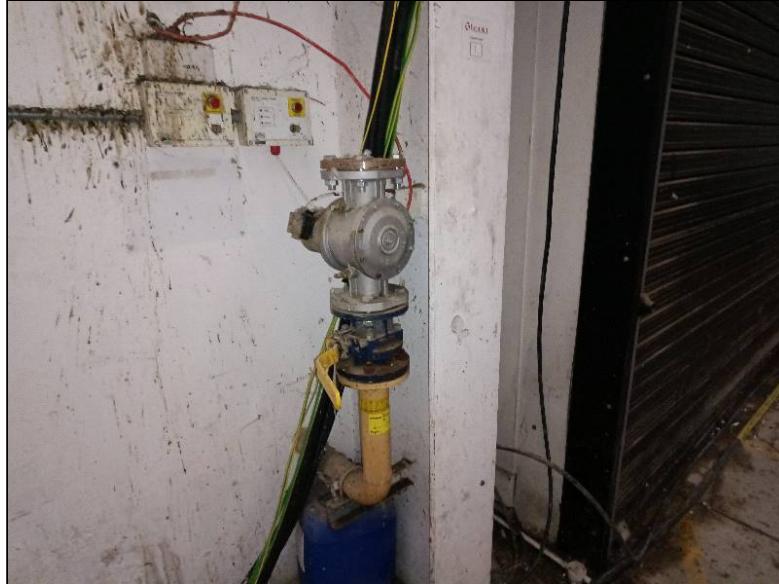
Room: Warehouse Damage: N/A

Material Comments: Non Asbestos Gasket x3

Action: No further action required
