# **St Andrews Park Window Survey**

- To carry out survey of timber and steel frame windows and doors.
- Report on overall condition for repair or replacement.

- Monday 31st August 2020 17:45

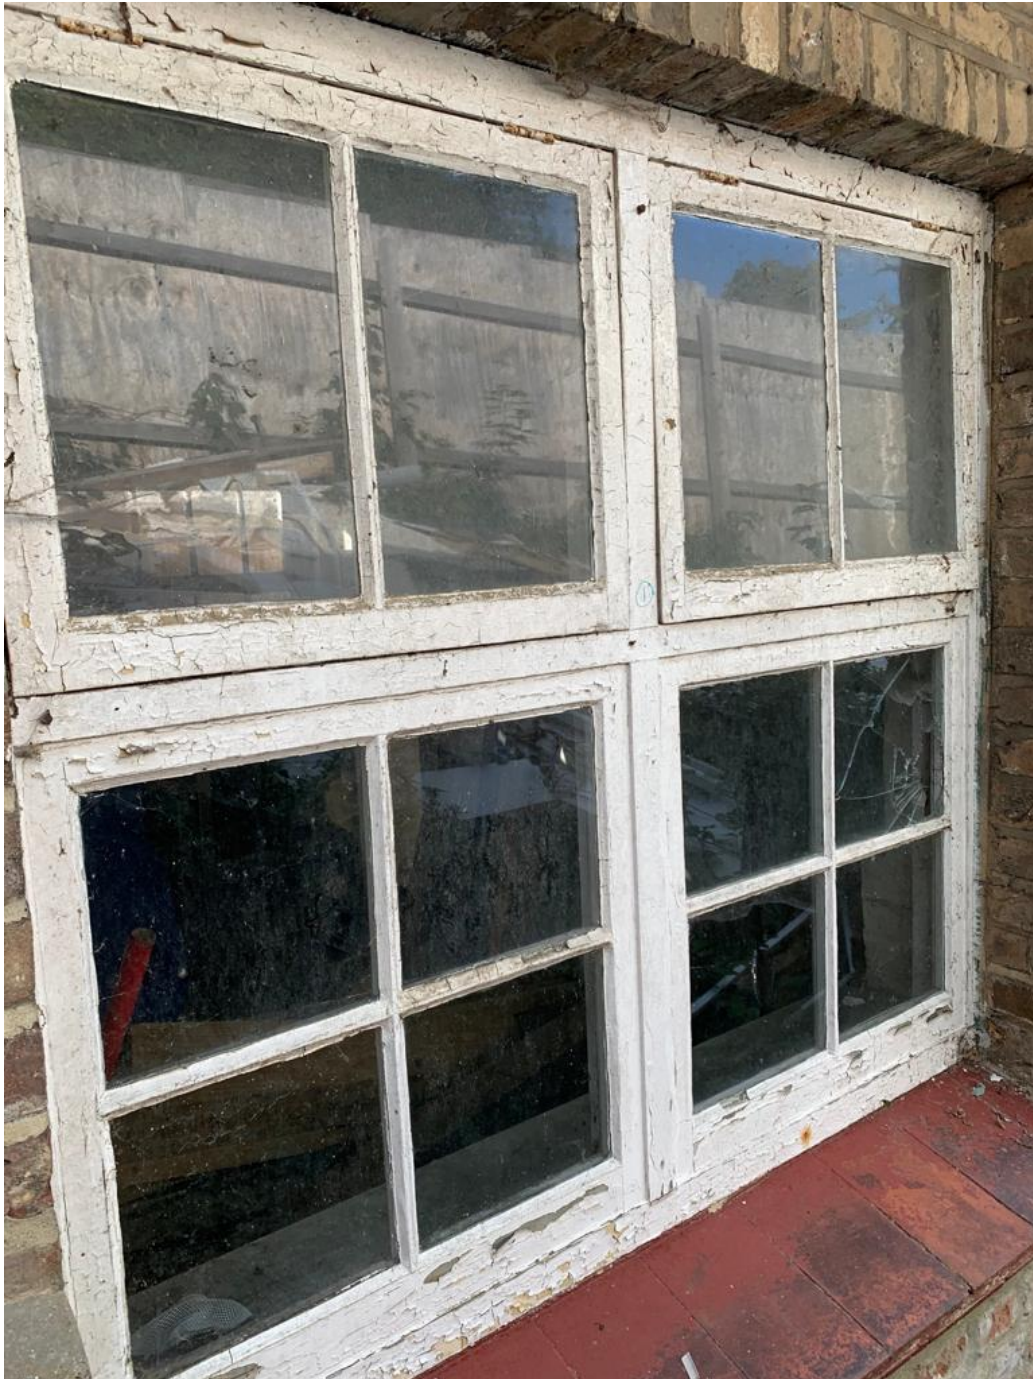
Window 1 (Timber)

1442 x 1387

Viewing the windows at distance they all seem relatively ok but upon closer inspection the overall condition of windows and frames are extremely poor. The timber windows and doors have fallen into disrepair and are rotting in many areas and no attempt should be made to repair but to replace them in their entirety.

In our opinion all windows should be replaced with new modern "Timber or Aluminium style".

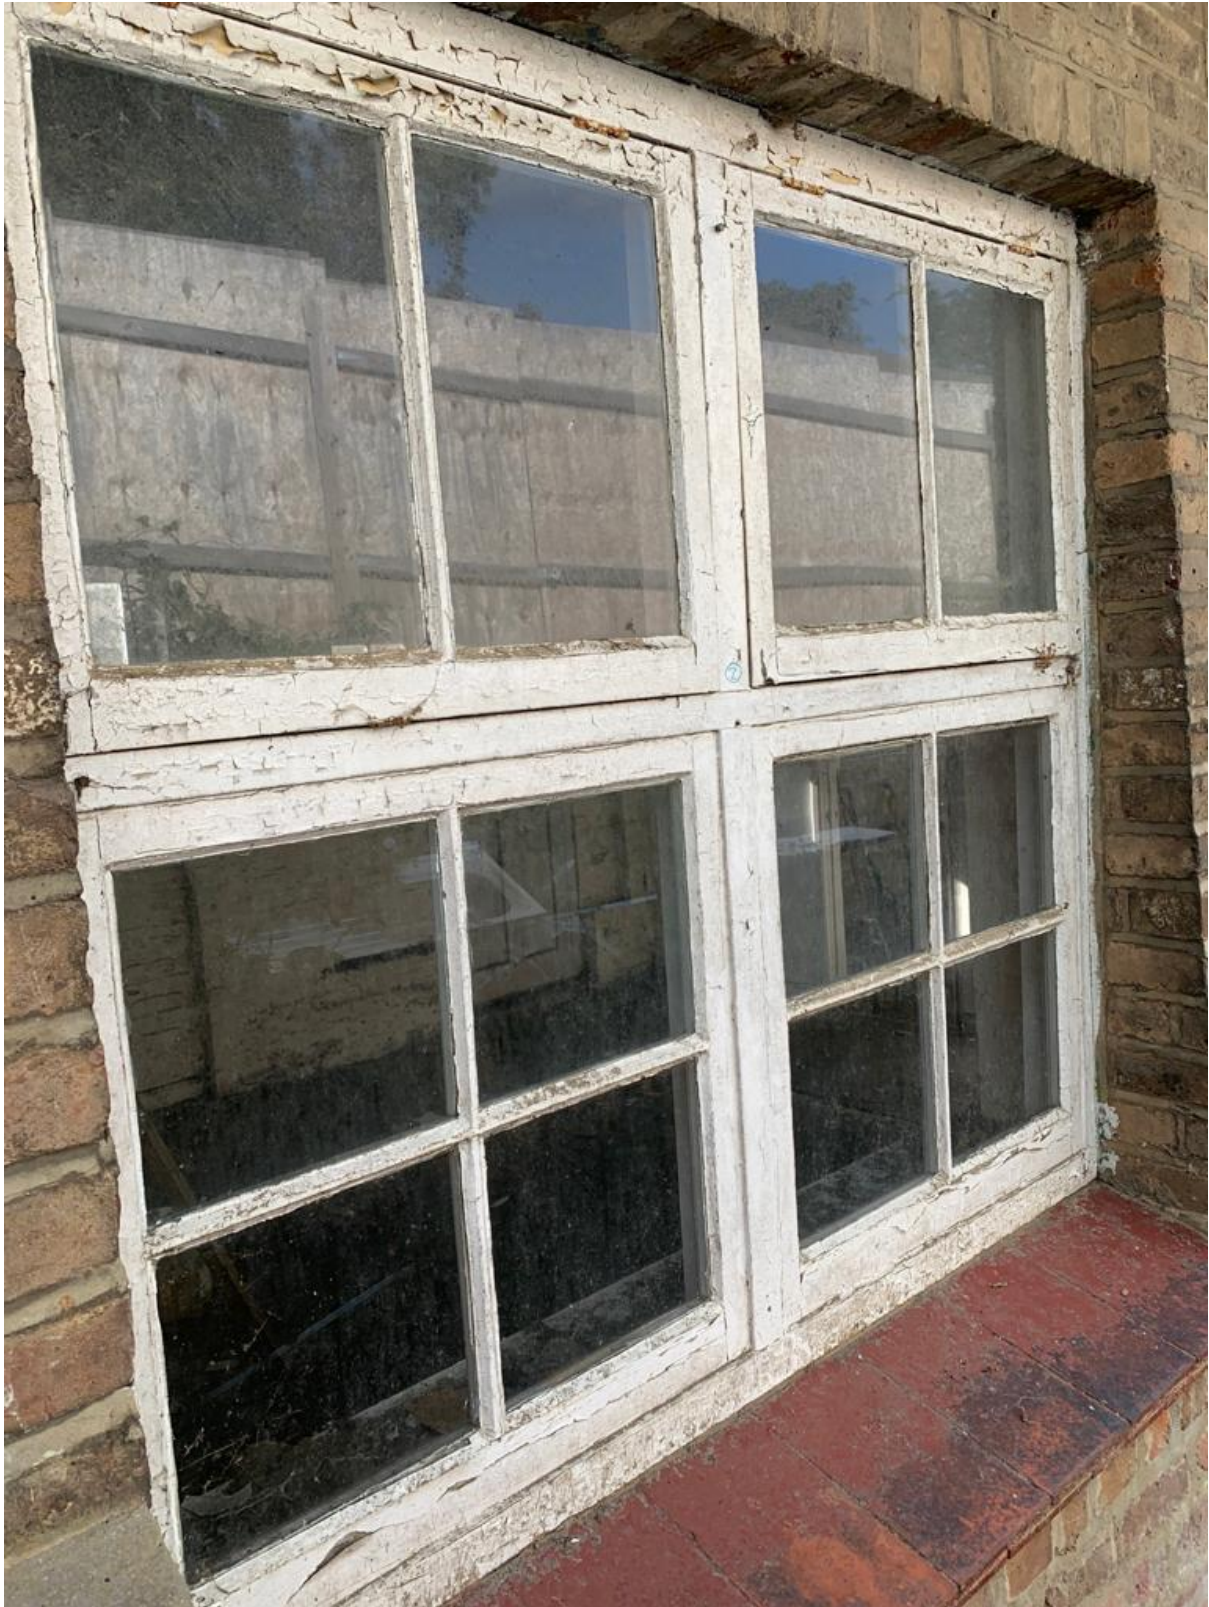
Window 2 (Timber)

1452 x 1375

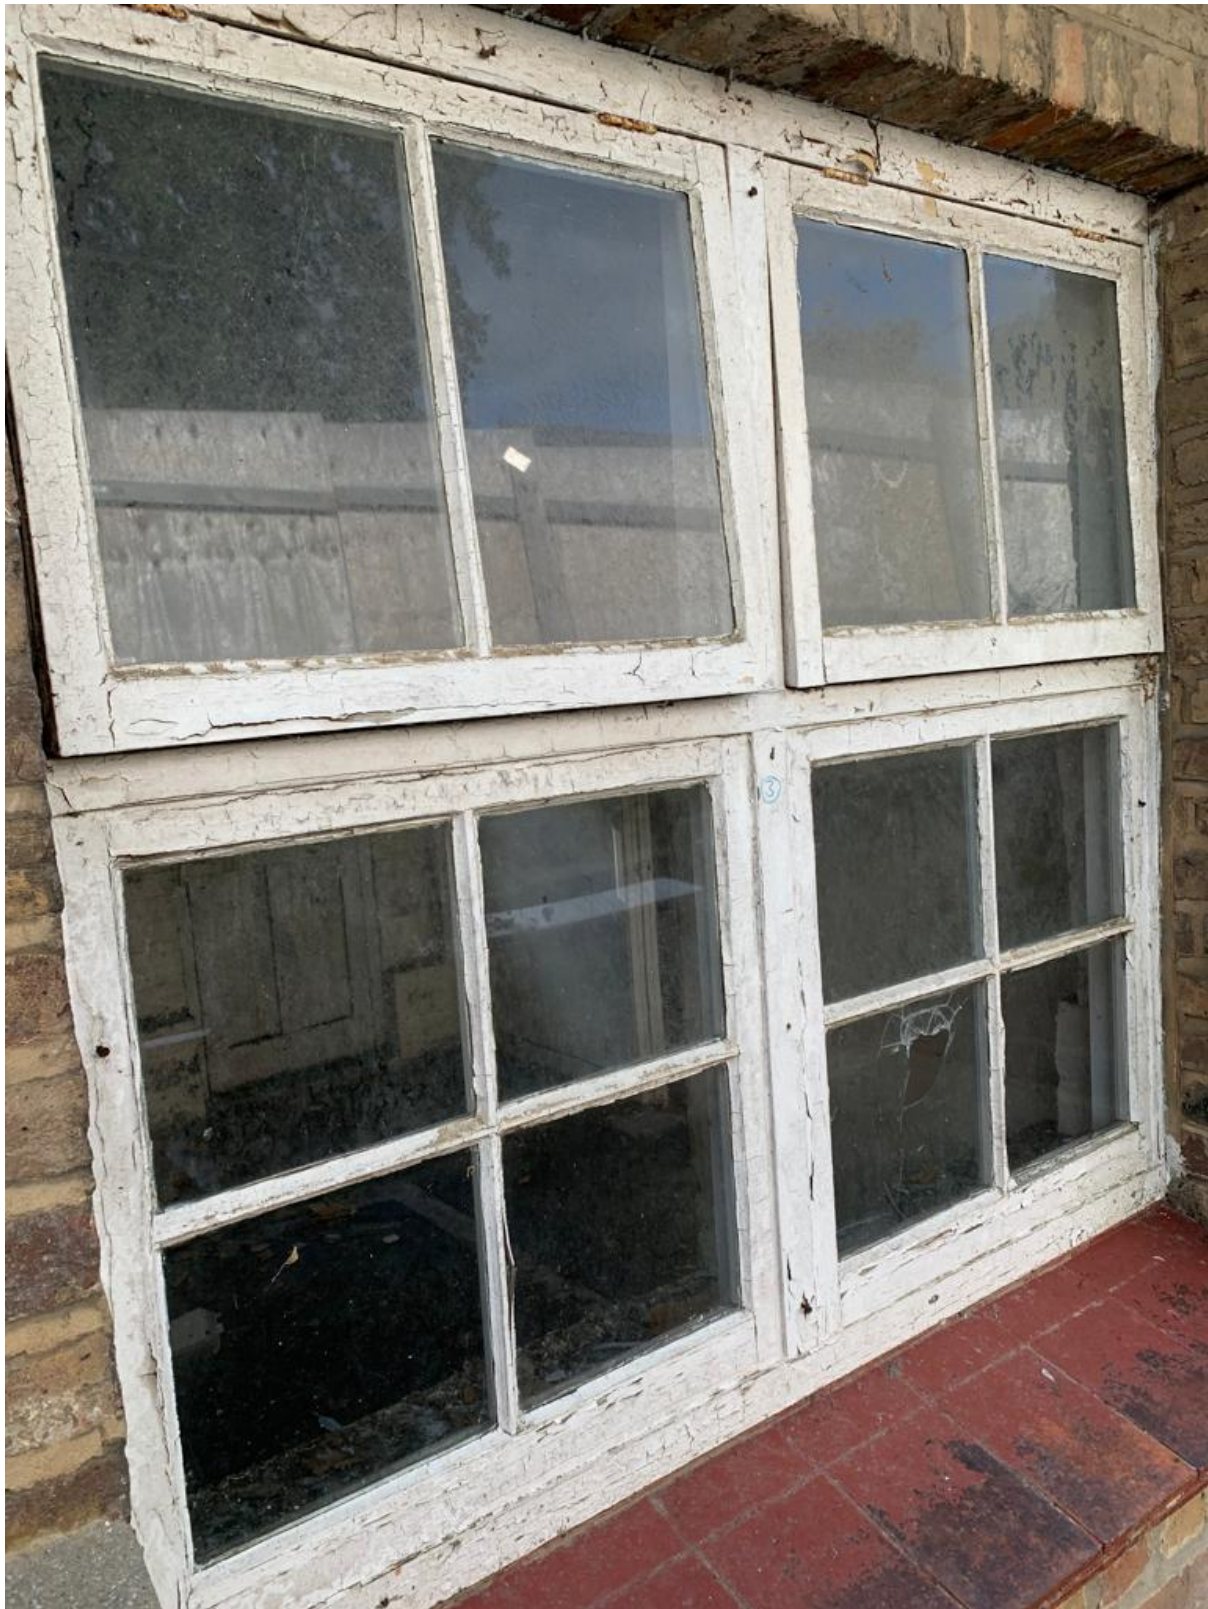
Window 3 (Timber)

1444 x 1338

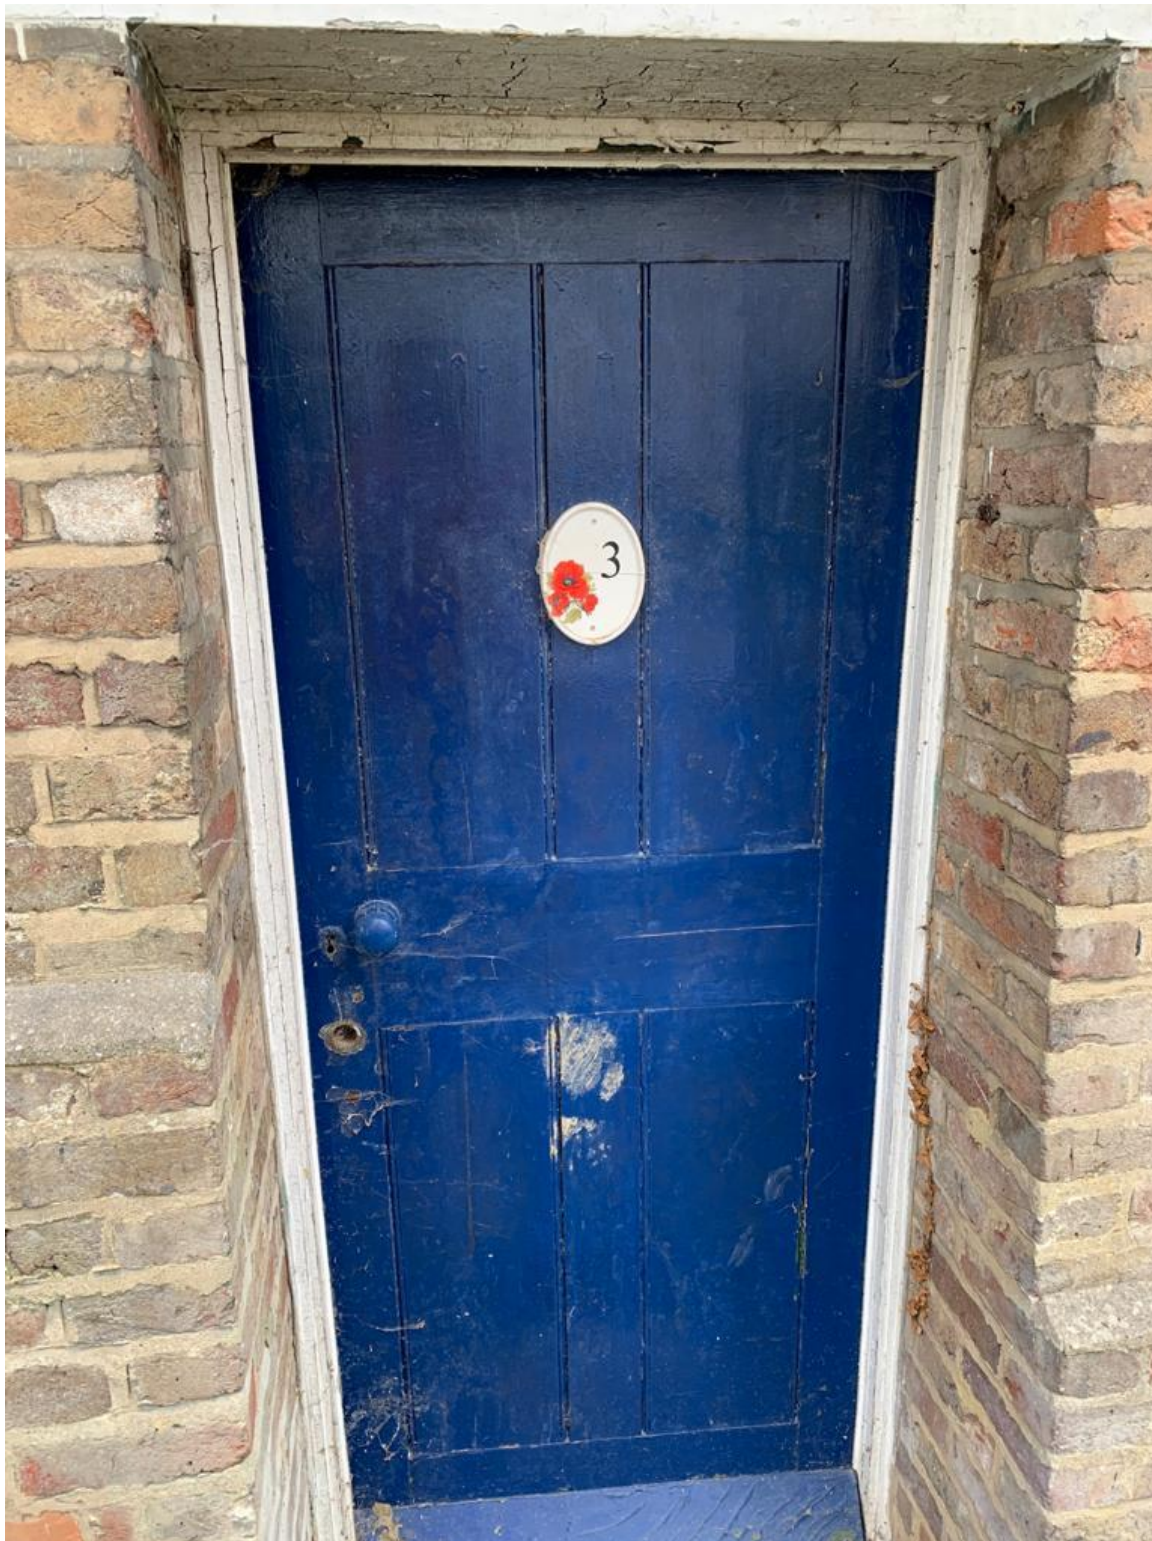
Timber Door to side / rear

847 x 1990

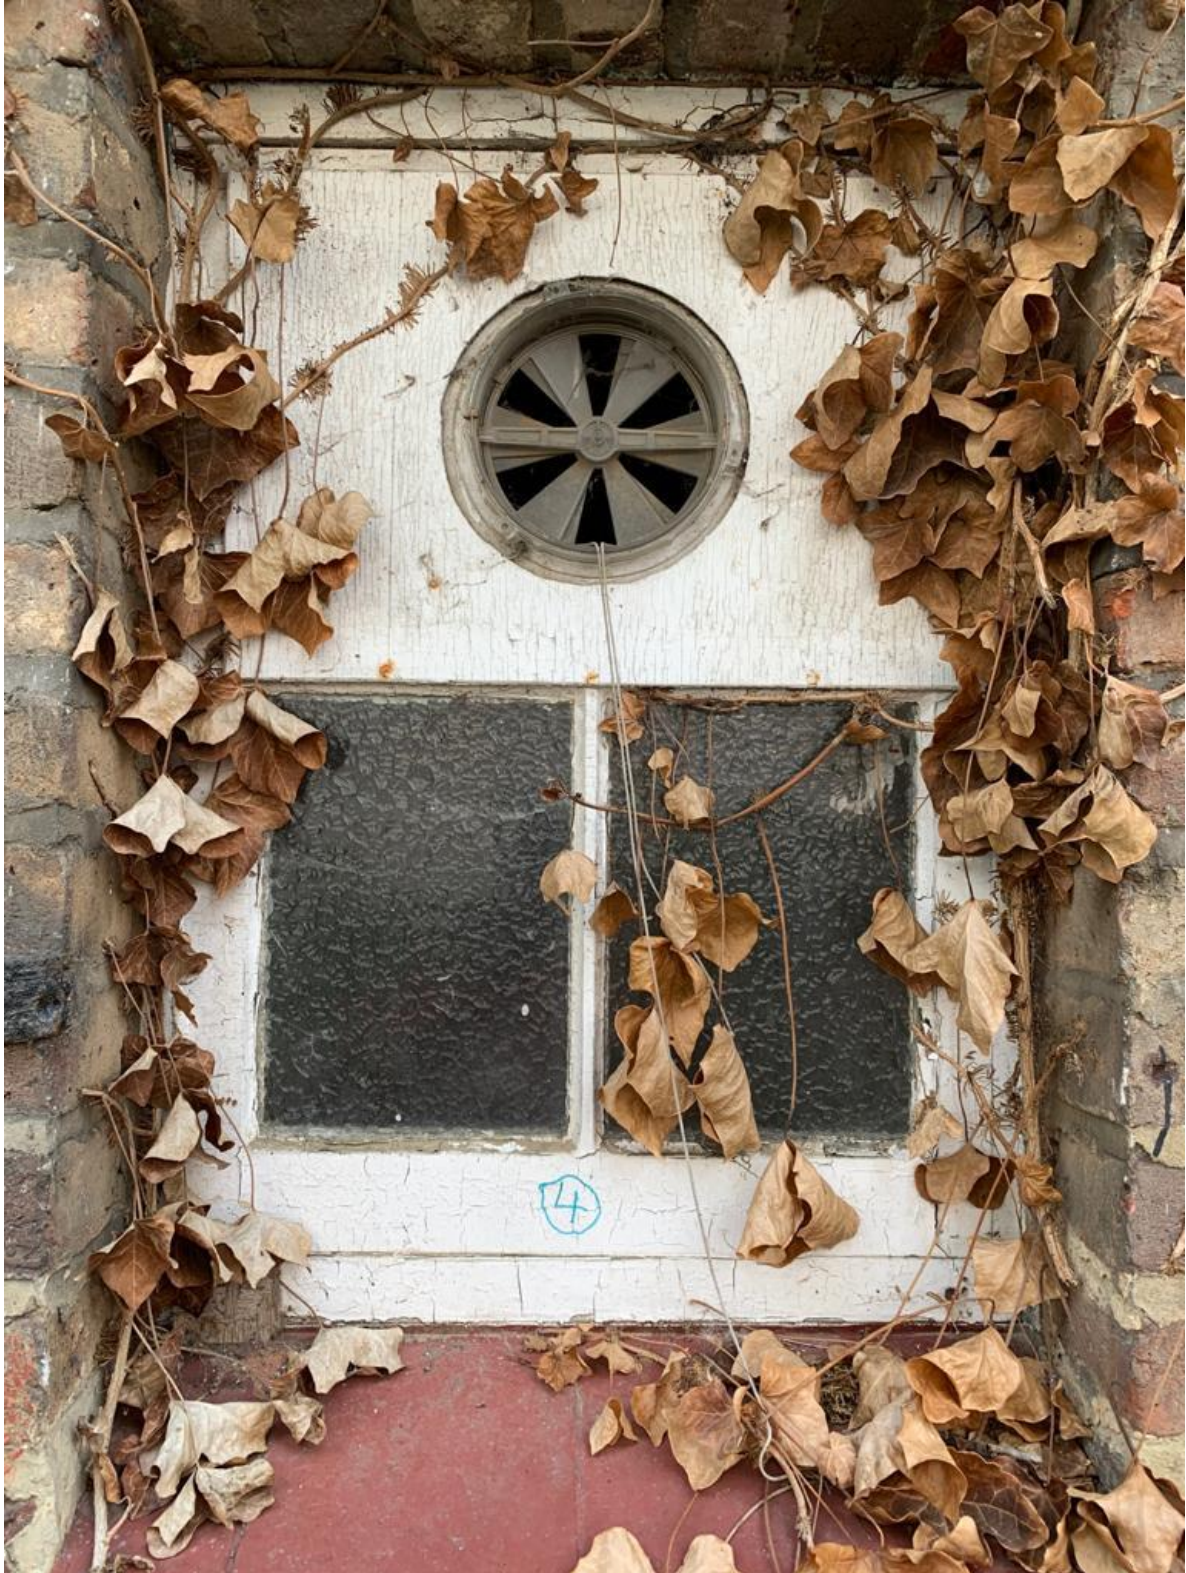
**Window 4 (Timber) with vent**

539 x 775

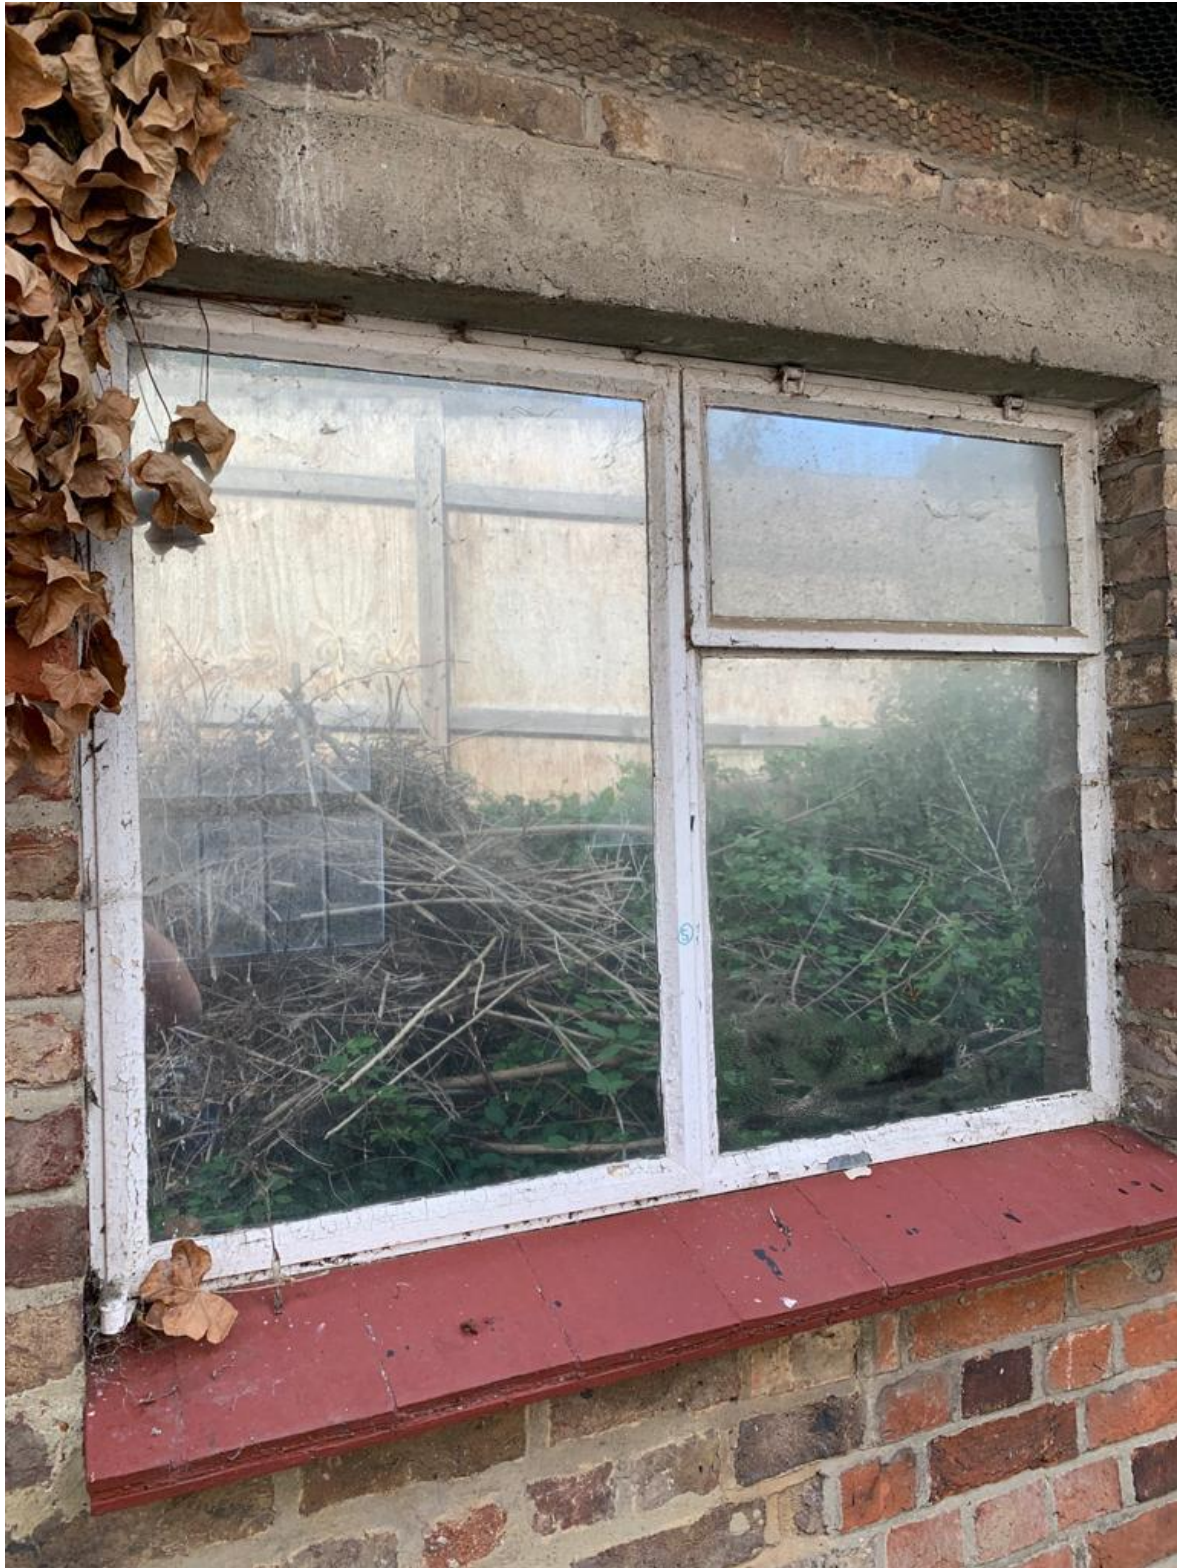
**Window 5 (Crittall style / steel frame)**

936 x 1245

The steel frame windows have also fallen into disrepair and many of the hinges are showing signs of metal fatigue. Due to the failure of window putty there has been significant water ingress through the frames which has caused serious decay of the window frames. Repair of this type of window is not an option and all windows should be replaced.

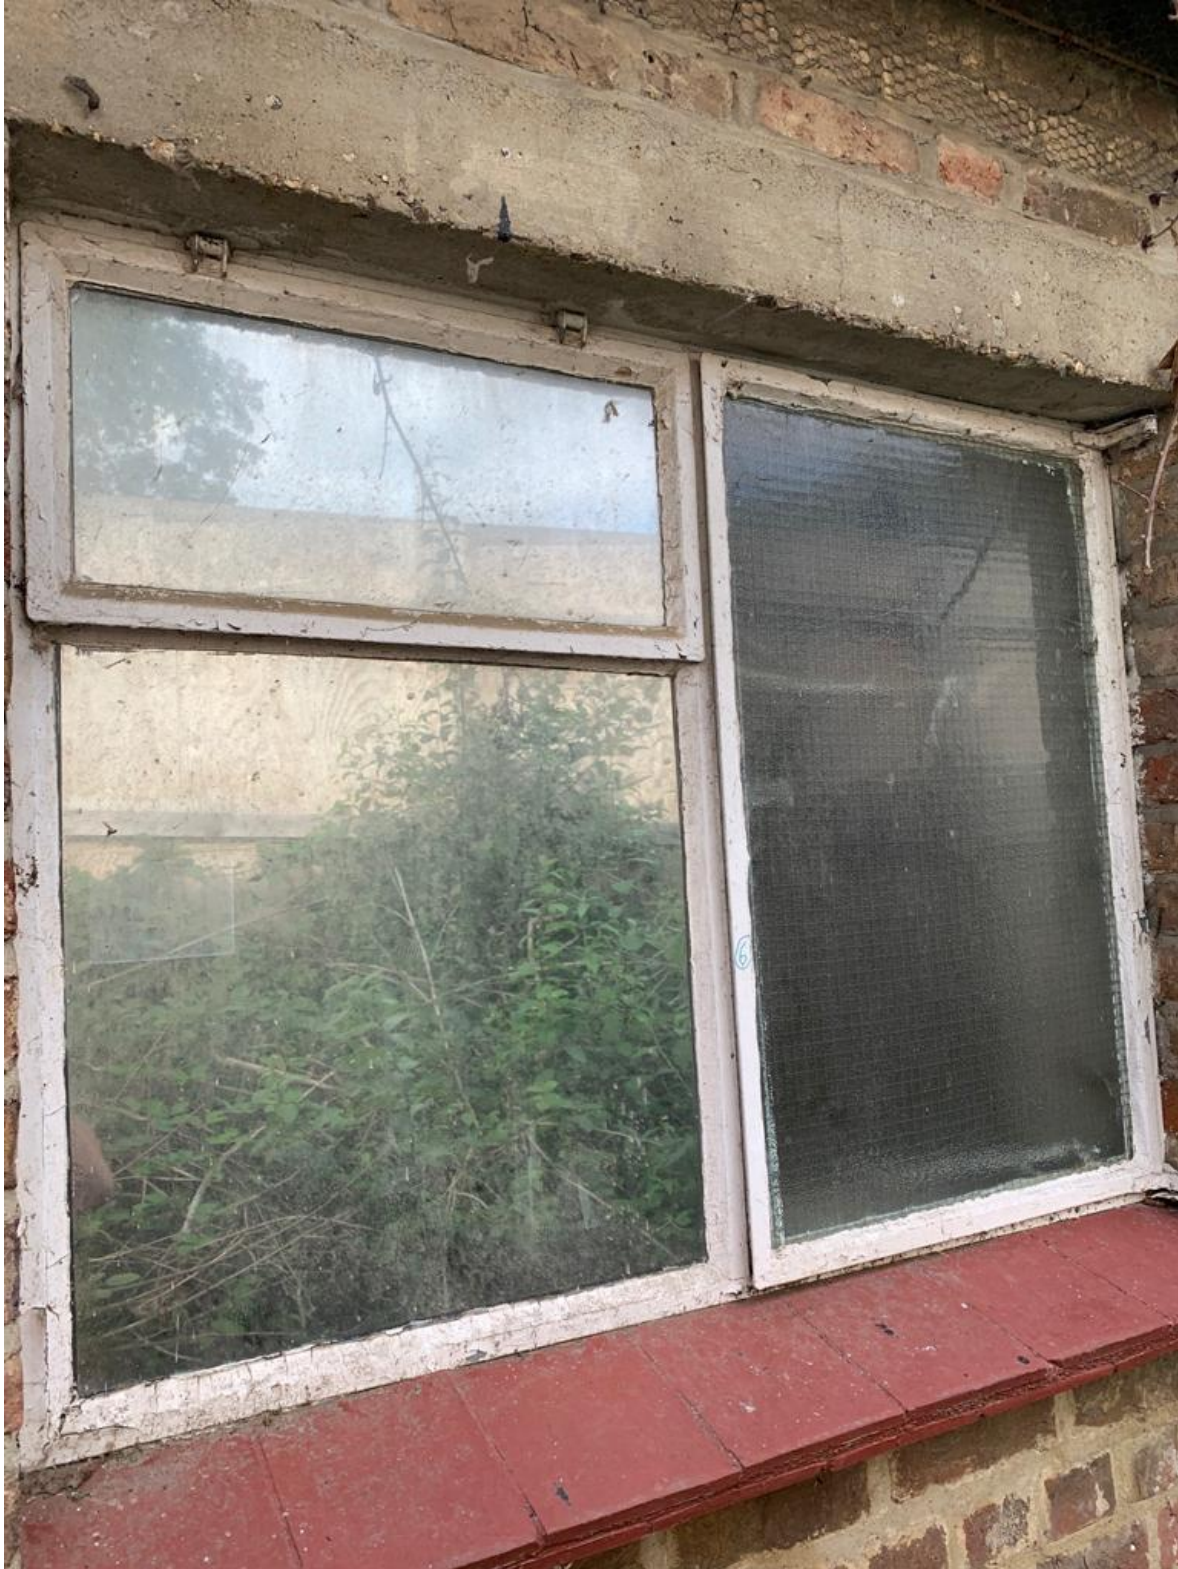
**Window 6 (Crittall style / steel frame)**

931 x 1243

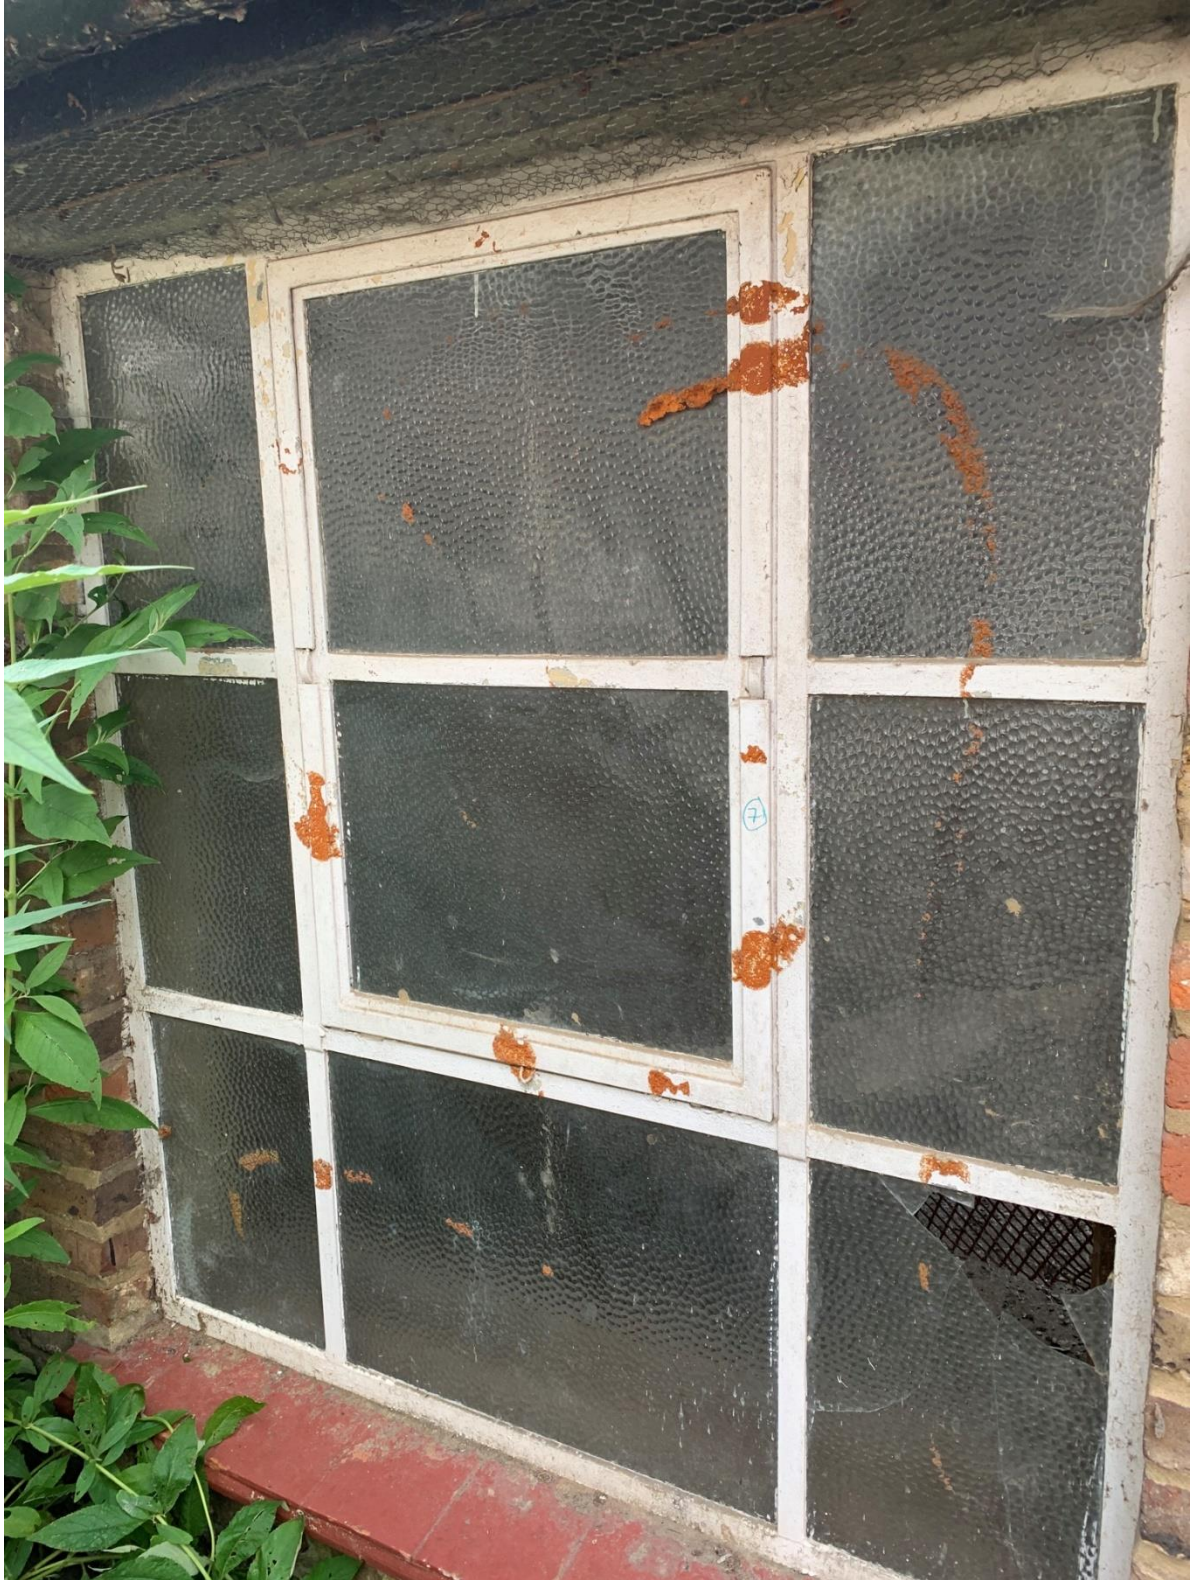
**Window 7 (Crittall style / steel frame)**

1307 x 1458

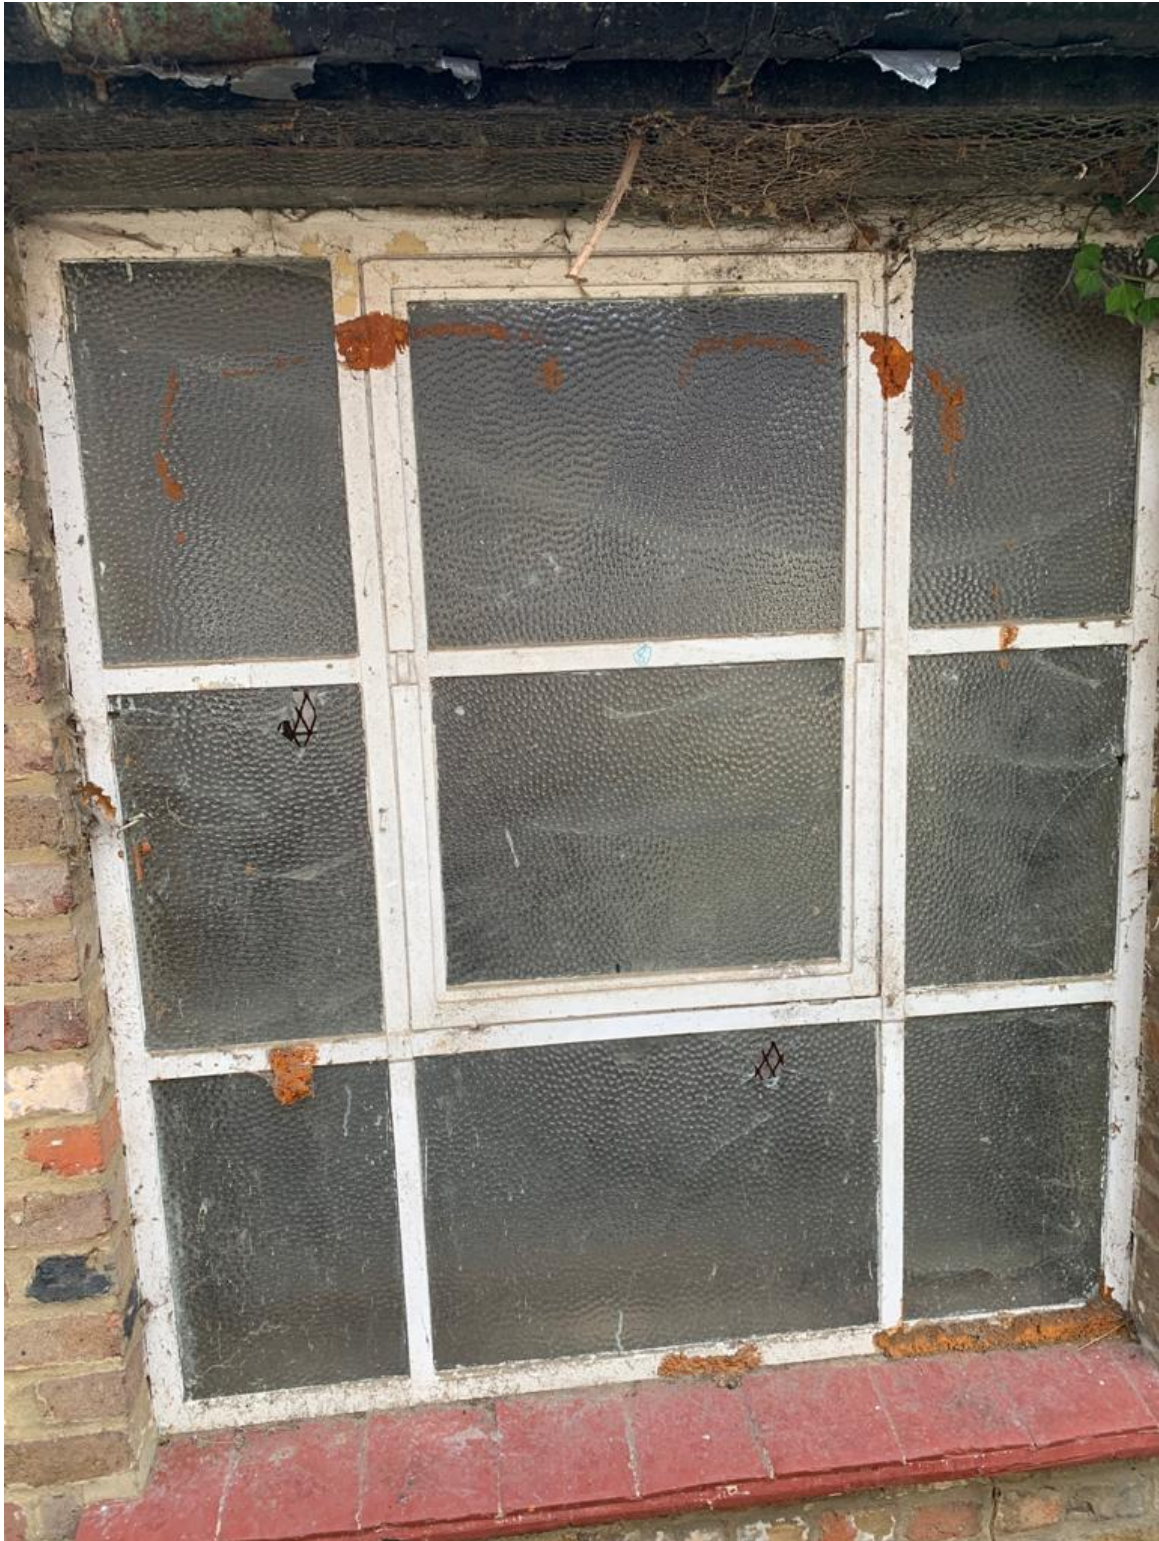
Window 8 (Crittall style / steel frame)

1307 x 1462

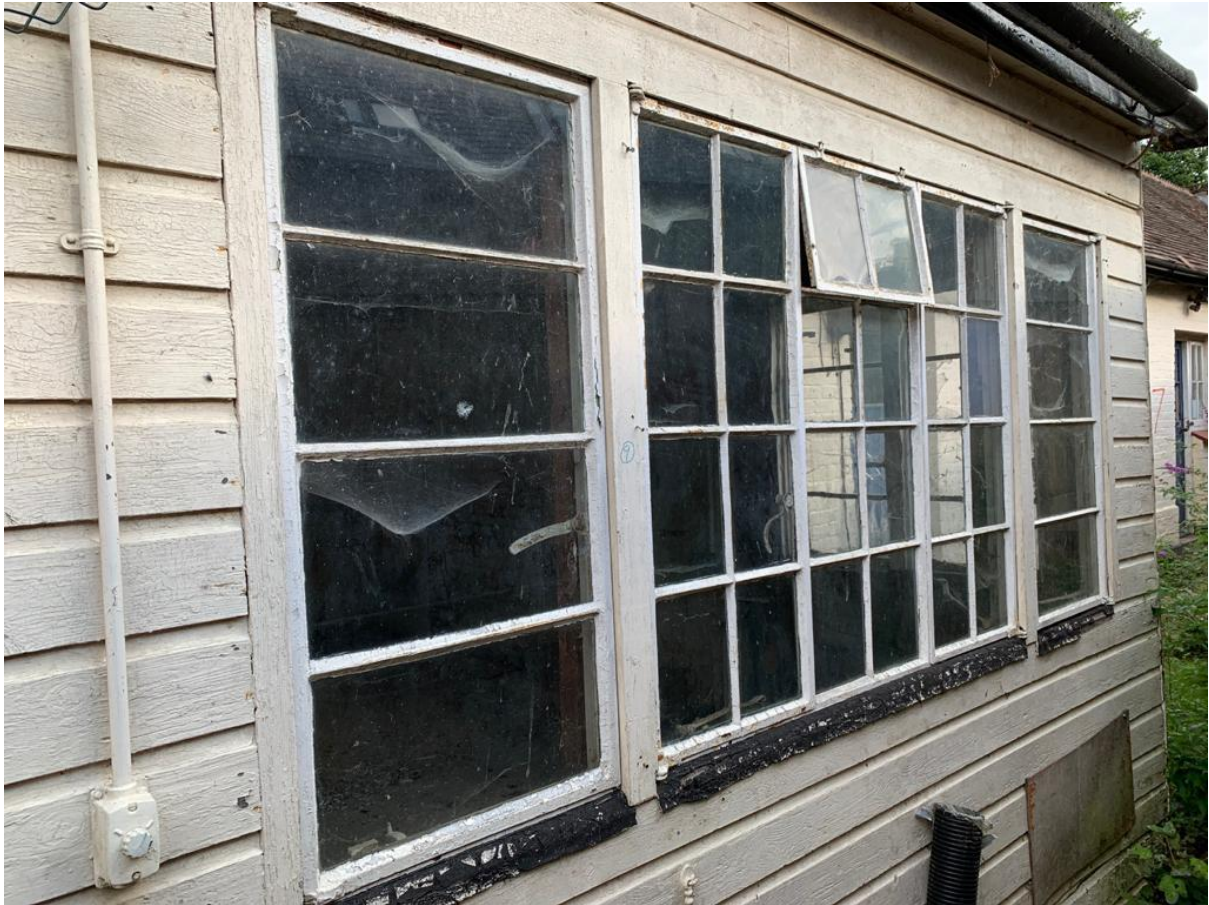
**Window 9 (Crittall style / steel frame)**

2900 x 1155

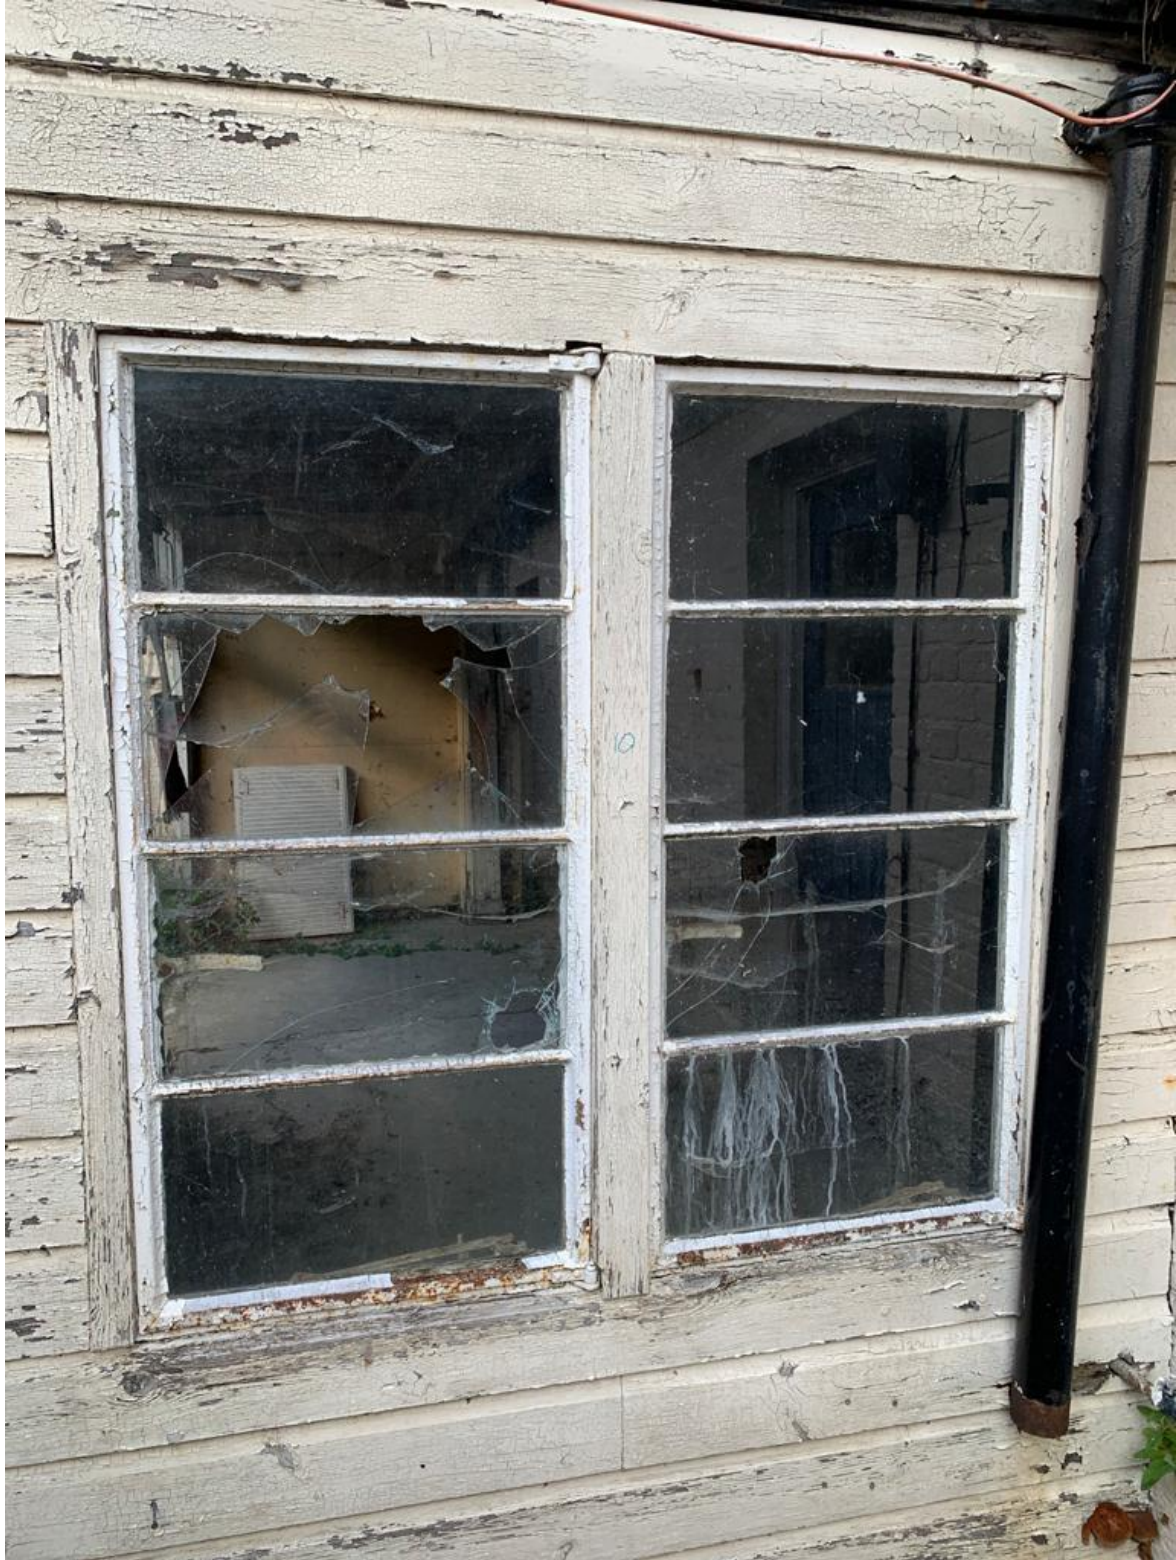
**Window 10 (Crittall style / steel frame)**

1210 x 1230

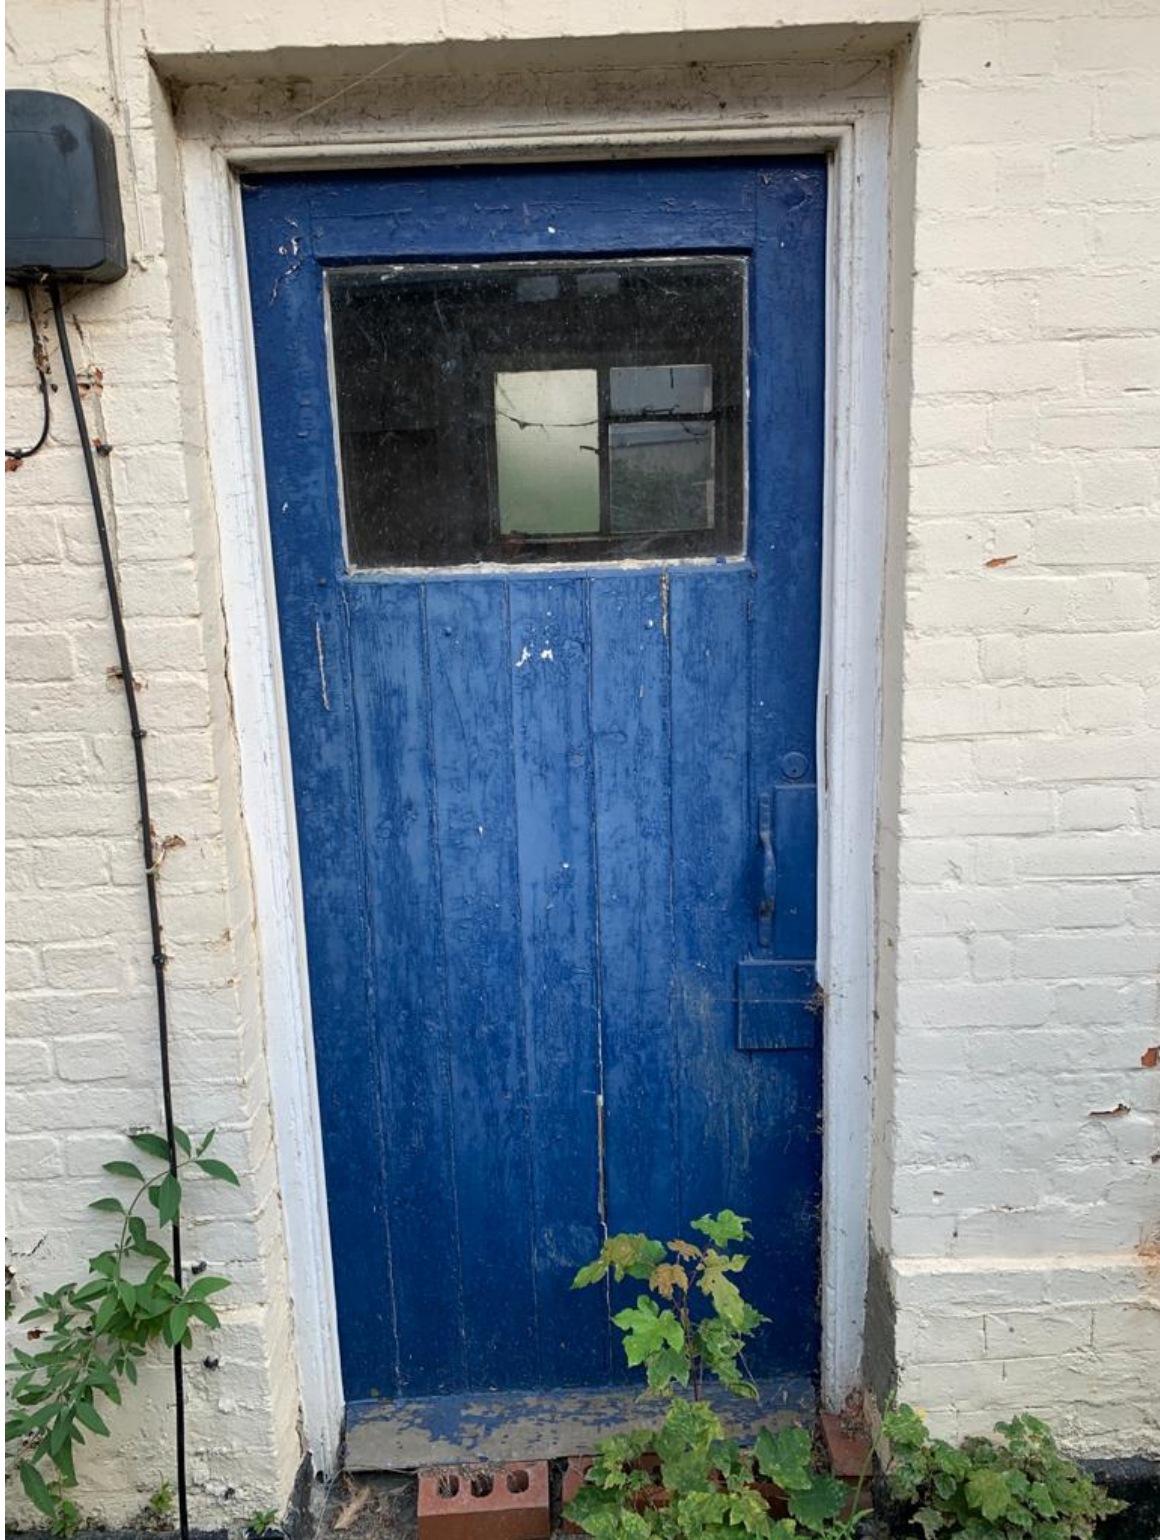
Timber Door to front / side

981 x 2217

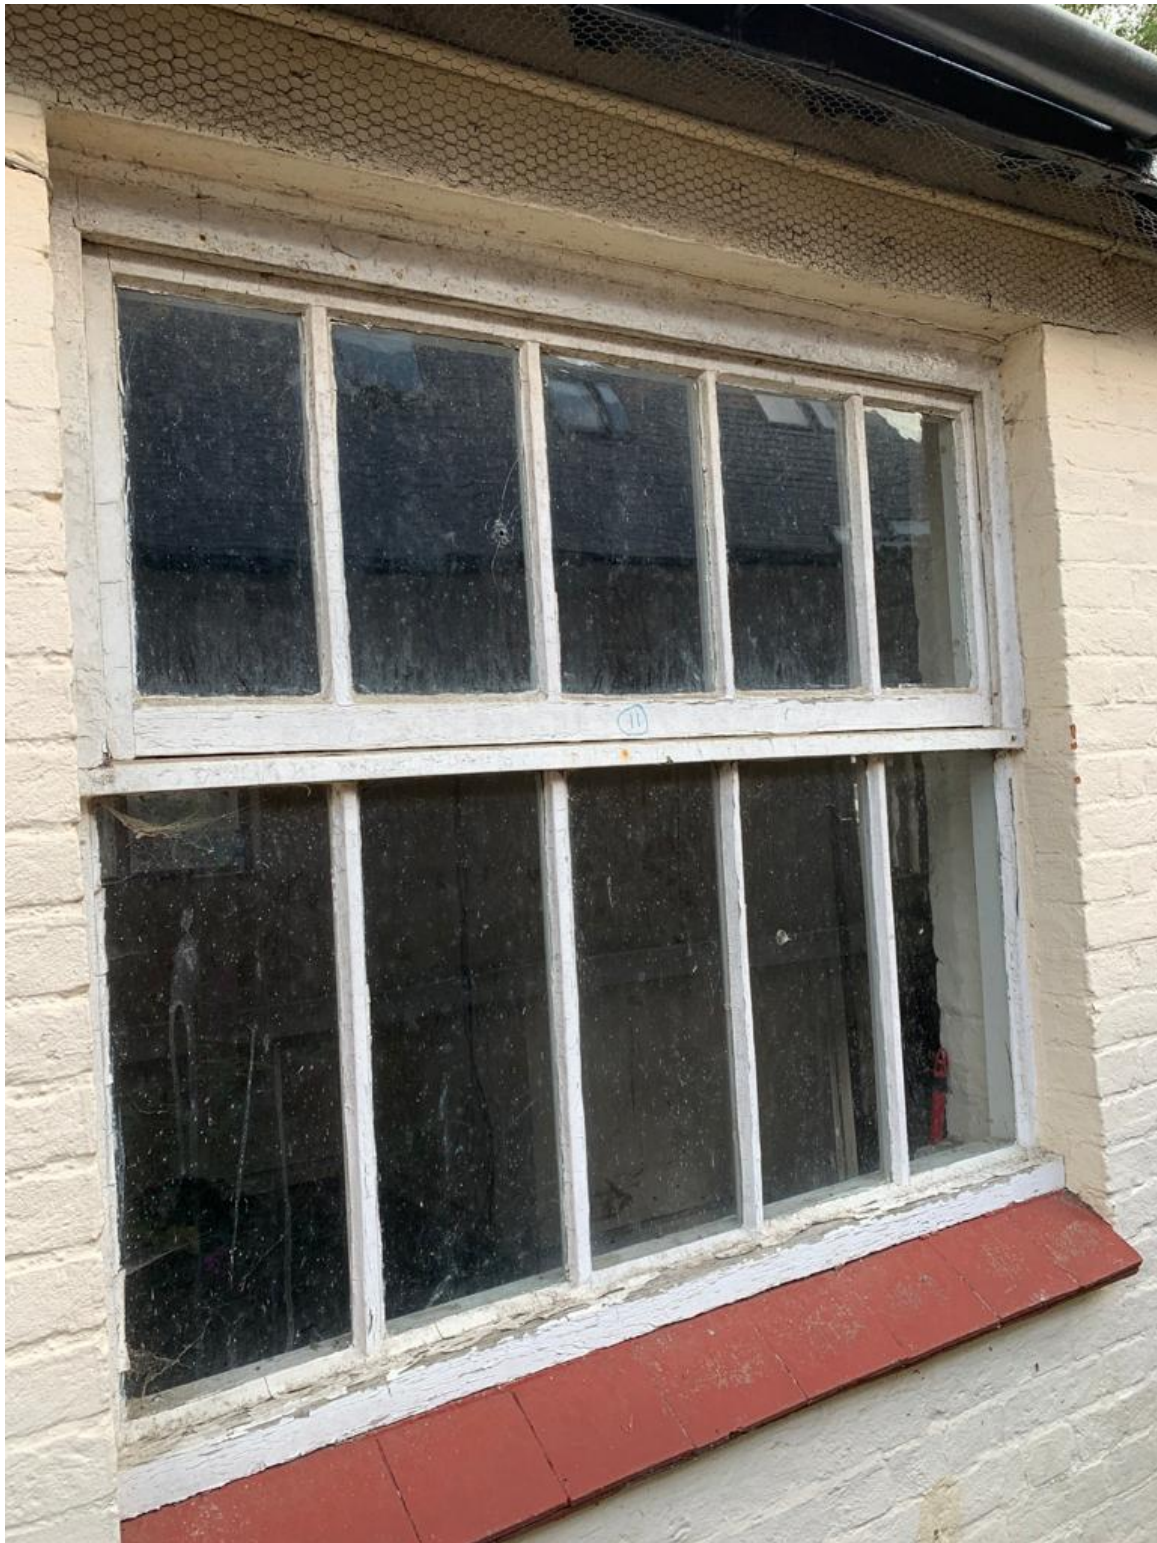
**Window 11 (Timber)**

1464 x 1330
