# **St Andrews Park Window Survey**

- To carry out survey of timber and steel frame windows and doors.
- Report on overall condition for repair or replacement.

- Monday 31st August 2020 17:45

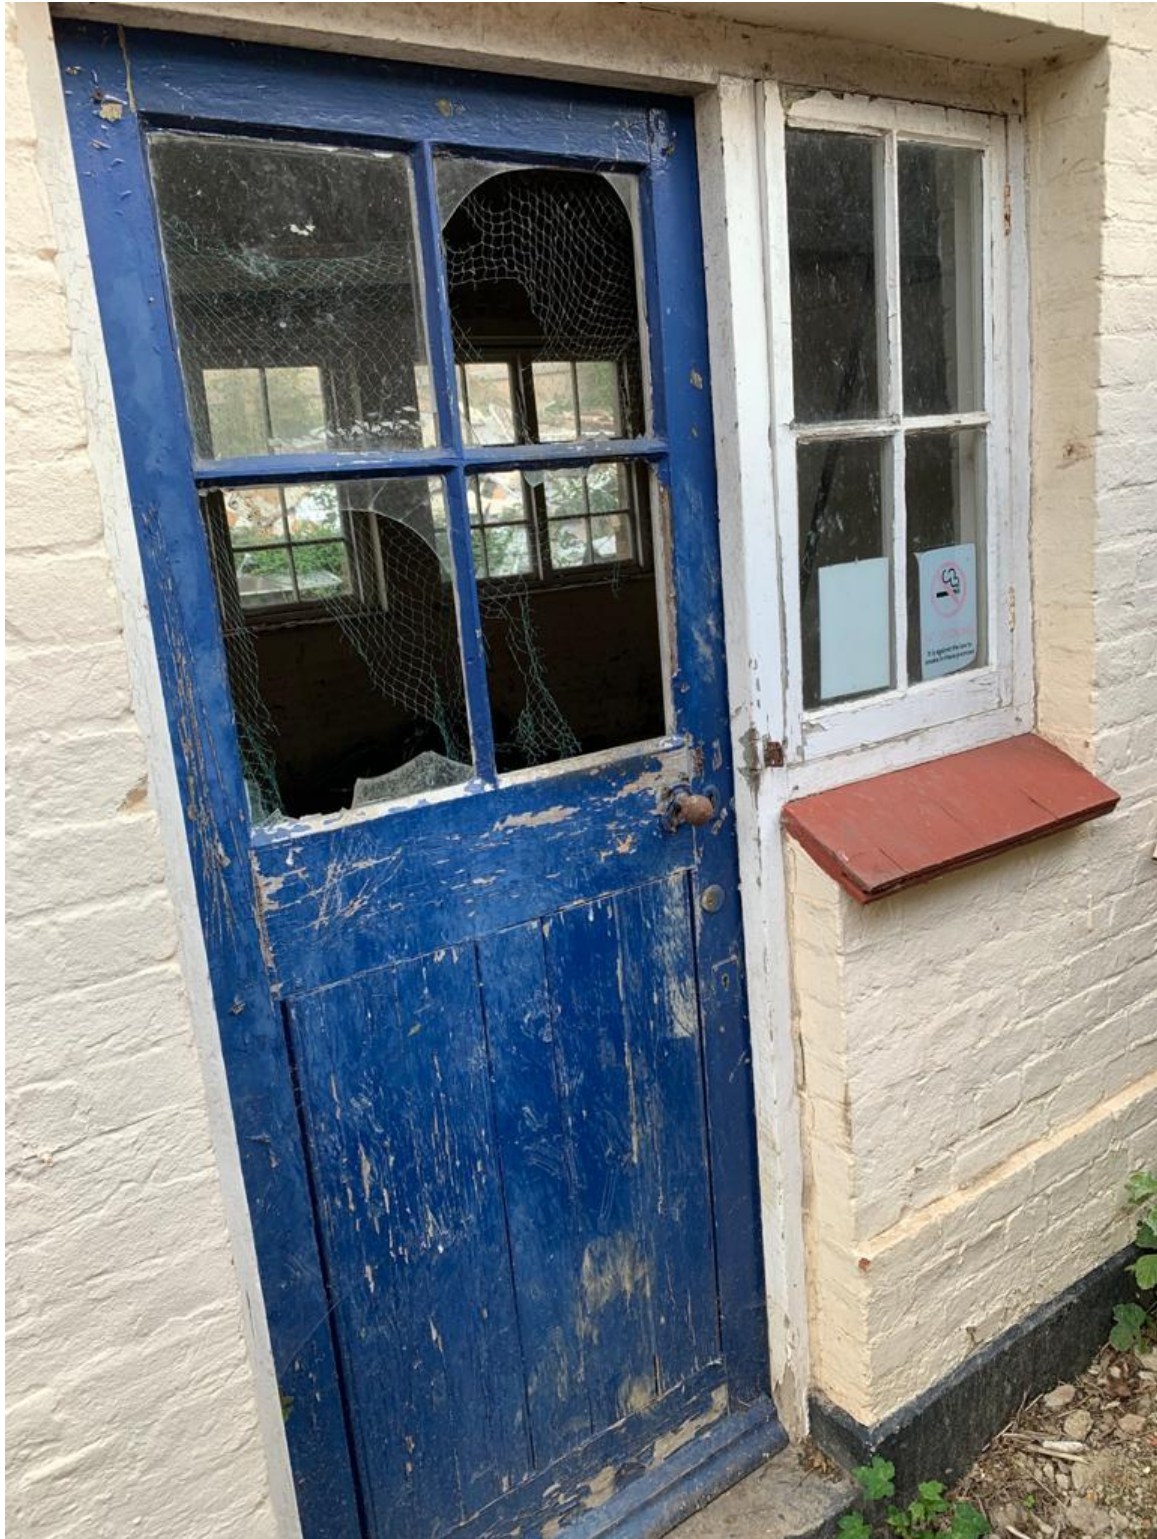
Timber door and side lite to front / side

Door 2089 x 789

Side Window 691 x 1030

Viewing the windows at distance they all seem relatively ok but upon closer inspection the overall condition of windows and frames are extremely poor. The timber windows and doors have fallen into disrepair and are rotting in many areas and no attempt should be made to repair but to replace them in their entirety.

In our opinion all windows should be replaced with new modern "Timber or Aluminium style".

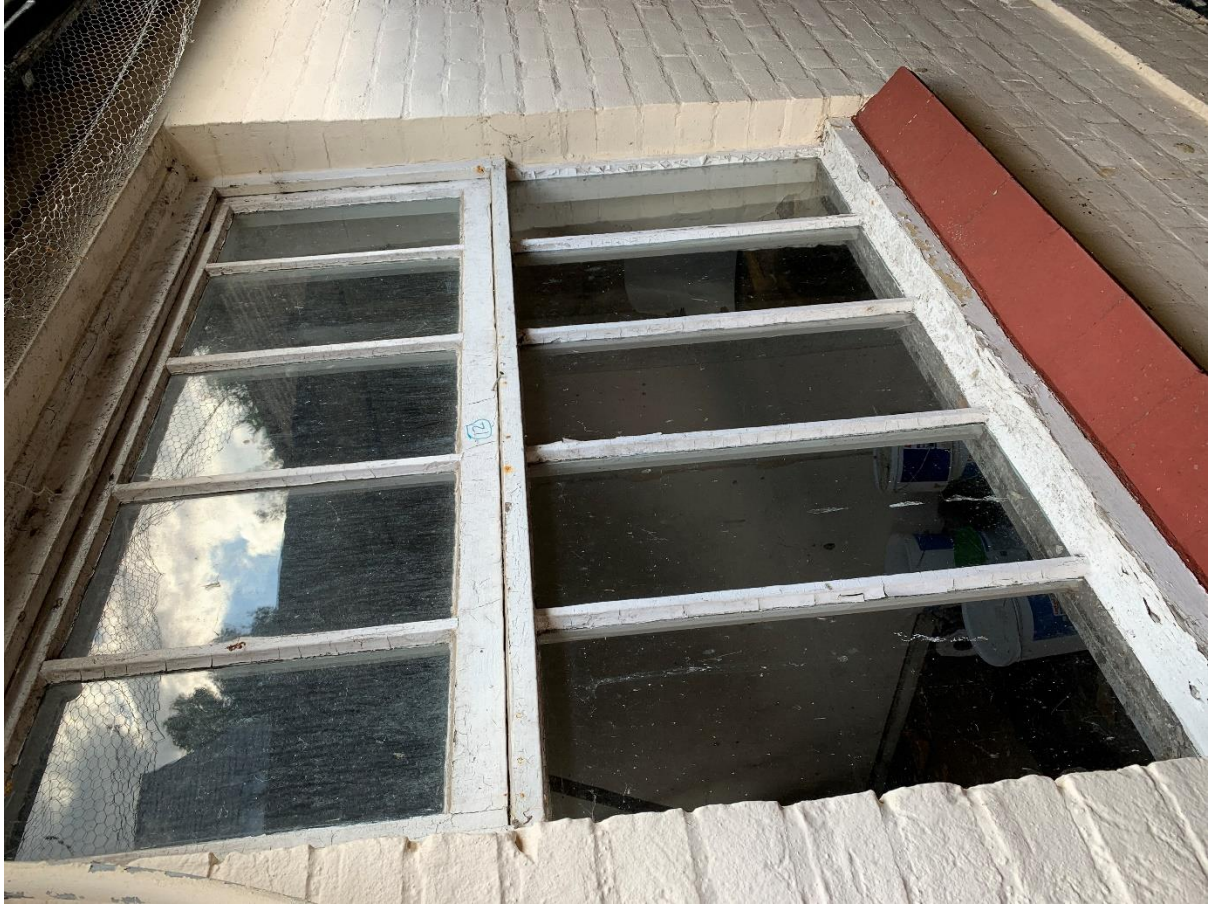
**Window 12 (Timber)**

1461 x 1387

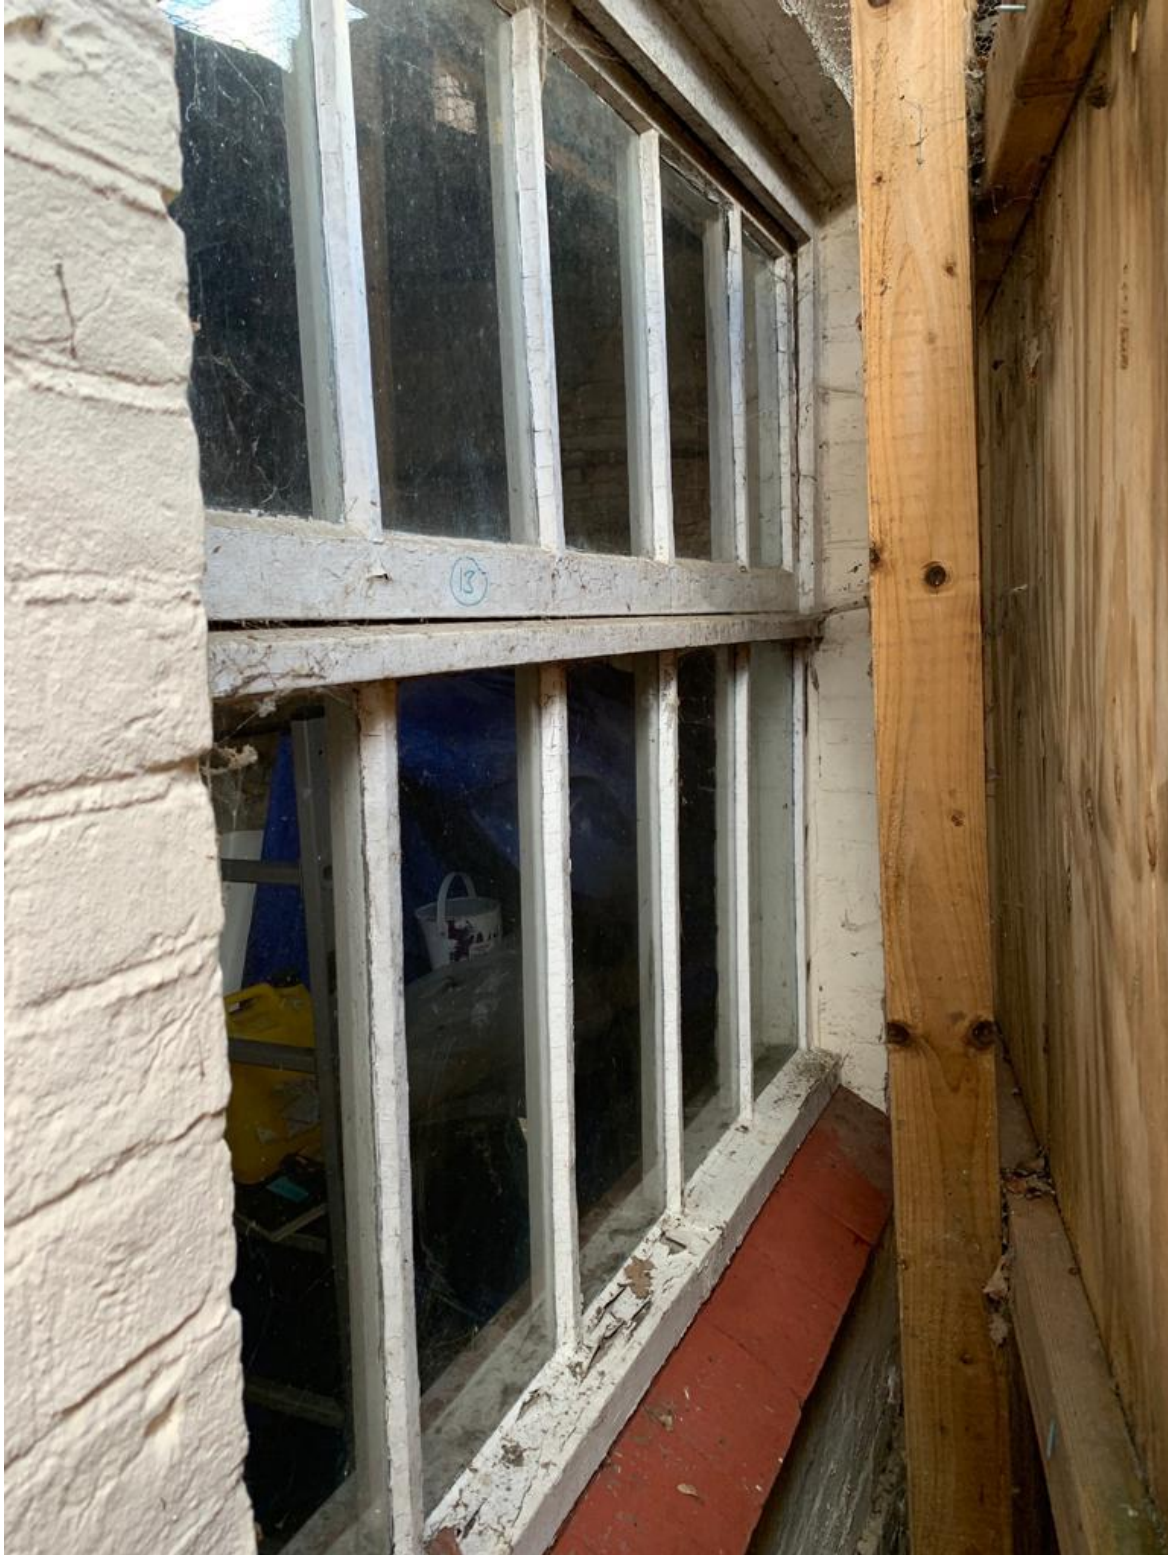
**Window 13 (Timber)**

1463 x 1399

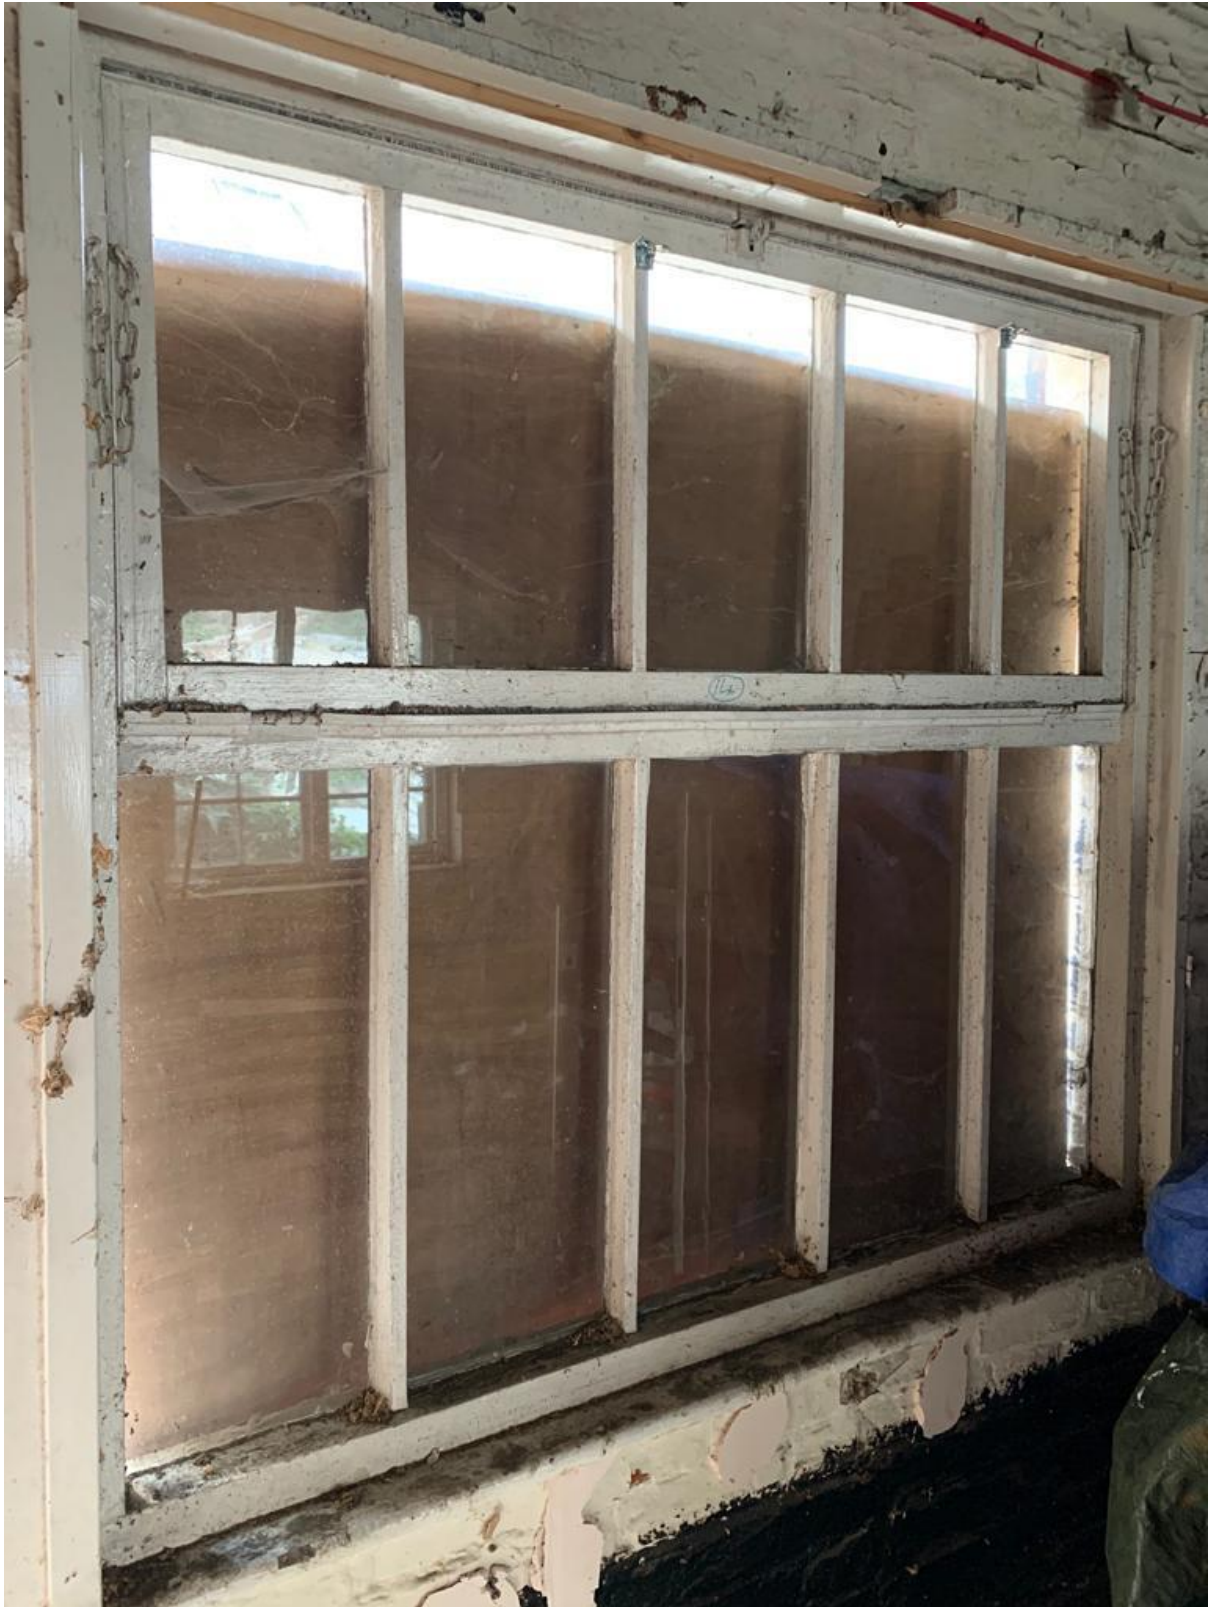
Window 14 (Timber)

1449 x 1308

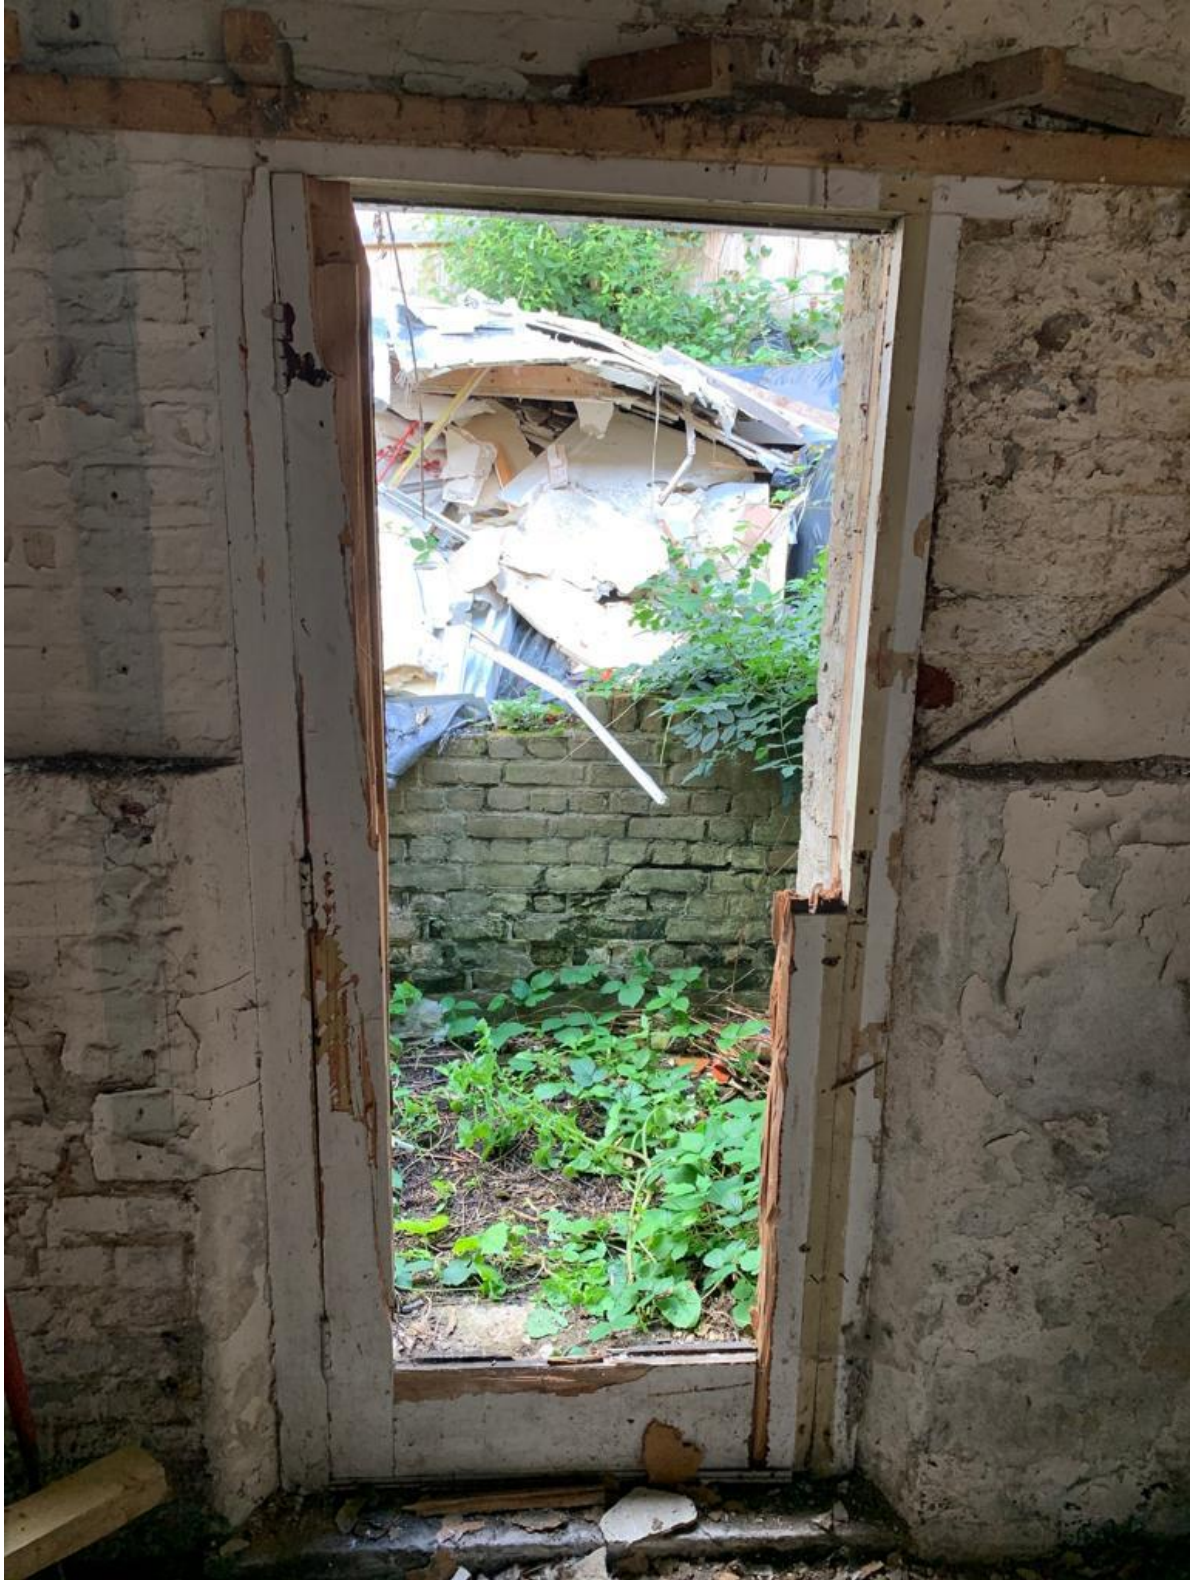
Timber Door opposite front door

949 x 1990

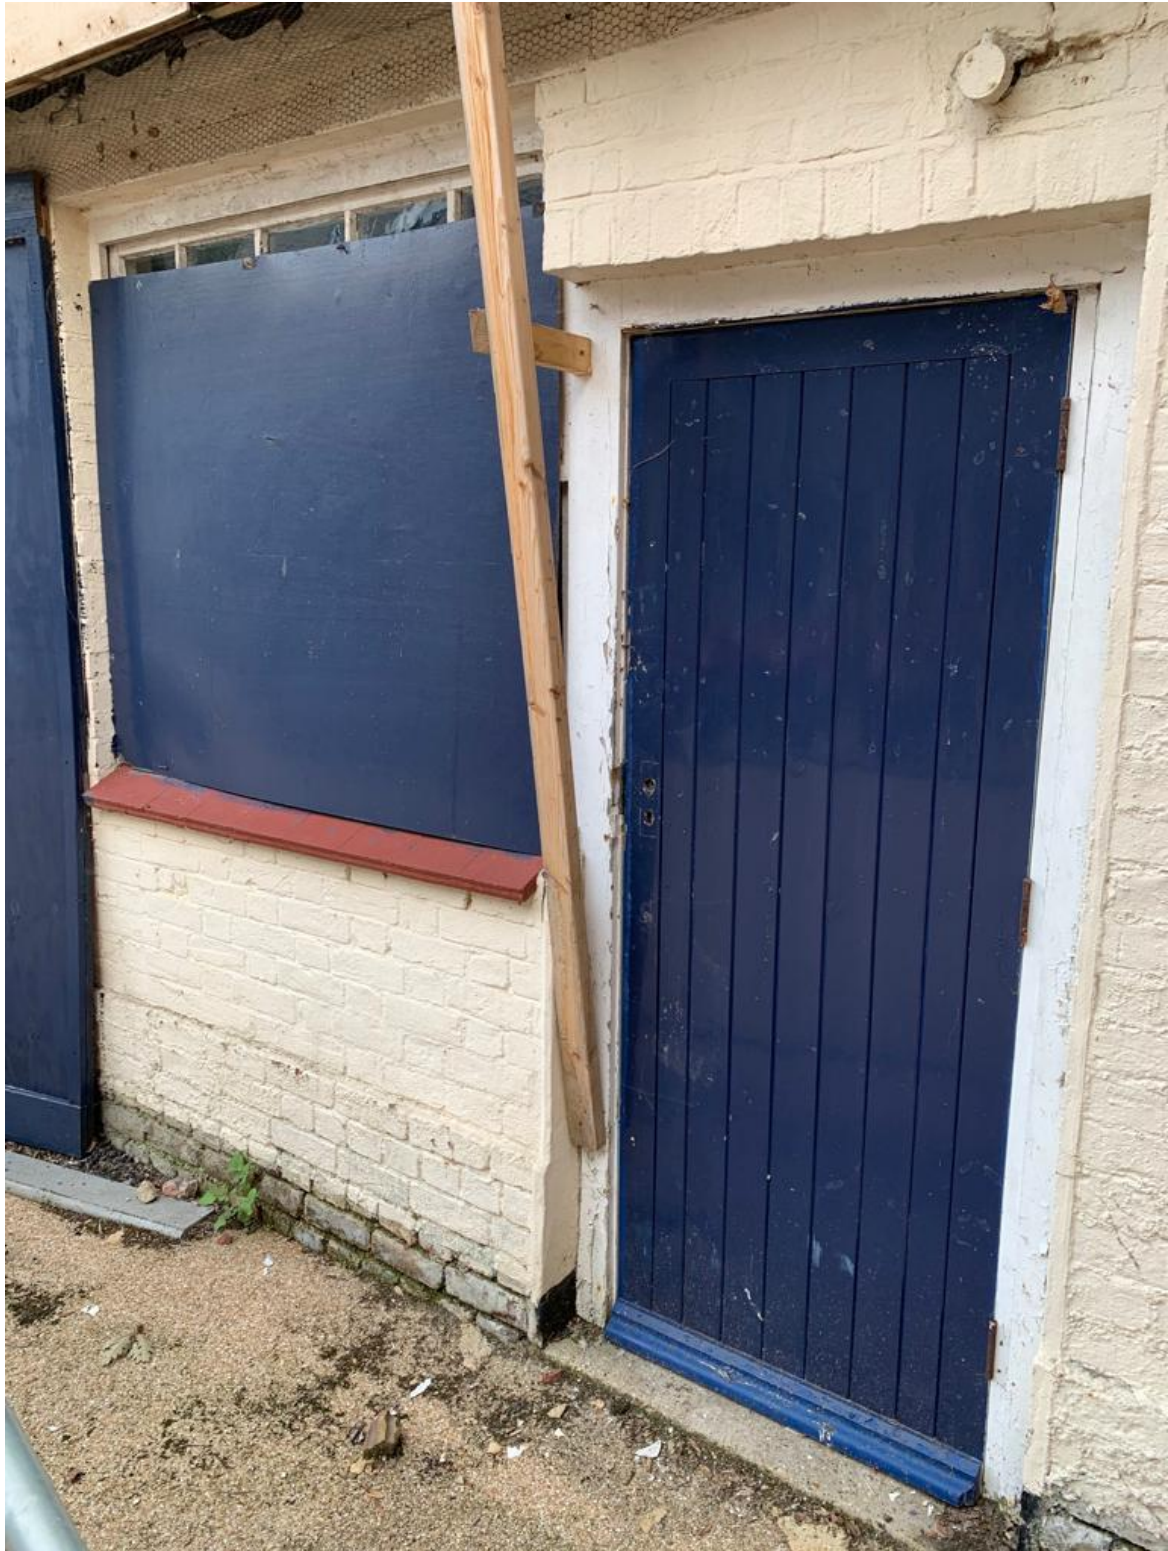
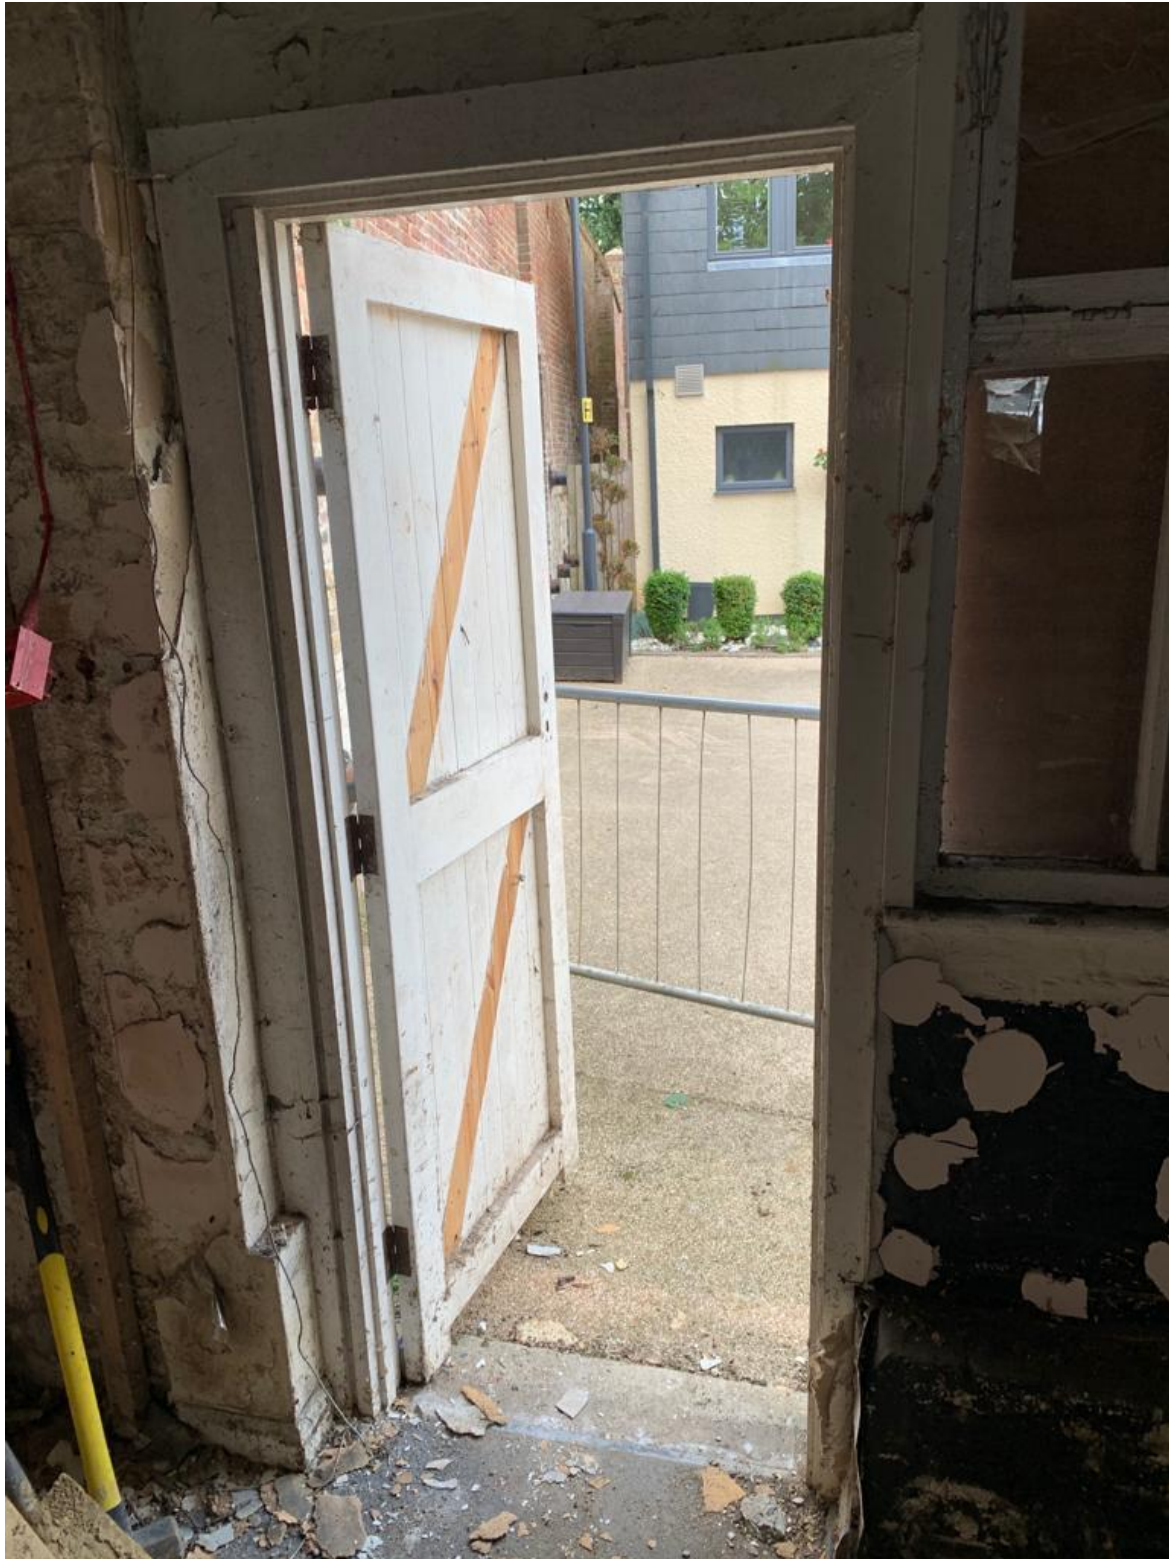
**Main entrance door (Timber)** external view

980 x 1998
