Pursuant to Detailed Planning  
In Principle Structural Repairs to Carpenter's Building

**Project:** St. Andrews Park, Uxbridge

**Reference:** S82605-JNP-ZZ-20-RP-S-1010 P01

### **In Principle Structural Repairs to Carpenter's Building**

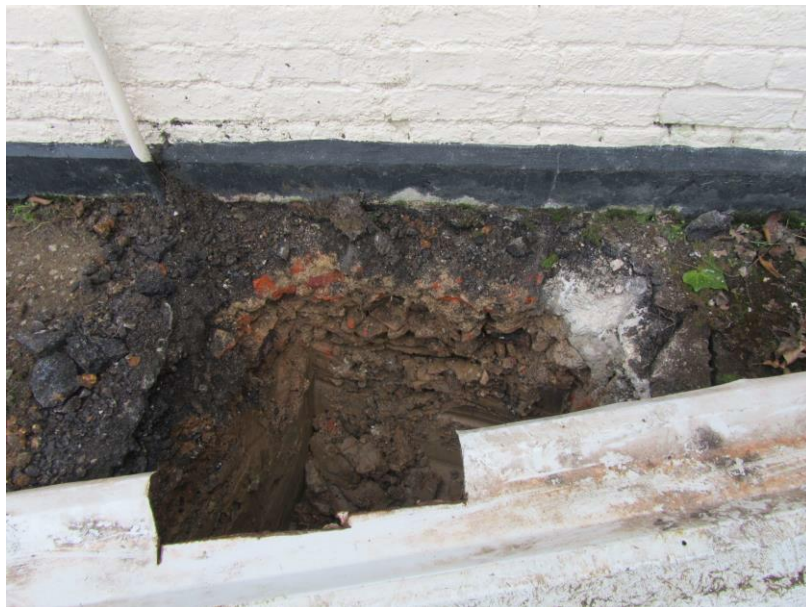
- a) Both front and rear elevations are significantly out of plumb to the point where they, on their own, would become inherently unstable.
- b) The existing internal walls may be providing some buttressing action but this is difficult to quantify.
- c) Trail holes to the existing external wall foundations have revealed extremely shallow foundations comprising corbelled brickwork supported on a bed of plain clay tiles, in turn supported upon the locally occurring London Clay. (see photograph below)

In simple terms the entire building has racked over by the order of 150-175mm.

In order to preserve the building, it requires structurally stabilising in its current, deformed, configuration.
