## TIMBER ROOF STRUCTURAL SURVEY

| Client name | ITJ Development Ltd |
| Property address | Carpenters Cottage, Former RAF Uxbridge, St Andrews Park, Hillingdon Road, Uxbridge, London |
| Survey date | 12/02/2022 |

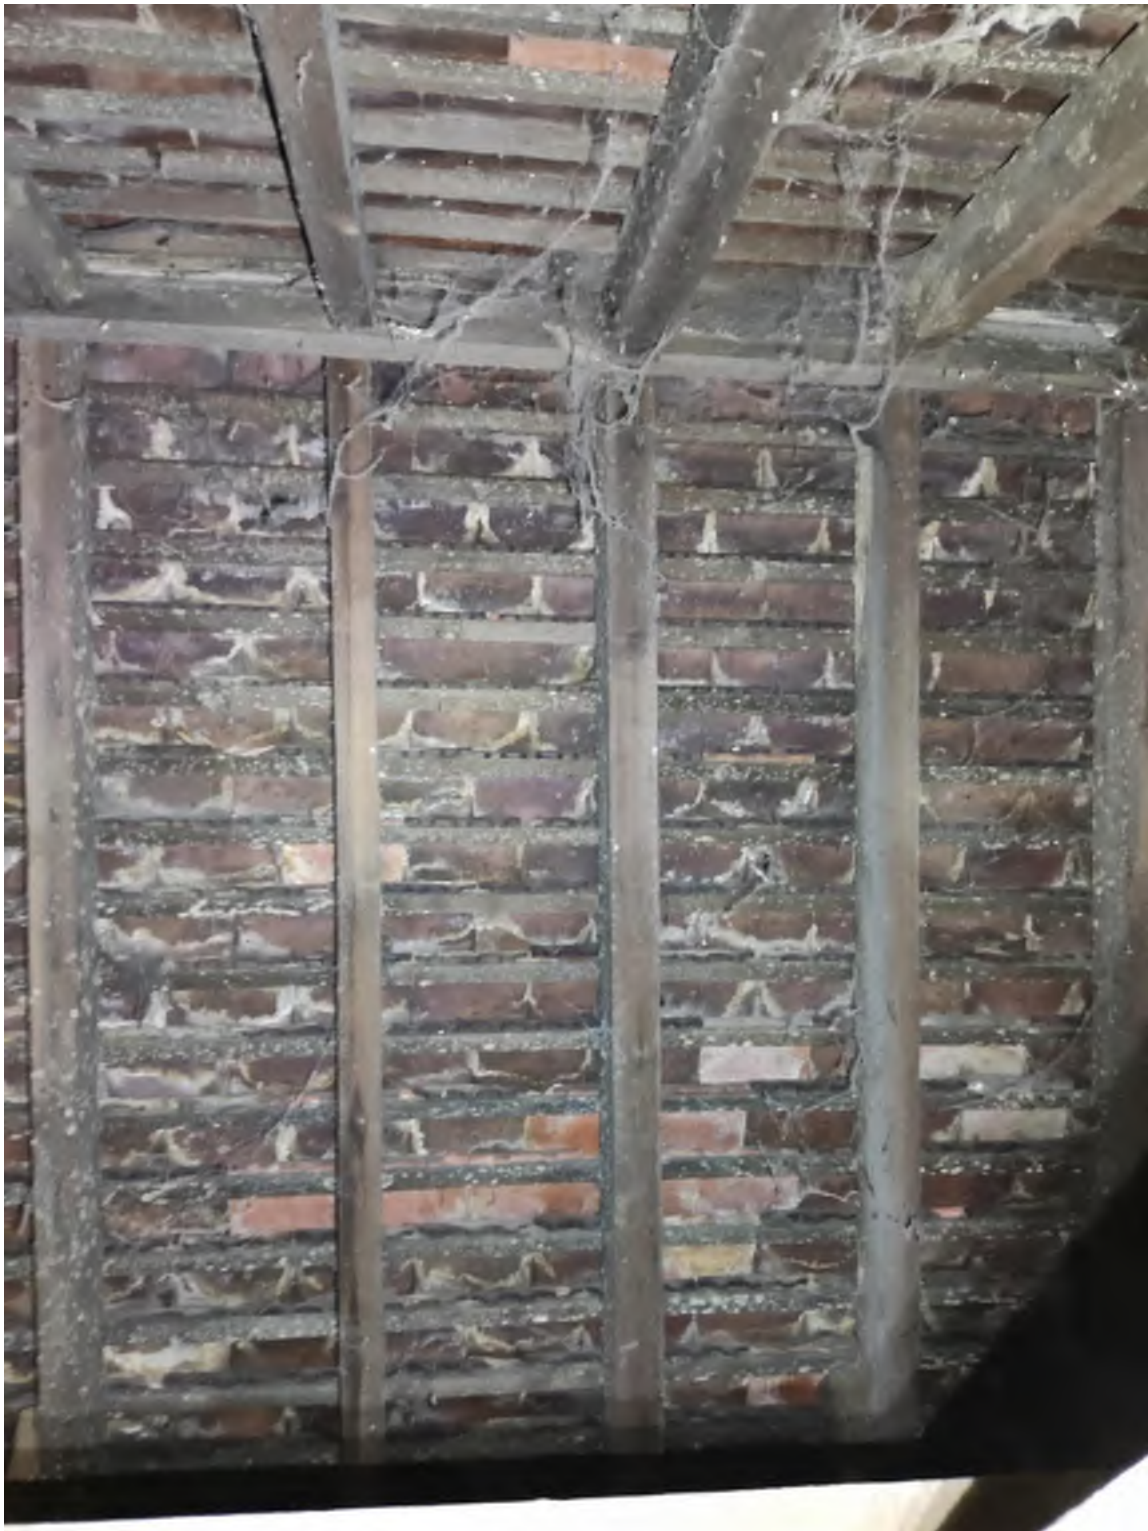
Photo 1: Roof Structure in good condition

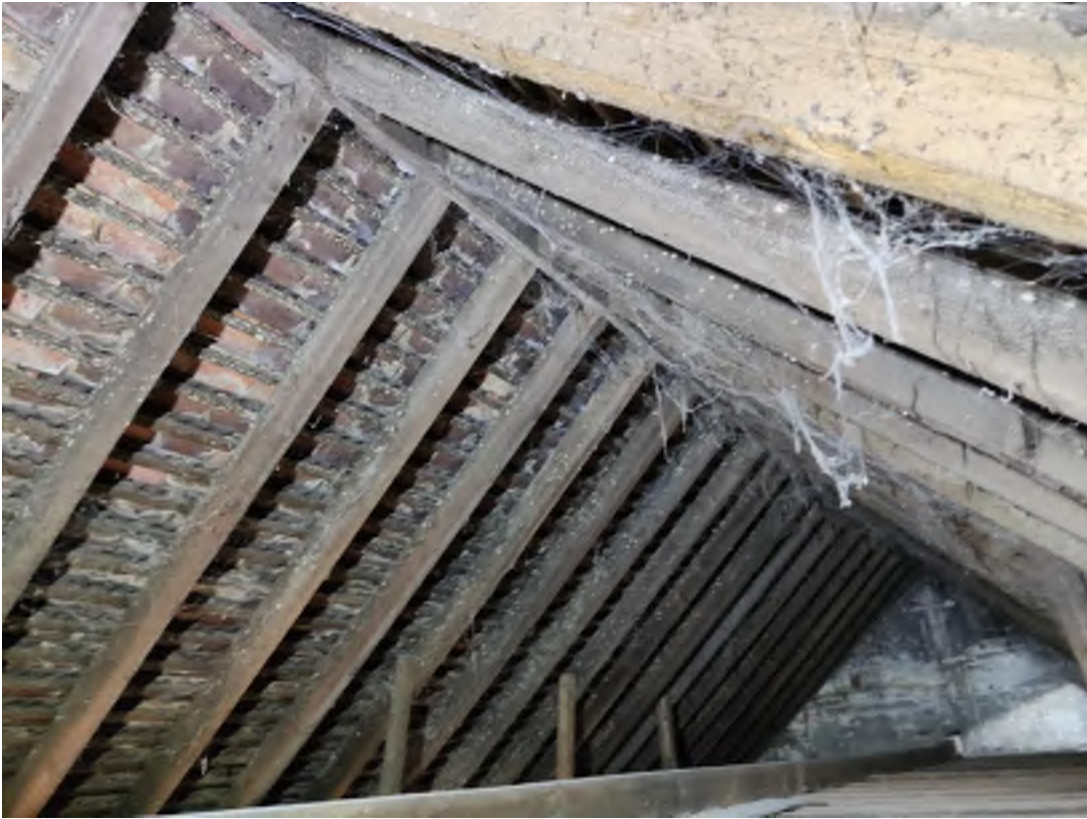
Photo 2: Roof Structure in good condition

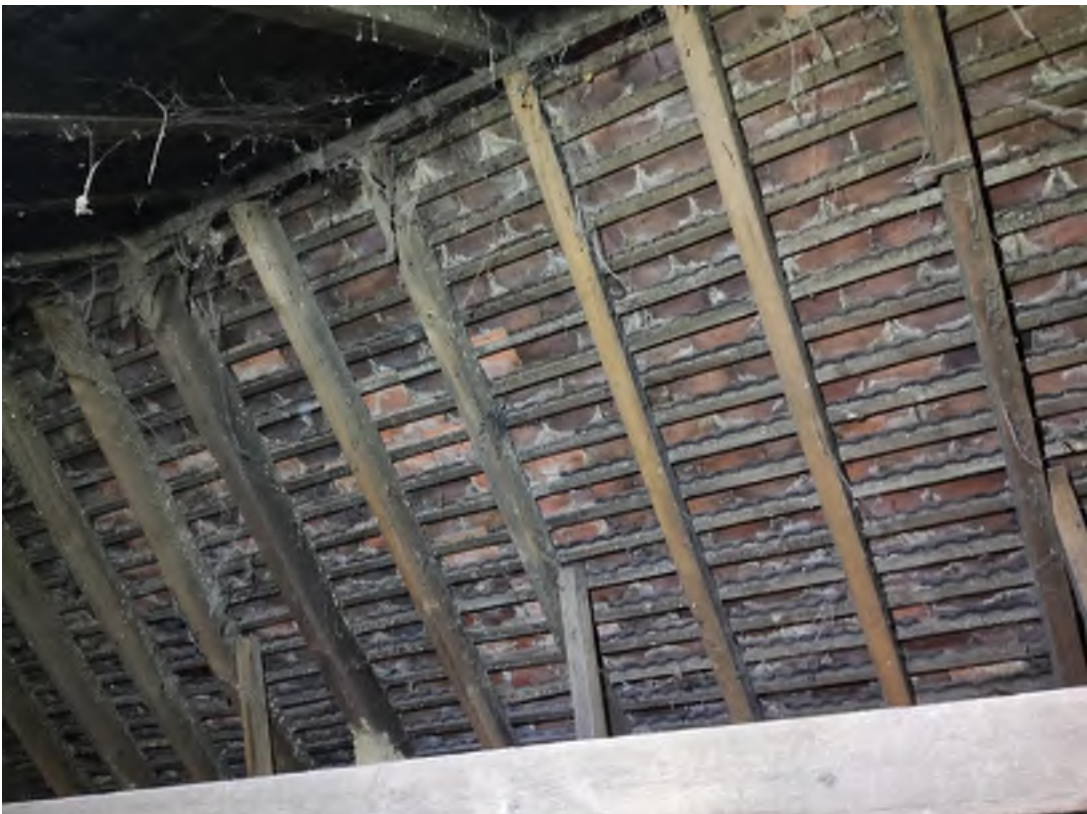
Photo 3: Roof Structure in good condition

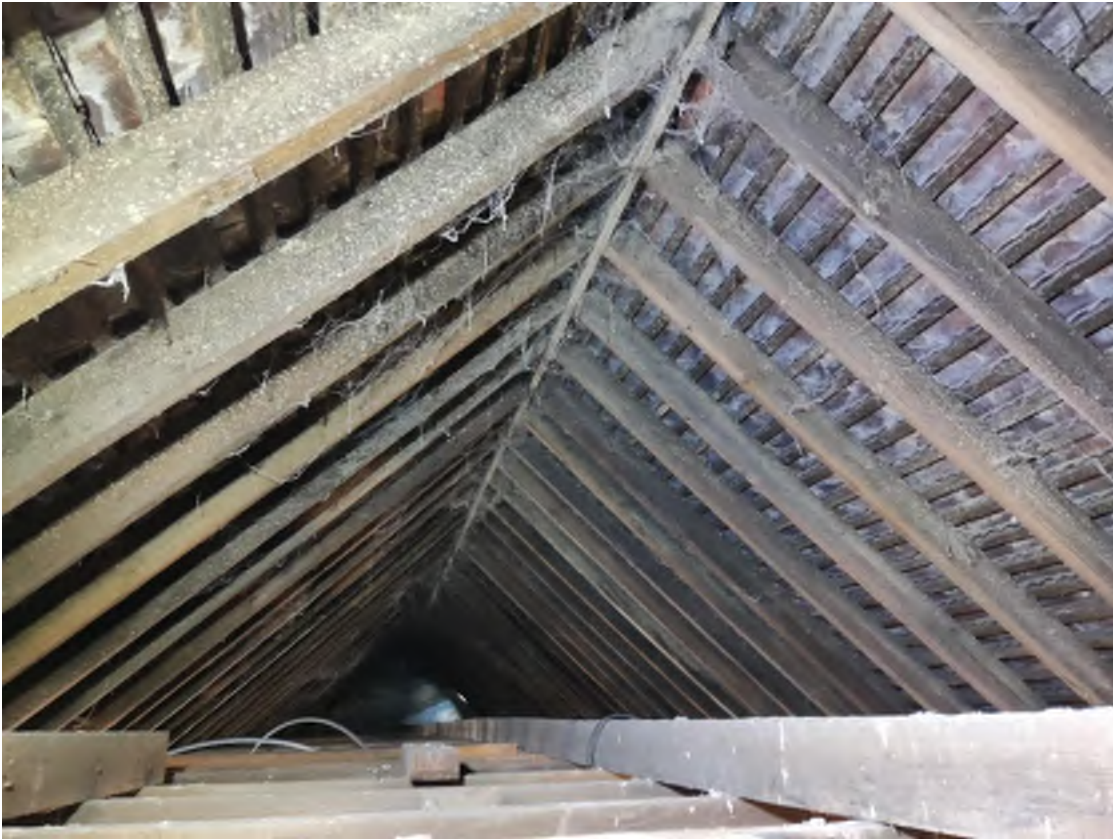
Photo 4: Roof Structure in good condition

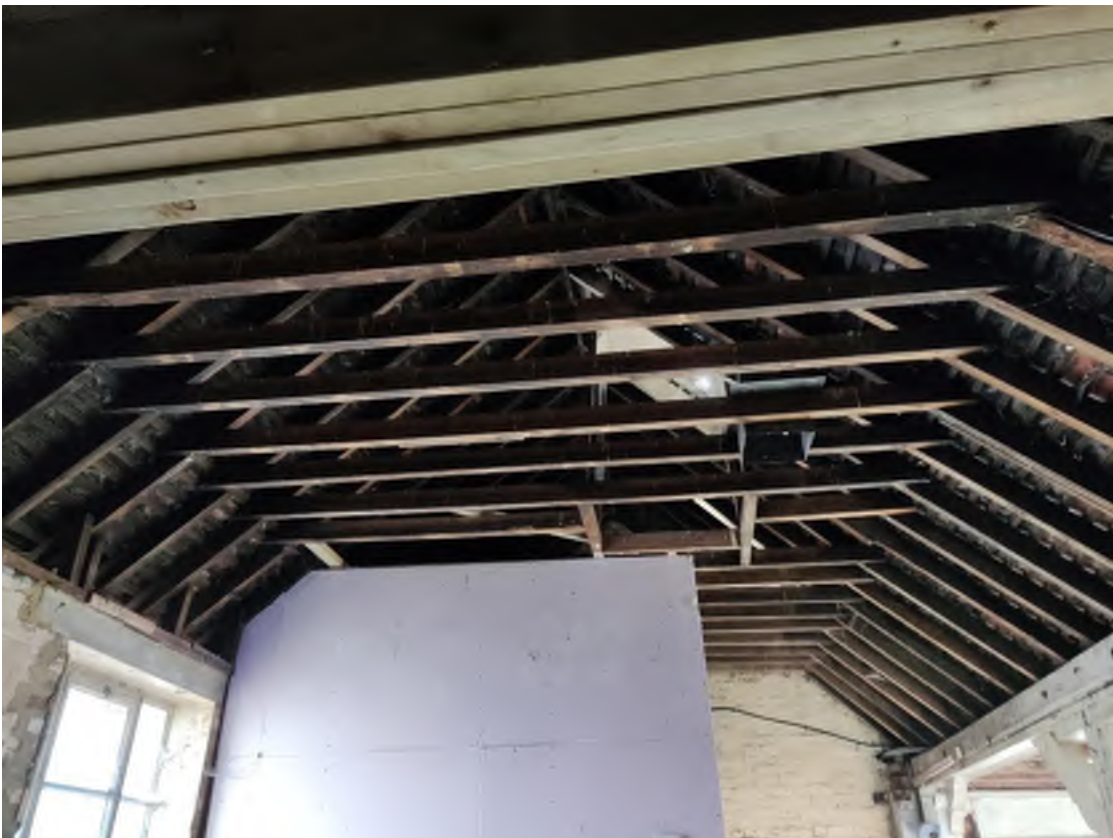
Photo 5: Roof Structure in good condition

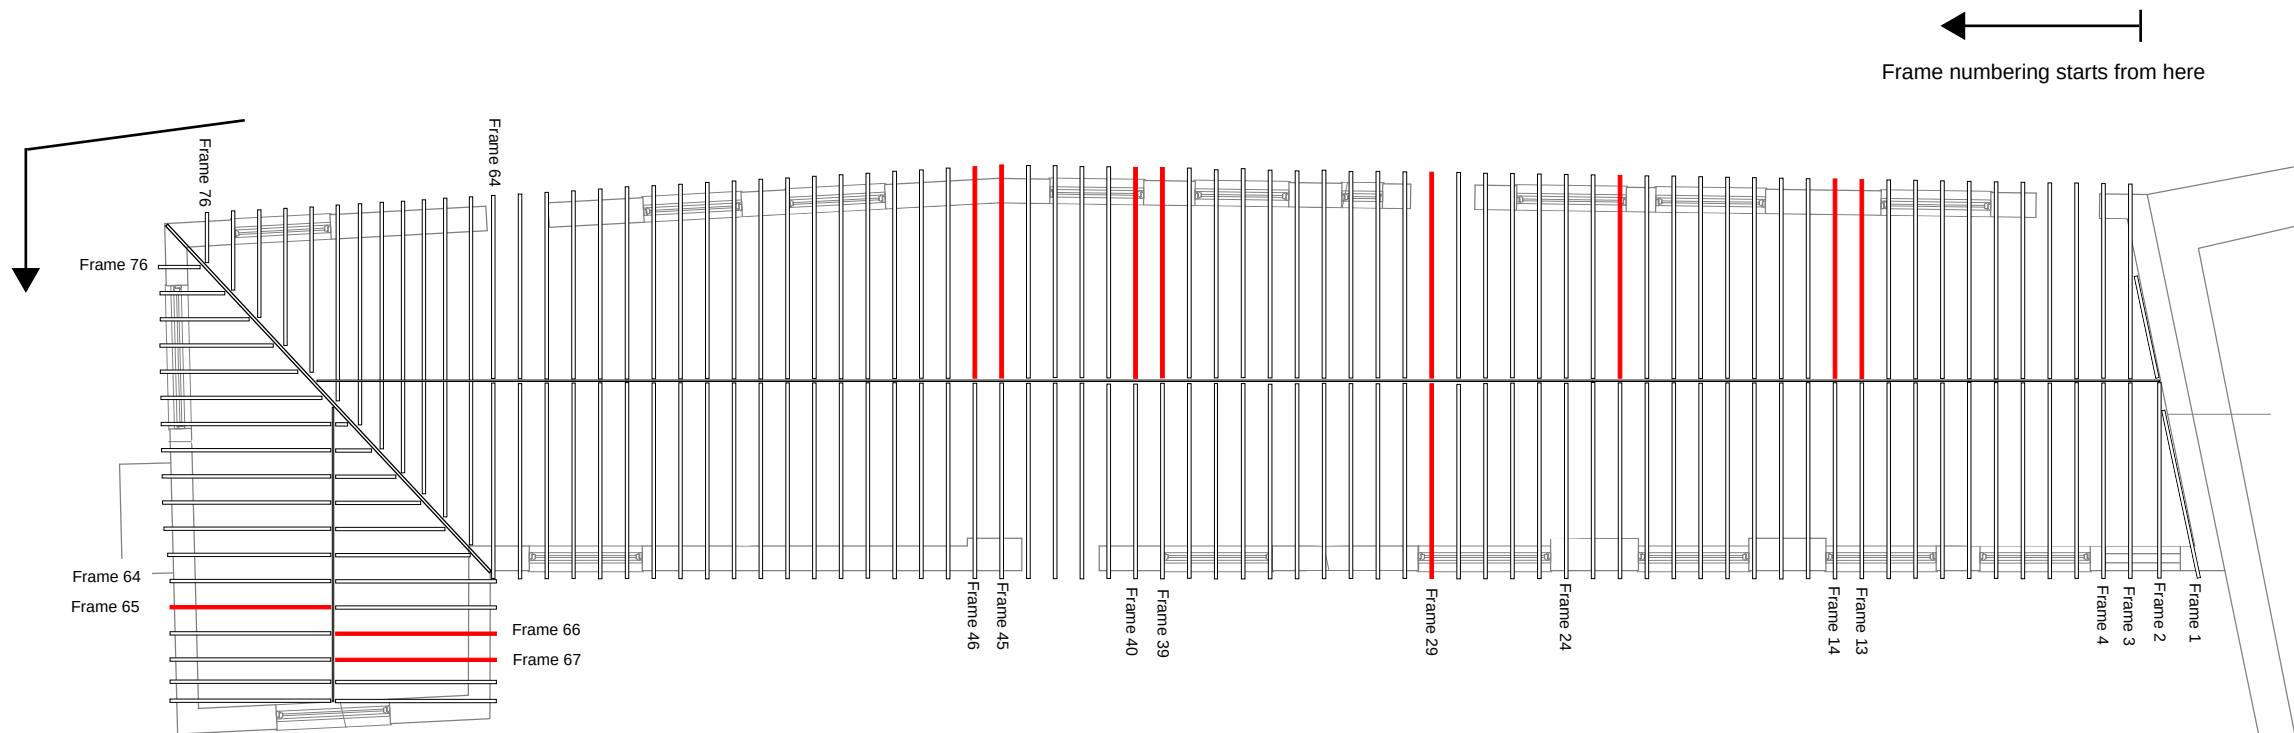
The survey has identified the decayed joists as listed in drawing SK001. All decayed joists should be replaced.

The replacement process should be carefully managed.

The roof timbers should be propped while decayed element is being replaced.

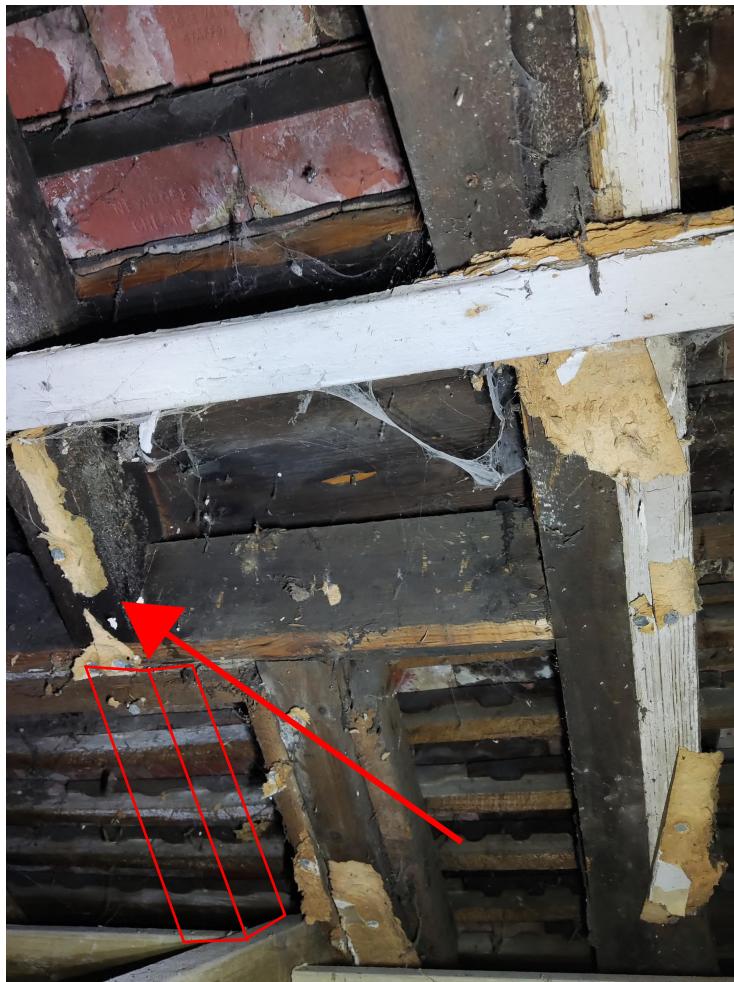
Rafter cut short. It has to be extended to the wall plate at frame No.13.

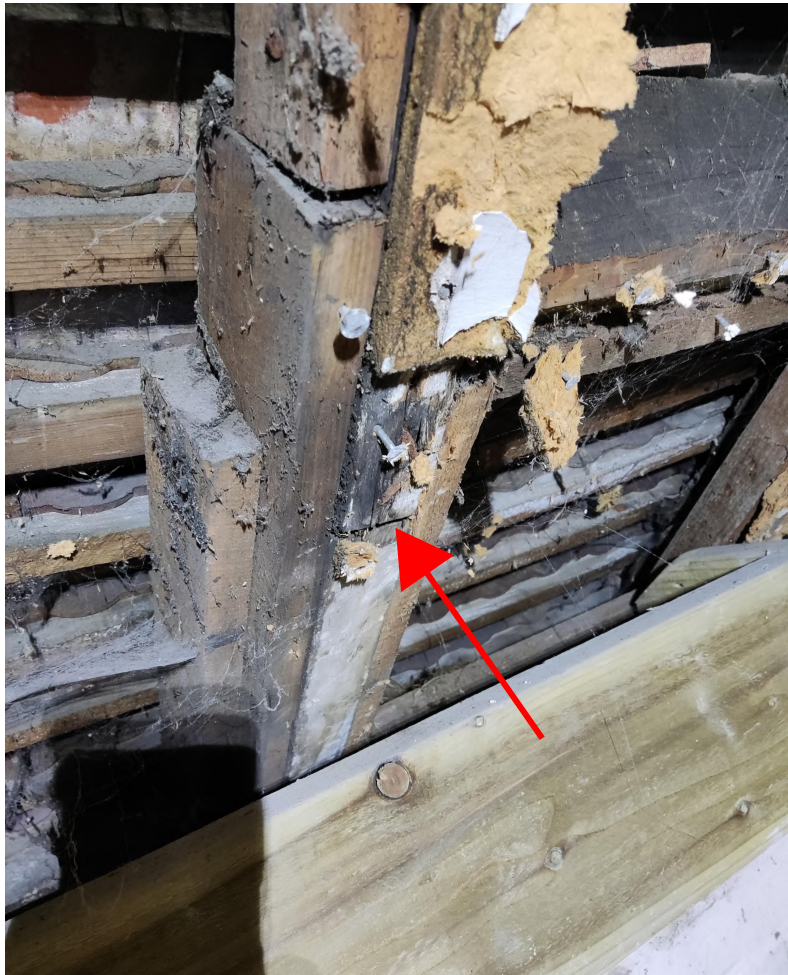
Poor repair to roof rafter at frame No.14. The rafter to be replaced.

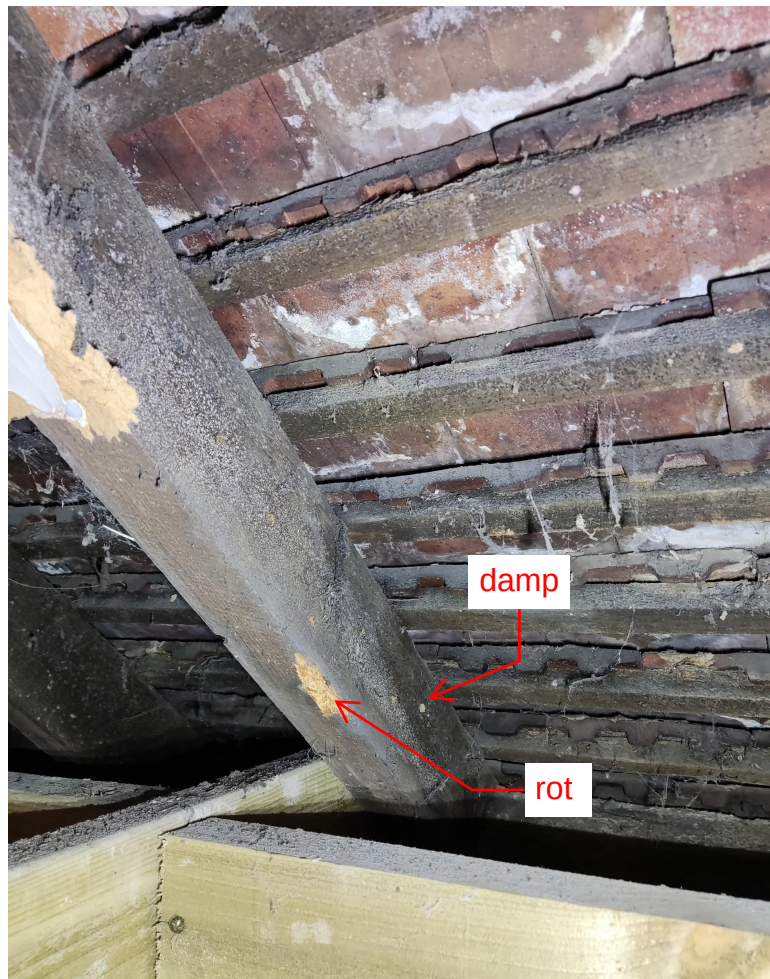
Rafter at frame No.24 is decayed and needs full replacement.

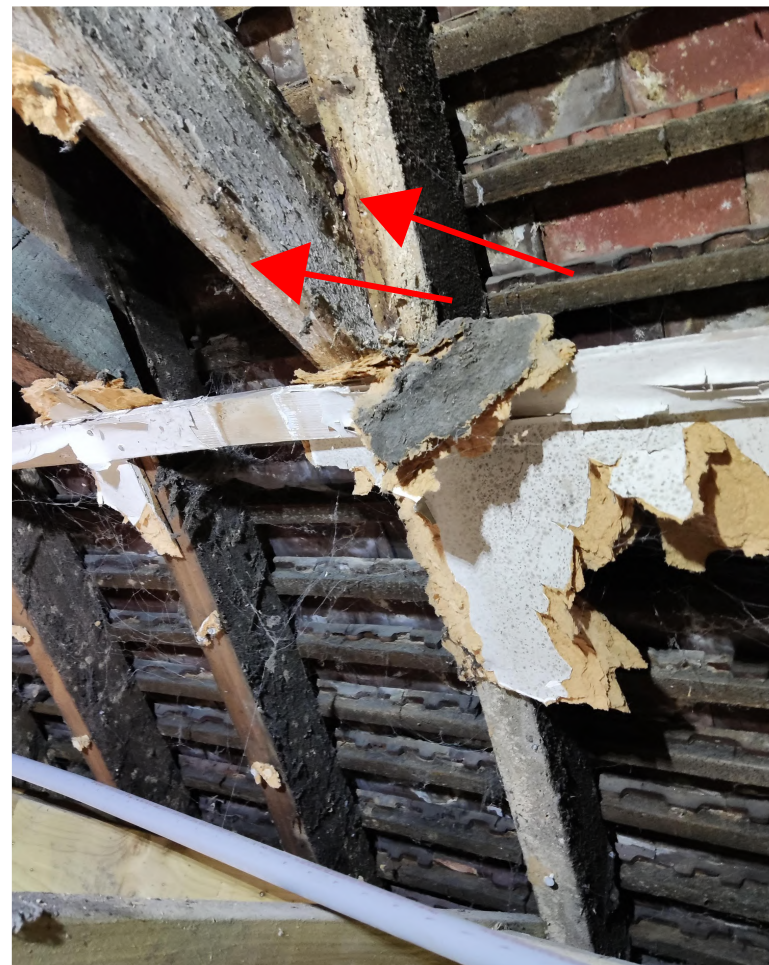
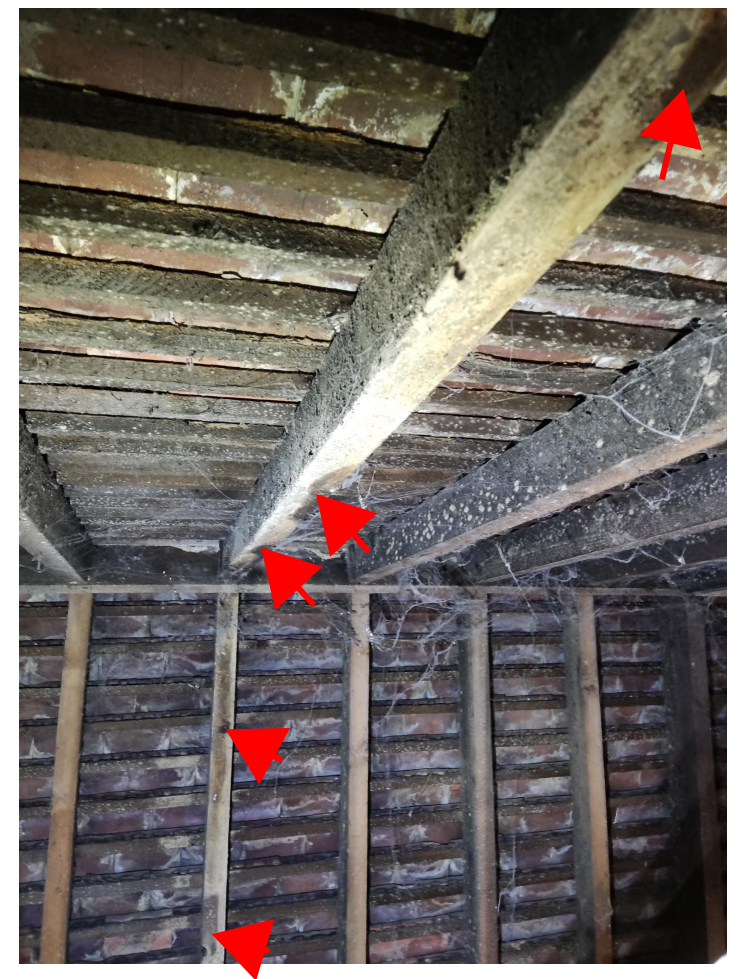
Roof Frame 29 decayed and should be fully replaced.

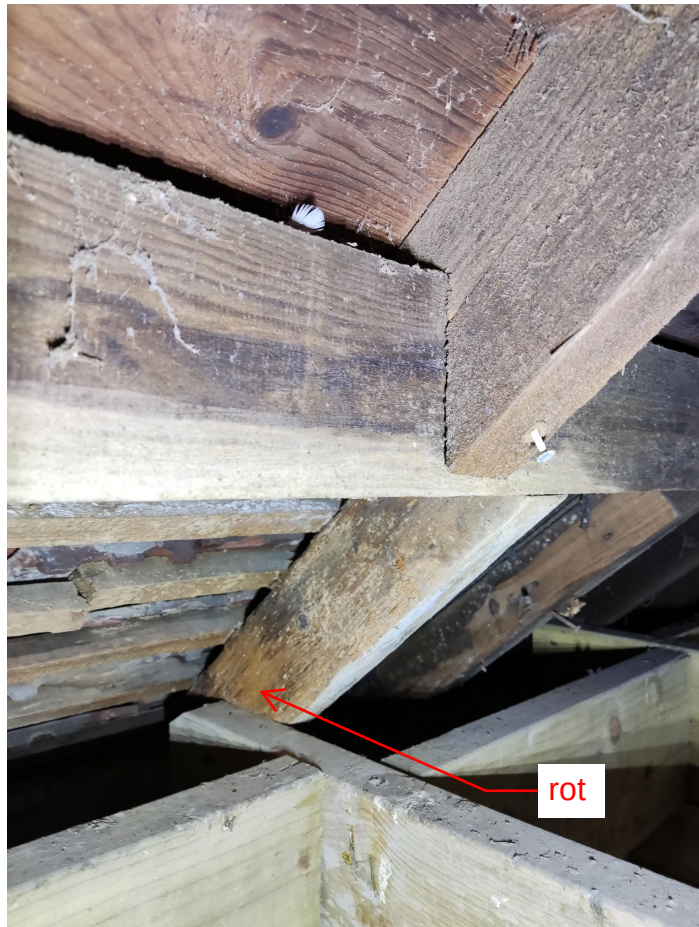
Rafter at frame No.39 is decayed and needs replacement.

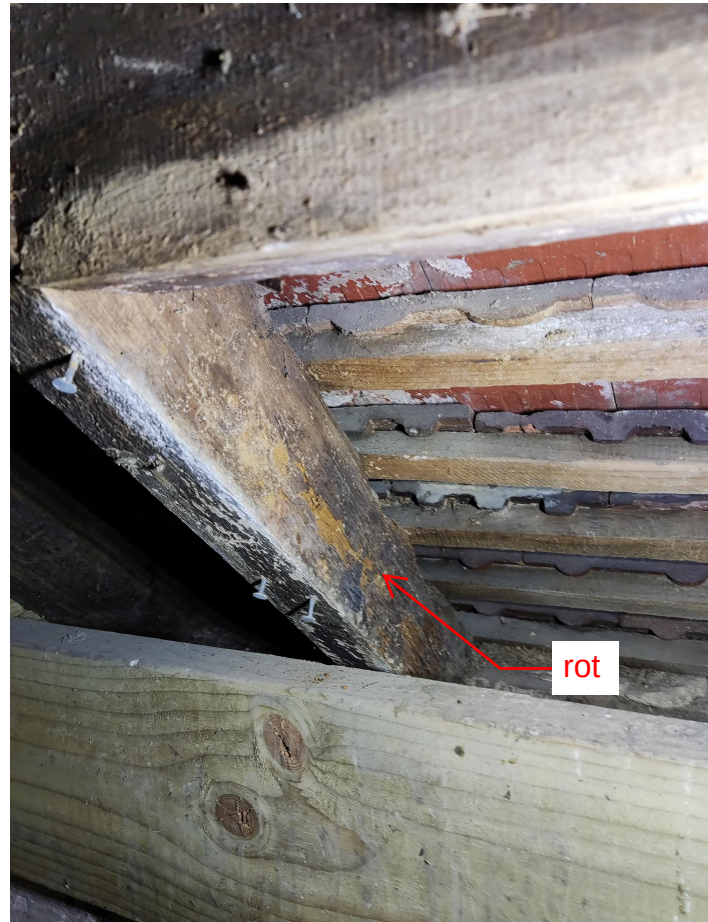
Roof Frame 40 decayed and should be replaced.

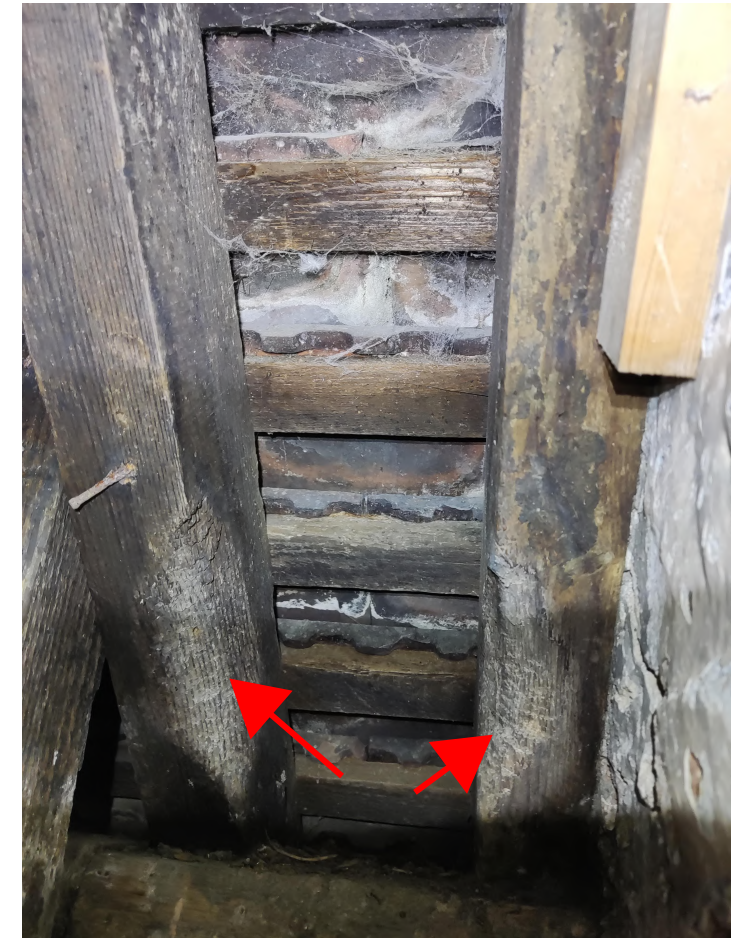
Roof Frame 45 and 46 decayed and should be replaced.

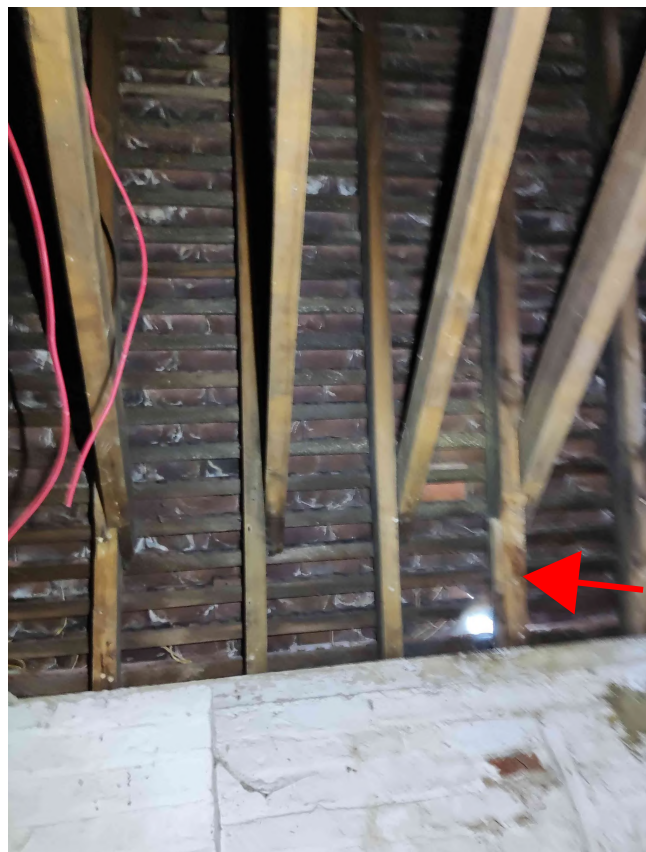
Rafter at frame No.65 is decayed and needs replacement.

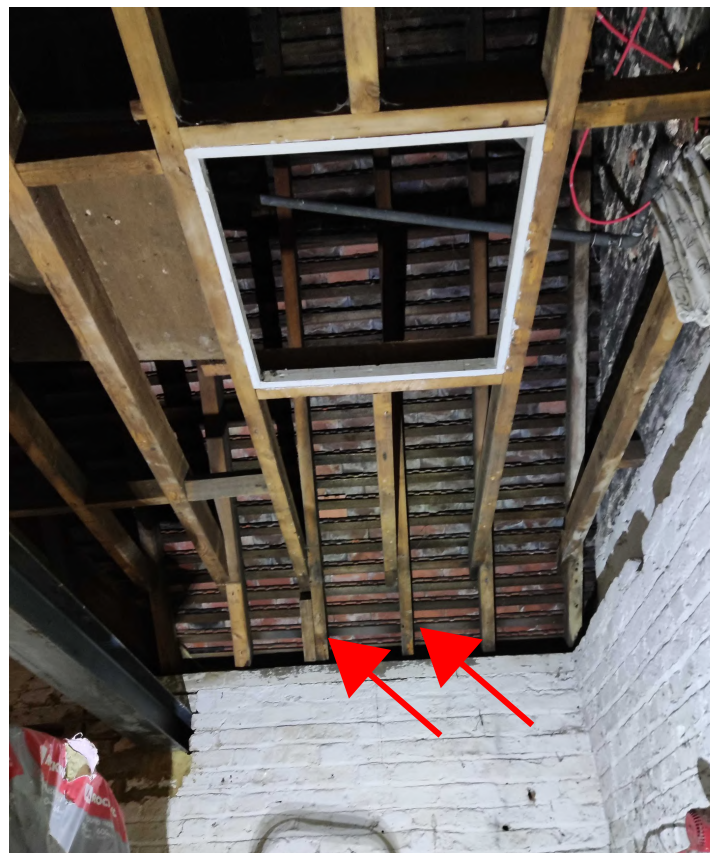
Rafters at frame No.66 and 67 are decayed and needs replacement.
