## FORMER RAF CINEMA BUILDING AND SQUASH COURTS, ST ANDREW'S PARK, UXBRIDGE

### STRUCTURAL CONDITION SURVEY REPORT

**Ref:** 220131/C Callow

**Date:** 17th June 2023

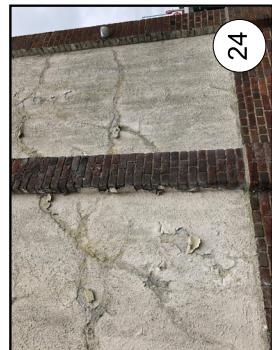
4.3.12 Large amounts of diagonal cracking were identified on the squash court external walls, see **Pictures 23, 24 and 25**. We were unable to determine if the cracking was superficial or whether the brickwork underneath the render had cracked.

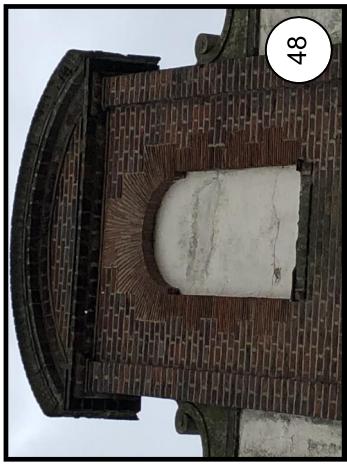
48

4.5.1 On the cinema gable wall, large amounts of vertical and diagonal cracking in the render were identified, see **Picture 45, 46, and 48**. A crack, around 5mm wide, was identified in the brickwork, close to where the previous remediation works had taken place, see **Picture 47**.

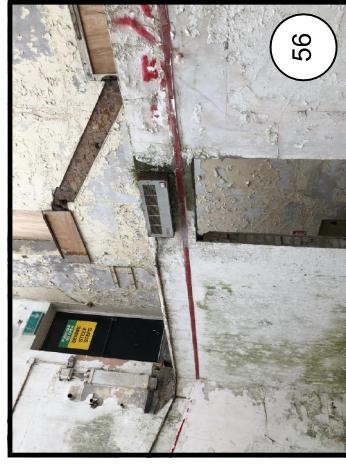
56

4.5.5 The internal intermediate squash court walls showed areas of cracking and render detaching from the brickwork, see **Picture 54 and 56**.

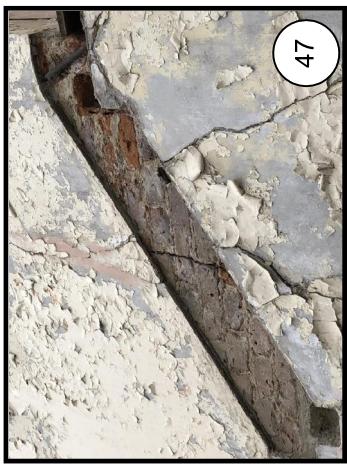
47

4.5.2 The stairs that once granted access to the observation deck have been removed. The removal of the stairs has resulted in distinct voids in the gable wall where the brickwork is absent, as depicted in Picture 47. The decision to remove the former squash court stairs was prompted by a collapse, posing a significant hazard to safety.

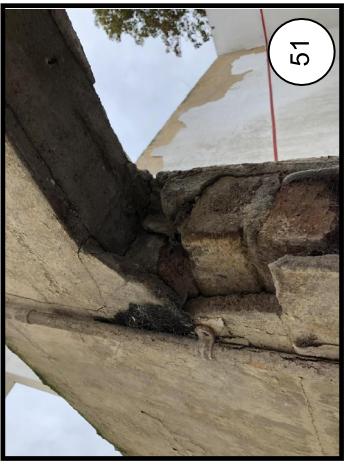
51

4.5.4 A solid brickwork wall, which separates the squash courts and internal walkway, showed signs of wear and damage. The original floor had been removed. In certain areas of the separating wall, this has caused a void between the brickwork wall and the floor. Furthermore, brickwork was missing around end bearings of lintels, see **Picture 49, 50 and 51**.

- 5.3.4 The solid brickwork wall, which separates the former squash courts and the internal walkway, currently shows signs of wear and damage, especially around end bearings of lintels. Due to the original floor being removed, some areas of the wall have a void between the brickwork and floor, see **Pictures 49, 50 and 51**.

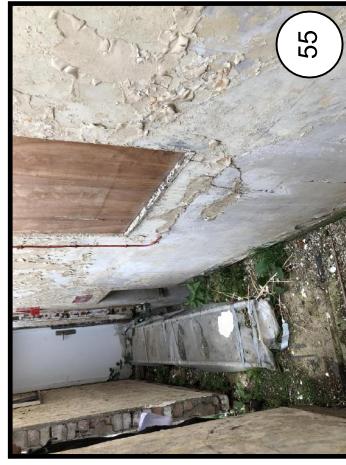
55

4.5.3 Near the squash court entrance, a large void space within the floor can be found, see **Picture 55**. A scaffolding plank currently forms a bridge over the void.

- 5.3.3 As illustrated in **Picture 55**, the large void, found near the side entrance of the squash courts, should be filled with well compacted hardcore. Allowance should be made for a new concrete floor, which has localised mesh reinforcement spanning across the opening.
