Schedule of Condition and Photographs

59 Elms Avenue Eastcote Ruislip HA4 8PE

Footpath adjoining 59 Elms Avenue Eastcote Ruislip HA4 8PE on Oak Grove Ruislip HA4 8PE leading to railway over bridge

Condition Survey Date: 8th May 2022 at 3pm

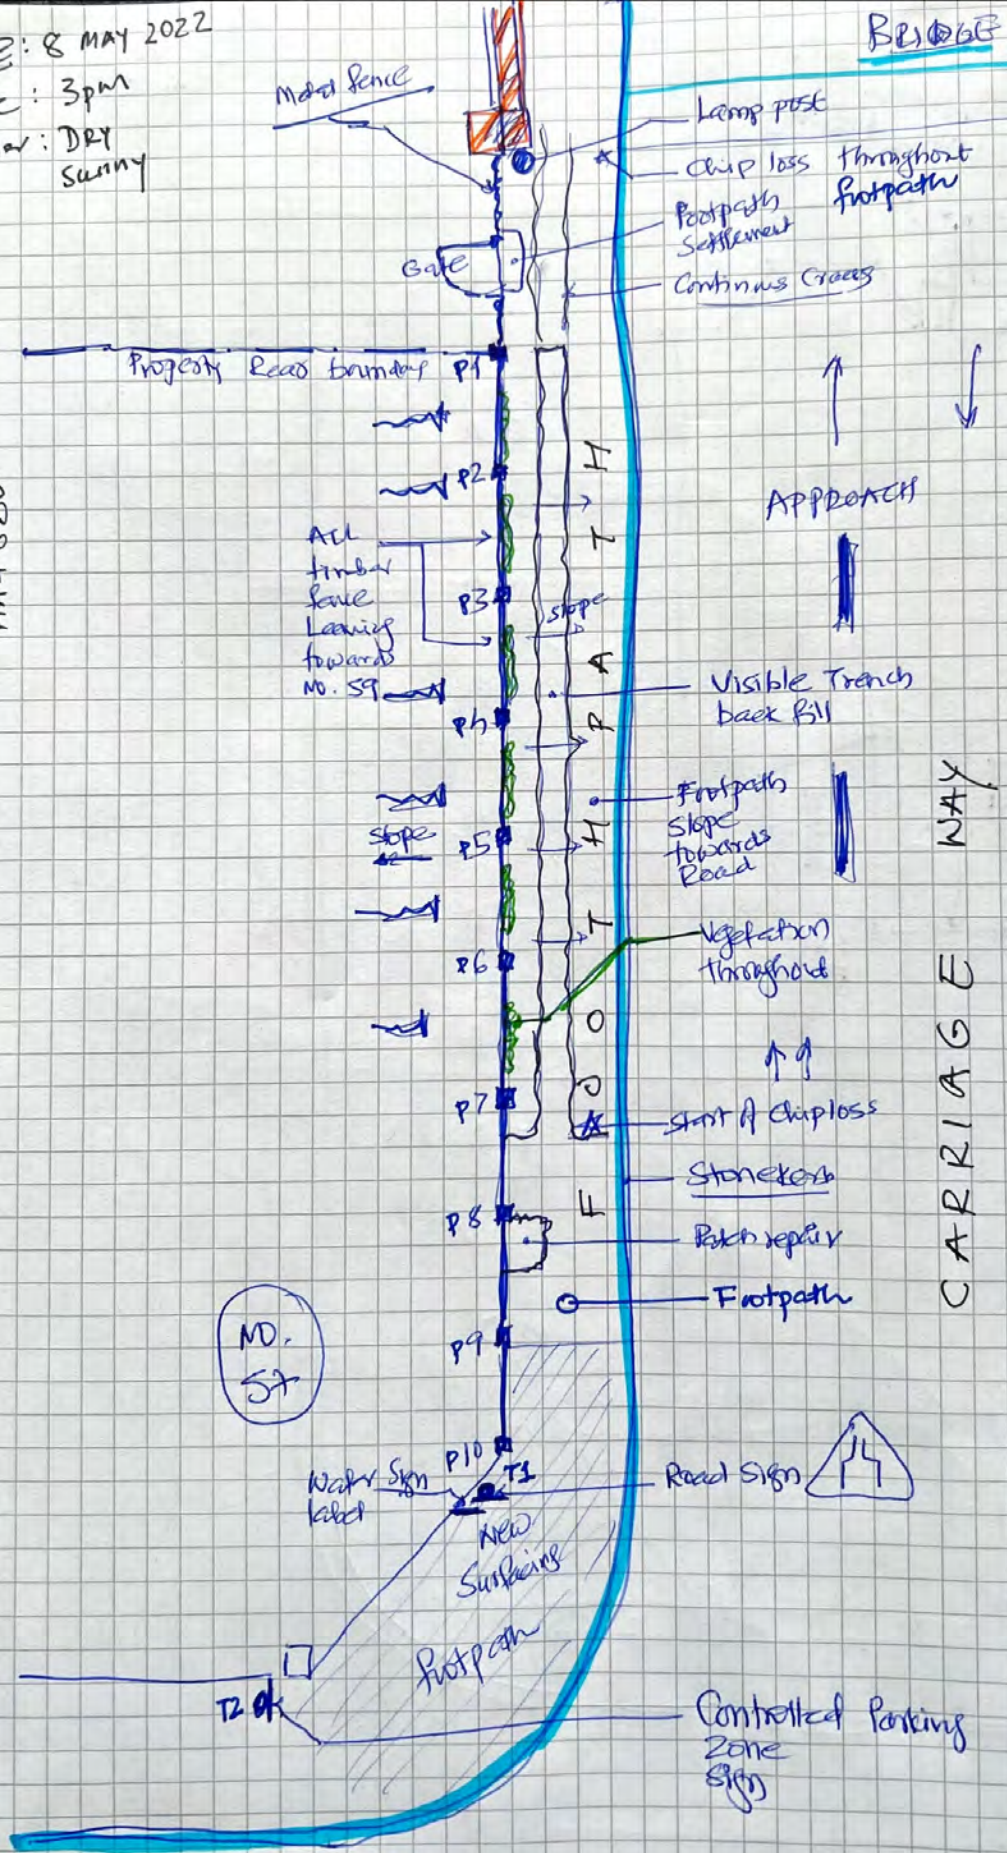
2. Survey Sketch

Patch repair

Start of Chip loss

Footpath Slope towards Road

Visible Trench back fill

Acl timber fence Leaning towards No. 57

Chip loss throughout Footpath
Footpath Settlement
Continuous Grasses
