**A review of a Lawson cypress hedge  
in support of an application to remove it  
at  
10 Tanworth Close  
Northwood  
HA6 2GF**

**Client: Rajesh Shah  
64 Copsewood Way  
Northwood  
HA6 2TZ**

**Date**  
09/11/2023

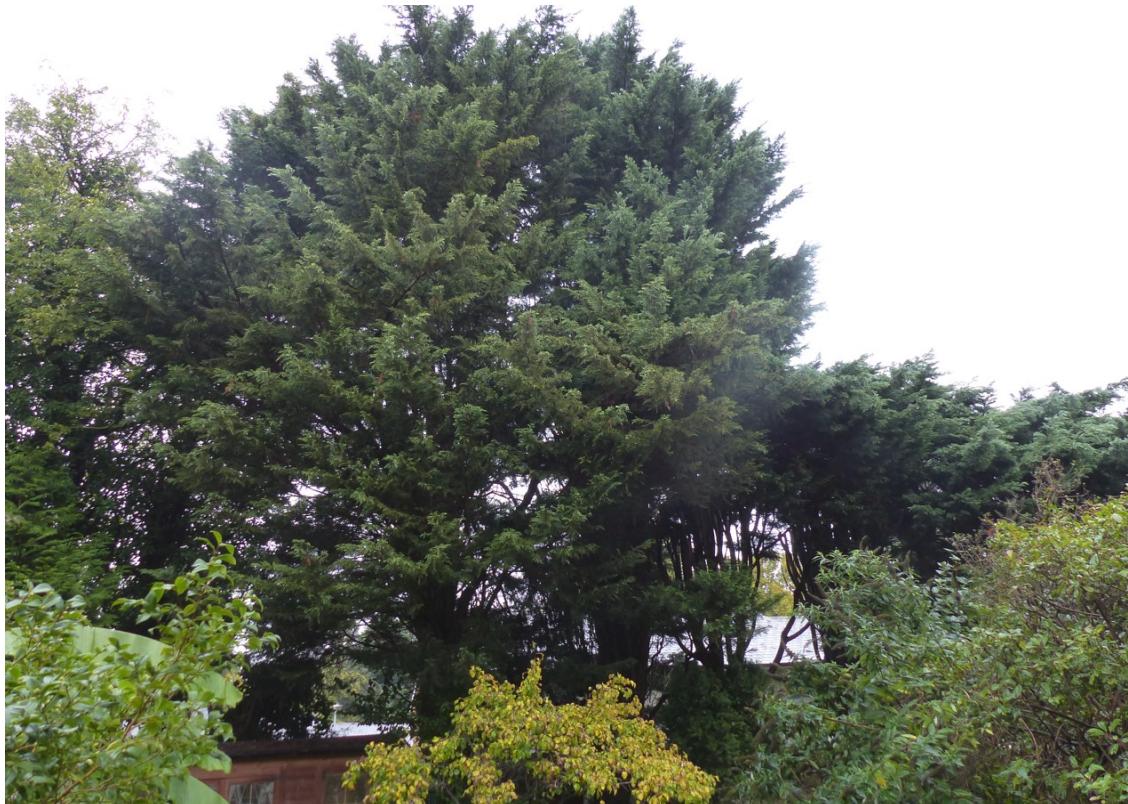
- 3.2 The two trees at the end of the row at the rear of 10 Tanworth Close are much larger than the other trees and look out of place. The lack of maintenance on these trees has left them overgrown, overbearing and unsightly.

Picture 1 The two trees at the back of the garden are much larger than the other trees in the group

- 3.4 The only realistic solution to the problem of how to deal with these trees, and indeed all of the trees within the group would be to fell them and plant a new hedge to provide screening in the future.

- 4.1 The hedge should be removed and replanted. Several species would be suitable on these soils and in this situation.
- 4.2 Appropriate replacement species would include Hornbeam (*Carpinus betulus*); Holly (*Ilex aquifolium*); Yew (*Taxus bacatta*) ; and Cherry laurel (*Prunus laurocerasus*).

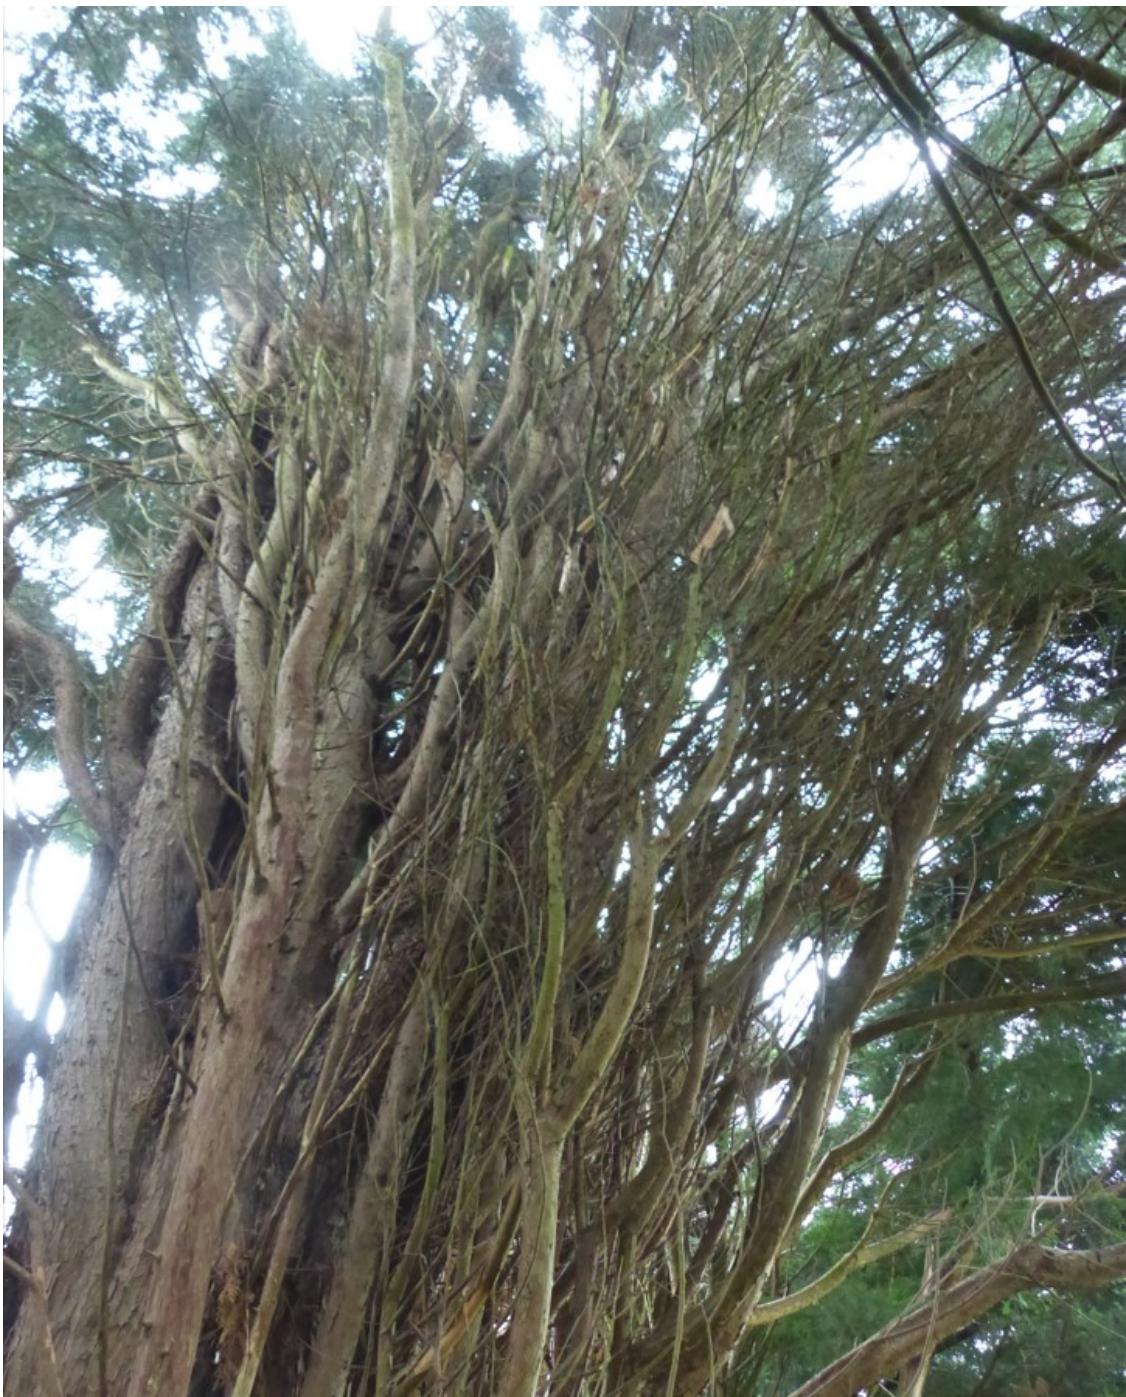
- 2.6 The inner crowns of these trees show large areas of dead wood and have experienced some small branch failures in the past.
- 2.7 The trees provide limited screening to views beyond the garden, as the house opposite at 43 Thirlmere Gardens is positioned off to one side. The removal of the trees would not expose this house to overlooking.

- 3.3 Just pruning the trees would expose the bare branches on the inside and would leave the trees looking worse than they do now. The pruning of the trees has been left too late to be able to produce anything attractive or constructive.

Picture 2 The interior of the trees shows a lot of deadwood and bare branches that would be exposed if the trees were just lopped
