Arboricultural Consultancy for Co-operative Insurance Society

Insured	Mrs Mary Merion	Address	26 Church Avenue, Ruislip, Middlesex, HA4 7HT		
Client	Subsidence Management Services	Contact	Kellie Ball	Claim No.	IFS-CIS-SUB-18-0080277
ES Ref	SA-242832	Consultant	Andrew Cayley	Contact No.	0330 380 1036
Report Date	04/01/2019	Revised:	02/05/2019

Scope of Report: To survey the property and determine significant vegetation contributing to subsidence damage, make recommendation for remedial action and assess initial mitigation and recovery prospects. The survey does not make an assessment for decay or hazard evaluation. This is a revised report following receipt of root analysis results.

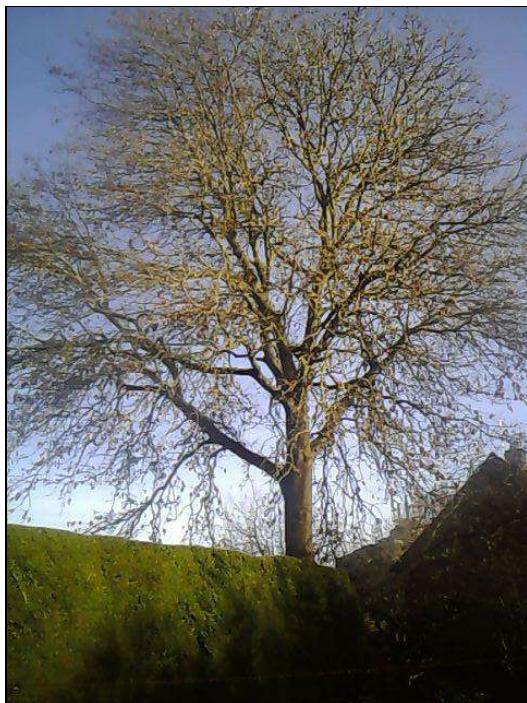
Based on our observations on site and with due regards to species profile, T1 (Cypress) and T2 (Ash) are considered the dominant features proximate to the rear of the property and accordingly we have identified them as the principal cause of the subsidence damage in this area.

T2 - Ash

Removal of T1 (Cypress), T2 (Ash) and T3 (Oak) will offer the most certain and reliable arboricultural solution likely to restore long-term stability.

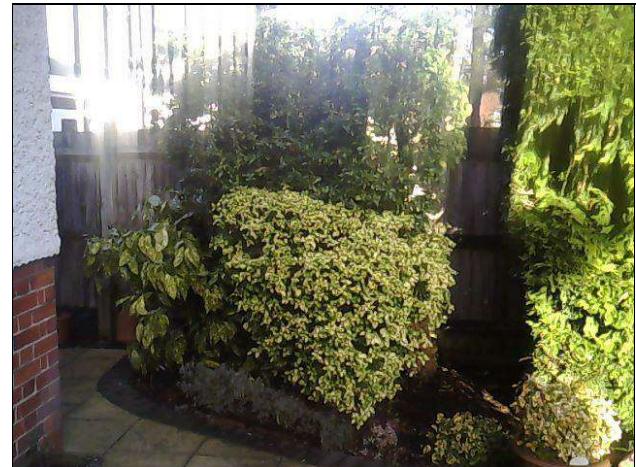
SG1 - Mixed species shrubs

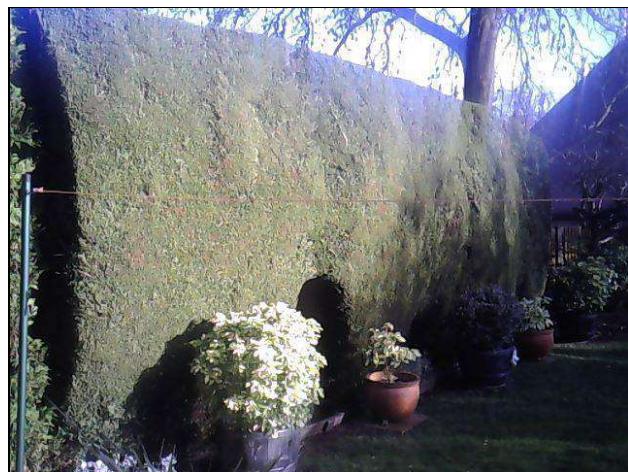
Please note that the footing of the insured property fall within the anticipated rooting distance of additional vegetation which we believe presents a foreseeable risk of future damage and accordingly we have made recommendations in respect of this.

H1 - Cypress

Tree No.	Species	Age Cat	Approx. Height (m)	Distance to Building (m) *	Ownership	Action	Requirement
H1	Cypress	1	3.2	5	C - Insured	Action to avoid future risk	Subject to regular management; maintain at current dimensions by way of regular pruning.
H2	Laurel (Cherry)	1	2.2	12	C - Insured	No action	No works.
H3	Ivy	1	3.2	0.7	A - Third Party	Action to avoid future risk	Subject to regular management; maintain at current dimensions by way of regular pruning.
SG1	Mixed species shrubs: Group includes Aucuba, Ceanothus, Pyracantha and standing dead Lilac or Buddleia.	1	2.3	1.7	C - Insured	Action to avoid future risk	Subject to regular management; maintain at current dimensions by way of regular pruning.
SG2	Mixed species shrubs: Rhododendron and Buddleia.	1	2.8	2.2	C - Insured	Action to avoid future risk	Subject to regular management; maintain at current dimensions by way of regular pruning.

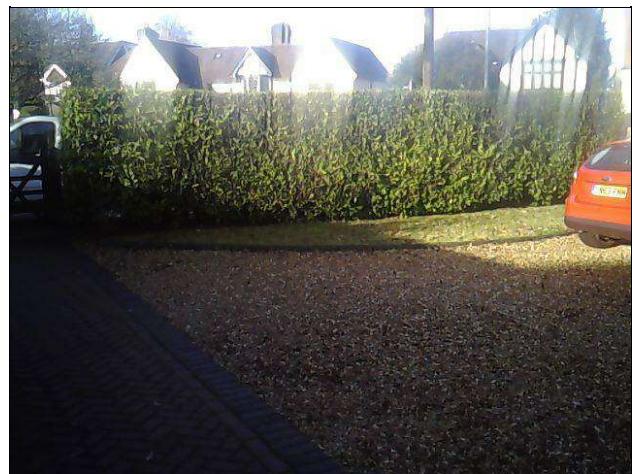
H2 - Laurel (Cherry)

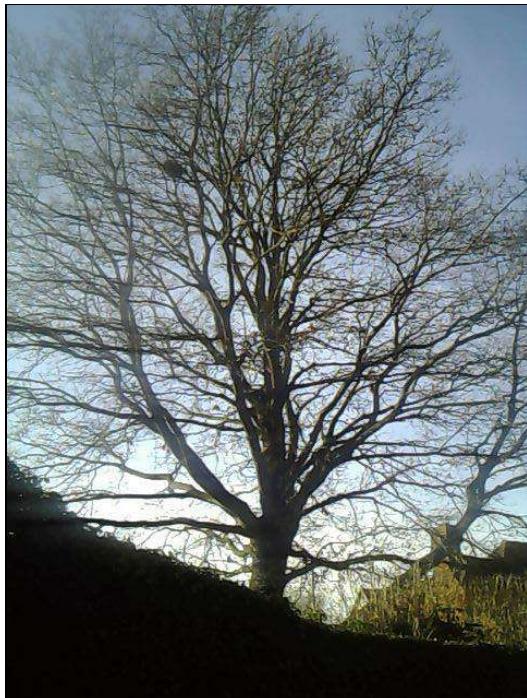
With due regards to species profile, size and proximity, T3 (Oak) will, also be contributing to the overall level of soil drying proximate to the front of the property and is therefore also considered to retain a significant contributory influence to the current movement / damage.

T3 - Oak

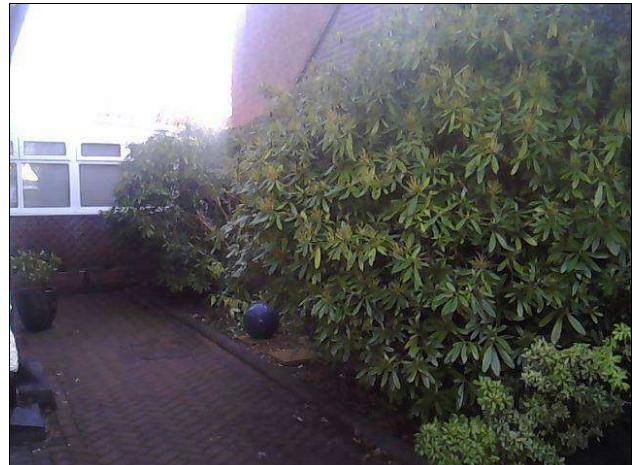
SG2 - Mixed species shrubs

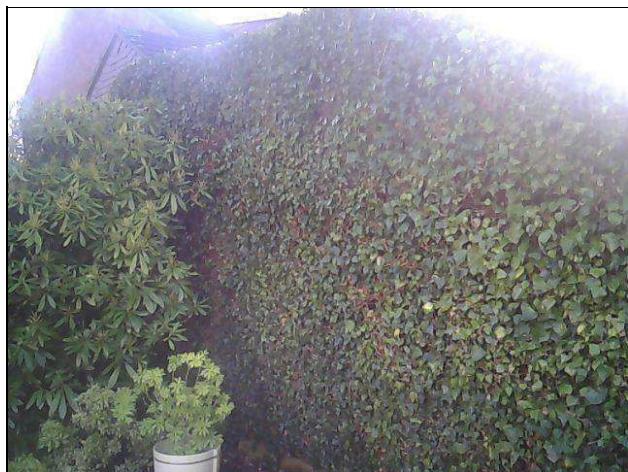
H3 - Ivy

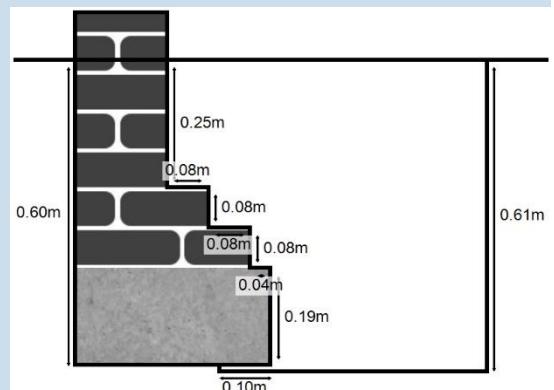
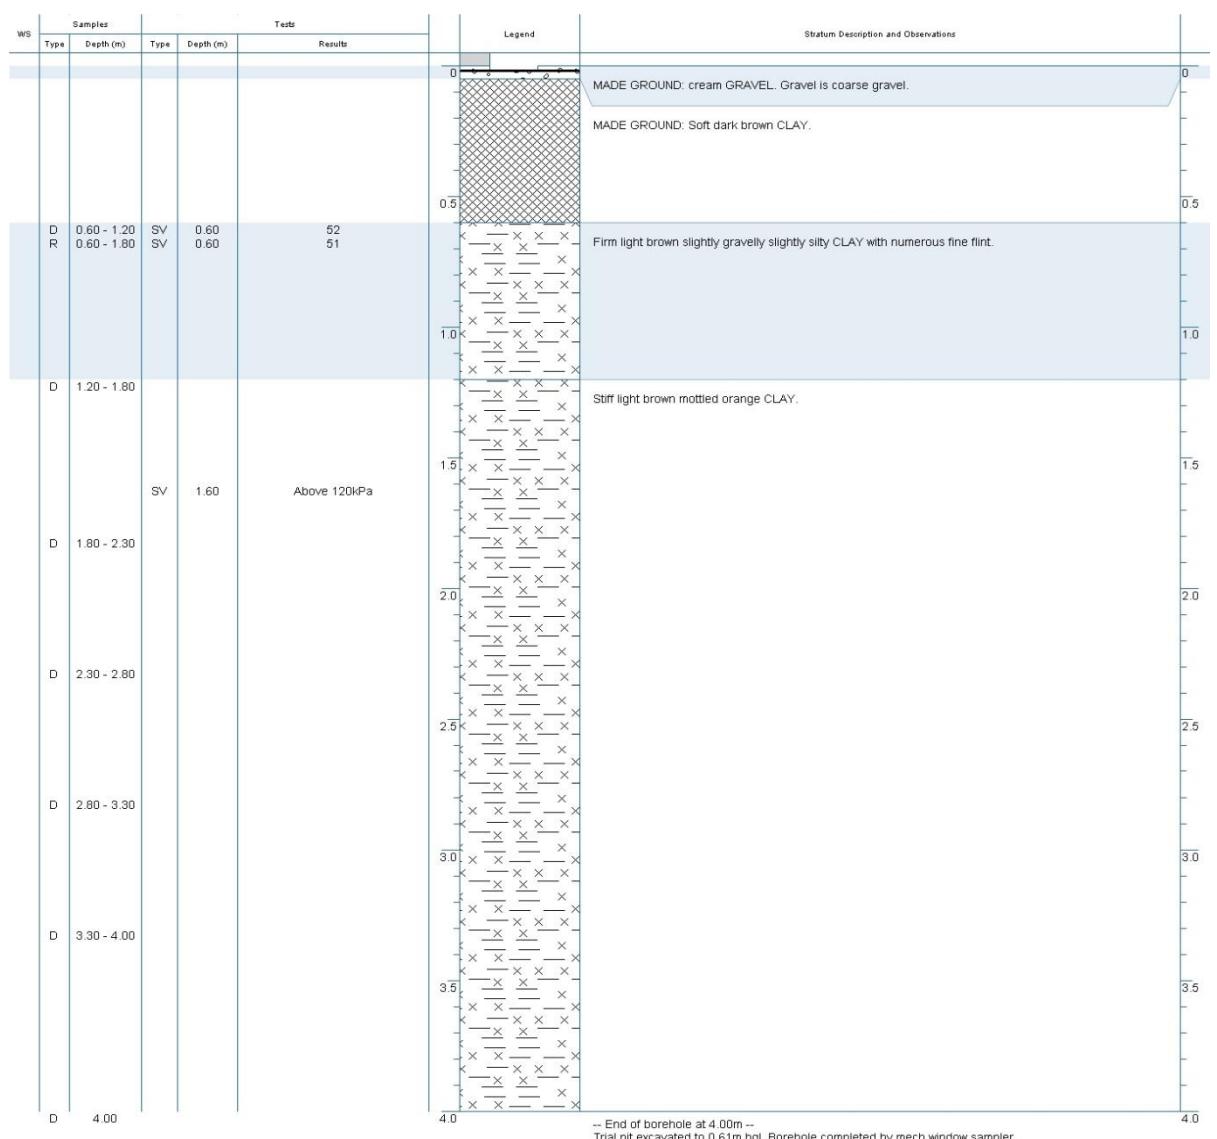
TP/BH1 Foundation Detail and Borehole Log

House foundation comprised of brick wall to 0.25mm bgl, bearing on stepped brickwork to 0.41mm bgl, bearing on stepped concrete to 0.60mm blg, with a total projection of 0.20mm from the elevation. Underside of foundation (USF) was exposed to 0.10mm back from the face of the foundation and probed 0.50mm back from the face of the foundation.

House foundation was exposed and the underside of foundation (USF) recorded to be .60m bgl (TP/BH 1).
