**PLANNING & HERITAGE/
DESIGN & ACCESS
STATEMENT**

**STRENGTHENING OF
EXISTING LANDINGS**

to the
STUDENTS STAIRCASE
within the

**MANSION HOUSE
HILLINGDON COURT
VINE LANE
HILLINGDON
MIDDX, UB10 0BE**

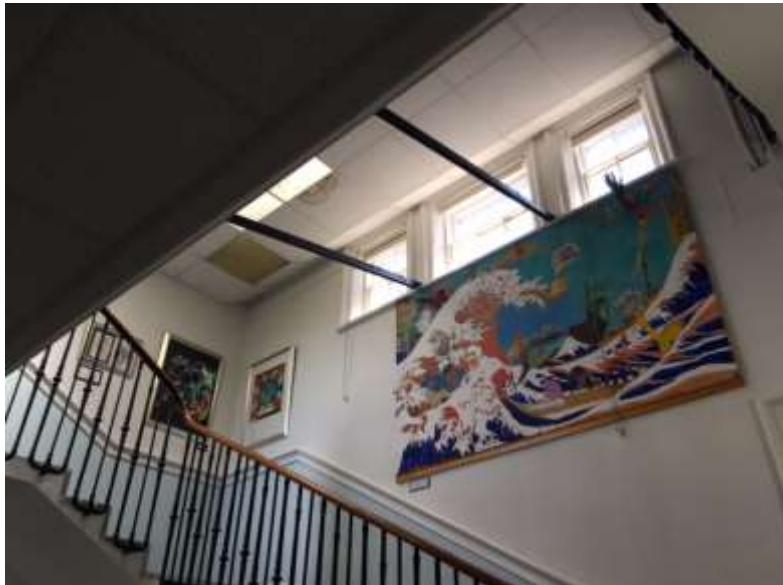
Student staircase stairwell

- (1) The existing balustrades to the first and second floor landings are being temporarily restrained with struts propped against the rear south wall of the stairwell area. Apart from being unsightly, they do not provide confidence to the users.
- (2) The line and shape of the timber handrail is considered crucial and, as a result, should not be altered unnecessarily.
- (3) The proposals to include new posts in the form of round hollow sections (RHS's) welded to a base plate and fixed through the landings provide adequate robustness in order to ensure the restraint of the remaining balusters.
- (4) There is no change to the access to any buildings on the site.

Temporary timber props installed to restrain the top of the landing balustrade at second floor level.

- (1) In order to avoid unnecessary works to the existing balustrades, it is considered to be more aesthetically acceptable to introduce a few new posts along each landing in order to provide the necessary lateral resistance to the existing balustrade without altering the line of the existing timber handrail.
- (2) The proposed remedial works will provide the necessary stiffness to the balusters at the landing levels, and avoid the need for any further works in the future.
- (3) These works are described in detail on ATA's drawing 41136/2/02 contained in Appendix V of this Document.

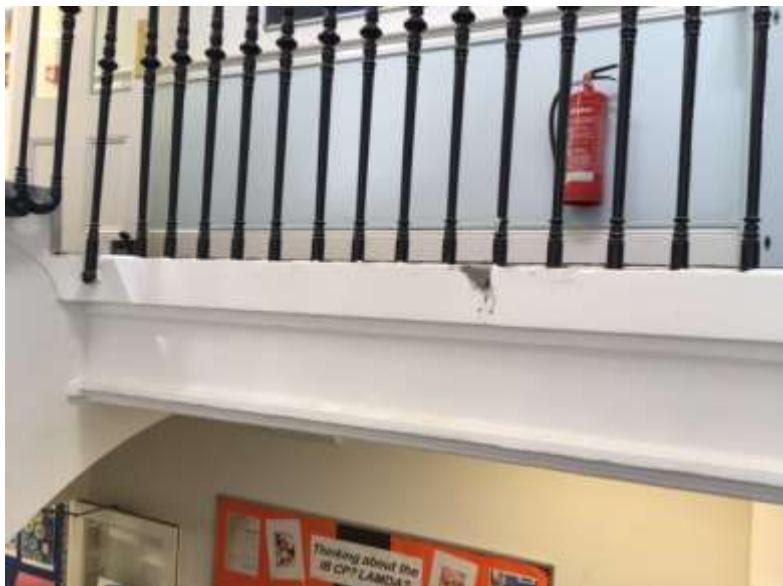
Second floor landing level

Movement of the balustrade causing spalling of the stone landing.

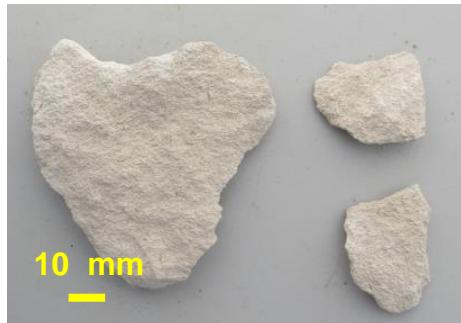
The stone is light buff in colour and medium-grained (see Figure 1). The fabric is grain-supported ooliths, with occasional shell fragments. The stone reacted vigorously to dilute hydrochloric acid, and water dropped onto the surface was readily absorbed, indicating it to be porous. No evidence of weathering or alteration was seen in the hand specimen.

Figure 1: Sample as received. The scale bar represents 10mm.

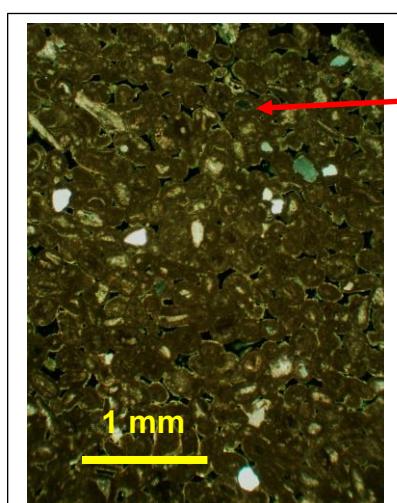
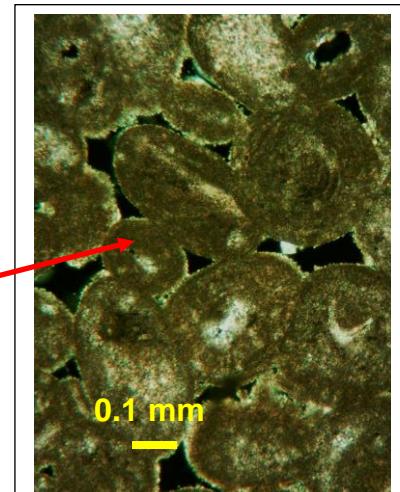
The stone is dominated by grain-supported micritic ooliths typically about 0.3mm in diameter that may have a concentric structure and are occasionally seeded with quartz grains with moderately abundant macropores (see Figure 2). Traces of shell and calcite matrix occur in the stone.

Figure 2: The thin section in transmitted light between crossed polars of the oolitic limestone.

A general view in thin section showing the brown grain supported micritic ooliths and traces of elongate shell fragments. The grey and white particles are quartz grains.

A detail of the micritic ooliths with dark macropores in the spaces between the grain supported ooliths.
