## SITE INVESTIGATION FACTUAL REPORT

Report No: 311141  
Client: Crawford Claims Management  
Site: 40 Swakleleys Road, Ickenham

Client Ref: SU1505084-  
Date of Visit: 19/01/2016

# Investigation Layout Plan

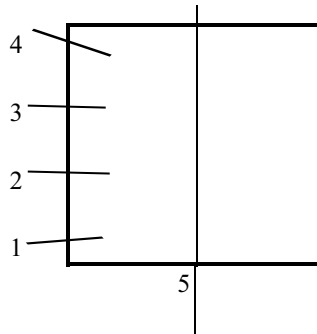
M/H: 1 Depth: 600mm

Chamber Dimension (mm): 650 X 450
