# **TECHNICAL REPORT ON A SUBSIDENCE CLAIM**

**Crawford Reference: SU1505084**

**Peter C Mills  
40 Swakeleys Road  
Ickenham  
Uxbridge  
UB10 8BE**

**SUBSIDENCE CLAIM**

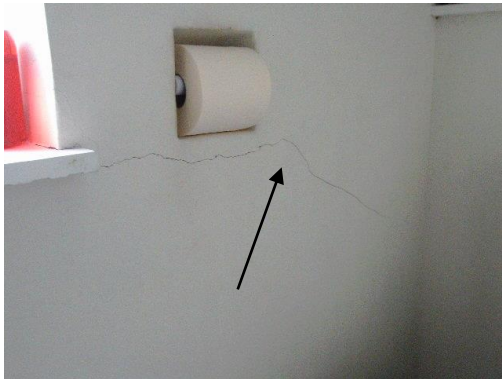
Cracking in w.c.

**W.C.** - 1mm diagonal crack to right hand flank, cracking to ceiling.

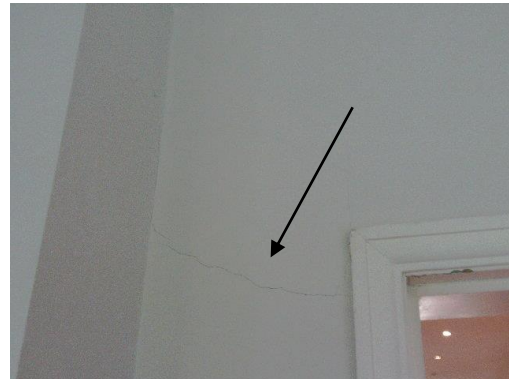
Cracking in rear extension

**Rear Extension** - 1mm vertical crack to right hand partition, hairline diagonal crack above door to hall.

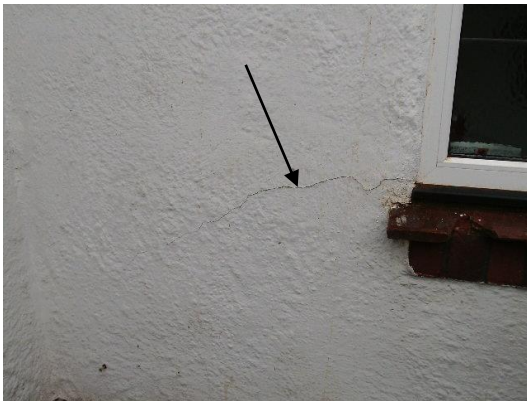
Cracking to right hand flank below w.c.  
window

**Right Hand Flank** - 1mm diagonal crack below w.c. window, 1mm vertical crack above w.c. window, the tarmac driveway has lifted and cracked in several places, previous repairs and cracking noted to right hand boundary wall, paintwork is peeling above garage door.

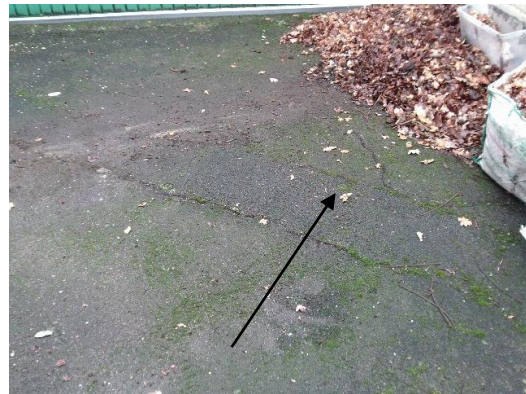
View of movement to tarmac driveway

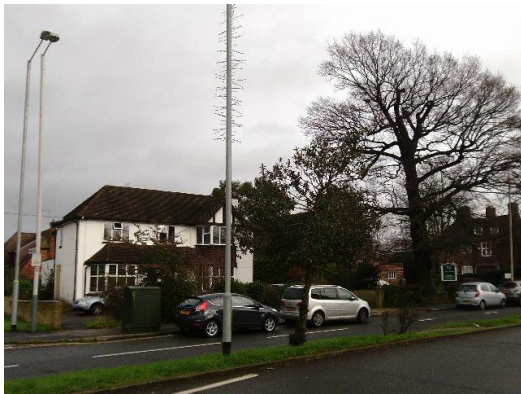
| Type | Height | Distance | Ownership |
|---|---|---|---|
| Oak | 20 m | 12 m | Neighbour 5 |

View of third party oak tree

Although the cause of the movement needs to be dealt with, we note the involvement of a commercial third party tree. Unfortunately, they will require certain investigations to be carried out to demonstrate the influence of their vegetation. We have also completed a soil risk analysis (VISCAT Assessment) which suggests a potential heave risk should the vegetation be removed. The site investigations will also enable us to quantify this risk in relation to the specific soil type at the property.

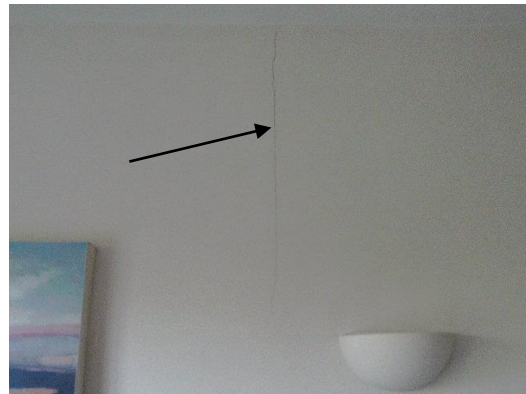
Cracking to right hand wall in rear extension

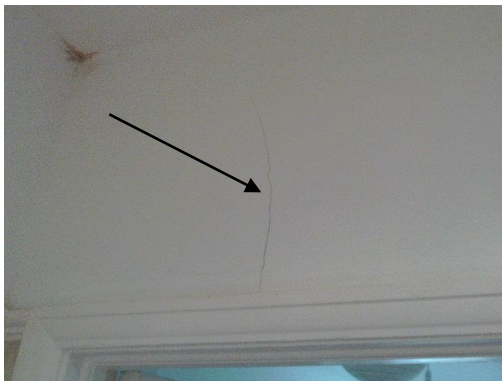
**Hall, Stairs and Landing** - Hairline vertical crack above door to rear extension, 1mm vertical crack above door to utility room, cracking to hall ceiling, historic slope to floor down towards w.c., vertical rucking in paper below flank window on half landing, rucking and cracking to landing ceiling in various locations.

Cracking in hallway

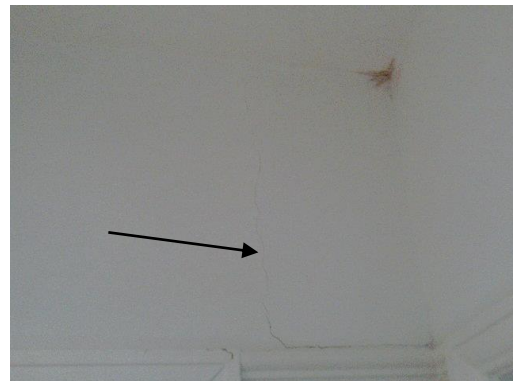
Cracking in hallway

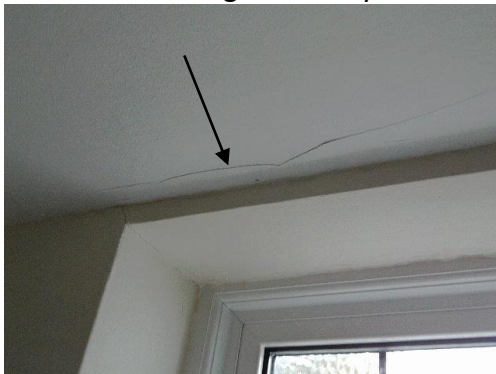
Cracking in w.c.

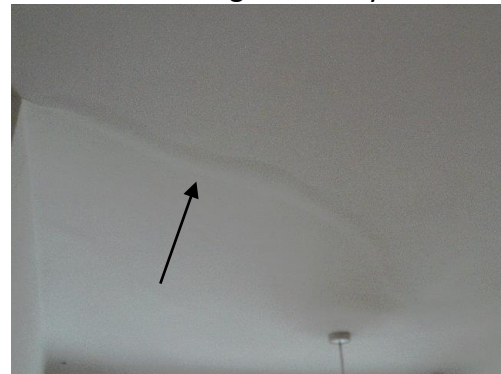
Rucking to landing ceiling paper

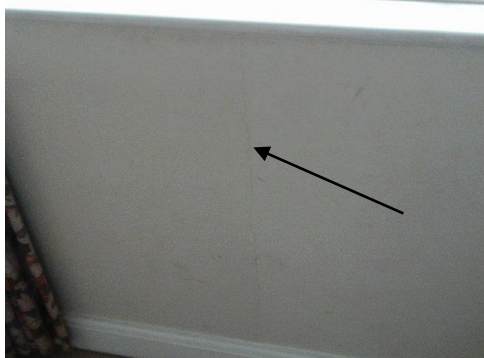
Rucking below half landing flank window
