# Arboricultural Appraisal Report

## Subsidence Damage Investigation at:

40 Swakeleys Road  
Ickenham  
Uxbridge  
UB10 8BE

| MWA REF: | SUB170124-1030 |

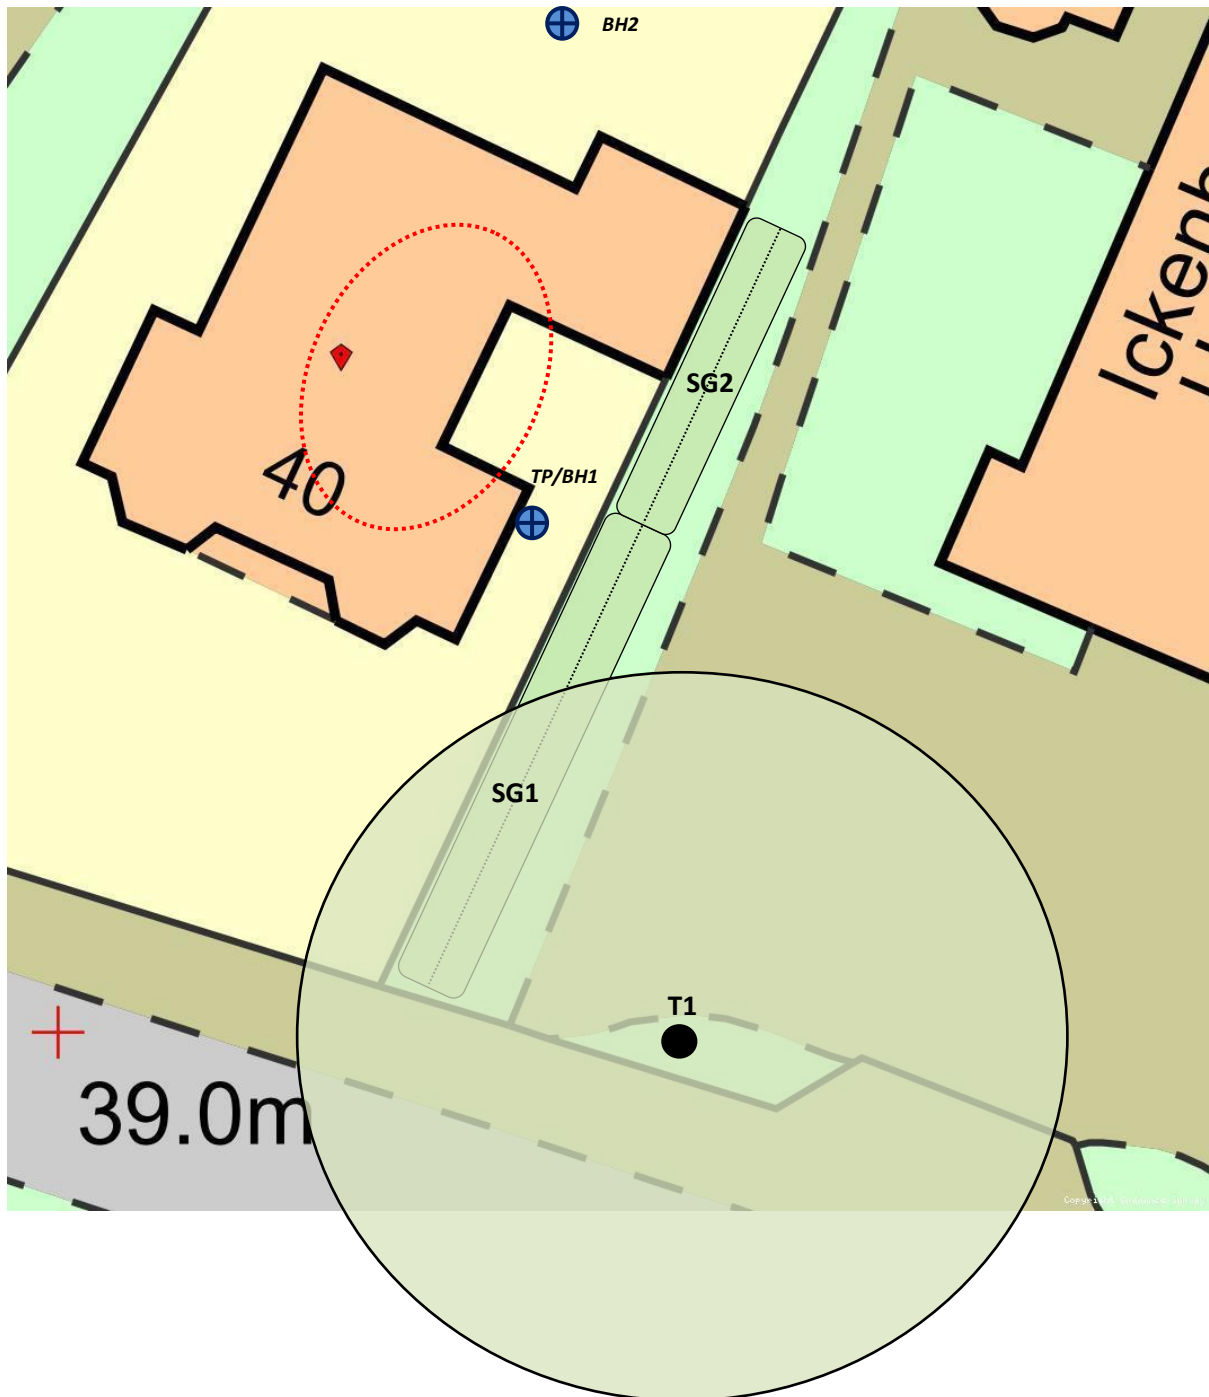
## SITE PLAN

Approximate areas of damage

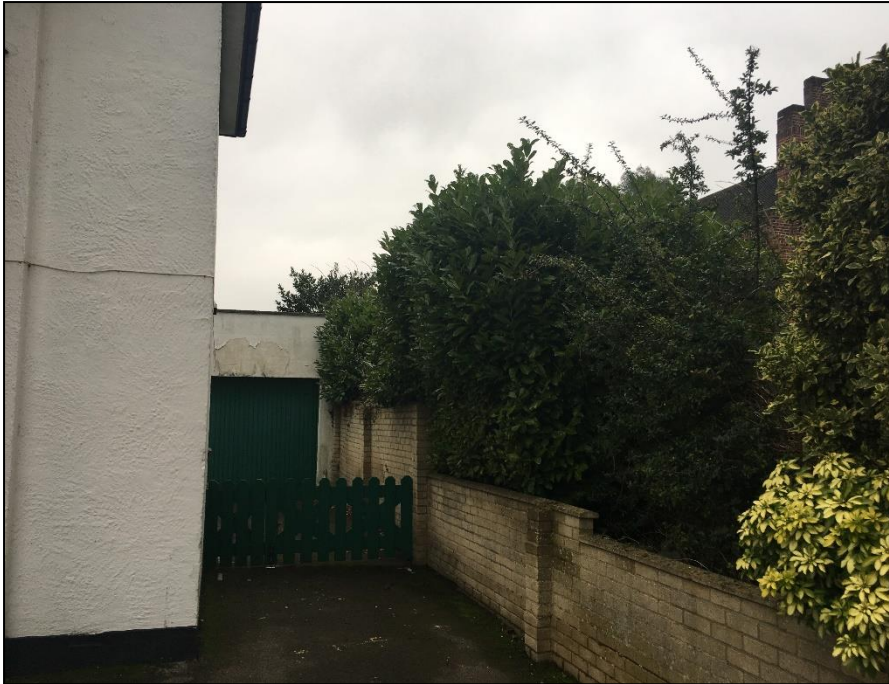
View of SG1,SG2

| Tree No. | Species | Ht (m) | Dia (mm) | Crown Spread (m) | Dist. to building (m) | Age Classification | Ownership |
|---|---|---|---|---|---|---|---|
| SG1 | Mixed species shrub group including Pyracantha, Choisya, Eleagnus, Holly, Berberis, Buddleija, Rhus | ≤ 3.5 | 40* ms | ~ 3 | ≥ 3 | Younger than Property | Third Party Ickenham URC |

| Tree No. | Species | Ht (m) | Dia (mm) | Crown Spread (m) | Dist. to building (m) | Age Classification | Ownership |
|---|---|---|---|---|---|---|---|
| Recommendation | | Do not allow to exceed current dimensions of influence through a program of annual pruning. | | | | | |

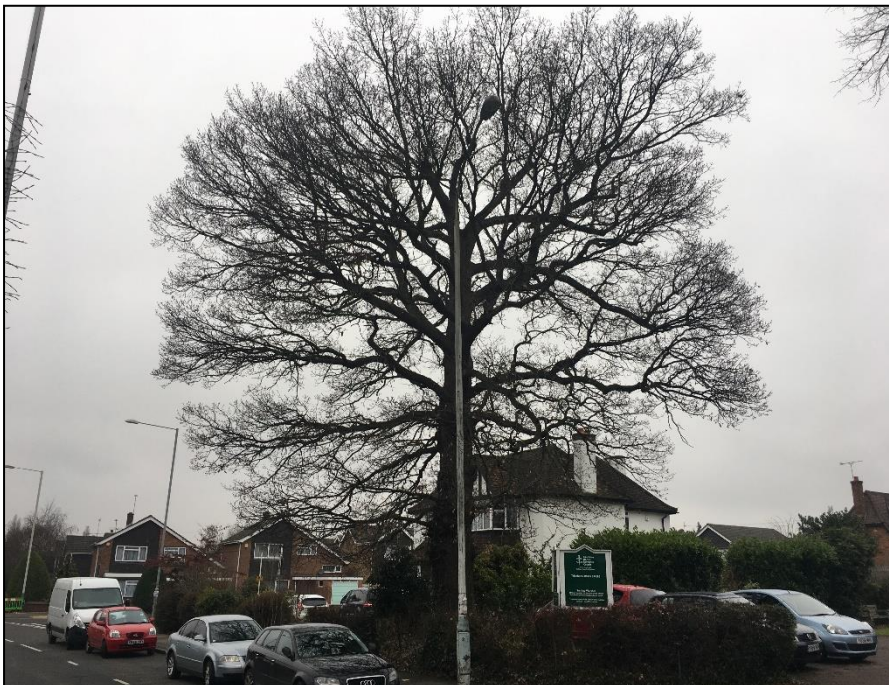
View of T1

Our survey of the site identified the Oak (T1) and we are confident that this is the source of the recovered roots.

Having considered the available information, it is our opinion that the Oak (T1) is the principal cause of the current subsidence damage.

| Tree No. | Species | Ht (m) | Dia (mm) | Crown Spread (m) | Dist. to building (m) | Age Classification | Ownership |
|---|---|---|---|---|---|---|---|
| T1 | Oak | 18 | 20 | 900* | 11.2 | Older than property | Third Party Ickenham URC |

If an arboricultural solution is to be implemented to mitigate the current damage and allow the soils beneath the property to recover to a position such that an effective repair solution can be implemented we recommend that the Oak (T1) is removed.

| Tree No. | Species | Ht (m) | Dia (mm) | Crown Spread (m) | Dist. to building (m) | Age Classification | Ownership |
|---|---|---|---|---|---|---|---|
| Recommendation | | Remove (Fell to ground level) and treat stump to inhibit regrowth | | | | | |

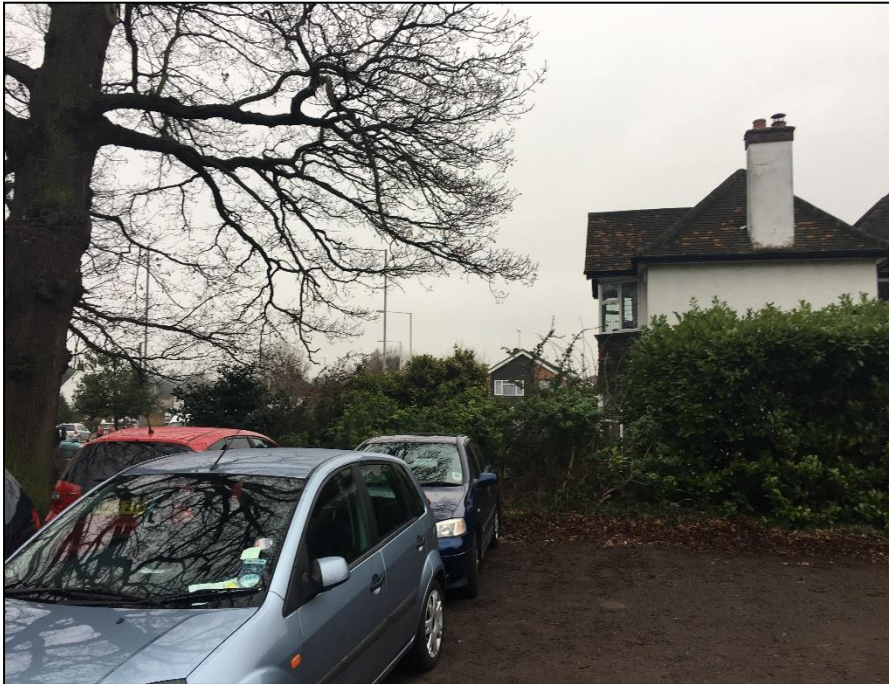
View of SG1, SG2 from Church

| Tree No. | Species | Ht (m) | Dia (mm) | Crown Spread (m) | Dist. to building (m) | Age Classification | Ownership |
|---|---|---|---|---|---|---|---|
| SG2 | Laurel | ≤ 3.5 | 100* ms | ~ 3 | ≥ 3 | Younger than Property | Third Party Ickenham URC |
