S973-J1-PPP-1

# REPORT

on trees in relation to

Ickenham United Reformed Church,  
Swakeleys Road, Ickenham, UB10 8BE

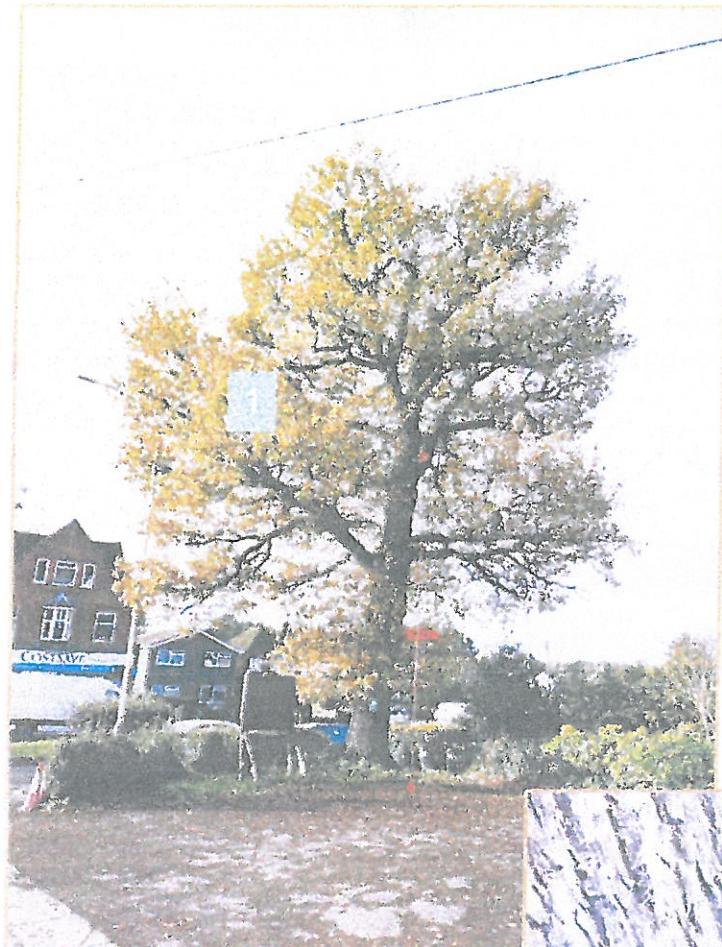
Tree number	Tree type	Height (m)	Stem diameters (mm)	Proximity (m)	Comments	Action description	Reason	Cost - £
1	English oak	15	1030	12	A tap test for the sonority typically associated with decay in trees was carried out in the basal area; nothing abnormal was detected beyond a little bark death noted on the south side of the tree but this does not appear to be associated with any deterioration of mechanically significant parts but should be monitored in the course of future inspections. A single partially dried bark exudation was noted on the western side of the tree at around 400 mm above ground level. Bark exudation can be an indication of Acute Oak Decline (AOD). This 'stem bleed' was an isolated instance, apparently of some age, and I do not attach significance to it. A future increase in the numbers of exudations could be a cause for concern.	Reduce to height of 13m and spread of 13m. Pruning cuts to be limited to a diameter of no greater than 100mm	Precaution	1000

View of tree from the north-east

No particular concerns in connection with tree 1 providing the recommended tree work is carried out. Shortening the pruning-repeat cycle of the tree to every two years would probably assist in generally reducing its soil drying further.

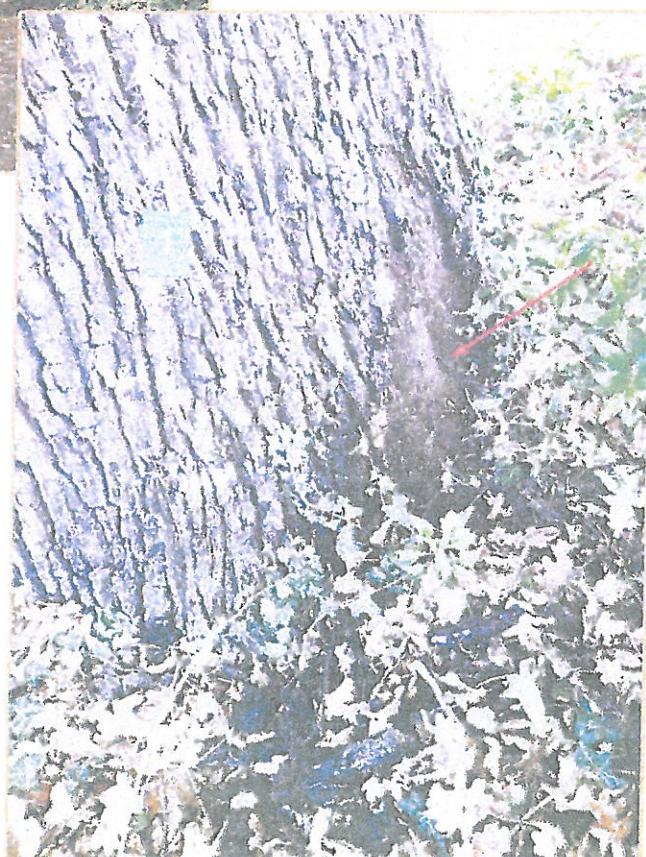
View of base of tree from the south; area of dead bark arrowed
