<p>Project:</p> <p>Gateway at Hillingdon Uxbridge Cemetery Uxbridge Road, UB10 0JF</p>

<p>Colony Architects Ltd.</p> <p>The Wine Store, Brewery Court, Theale, Reading, RG7 5AJ</p> <p>+44 (0)118 380 0328</p> <p>hello@colonyarchitects.com</p> <p>colonyarchitects.com</p>		
	<p>Collaborating with:</p> <p>Total Construction & Hillingdon Council</p>		<p>Drawing Name:</p> <p>Proposed North Elevation</p>				
	<p>Job: 1048</p>		<p>Date: 12.2024</p>			<p>Status: planning</p>	
	<p>Drawing: 05-11</p>		<p>Drawn By: HS</p>			<p>Checked By: SH</p>

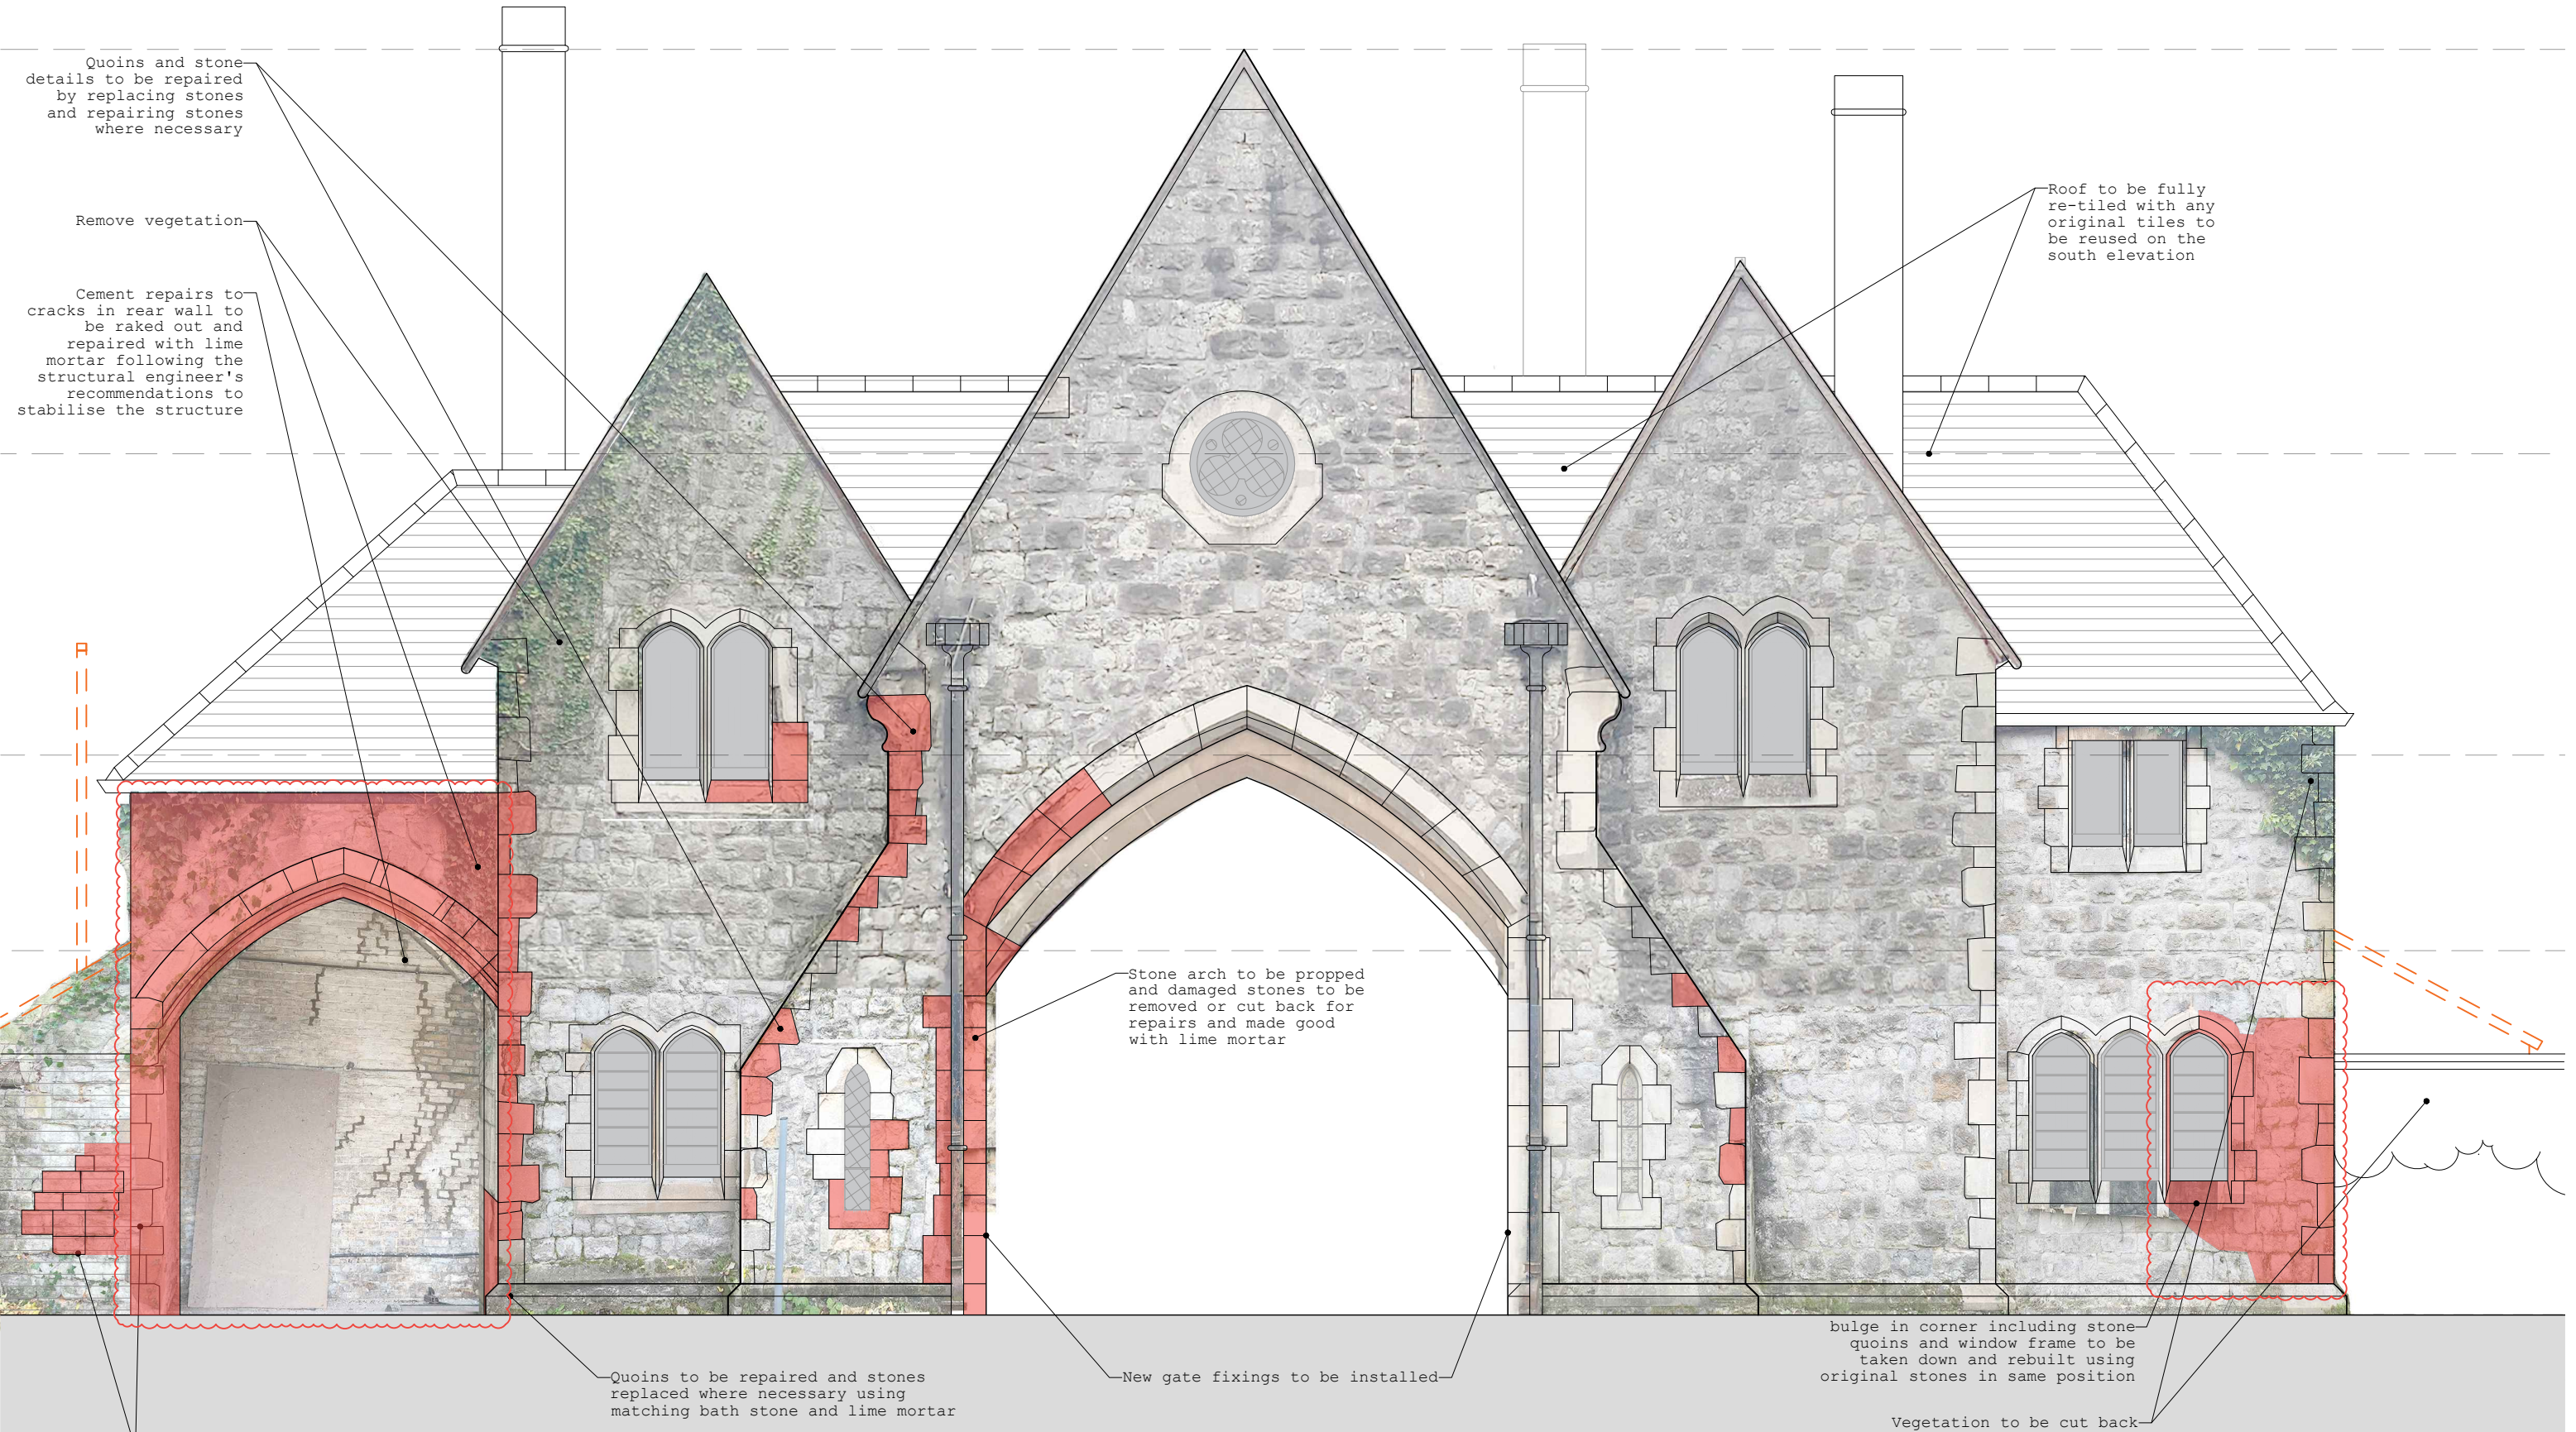
Cement repairs to cracks in rear wall to be raked out and repaired with lime mortar following the structural engineer's recommendations to stabilise the structure

bulge in corner including stone quoins and window frame to be taken down and rebuilt using original stones in same position

movement in side wall and arch to be repaired by carefully taking down the stone arch and rebuilding it with the reclaimed stones or replacements where necessary. Brick arch to be retained as is.

Quoins and stone details to be repaired by replacing stones and repairing stones where necessary

Remove vegetation

Roof to be fully re-tiled with any original tiles to be reused on the south elevation

Stone arch to be propped and damaged stones to be removed or cut back for repairs and made good with lime mortar

Quoins to be repaired and stones replaced where necessary using matching bath stone and lime mortar

New gate fixings to be installed

Vegetation to be cut back
