INDIVIDUAL TREE RISK SURVEY

| SITE: | 131 KNOLL CRESCENT HA6 1HX NORTHWOOD. |
| BRIEF: | CARRY OUT AN ISA LEVEL 2 AND 3 TREE RISK ASSESSMENT (TRA) |

| JOB REFERENCE: | 101 184 |

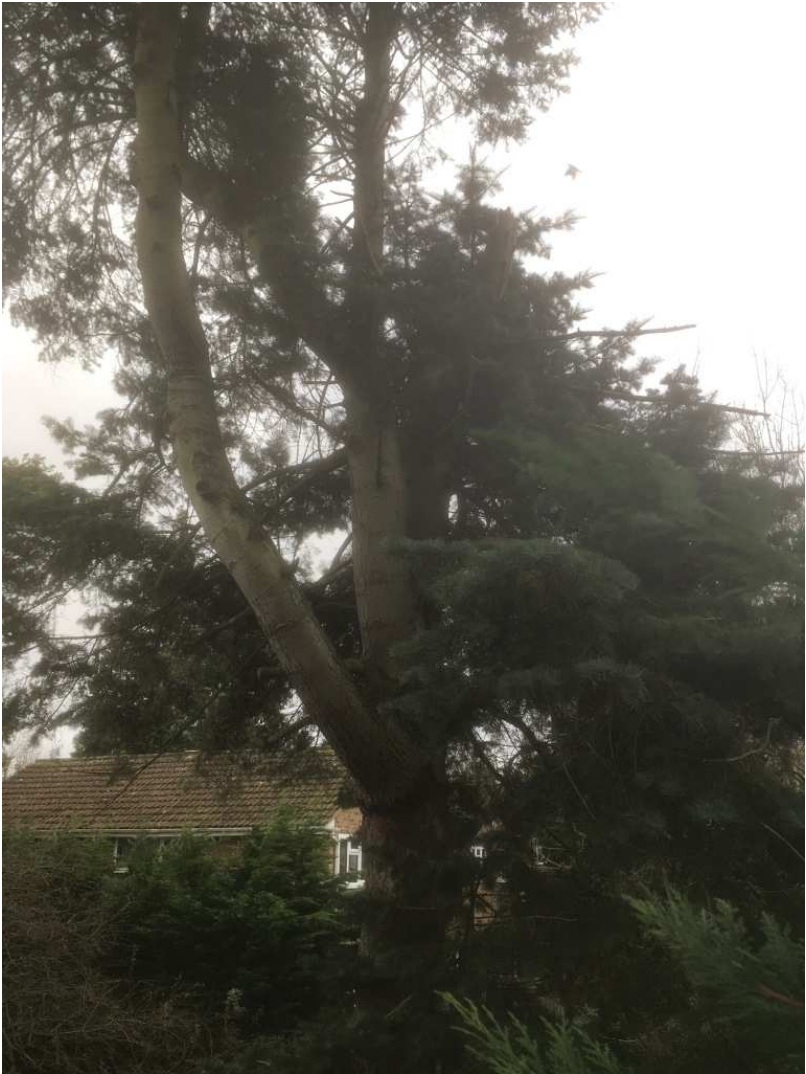
The risk posed by T1 is not total tree failure but additional future limb loss (**NB I** There have been two such failures within the last [approx.] 10 years and **NB II** The two remaining branches have long *lever-arms*). Within the branch failure zone of T1, there is a driveway and a newly built extension. In terms of potential driveway targets, we are advised that two cars are regularly parked on this drive used by the residents who have a three children family. Additionally, another target is an electric transformer sited under the crown of T1 (this could be struck by a failing branch; see photo no. 4). Given the defects described in the above survey assessment, it is foreseeable that decay will continue/begin to spread (progressive defect) into the main trunk. As a softwood tree species, internal CODIT decay walling-off is typically weaker when compared to hardwood tree species. Importantly, Douglas fir can be susceptible to colonisation by *Phaeolus schweinitzii* (1) causing a brittle fracture that can cause branch snap or break out (2) and *Sparassis crispa* (1) also causing a brittle fracture that can cause branch snap or break out (2).

Photo No. 1 to show (in the mid right-hand side of photo) the protruding base of the torn-out eastern scaffold limb.  
**NB** The torn-out base of the missing central leader (see photo below) which is obscured by foliage

(A) Reduce the two remaining branch (*lever-arms*) by 4-5m or (B) remove and replace T1.

Option (A) would result an even more ‘disfigured’ crown and there would still be a *residual risk* of falling branches requiring future periodic tree risk assessment to evaluate the likelihood of such a failure (3): a unfair financial burden for the owner of a now low-grade (crown form) tree that is nonetheless still subject to a TPO. We would recommend the tree replacement option as set out below.

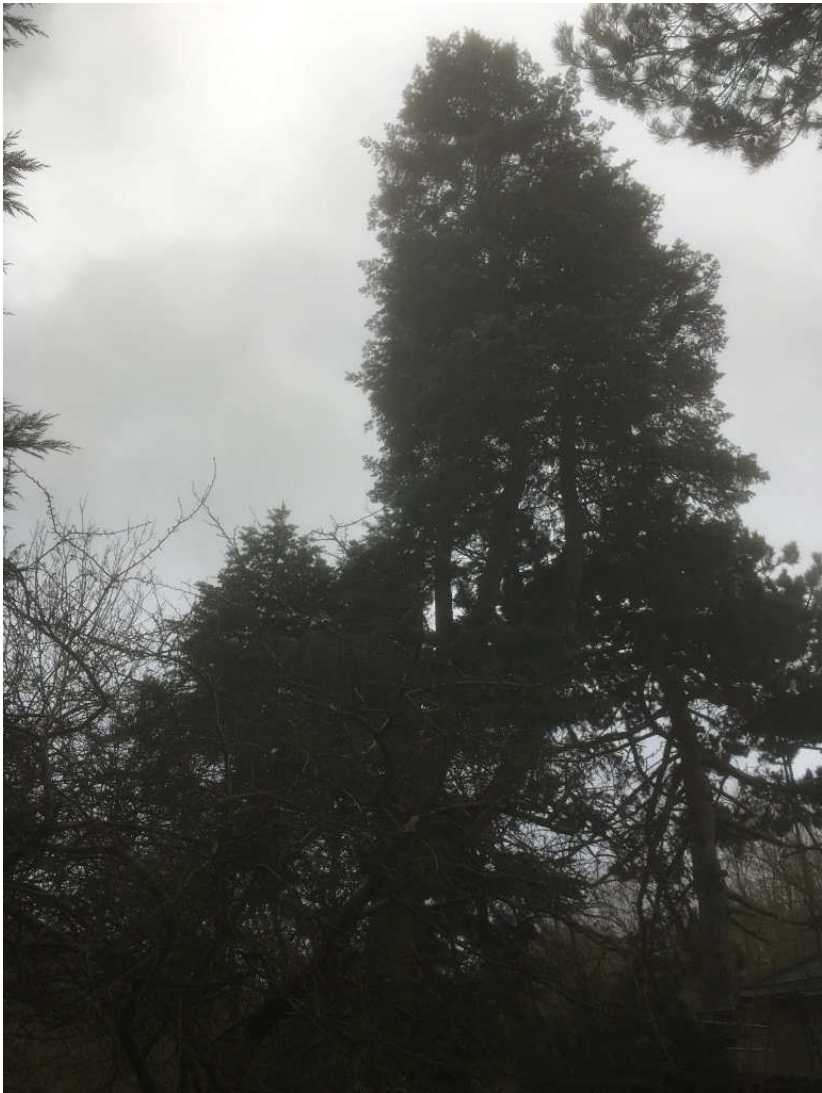
Photo No. 2 to show the unbalanced crown form of T1 due to the loss of the central leader (as viewed from the west - on property front driveway)

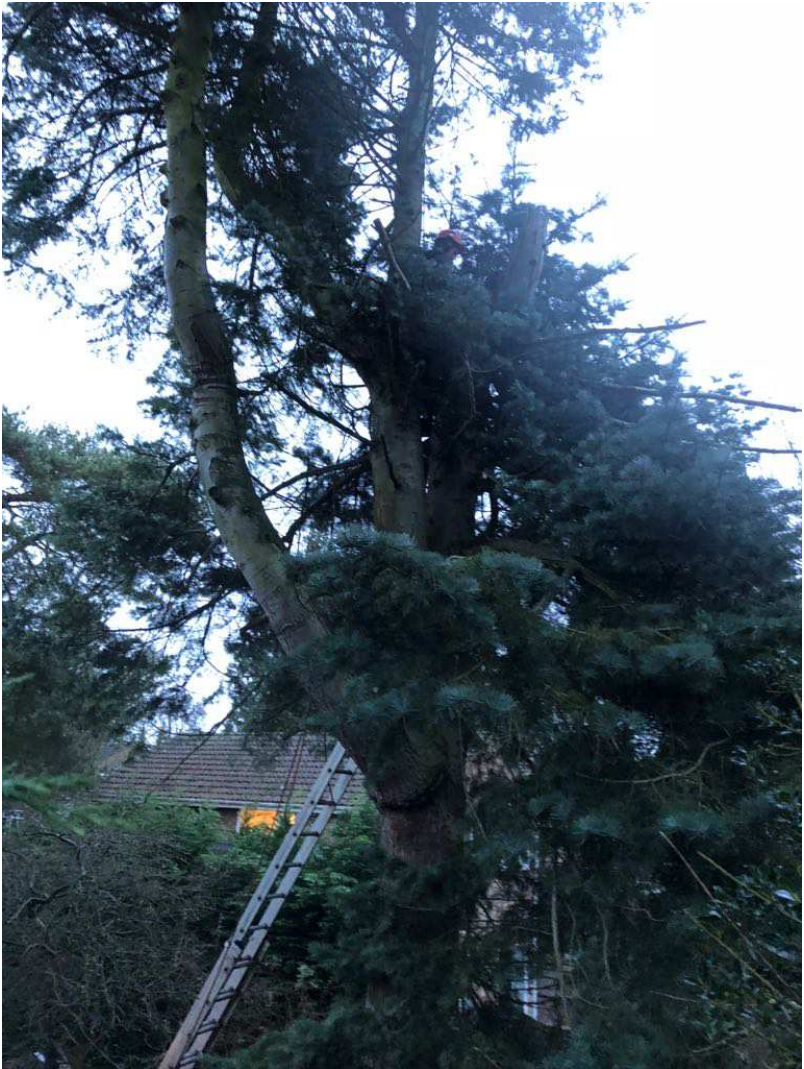
Photo No 3 to show climbing inspection in progress

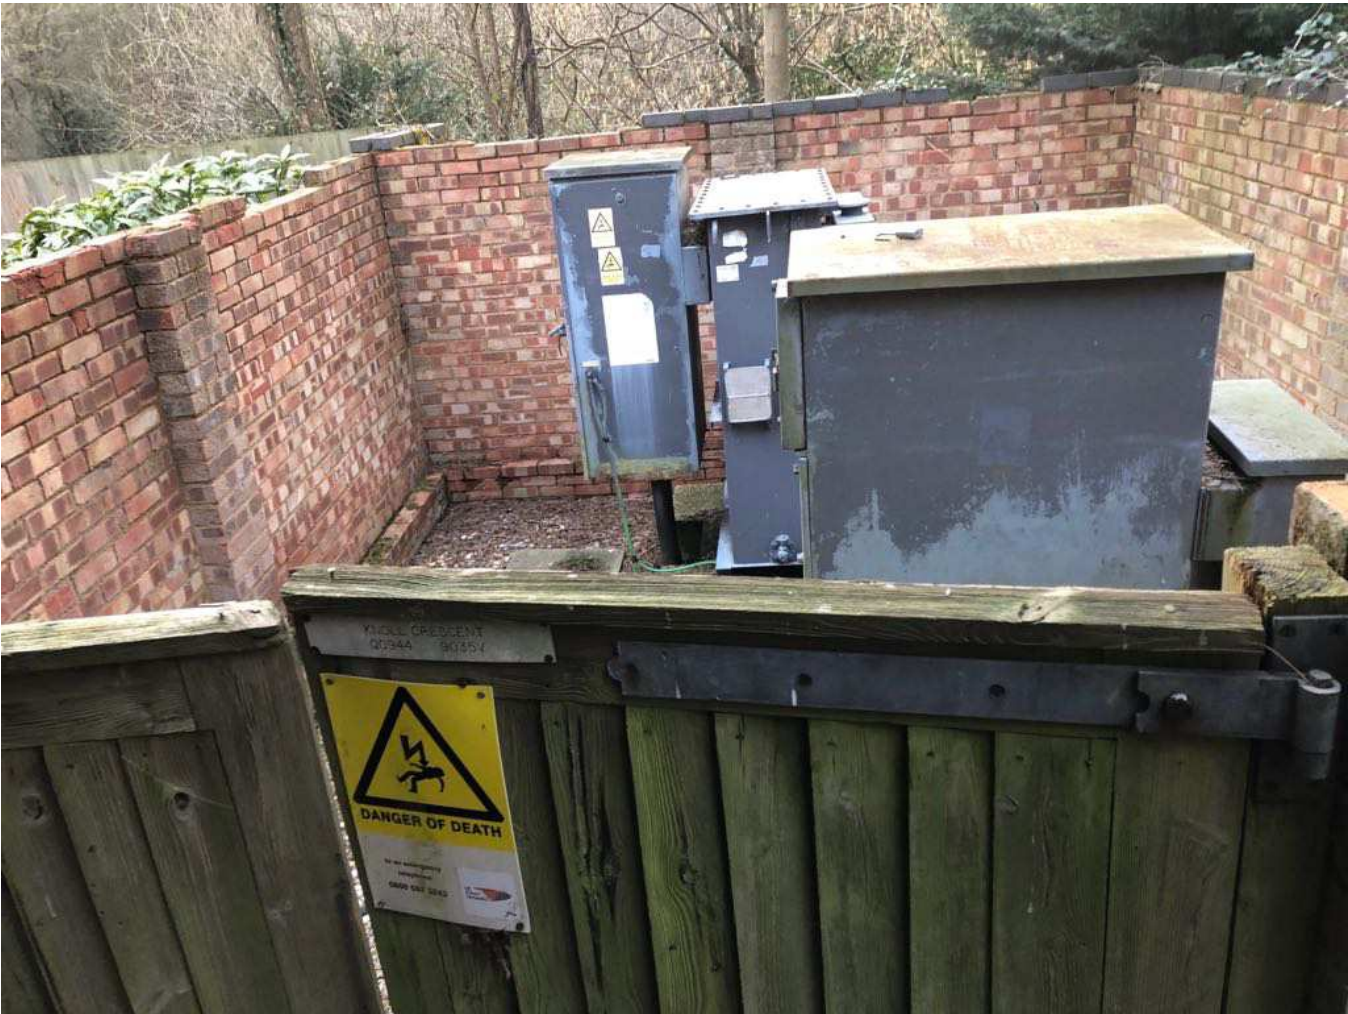
Photo No. 4 to show the fenced-off electric transformer under T1

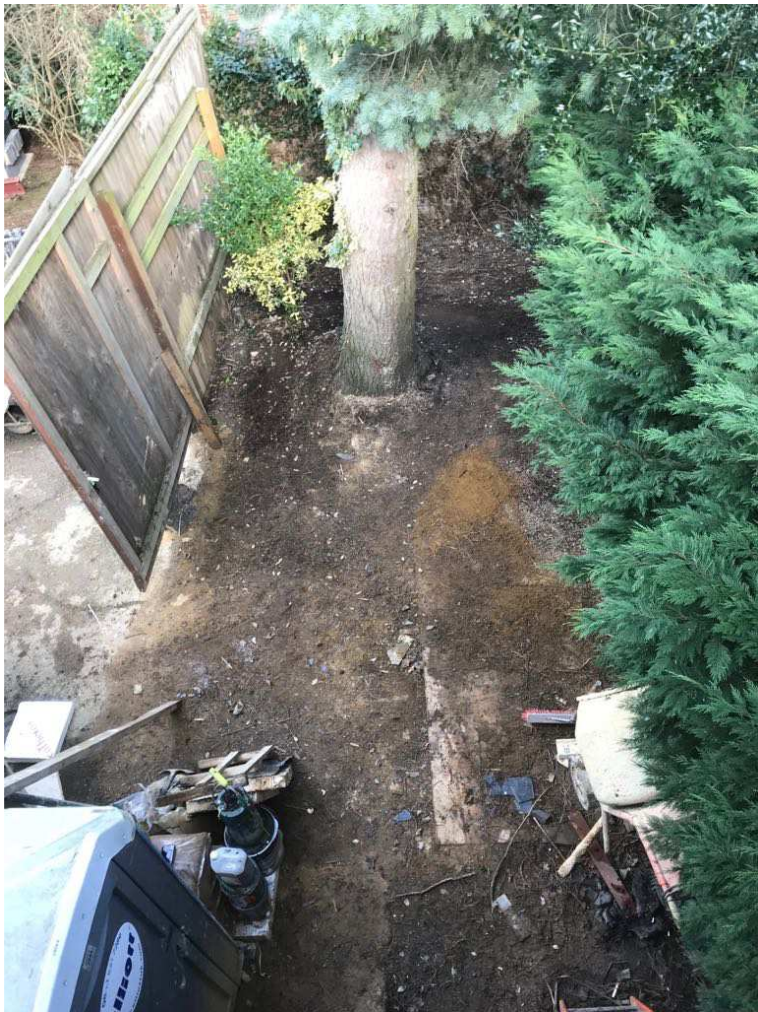
Photo No. 5 to show the limited garden space within which to plant another Douglas fir

We would not recommend the planting of another Douglas fir as the garden space is very limited for such a large maturing tree species and also it is documented (1) that such tree species – as they mature – “tend to shed heavy lower branches with foliage and are therefore not well suited to sites heavily frequented by people” (see photo. no. 5 & 5a). We would recommend therefore a replacement planting of a silver birch (to be supplied as a container-grown Heavy Standard tree with a 12:14cm trunk girth).

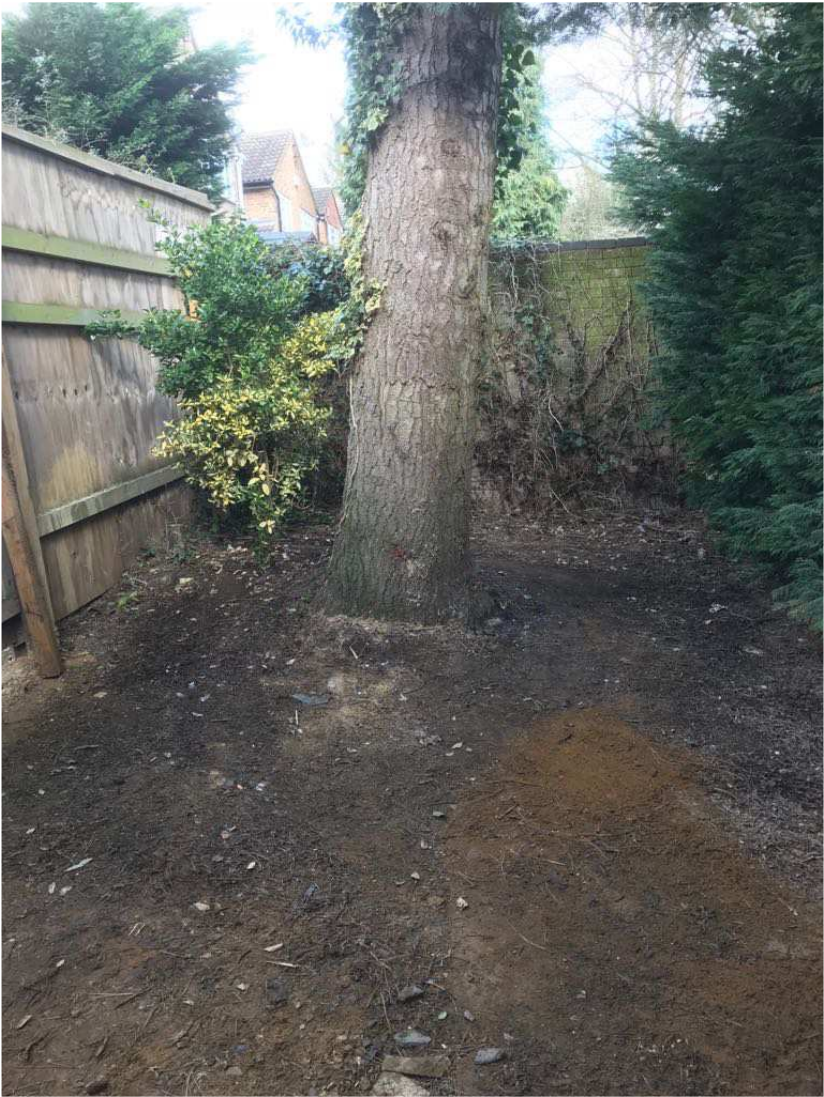
Photo No. 5a to show the limited garden space within which to plant another Douglas fir
