**DOWER HOUSE, HIGH STREET, HARLINGTON**  
**STRUCTURAL ENGINEERING APPRAISAL**

## STRUCTURAL ENGINEERING APPRAISAL

SFK Consulting is appointed as Structural Engineer to advise Komfort Services Ltd (the property owner) on the repairs and alterations necessary to bring the Dower House building back into reuse as a residential property.

The Dower House is listed grade II and suffered a significant fire in May 2011. Since then the property has stood vacant and derelict. In 2018, a temporary scaffold frame roof was erected over the building, but no repairs have been undertaken following the fire in 2011.

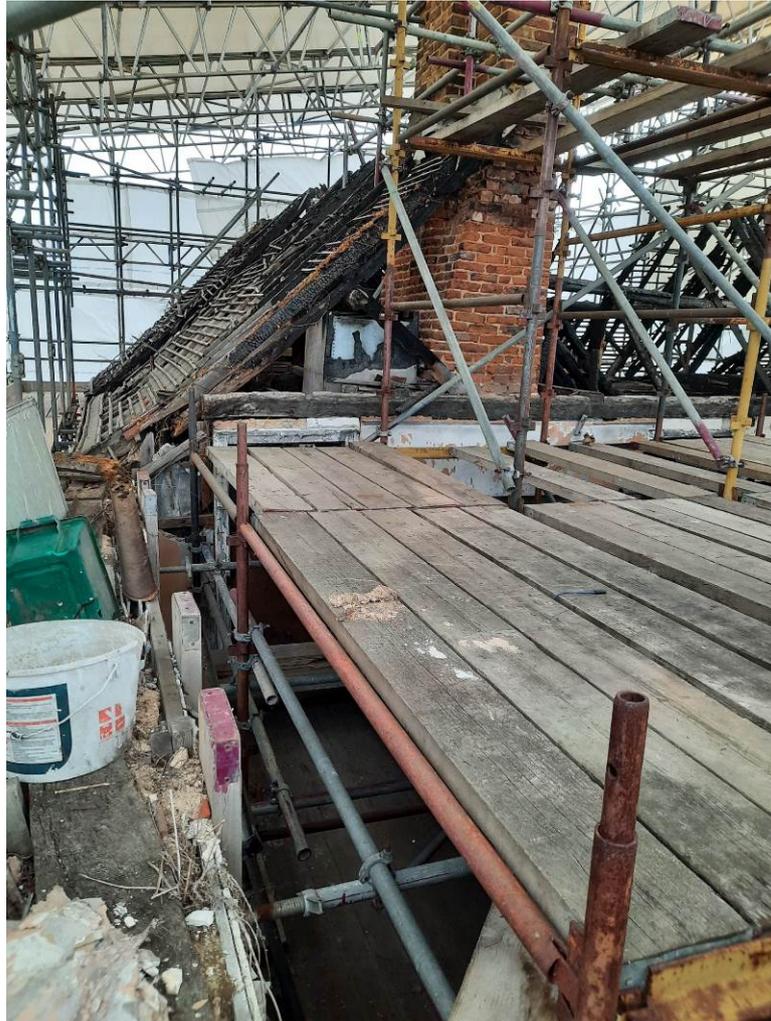
Area 1 was an addition to the original building, but still in a style that is sympathetic to the form and materials of the original building construction. The fire has completely destroyed the roof in this area. Only a few timber wall plates remain, however these wall plates indicate that a significant structural failure occurred pre fire. The wall plates that have failed are at the top of the walls to the southern and the western elevations, the walls in these areas also required rebuilding.

**Figure 2.2 - Roof area 1 with roof structure having collapsed**

This area will require new structure in the form of green oak queen post trusses in a similar manner to the survived existing trusses in areas 3 and 4.

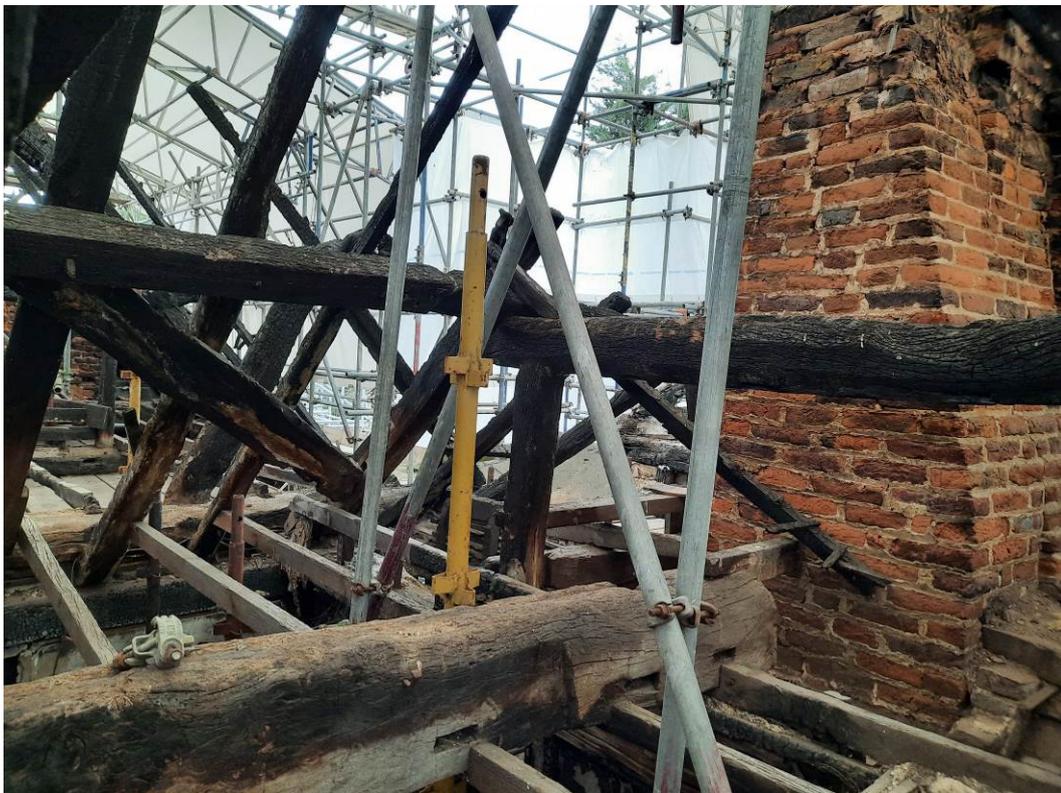
**Figure 2.3 - Roof Area 3 looking south east**

Area 3 was a later addition to the original roof but follows the same principles and form of the roof to the original building, with evidence of a junction around the chimney stack. The top part of the rafters to the queen post truss to the north of the stack requires replacing by means of splicing. This approach will preserve the maximum amount of

The purlin to the east side of the chimney requires replacing and the strut which supports it to the west side of the chimney assessed for suitability after charring is removed.

The queen post truss to the north of chimney needs to have its support to the east bearing assessed. The survey allowed for limited access and visibility to this, so needs to be investigated when possible.

historic timber. It is recommended to use 3 year air dried seasoned oak for this with a hidden stainless steel splice plate.

All common jack rafters require replacing with new rafters. It is recommended to replace these with similarly sized treated softwood rafters.

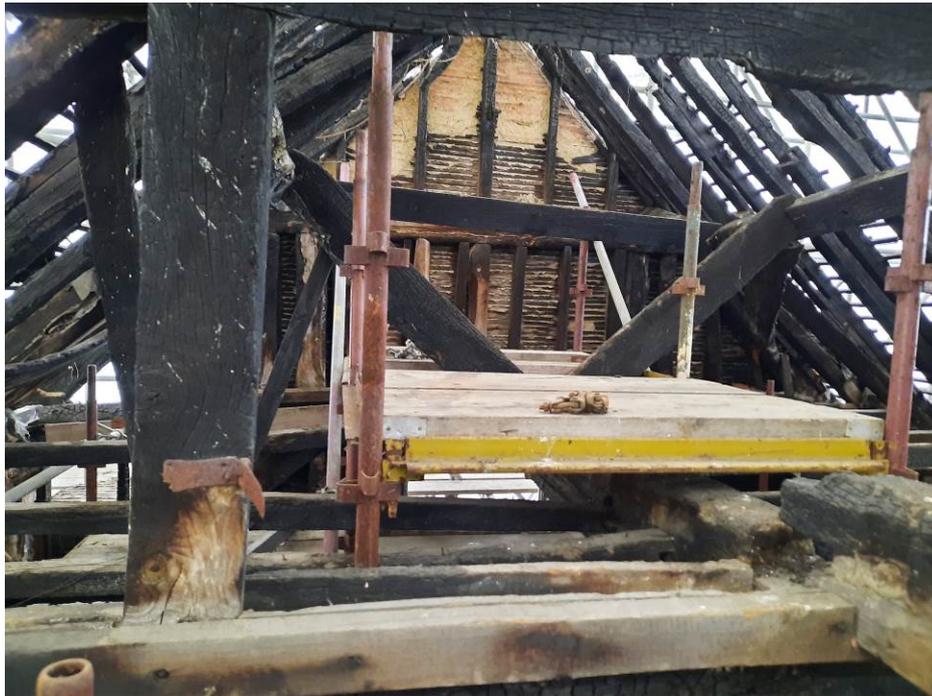
**Figure 2.4 - Roof Area 4 looking north**

Area 4 of the roof is part of the original house and has been seriously impacted by the fire. Most of the lower ceiling members, truss ties and struts to the trusses and purlins show evidence of charring, however these have not been structurally undermined, so have the potential to be retained. However, the top parts of the queen post truss will require replacing due to extensive damage. A similar approach to area 3 is recommended in order to preserve historic fabric.

The queen post truss to the north gable is in very poor condition and the external render has detached from the frame. The entire gable in this location needs replacing, due to extensive fire damage to the vertical timber studs. Replacement of the structure could be achieved through a timber framed gable as opposed to a replacement truss, which may make detailing of the wall more straightforward (weathertightness and insulation).

As with Area 3, the eastern bearing to the roof truss would need further investigation as the survey provided limited access and visibility.

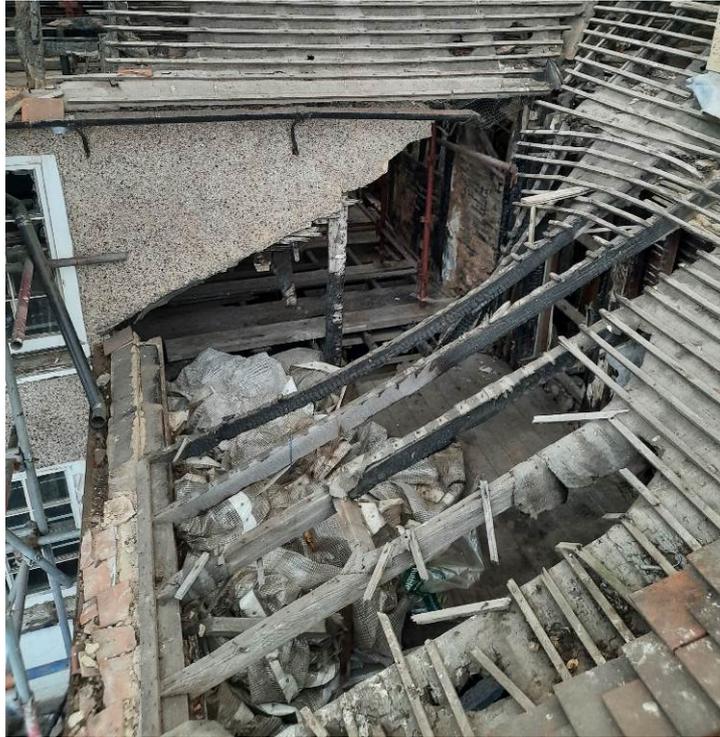
**Figure 2.5 - Roof Area 5**

Area 5 is another later addition to the original house and had a catslide roof which has partially collapsed due to the fire, whilst the majority of the surviving structural members display significant fire damage and would need to be replaced. Softwood common rafters would be a suitable replacement.

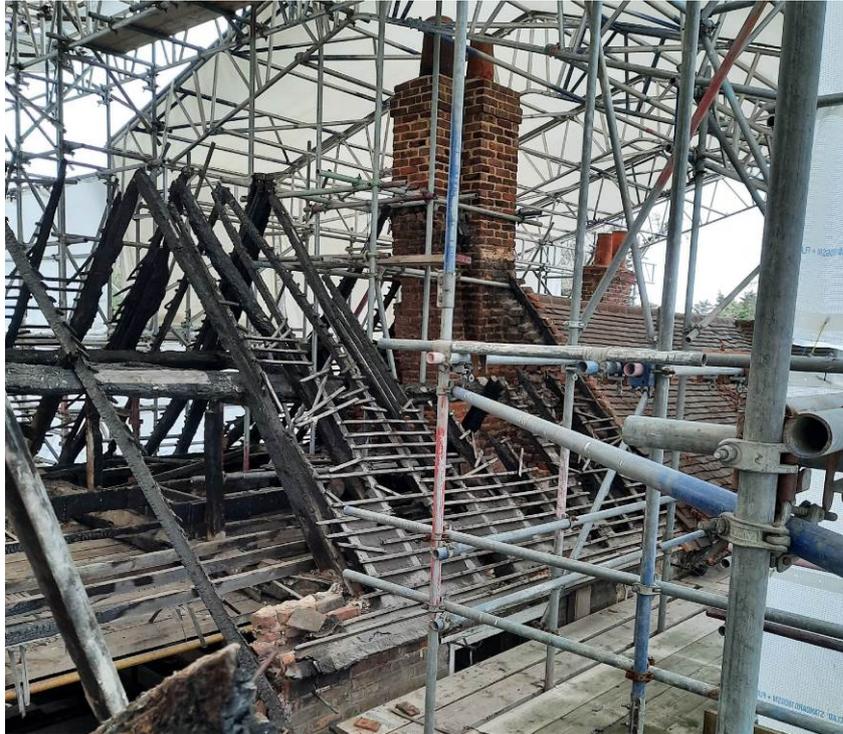
**Figure 2.6 - Roof Area 6**

Roof area 6 is part of the latterly extended eastern wing and has been heavily impacted by the fire. The roof structure in this area was timber queen post trusses in a similar arrangement to the original house, but of lower quality than area 4. This area has sustained more damage than area 4 and will require complete replacement as a result of the fire damage. There is however sufficient evidence remaining to remake the primary structure on a like for like basis using green oak for trusses and purlins and treated softwood for common rafters.

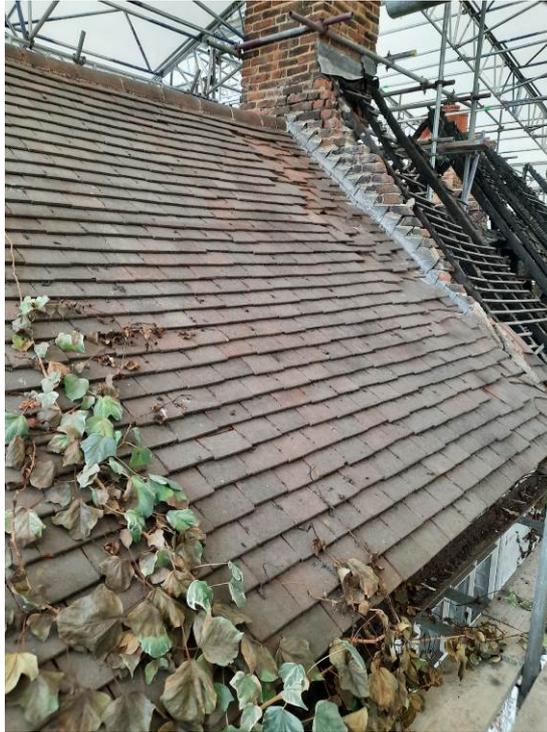
**Figure 2.7 - The external view of roof area 7**

The surveys did not allow for internal access to this area of the roof, however external inspection was possible. From what could be seen, this area of the roof displays not signs of fire damage from a structural perspective nor of any obvious structural damage or failure. It is anticipated that there will be a level of repairs required in this area once it has been inspected, so allowances must be made for some rafter replacements, rafter end replacements and valley replacement.

The masonry gable wall between roof areas 6 and 7 is mostly intact following the fire event, but local repairs may be required after further investigation and the wall should be repointed using NHL 3.5 lime mortar.

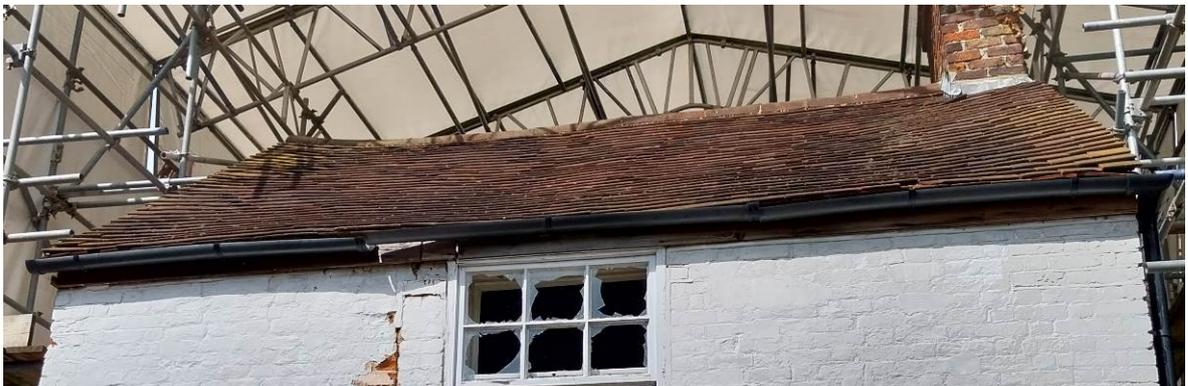
**Figure 2.8 - Roof area 8 from the east elevation**

As is the case for area 7, there was no internal access to the roof for area 8. Whilst externally it shows little evidence of fire damage, it does show signs of structural failure as a result of insufficient lateral restraint from the wall to the thrust at the base of the rafters.

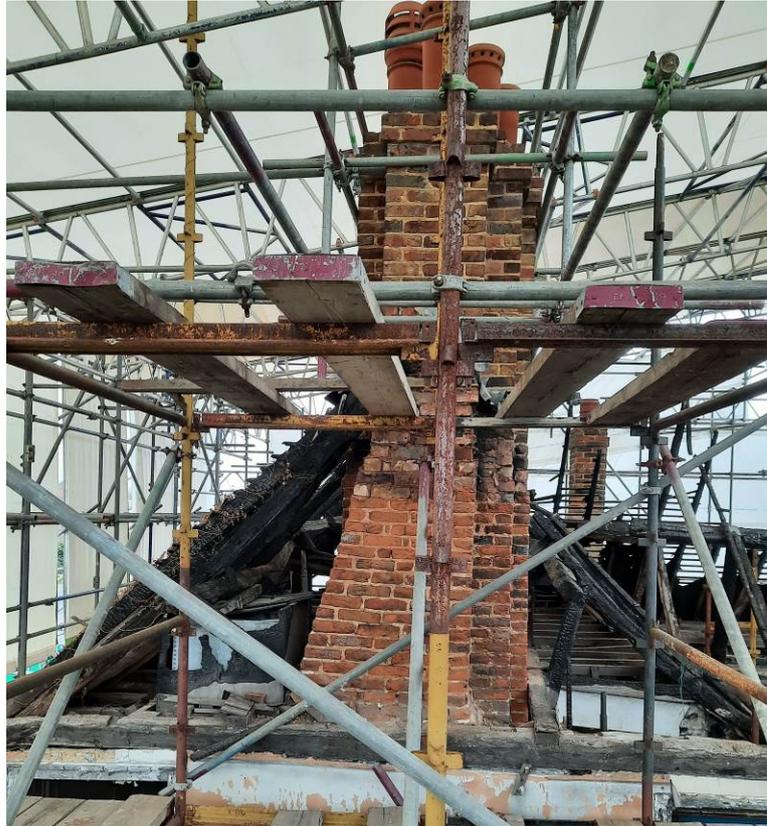
**Figure 2.9 - Southernmost Chimney**

All of the brickwork chimneys remain in reasonable condition and do not appear to pose any concerns from a structural perspective, with any damage appearing to be localised and should be repaired accordingly. The brickwork to the chimney should be repointed using NHL 3.5 lime mortar, with the top 4 courses rebuilt with NHL 5 lime mortar. Repointing above roof level will be required.

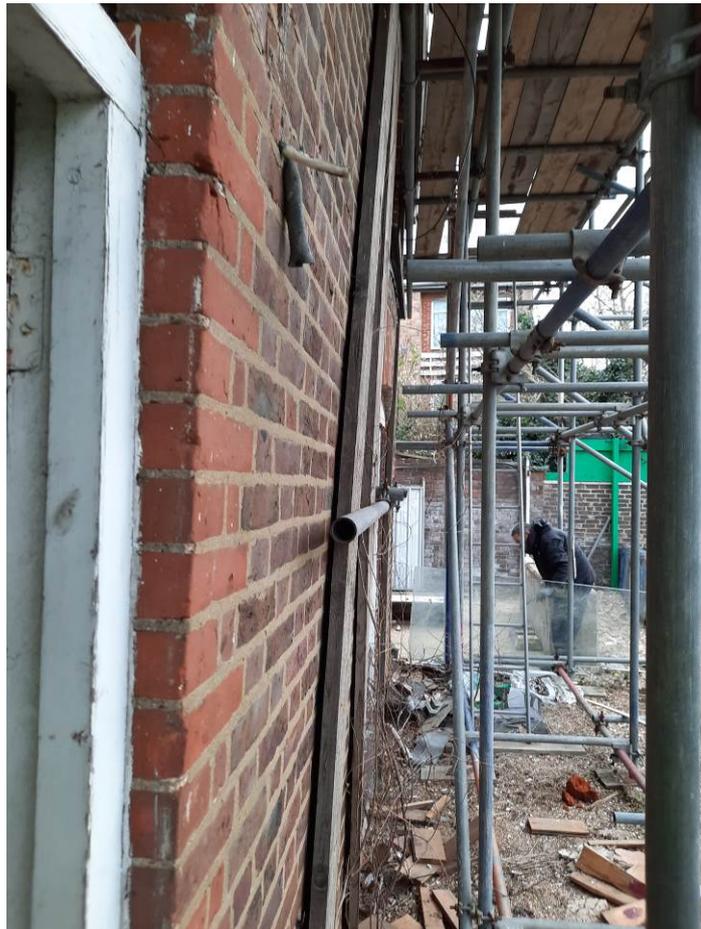
The southern part of the elevation, where the roof has collapsed, is leaning out significantly due to long standing lateral thrust that predates the fire.. This extends from the southern wall to the main entrance doorway and encompasses the area above this doorway. This failure has to be resolved by the rebuilding of this portion of the wall. This rebuild may also include the replacement of the footings if found to be insufficient when exposed.

**Figure 2.11 - Portion of the Western Wall demonstrating lean present**

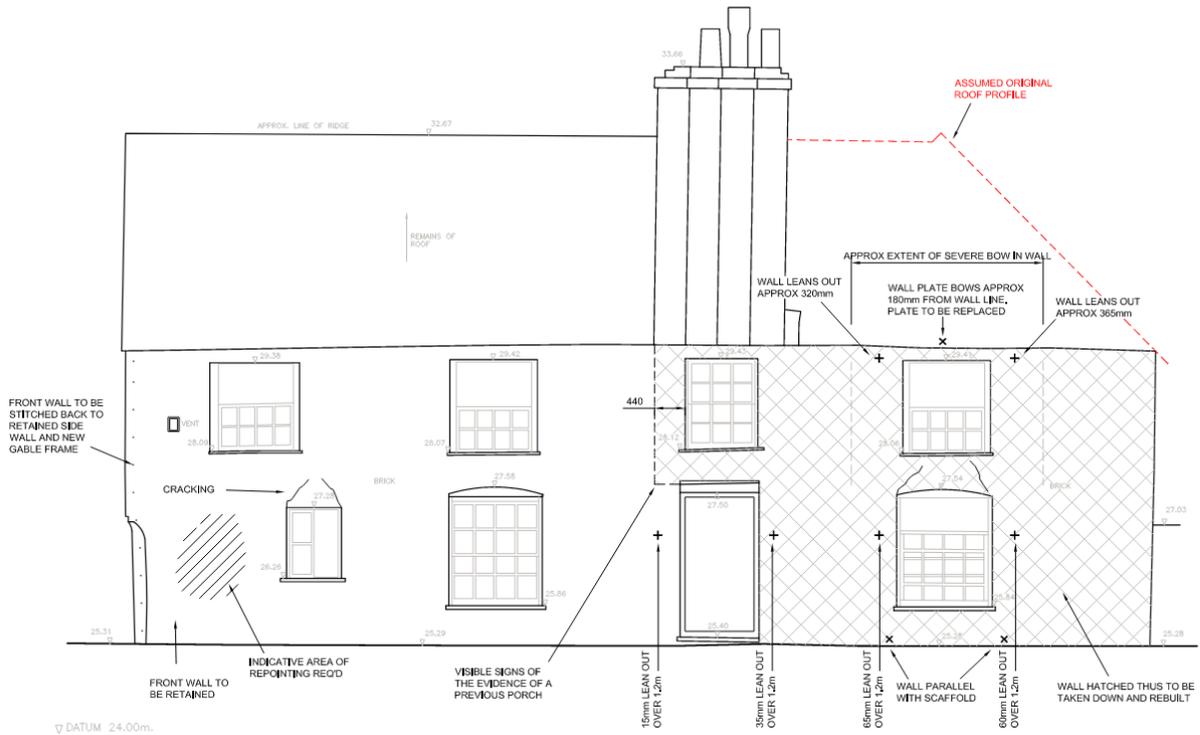
Figure 2.12 - Overview of findings and repairs to the western elevation

There are areas of the masonry on the elevation that require repointing in lime mortar which will be identified on any repair layouts, see Figure 2.12.

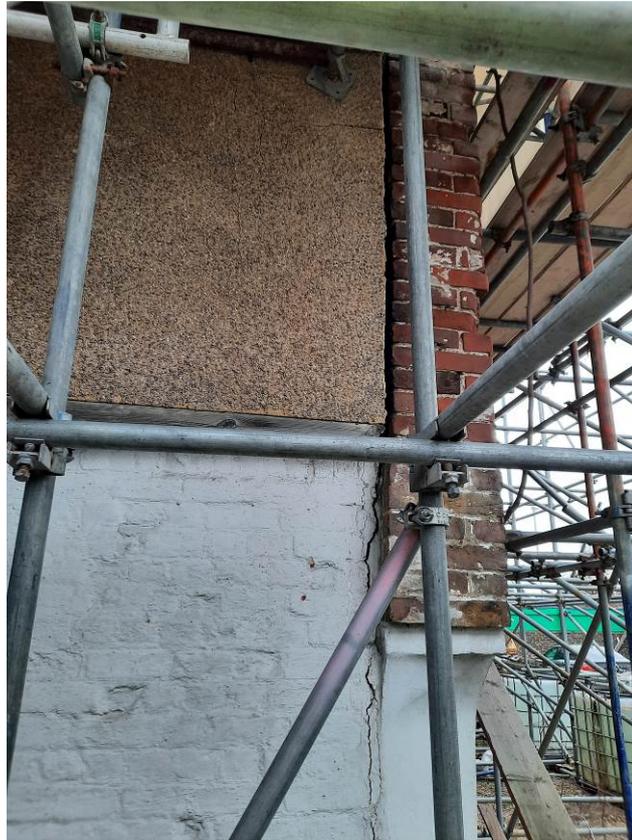
The first part of the northern elevation is part of the original building and is showing various signs of damage that require intervention. The first of these is cracking at the corner to the western elevation, where the return is separating from the elevation. This is

**Figure 2.14 - The crack to the north west corner**

required to be stitched back into the northern elevation from the ground up to eaves level. This can be achieved through the use of sock anchors approximately 1.0m long.

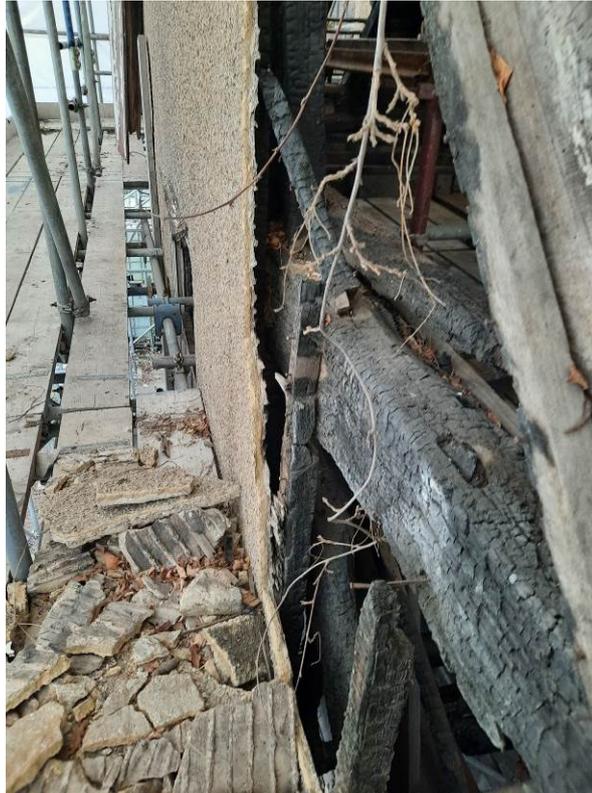
**Figure 2.15 - The Northern Gable**

The western portion of the wall at first floor and roof levels is constructed in a timber frame with an external pebbledash render, however this has exhibited damage to the point of needing replacement. The first floor and gable is fire damaged beyond repair and should be rebuilt in timber frame, also allowing for modern insulation to be incorporated for future habitation. The same applies to the portion of wall to the rear of the later extension at first floor level, see Figure 2.17.

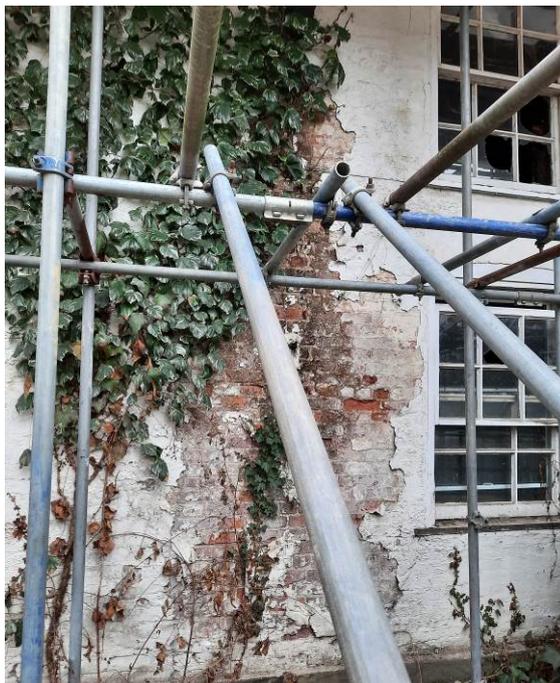
The eastern part of the elevation is showing signs of water damage owing to damaged/missing guttering and downpipes. This requires replacement to ensure no further damage to the external masonry, see Figure 2.16, the brickwork will also require consolidation with local replacement and repointing.

**Figure 2.16 - Water damage to the northern external wall**

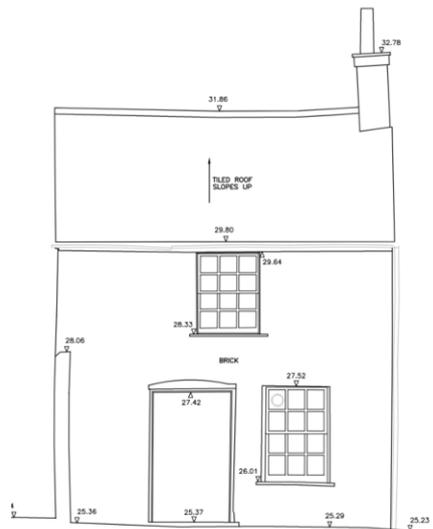
Figure 2.18 - Eastern Elevation

The eastern elevation shows significant bowing out at the eaves level owing to the roof spread above (see 2.1.8). This wall requires tying into the first floor structure to help laterally restrain the wall and ties within the roof/ceiling structure. The nature of this repair is unclear currently as the area was inaccessible during the inspections, so further investigation is required.

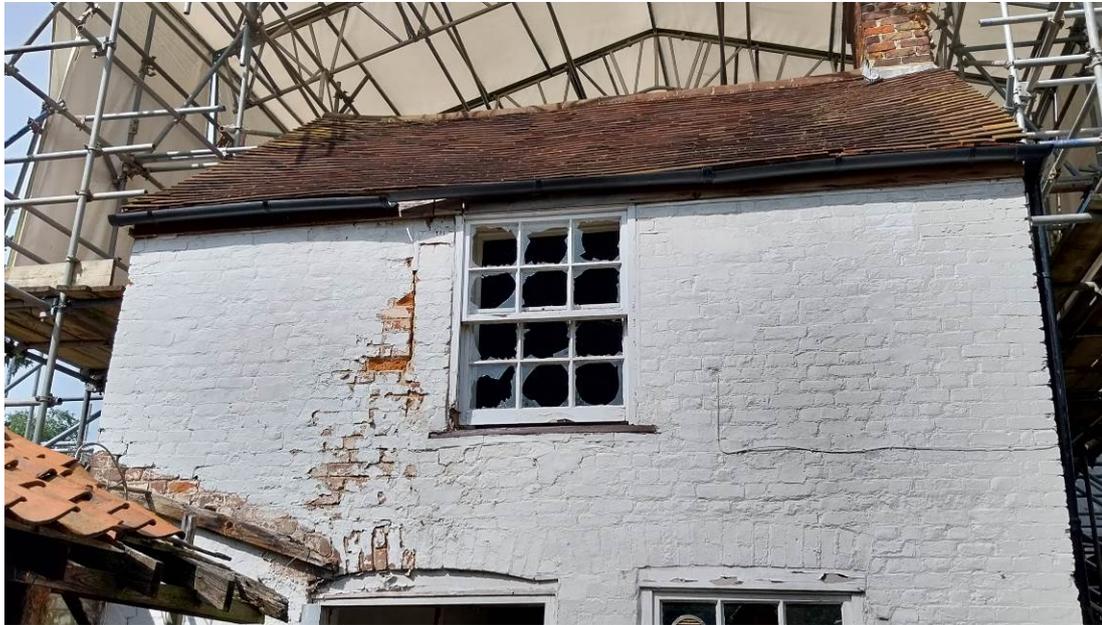
**Figure 2.19 - The first floor of the western elevation**

There is also an area to the southern side of the first floor window showing some cracking in the masonry where it looks as though some infill has been applied to accommodate a smaller window (Figure 2.19) than what would have been the original. This area of brickwork requires to be rebuilt and stitched in to the adjacent masonry.

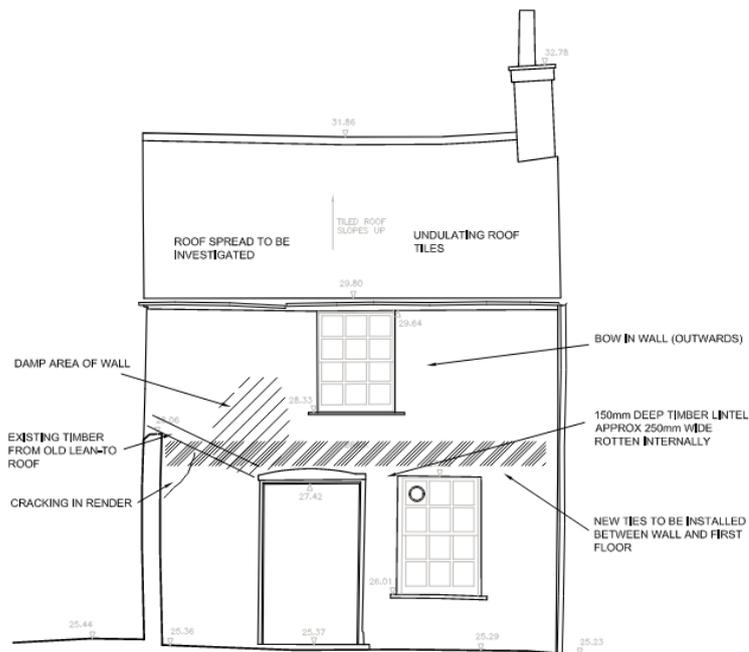
The southern corner has a number of cracks between the ground and first floor where the return requires strengthening, this should be achieved by anchoring the corner with bent Helifix (or similar) bars in the bed joints.

**Figure 2.20 – The eastern elevation with repairs and observations**

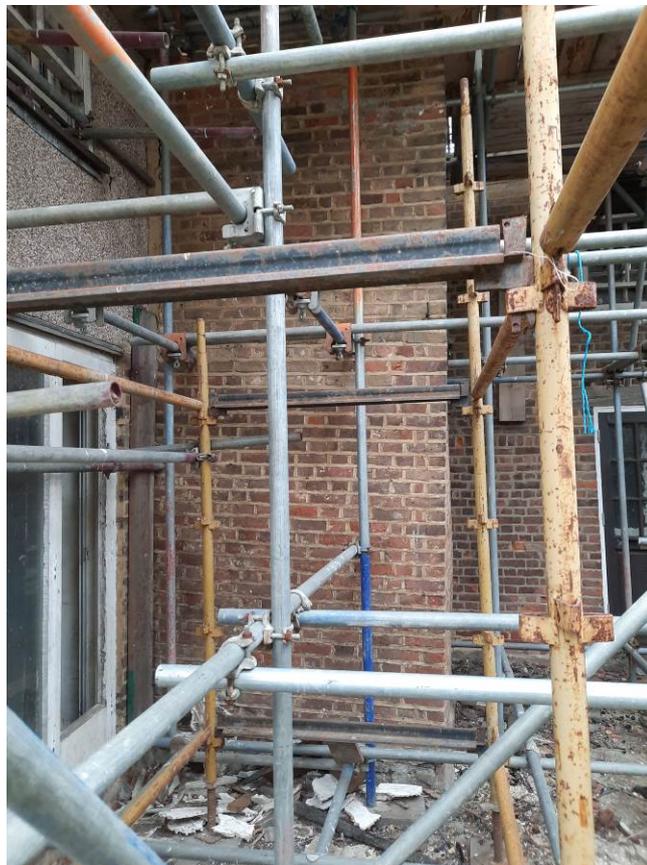
The next part of the southern elevation is the staircase that forms the return between the original house and the eastern wing and is a latter intervention to the building. This section of the building shows signs of significant structural failure with a large lean outwards from the original construction as the level ascends. This lean has also resulted in the debonding of the masonry between this stairwell and the original wall at higher level, see Figure 2.23. This portion of the building is to be taken down and rebuilt, with the foundations assessed for suitability prior to the walls being rebuilt.

**Figure 2.23 - The stair extension displaying structural failure**

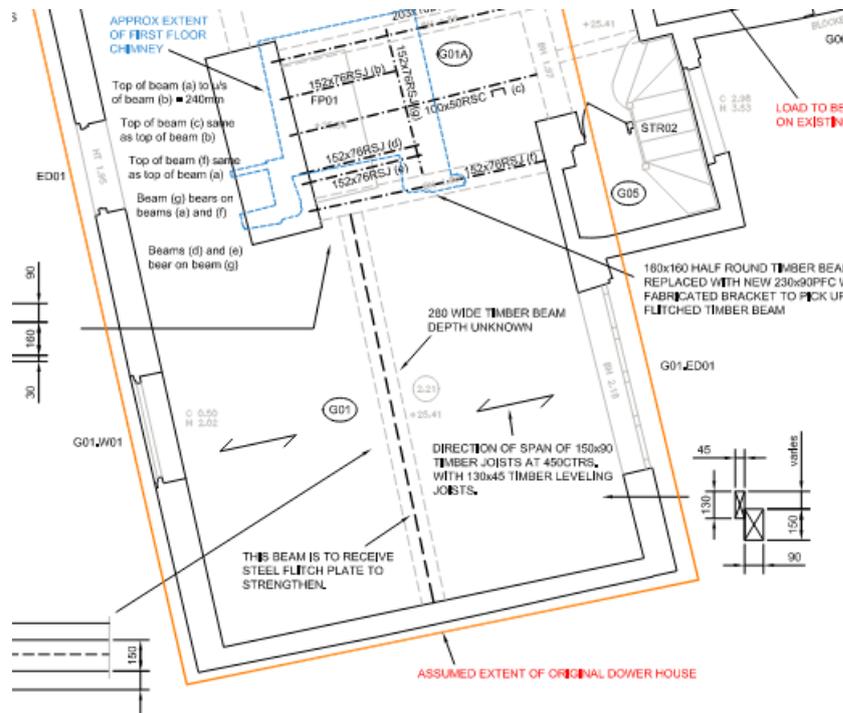
Figure 2.25 - Southern Portion of Dower House Ground Floor

The southern portion to the ground floor at the Dower House has a timber floor above with a beam that spans north to south in the middle of the room which bears on the southern gable wall and onto a timber half round beam, supporting floor joists that span

east to west. This beam may need to be strengthened as it shows evidence of sagging, for which we would propose the use of a steel flitch plate in order to retain the maximum amount of original fabric. The timber beam at the chimney end of this beam appears to be under strength and we would propose the use of a steel channel section to support the end of the original timber floor beam.

The current fireplace arrangement is a modern intervention and current proposals recommend its removal. The chimney breast above is supported by a number of steel beams within the floor space. It would be too complex and potentially damaging to reverse this so it is recommended to retain the steel supports whilst a new chimney breast is built to reflect what is believed to be similar to the original, off a 200mm thick reinforced concrete slab.

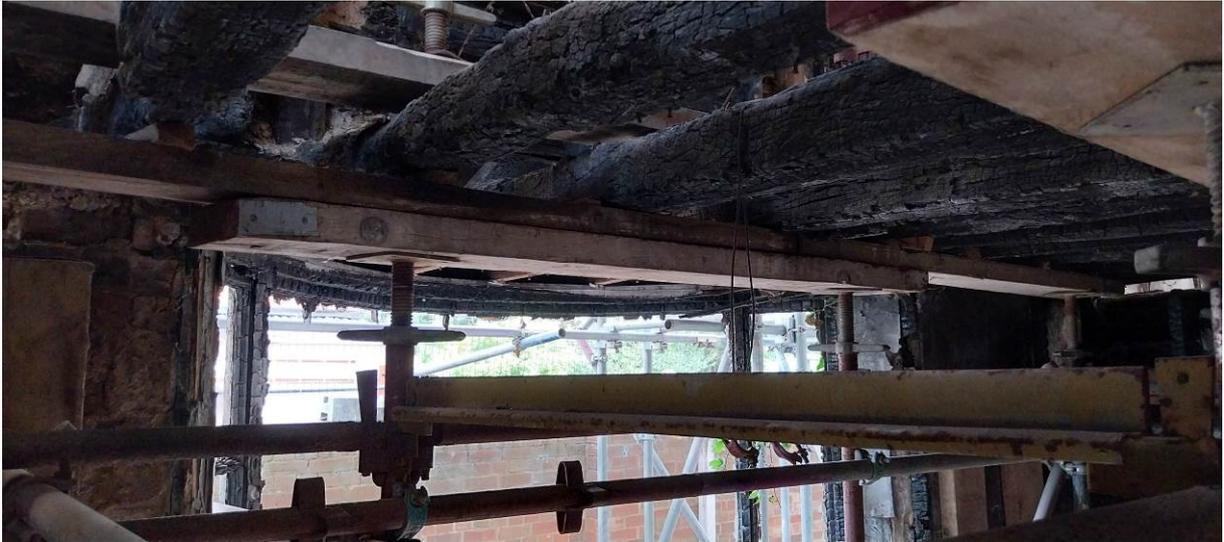
The first floor structure to the northern part of the original house shows signs of fire damage, with some joists with charred/missing ends and some joists missing entirely. These are to be replaced where missing or spliced with new ends if possible where the ends are charred or damaged, alternatively, replaced entirely.

Figure 2.27 - Charred joists to the north end propped up

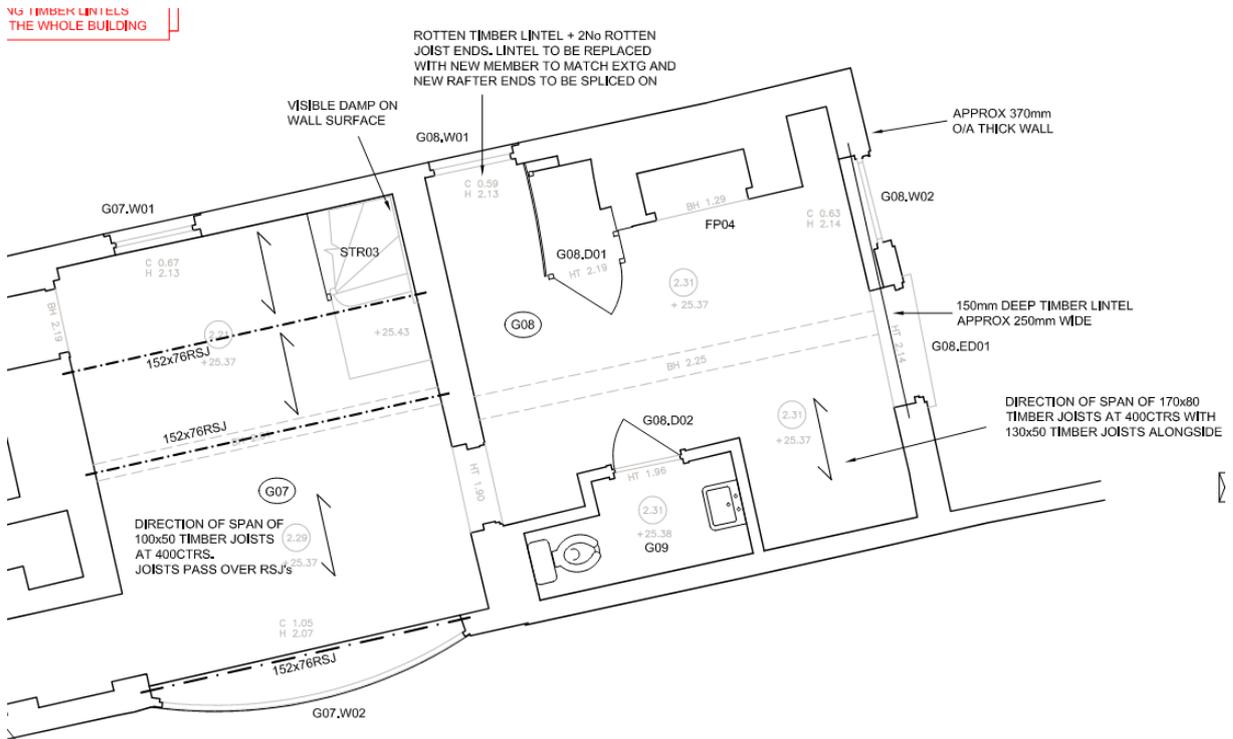
Figure 2.28 – East Wing

The walls to part of the east wing show evidence of damp and allowance must be made for joist replacement and joist end replacement due to rot and moisture damage. This

continues into the easternmost room where this rot has reached the lintel over the northern door.

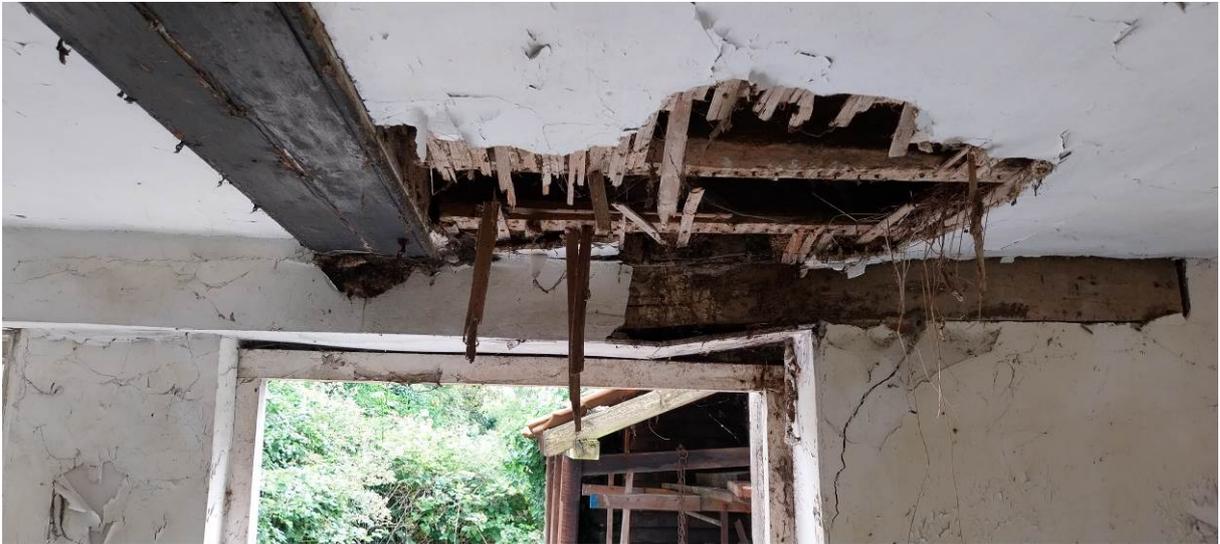
The lintel over the eastern openings into the garden has structurally failed and requires full replacement, see Figure 2.29.

**Figure 2.29 - Failed lintel to eastern doorway**

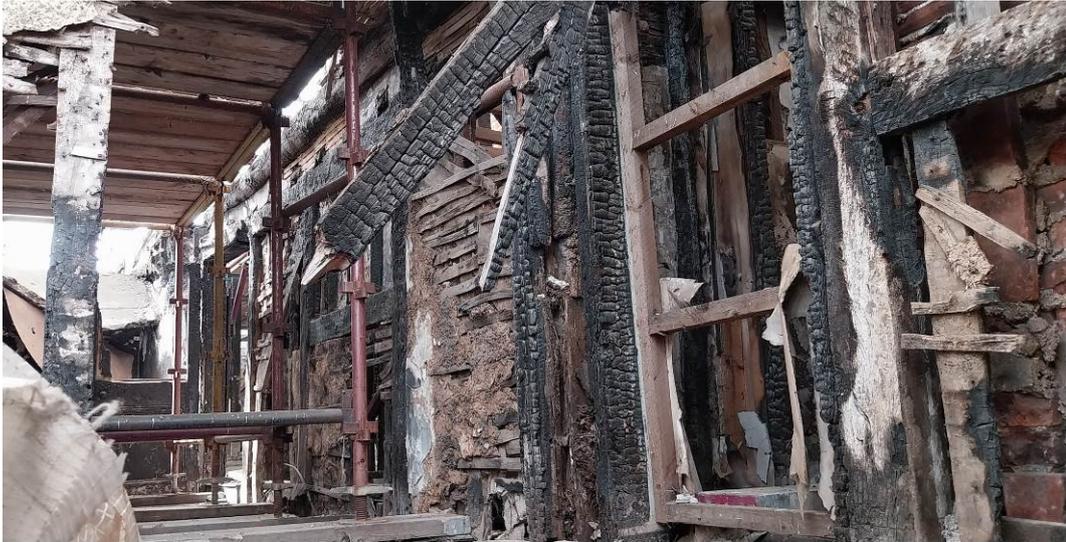
The fire has exposed some of the original structure which would have formed the external timber framed wall to the original house but then latterly was internal, abutted but the eastern wing and possibly covered, see Figure 2.30.

**Figure 2.30 - Original timber frame at first floor**

The timber elements for this wall should be assessed for suitability for repair by specialist and replaced where necessary.
