Arboricultural Report

Arboricultural Impact Assessment

Pocket Park - UKPNS EV Charging Project

6th January 2026

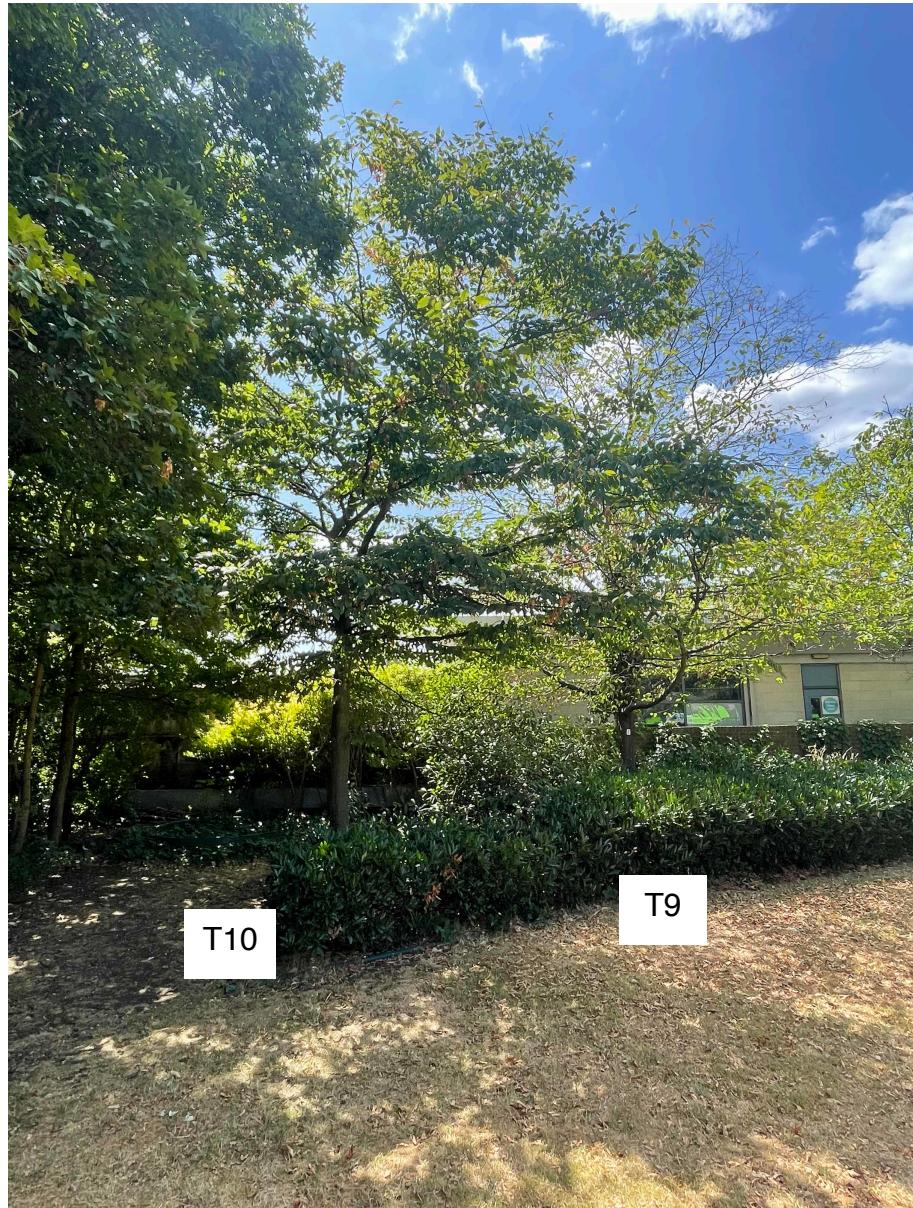
3.5.2. Possible routes for the new cabling have been analysed in order to find the best route, which will cause the least harm and this is the route shown on the Tree Protection Plan. This will require the loss of trees T1 Horse Chestnut and T9 Hornbeam and T10 Hornbeam, all the trees are classed as U grade - unsuitable for retention.

The route will require the removal of trees T9 and T10 shown above

3.10.1. There are three trees that are to be removed in order for this route to be instigated. T1 Horse Chestnut and two Hornbeam trees T9 and T10 north east of the Taxi Canteen. Due to the cabling beneath the surface, it is recommended that large growing shrubs replace the lost trees.

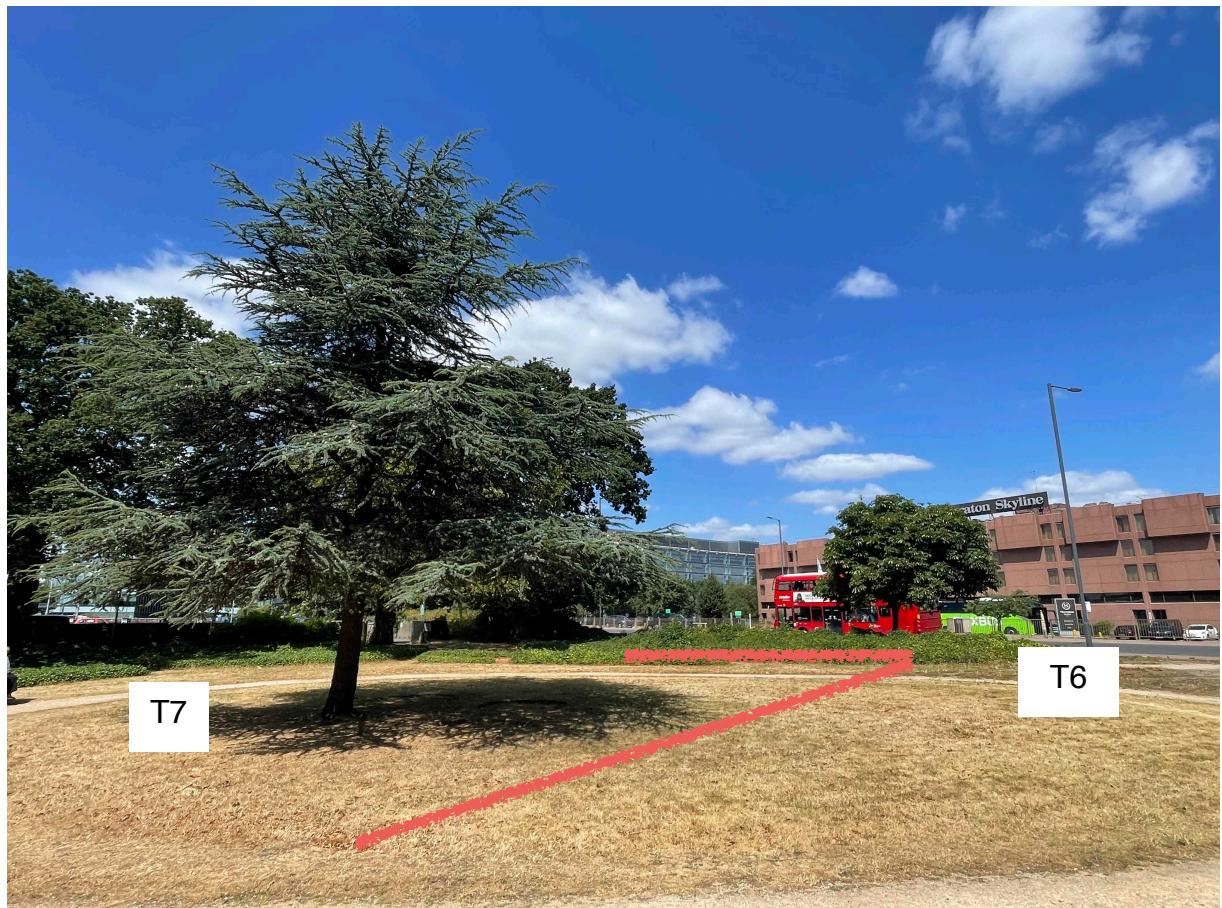
The cable route will be close to the northern edge RPA of T3 and 2m to the east of T7 so extra care is required when digging the trench that runs parallel to those trees. Site monitoring is therefore required to ensure damage is limited in regard to T3 and hand digging maybe essential based upon physical evidence at the time.

The route will avoid the RPA of T6 and T7

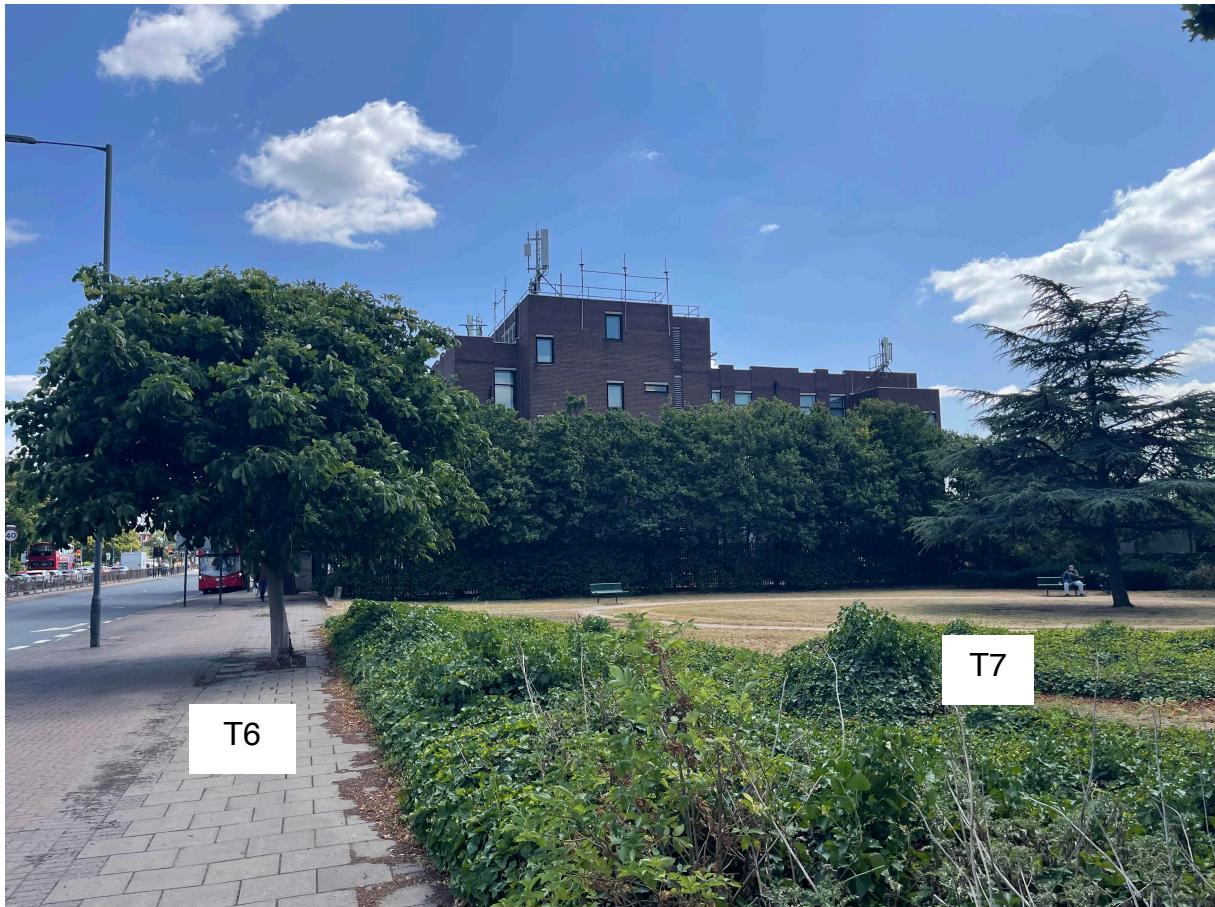
The route will avoid the RPA of T6 and T7

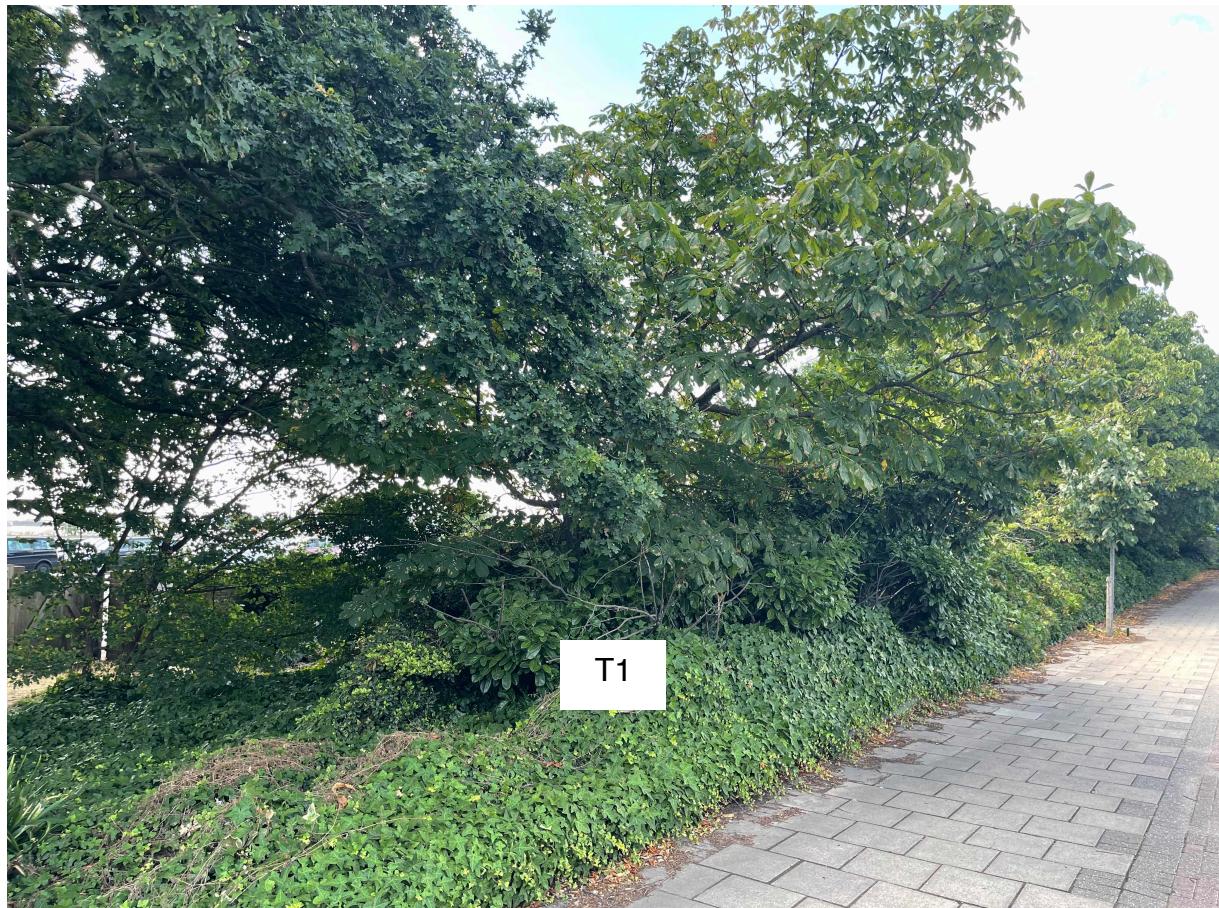
The route will require the removal of T1

4.5.1. Tree surgery is required to remove trees T1, T9 and T10 and this work should be undertaken to BS 3998:2010 Tree work. Recommendations.

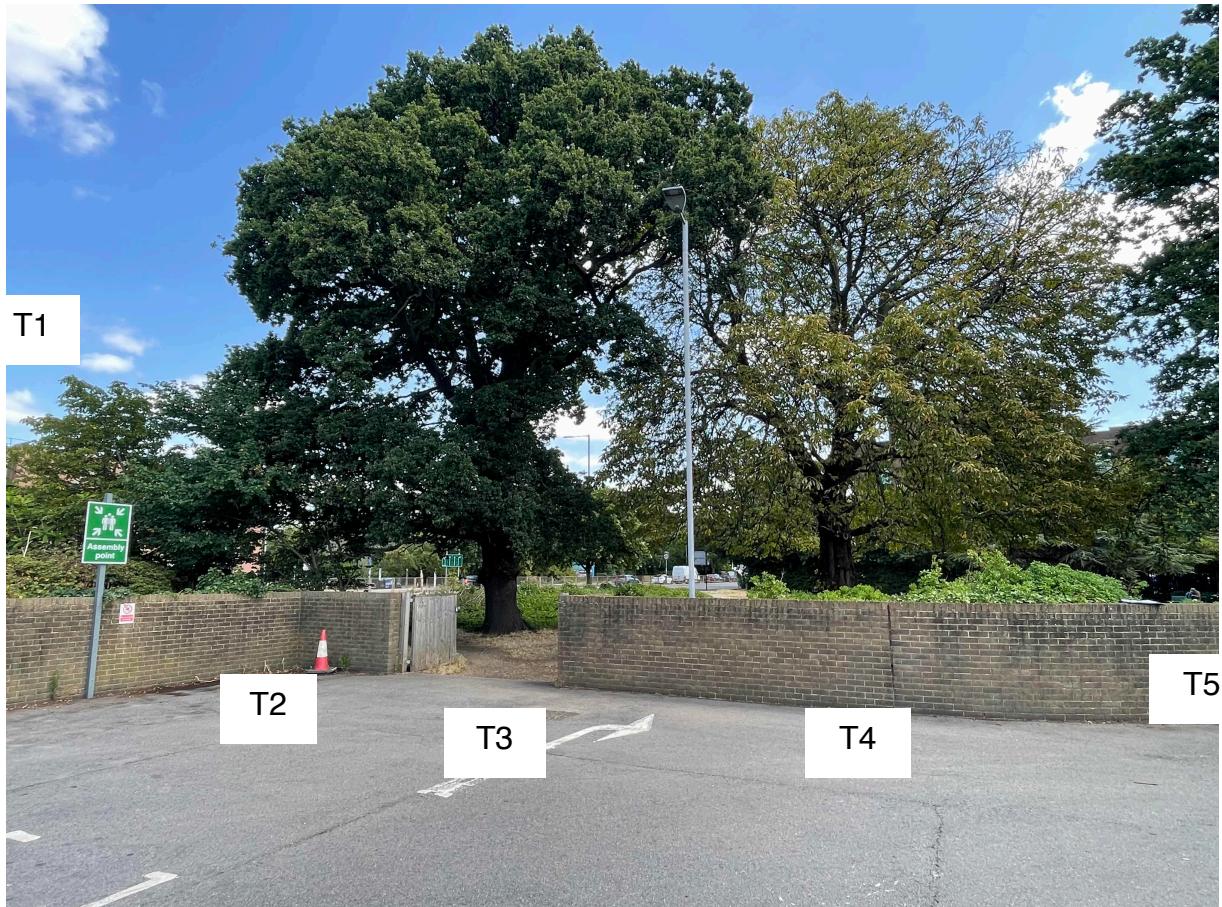
View from the Taxi Feeder Park

The route will require the removal of T1
TPO trees T3/4/5 remain and will be protected by fencing within a
Construction Exclusion Zone

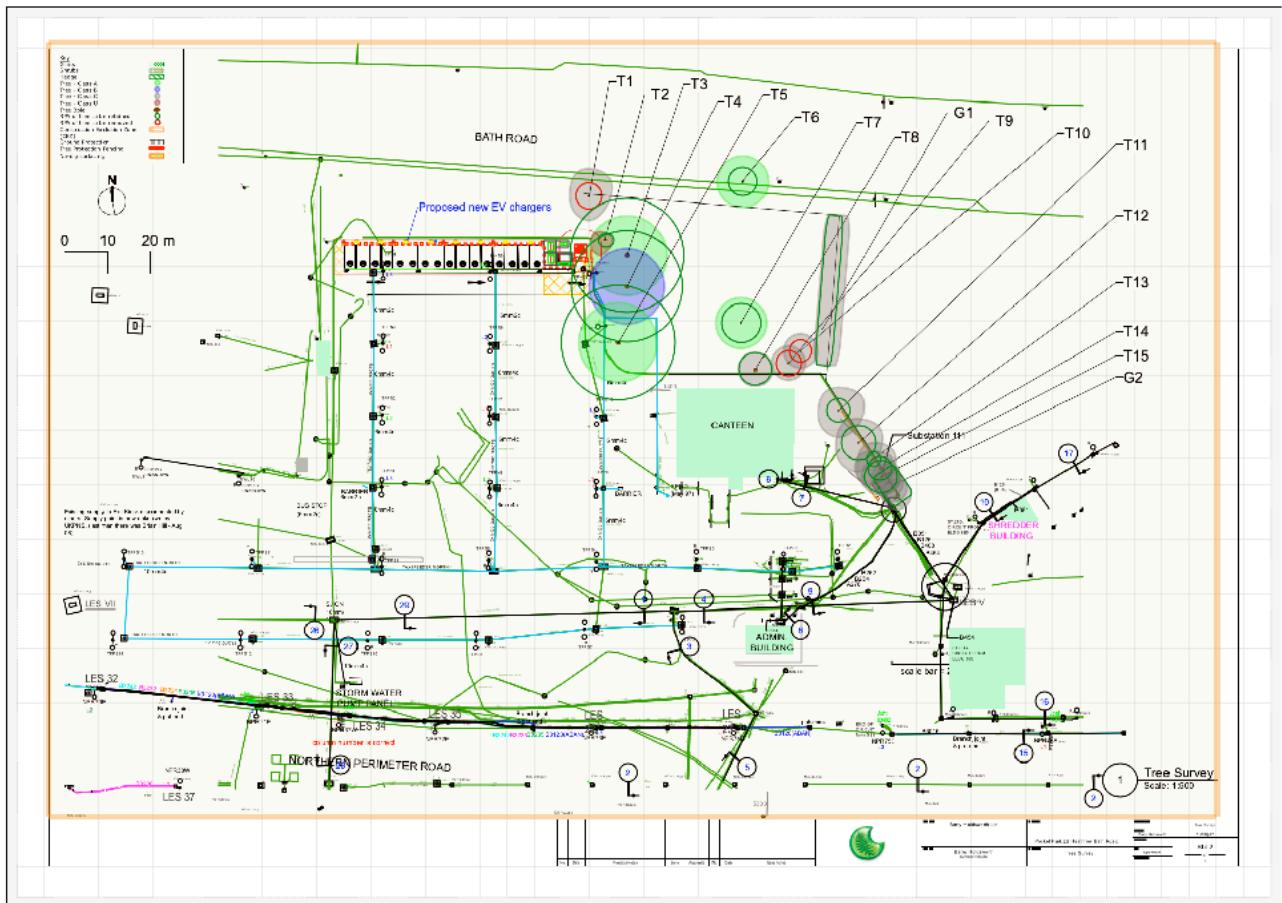
Appendix 2. Tree Protection Plan

3.7.2. The Tree Protection Fence will create a Construction Exclusion Zone (CEZ) and this is shown as orange hatching on the Tree Protection Plan (Appendix 2. Tree Protection Plan).

4.4.1. The protective fencing that forms the CEZ will be erected along the lines indicated on the Tree Protection Plan by Barry Holdsworth Ltd, together with the ground protection measures as detailed above prior to commencement of any development works on the site.
