Tree survey

Sipson Village

Jonathan Hazell
Independent arboricultural consultancy
8 July 2013

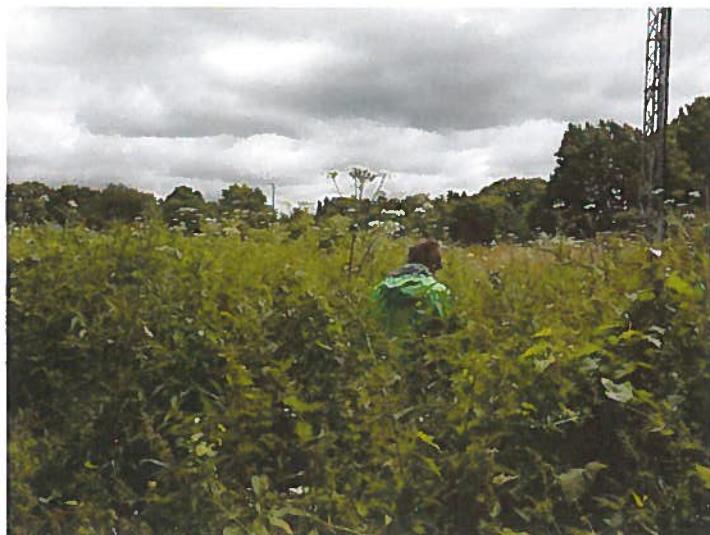
1. A significant proportion of the site was overgrown with head-high ruderal vegetation which prevented pedestrian access.

Image 1: the head-high ruderal vegetation that covered much of the site

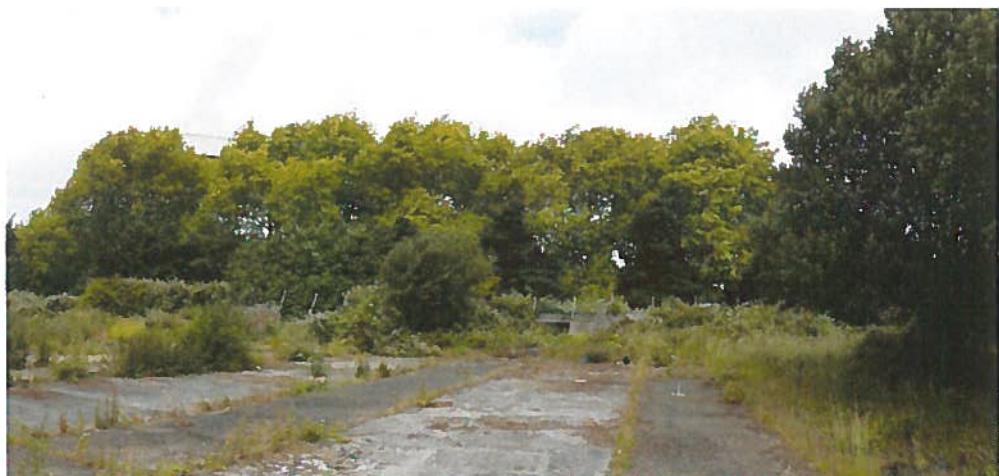
2. Access to the whole of the northern boundary was constrained by the continuing presence of the garden centre's secure boundary fence adjacent to where the poly-tunnels of the now-abandoned garden centre had once stood.

Image 2: the northern boundary showing the garden centre's secure boundary fence (panorama)

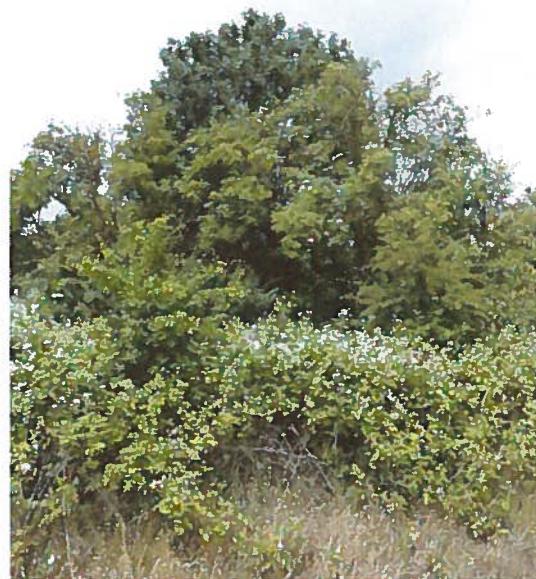
3. Access to the rear of the properties along Sipson Road and Russell Gardens was impossible due to the overgrown nature of the site.

Image 3: the mass of vegetation behind Sipson Road

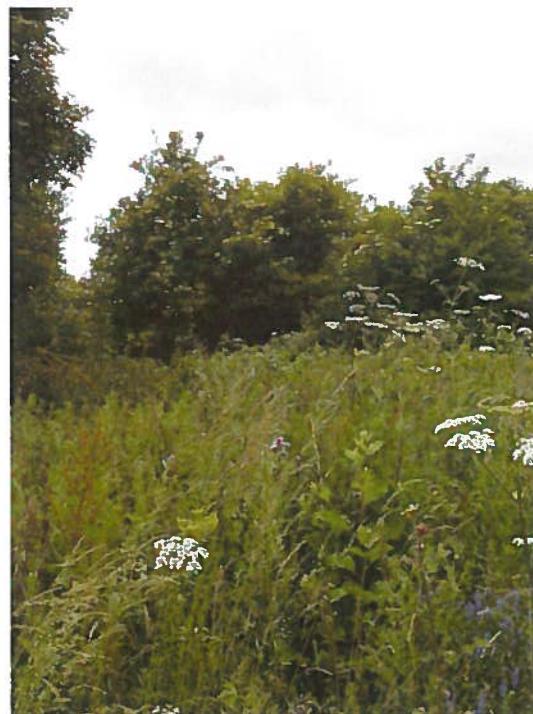
4. Access to a significant proportion of the south of the site was denied by the presence of informal, but none-the-less secure, barricades and fences. These barriers, which may have been in position for some years, were often disguised by the burgeoning vegetation but may be just glimpsed in several of the site photos.

Image 4: one small section of barrier is just visible in the centre of the image

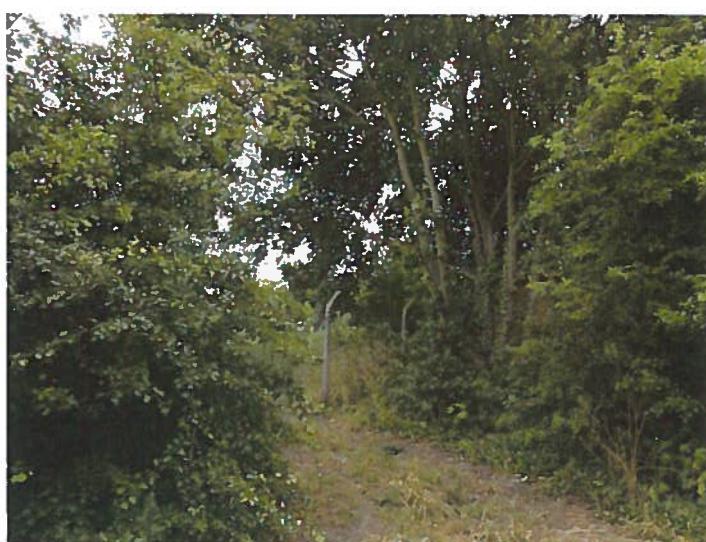
1. I gained access to the site through a gate in the south east corner where a substantial multi-stemmed sycamore (*Acer pseudoplatanus*) had been poorly crown lifted to allow high sided vehicles to access the site through the gate.

Image 5: the sycamore in the south east corner of the site, branch removal is evident presumably to allow access to the site for high sided vehicles

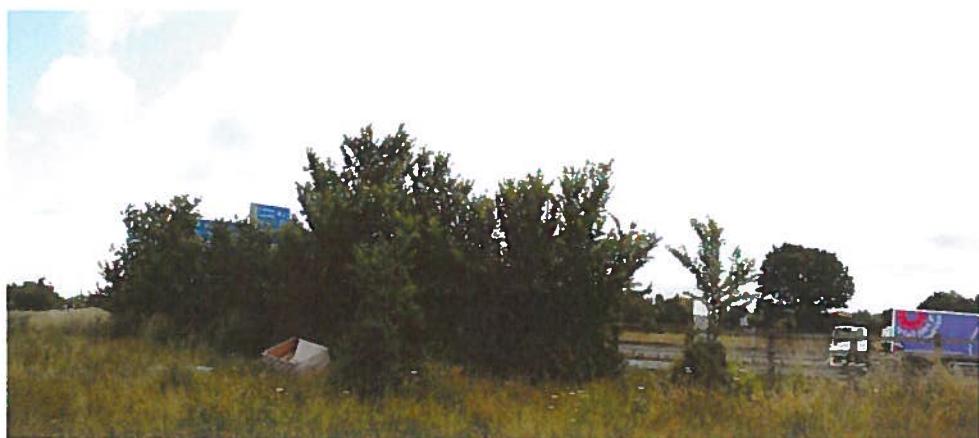
2. I then moved north along a well-defined but informal vehicle track, passing a patch of elm sucker regeneration (*Ulmus* sp.) near to the overhead gantries over the M4 spur into Heathrow airport, but was unable to access the north eastern boundary because of the wild and overgrown nature of the site. Where individual trees existed they were of pioneer species, such as hawthorn (*Crataegus monogyna*) or goat willow (*Salix caprea*), and were small (both low growing and with compact canopies) and apparently therefore relatively recently established. I did not see any individual trees or groups of trees of merit, as assessed under *Table 1*, in this part of the site.

Image 6: the elm regeneration on the eastern flank of the site (panorama)

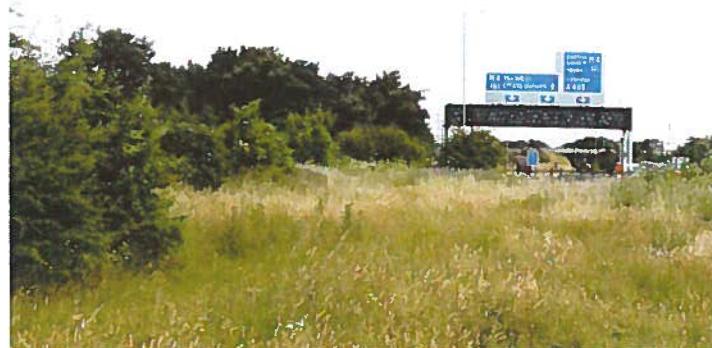
Image 7: the ruderal vegetation to the north of the site

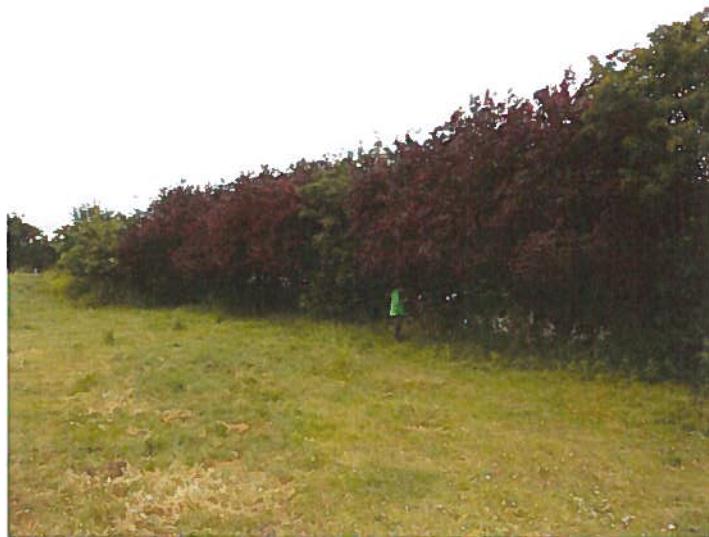
3. I was able to access the individual trees surrounding the abandoned garden centre buildings in the north west corner of the site and to use the GPS device to record the locations of individual trees in this area. These planted, as opposed to self-set, trees fell into two categories:
 1. individual exotic ornamental conifer cultivars of Lawson cypress (*Chamaecyparis lawsoniana*), which had presumably been planted to advertise the garden centre business, and
 2. a broadleaved hedge primarily composed of purple leaved plum (*Prunus cerasifera Nigra*) with the occasional mountain ash (*Sorbus aucuparia*).

Image 8: looking north west along the hedge along the northern boundary, T5 to the left of centre

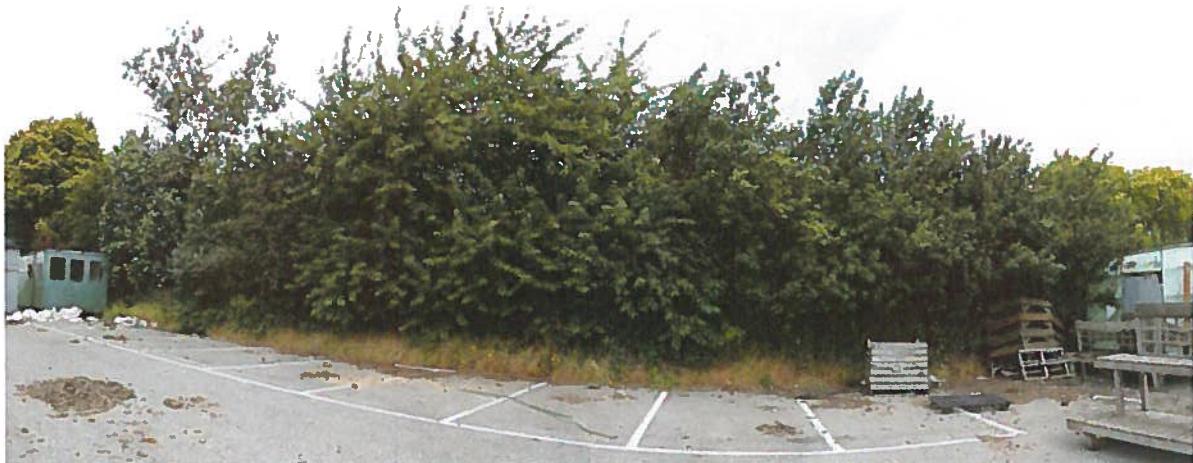
4. A fence to the north of the car parking area prevented access to an apple (*Malus domestica*) and a flowering cherry (*Prunus avium* in variety).

Image 9: beyond the car park fence (panorama)

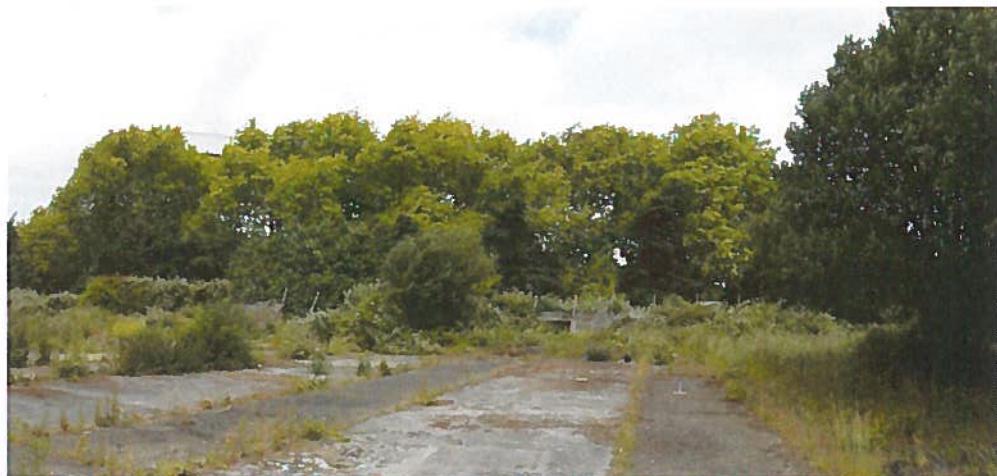
5. Where the site boundary stepped to the north behind the abandoned buildings (where the goat willow (*Salix caprea*) T26 was located) I was denied access once again to the edge of the site by the rampant vegetation. Whilst flowering cherry was again evident I did not see any individual trees or groups of trees of merit, as assessed under *Table 1*, in this part of the site. The poplar evident in the panorama below were on the Holiday Inn site, the pine may have been within the site boundary but were inaccessible.

Image 10: the northern boundary, looking out of the garden centre (panorama)

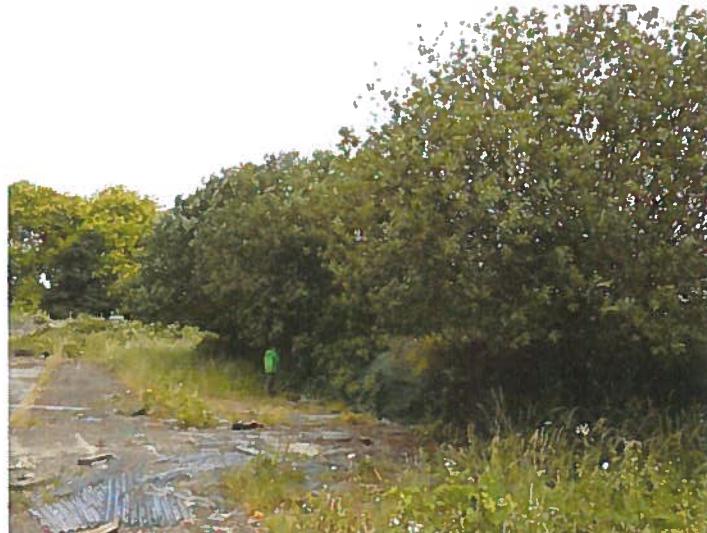
6. On the eastern limit of the concrete pad behind the abandoned buildings a few goat willow (*Salix caprea*) had struggled to establish themselves: all were multi-stemmed, some had been damaged by grazing horses, but none was considered worthy of retention as assessed under *Table 1*.

Image 11: the goat willow flanking the concrete pad

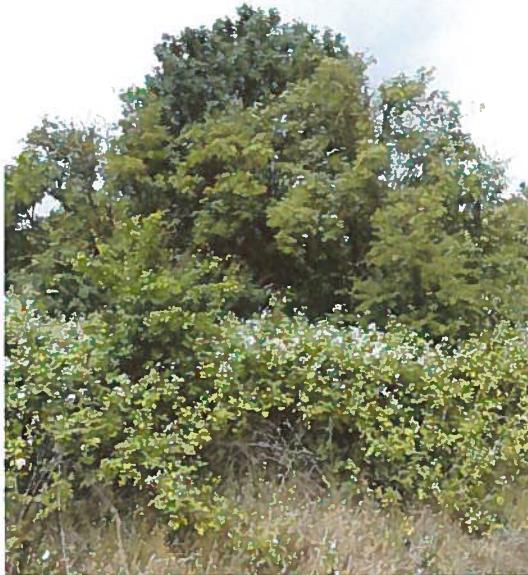
7. The boundary to the west of the site, south of the garden centre and bordering the rear gardens of Sipson Road and Russell Gardens, was out of reach but a relatively tall ash (*Fraxinus excelsior*) was plotted by eye rather than by using the GPS. As it was not possible to access the tree it was not possible to assess its diameter or its condition, and so the categorisation of the tree under *Table 1* has not been carried out.

Image 12: the ash behind Sipson Road

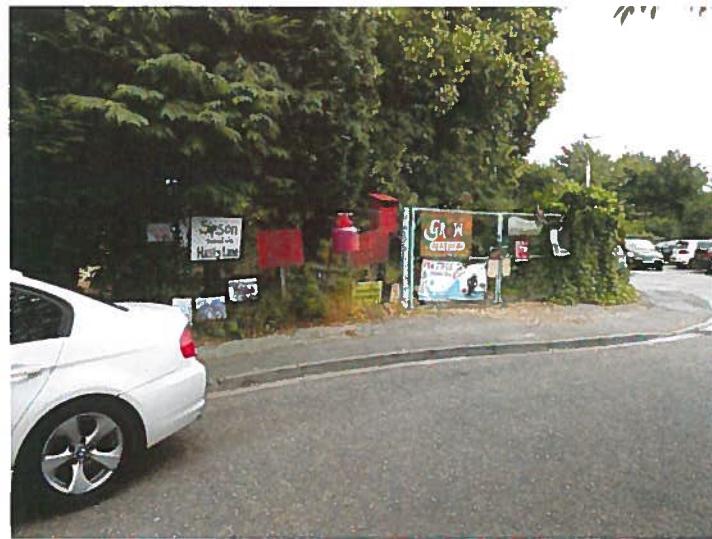
8. Working south along the western boundary proved to be impossible, not simply because of the vegetation but because some of the site seemed to have been occupied and secured: members of an informal community *Transition Heathrow* living outside the south west corner of the site suggested in conversation that they may have been responsible. The aerial photography from both Google™ earth and bing™ maps suggests that there may have been a number of unregulated structures and barrier fences on the site for some time.

Image 13: the entrance to Transition Heathrow in Vineries Close

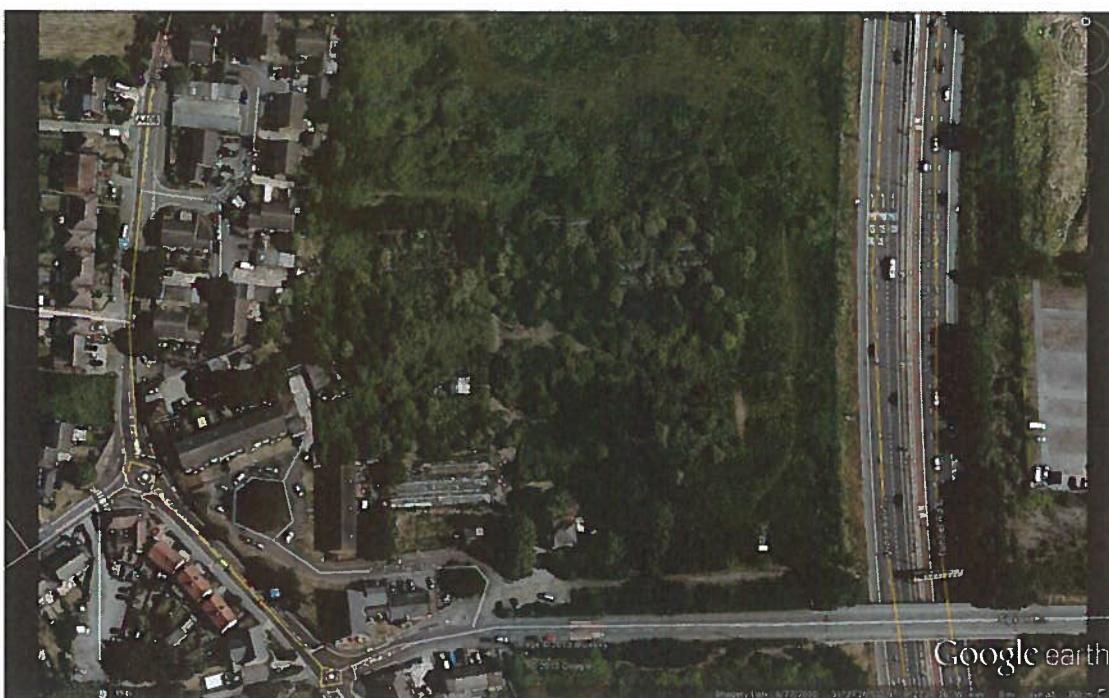
Image 14: the Google™ earth image of the south of the site, retrieved 8 July 2013, showing what appears to be structures within the wooded area at the south of the site: the image date is given as 27 June 2010

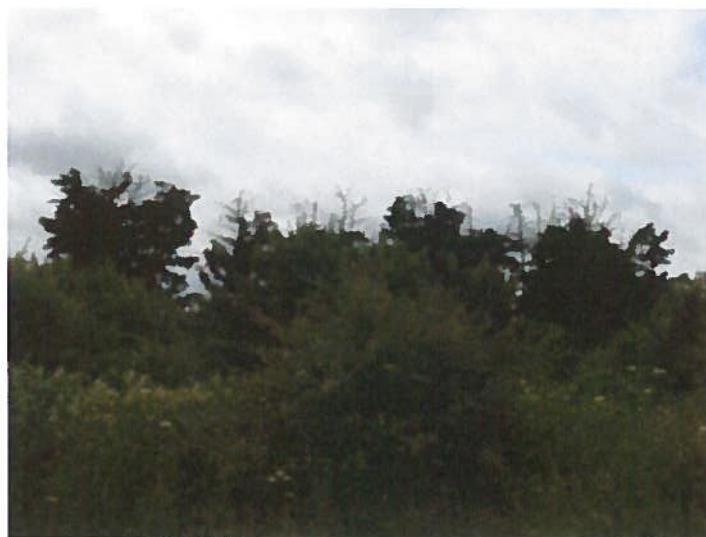
9. To the north west of this occupied area was a line of conifers which I presume had been deliberately planted, however they now exhibit dead tops as symptoms of an unknown stress: as access was not possible their attributes have not been included in the schedule. A single emergent sycamore, which in all probability was self-set, was located in the centre of the informal site boundary. These trees were not plotted as their position could not be determined with any degree of confidence. Even though access was not possible the poor condition of the conifers (evident from a distance rather than close inspection which was not possible because of access difficulties) and the relative youth (and pioneer nature) of the sycamore meant that these trees were not considered worthy of categorisation as anything more than C under *Table 1*.

Image 15: the conifers, their dead tops clearly evident even in this poor image

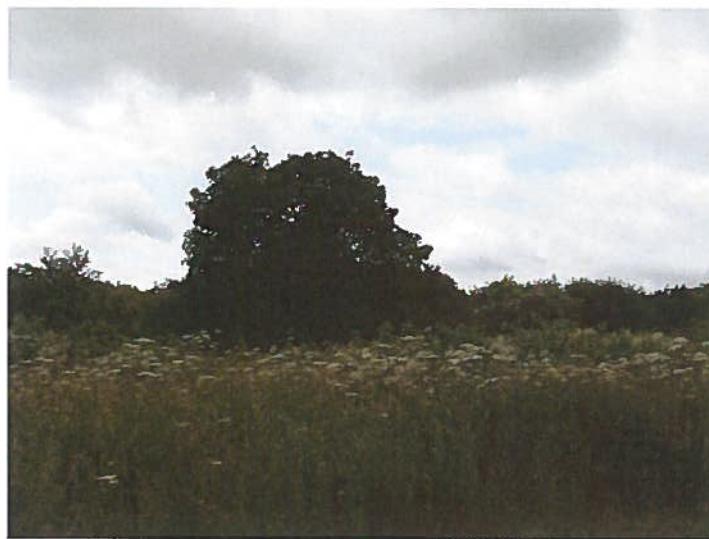
Image 16: the sycamore to the east of the conifers shown in image 15

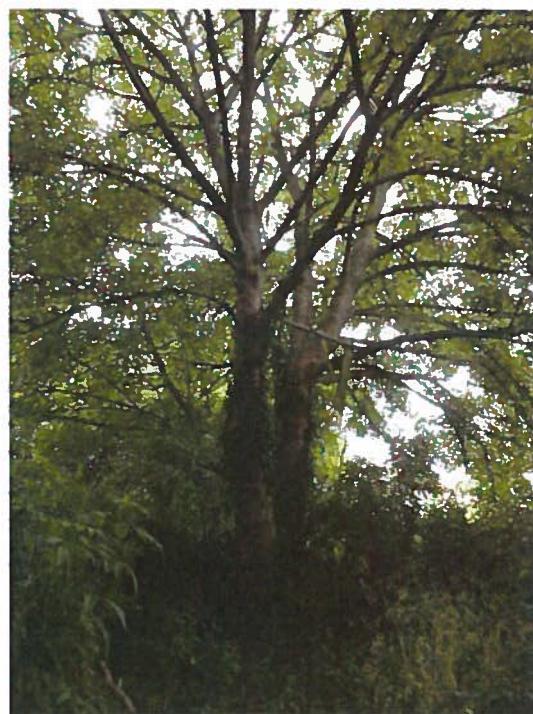
10. There were three substantial, mature, broadleaves along the southern boundary: unfortunately two of the three were a significant hazard, in relatively poor condition with major defects (the sycamore (*Acer pseudoplatanus*) had a substantial cavity in the southern most limb above the fork, callusing well but not doubt an entry point for decay organisms, and the lime had a significant wound at ground level that was attempting to occlude). Whilst the site is unoccupied their condition is not a cause for concern or comment, however should the site be developed then the risk that the trees will represent to targets will need to be addressed.

Image 17: T35 the sycamore to the south of the site, image taken looking north

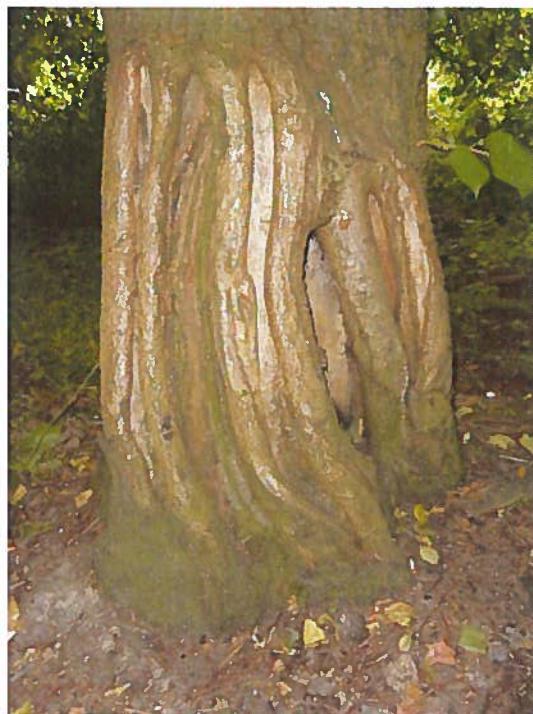
Image 18: the base of T37 the lime, image taken looking south, with automatic flash
