ASSESSMENT OF THREE TREES LOCATED WITHIN THE CURTILAGE OF NO. 1 & 2 ELMSDENE MEWS, WITH COMMENT ON THEIR CONTEMPORARY PHYSIOLOGICAL AND STRUCTURAL CONDITION AND POSSIBLE IMPLICATION IN SUBSIDENCE EFFECTS ON THE DWELLING HOUSE AND ASSOCIATED HARD-LANDSCAPING

Assessment of Tree Implication in Subsidence Related issues at:

No. 1 Elmsdene Mews, Northwood, Middx HA6 2BN

Date: 6th September 2022 - Our Ref: SAL/KMA/11249

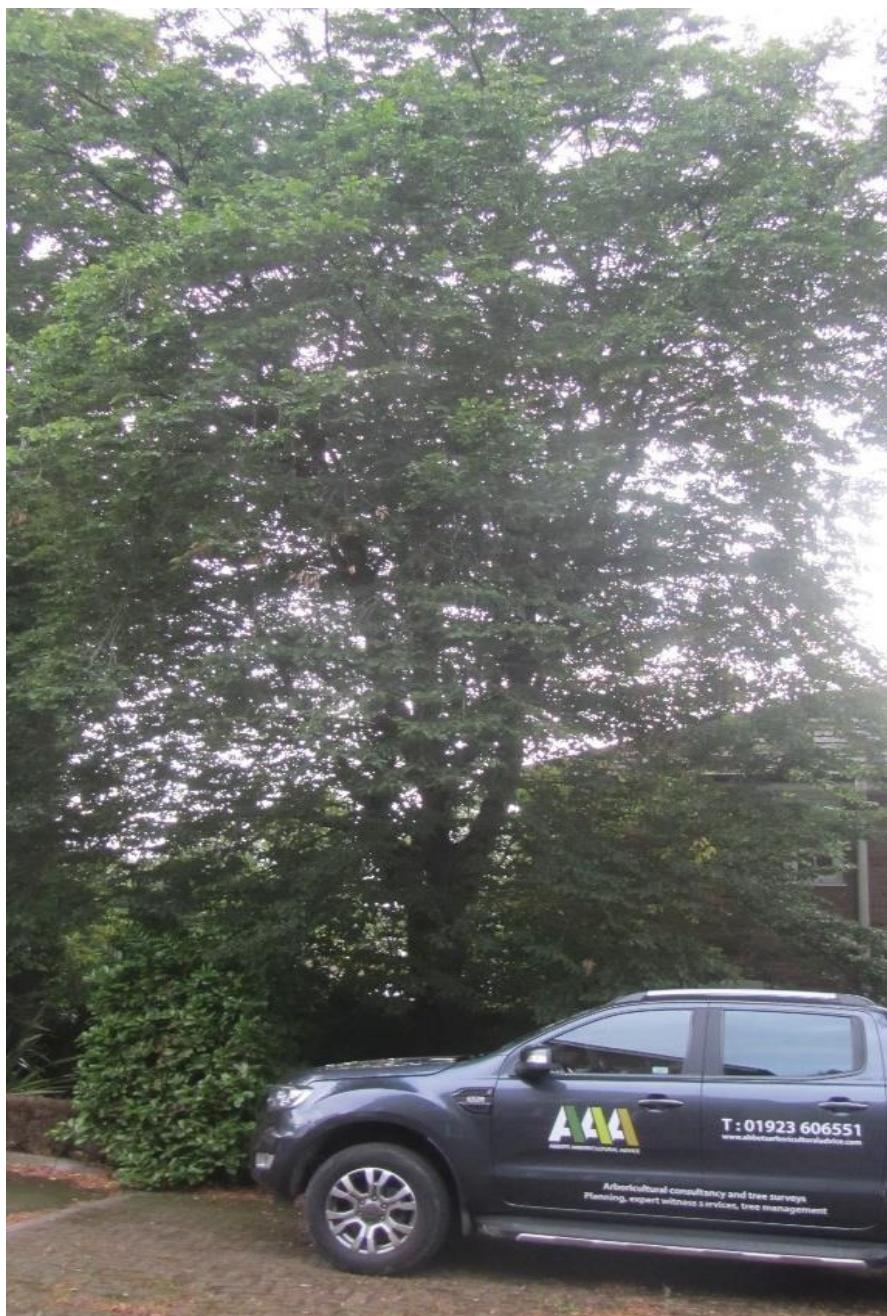
PHOTOGRAPH NO. 1 - T1 - HORNBEAM

3.2 The first tree included within this report is a hornbeam (T1) growing 15 m from the front elevation of the dwelling house. It is an early-mature tree which pre-dates construction of the mews houses though probably only by twenty years or so. The tree location, close to a property in High Elms Close (see photograph 1, Appendix 1 at the back of this report) suggests that it is likely self-seeded, having arrived by windblown seed. Hornbeam, is a tree of low-water demand (NHBC Standards 2020) with a calculated Theoretical Zone of Root Influence (TZI) of 8.5 m. Due to this it is unlikely to affect the structure of the dwelling house.

4.1 Tree 1, the hornbeam, is probably a self-seeded volunteer. It is in good physiological and structural condition and growing outside its TZI in relation to the dwelling house, No. 1 Elmsdene Mews. It will eventually outgrow this location due to its proximity to the nearby house in High Elms Close. However, this situation can be addressed by considered reduction pruning.

7.1 **T1 – Hornbeam** - no action

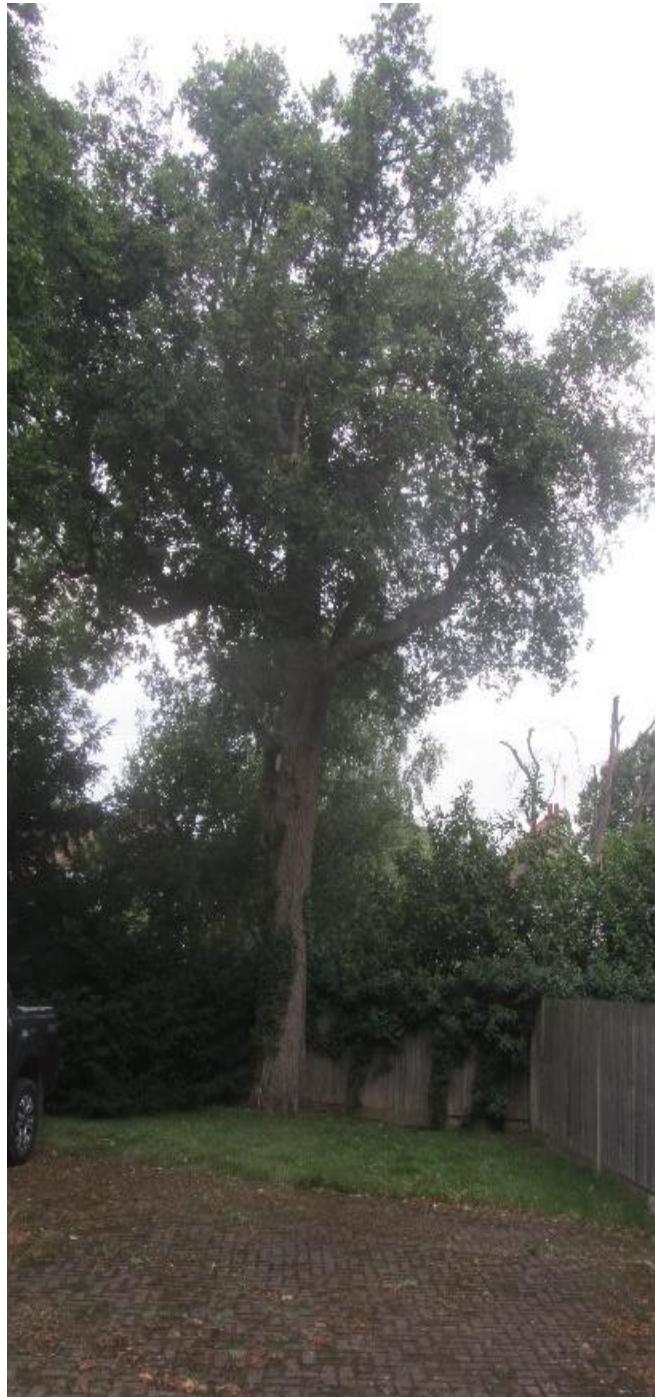
PHOTOGRAPH NO. 2 – T2 - OAK

3.3 A mature English oak (T2) is growing around 9 m from the front southwest corner of the dwelling house (see photograph 2, Appendix 1 at the back of this report). It might well be classed as a veteran tree (BS 5837: 2012 Trees in relation to design, demolition, and construction – Recommendations) due to many inherent 'defects' which constitute *de-facto* wildlife habitat.

- i) **Trunk:** the trunk base is swollen around its circumference to about 2 m above ground level (see photograph 2, Appendix 1 at the back of this report). This indicates internal heartwood degradation and 'sounding' of the trunk using a nylon-tipped mallet seemed to confirm this. It has likely been colonised by the brown-rotting beefsteak fungus (*F. hepatica* [Schaeff.] With. [1792]). Response growth and associated trunk swelling is more usually associated with white-rot fungi. However, this feature can arise with brown rot fungi when the wood degradation proceeds slowly. I saw an open cavity at around 7 m above ground level on the south side (see photograph 3, Appendix 1 at the back of this report) with what seemed to be a fruiting body of beefsteak fungus inside. (Beefsteak fungus is a brown-rotter which preferentially degrades the cellulose cell constituents leaving the lignin component initially intact. The likely result of this is brittle fracture.

4.2 A mature English oak (T2) is the second tree inspected. It is growing around 9 m from the front southwest corner of the dwelling house which is well within its TZI. It will have been in place when the dwelling house was constructed so the foundations will likely have been designed and constructed with due consideration to the tree's proximity. The area is shown to overlie a moderately shrinkable geographical stratum and so this consideration would have been especially pertinent. Some further mitigation against potential indirect (subsidence type) structural damage is afforded by the tree condition. The tree has been historically poorly pruned and as a result shows lower vitality than would be expected and evident in a higher quality oak tree. Lower vitality equates to slower growth and consequently reduced water uptake.

4.2.1 The oak tree's structural condition is of significant concern. Historic pruning works have been ill-considered, reactive, and poorly executed. All the works seem to have been performed in response to outside influences with little thought given to the tree as an integrated organism. A very large scaffold branch growing westwards over the neighbouring property has been truncated. Similar works have been undertaken on the eastern side with slightly more moderate pruning to the northern side. One particularly large scaffold branch growing southwards has barely been pruned at all and is now significantly over-extended. It is therefore now growing outside of the regular canopy outline and predisposed to wind-induced breakage.

7.2 **T2 – Oak** – reduce central leading stem by 2-2.5 m to appropriate pruning points at a union with live growth. Ensure that a detailed assessment of this section is made before actual works begins. Reduce the distal ends of the second-order branches of the over-extended southerly growing scaffold branch by 4 m and reduce all other areas by around 1.5-2.5 m as necessary to create a reasonably symmetrical and balanced form.

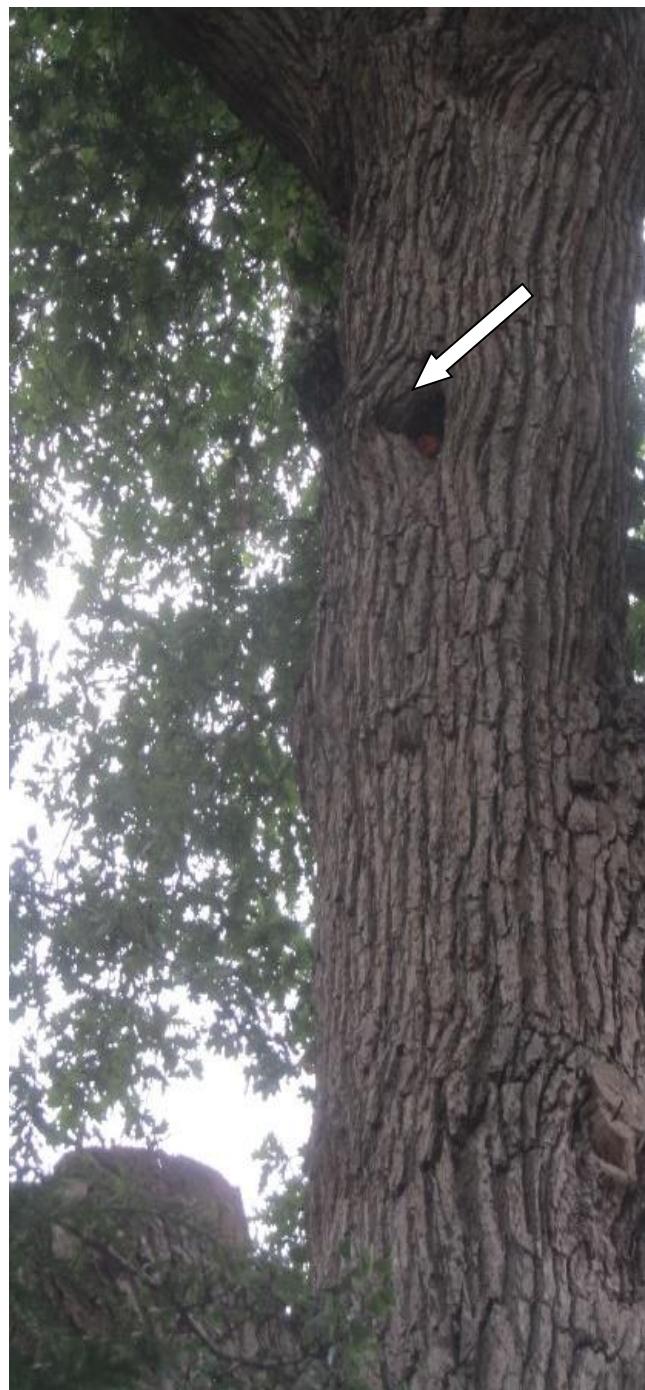
- ii) **Central leader** (upper trunk section): I saw that this area of the trunk is significantly damaged and structurally compromised (see photographs 3-6 Appendix 1 at the back of this report). There are several cavities and bark/sapwood damage apparent on this section and the leader terminates in a significantly sized (around 3 m long) dead stub (see photograph 7, Appendix 1 at the back of this report).

**PHOTOGRAPH NO. 3 – T2 – OAK – OPEN CAVITY ON SOUTH SIDE OF TRUNK
WITH BEEFSTEAK FUNGUS FRUITING BODY INSIDE (ARROWED)**

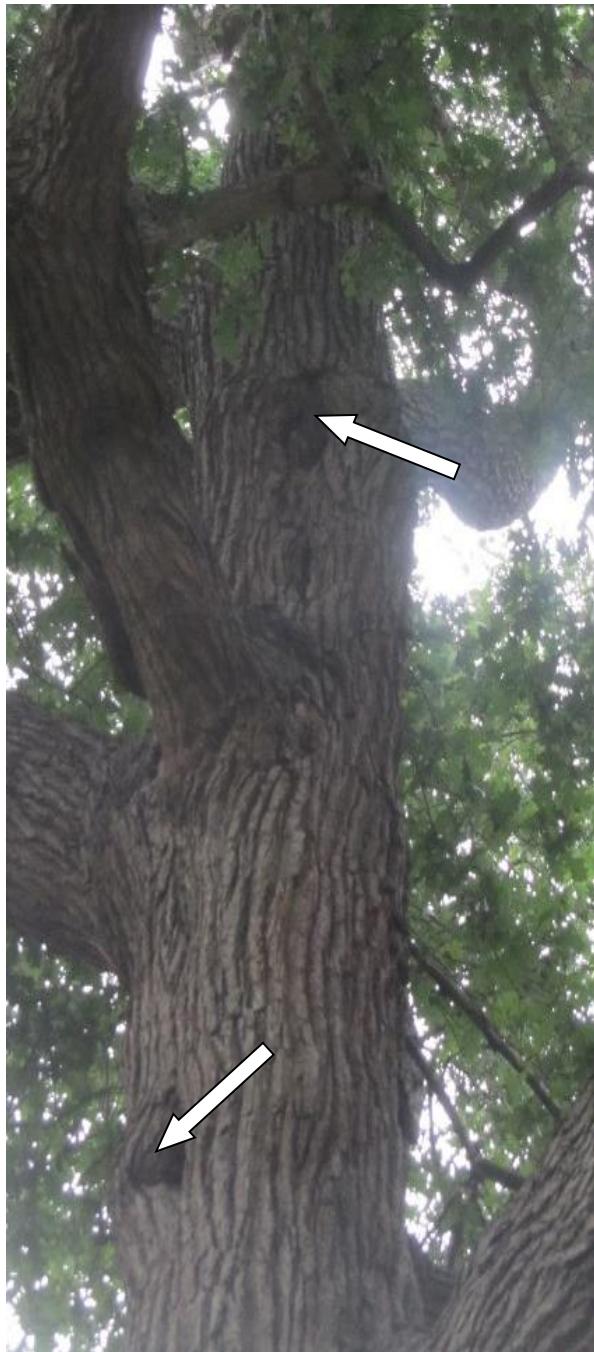
4.2.2 There is significant damage apparent on the upper section of the central leader. The leader has been historically truncated resulting in a reduction of the supply of sugars (manufactured in the photosynthetic process) to lower parts of this section. With insufficient resources the central leader has been unable to resist decay actors and has noticeably declined as a result. It is now hazardous. Pruning works will be prescribed in section 7 to address this issue.

PHOTOGRAPH NO. 4 - T2 – OAK - COMPROMISED AREAS ON UPPER CENTRAL STEM (ARROWED)

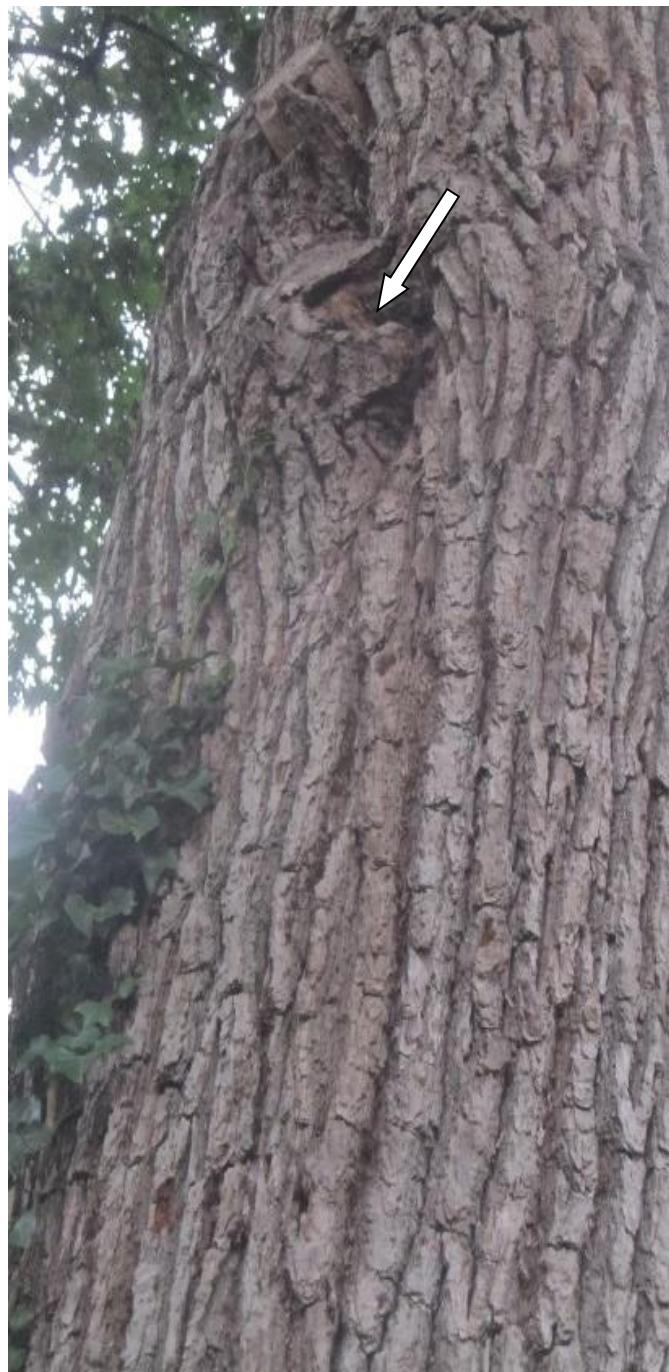
PHOTOGRAPH NO. 5 - T2 – OAK - COMPROMISED AREAS ON UPPER CENTRAL STEM (ARROWED)

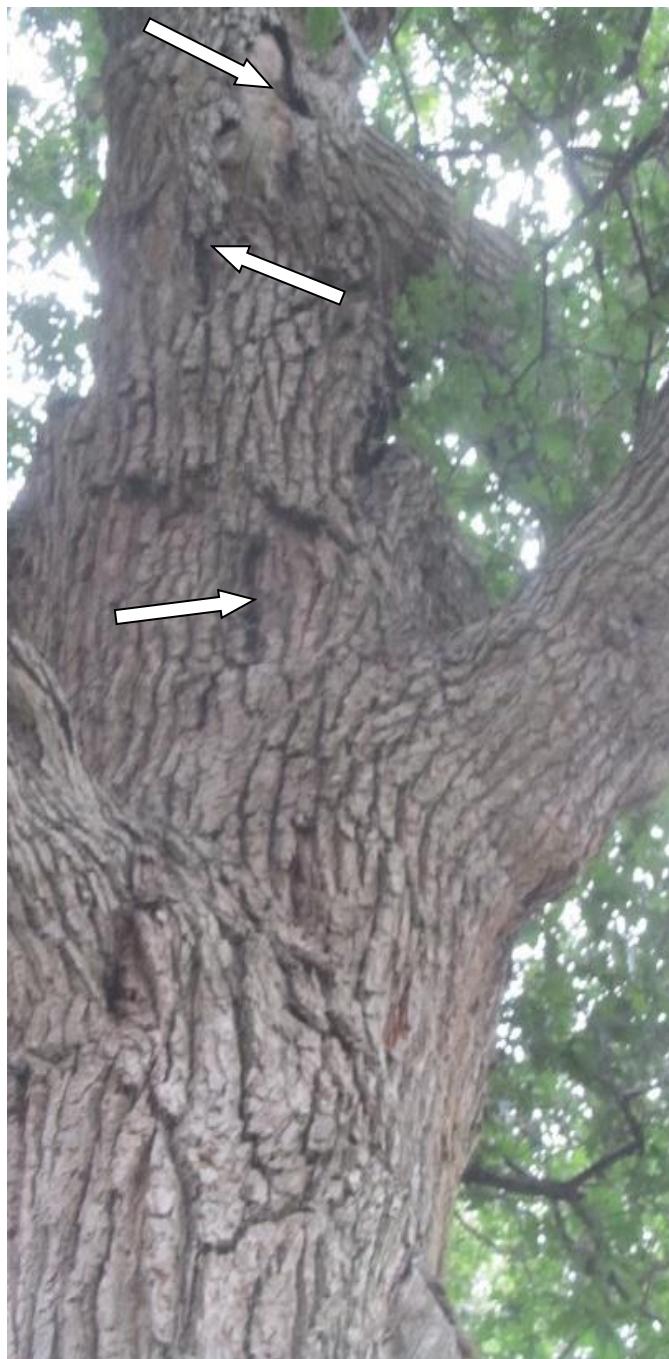
**PHOTOGRAPH NO. 6 - T2 – OAK - COMPROMISED AREAS ON UPPER
CENTRAL STEM (ARROWED)**

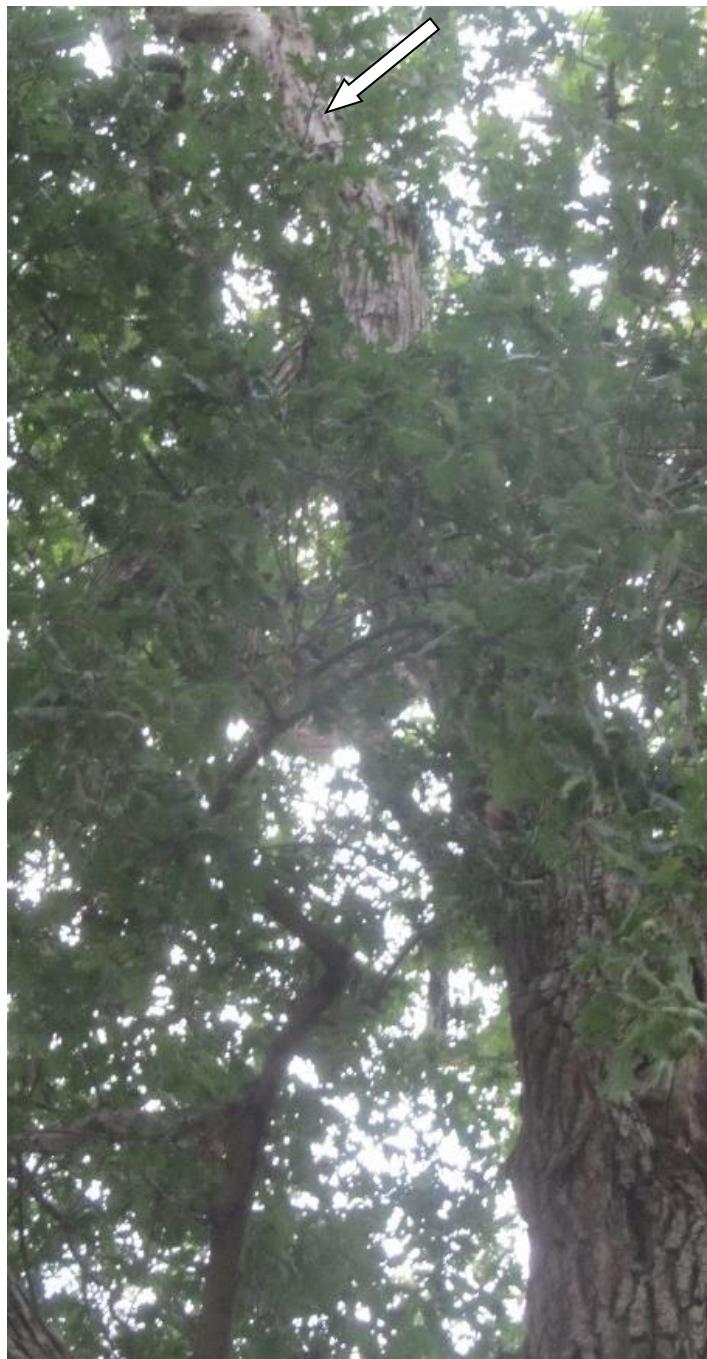
PHOTOGRAPH NO. 7 - T2 – OAK - DEAD ‘SNAG’ AT TOP OF CENTRAL LEADER (ARROWED)

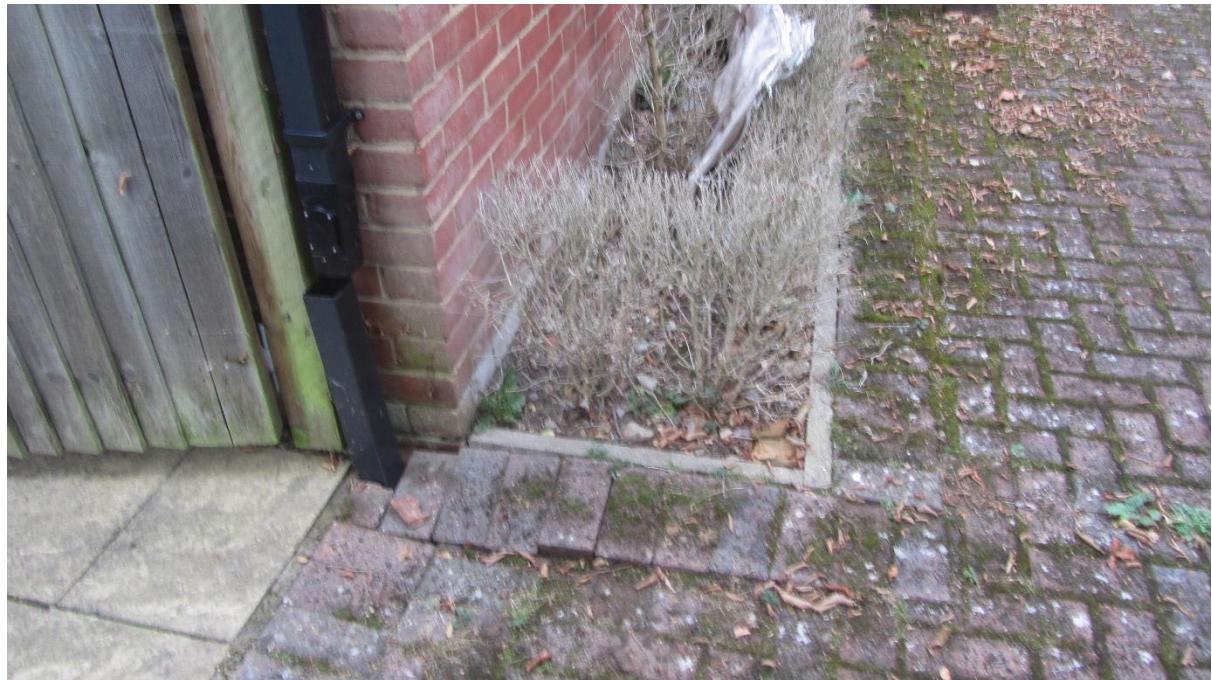
3.3.2.1 Mr Elder is concerned about movement of the rainwater downpipe and block-paving close to the building southwest corner (see photograph 8, Appendix 1 at the back of this report). I looked closely at this area and removed both the bottom section of the downpipe and the nearest block-paviours. I found no evidence of root incursion but did see that a void was present beneath the paving.

**PHOTOGRAPH NO. 8 - DISTURBED DOWN-PIPE AND BLOCK PAVING BY
SOUTHWESTERN CORNER OF THE DWELLING HOUSE**

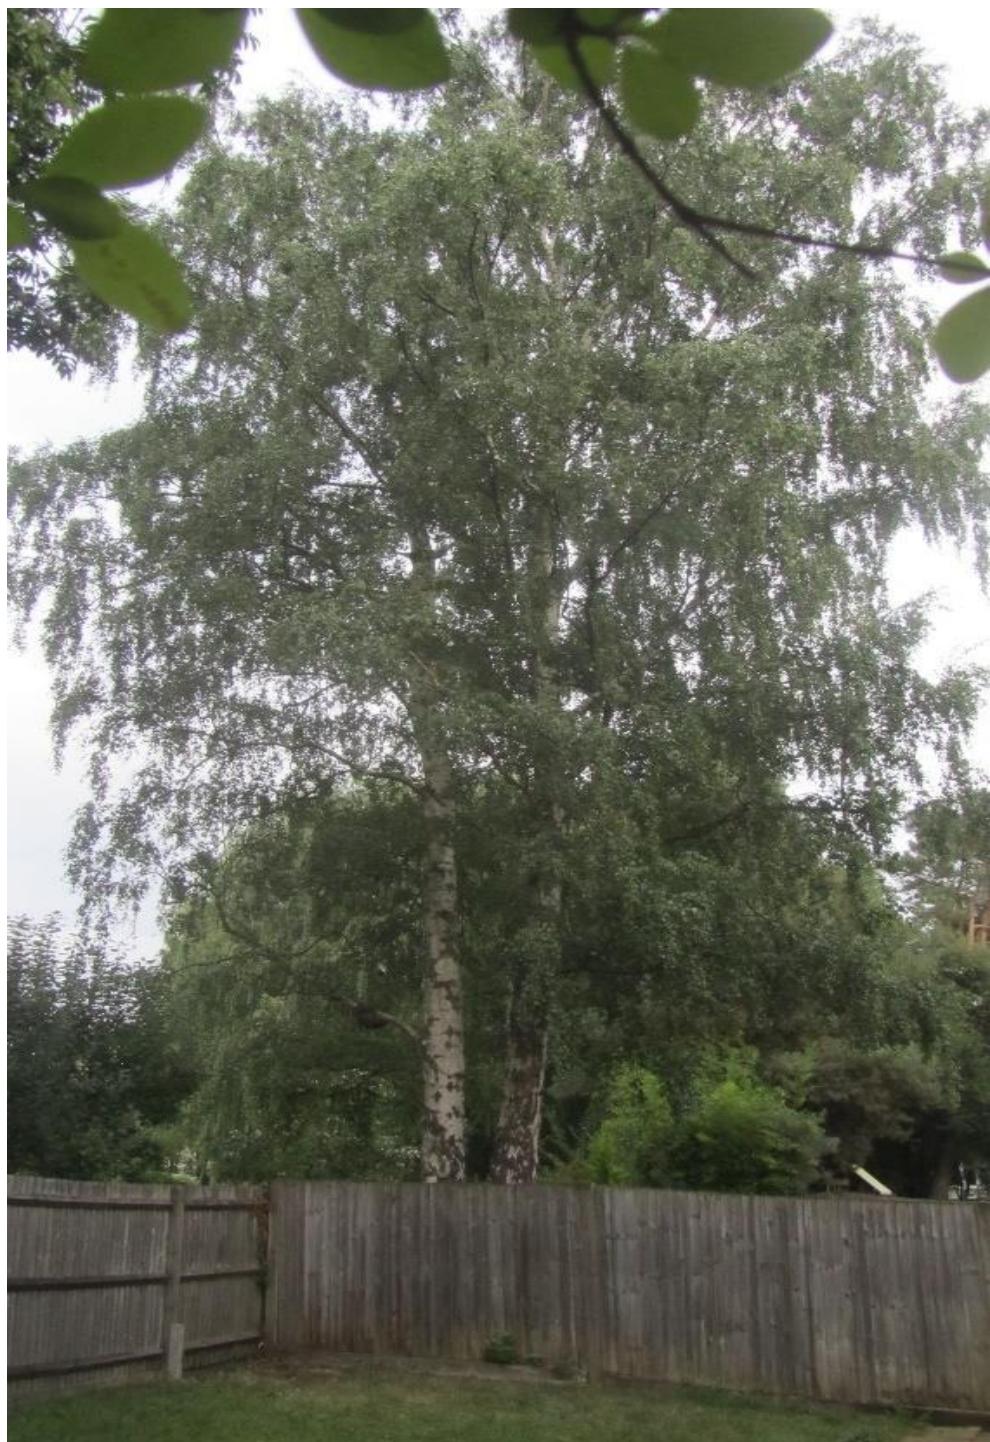
PHOTOGRAPH NO. 10 - T3 – BIRCH – VIEWED FROM THE WEST

3.4 The final tree inspected is a silver birch located within the rear garden of a third-party property (see photograph 10, Appendix 1 at the back of this report). This tree too, pre-dates construction of the mews houses. Birch trees are notorious for producing extensive shallow roots which often disrupt light structures or hard-landscaping. On this site I lifted several paving slabs to the side of, and behind the dwelling house. Under each one I found roots of significant diameter, often around 20 mm, and a network of finer, absorbing roots (see photographs 11-16, Appendix 1 at the back of this report).

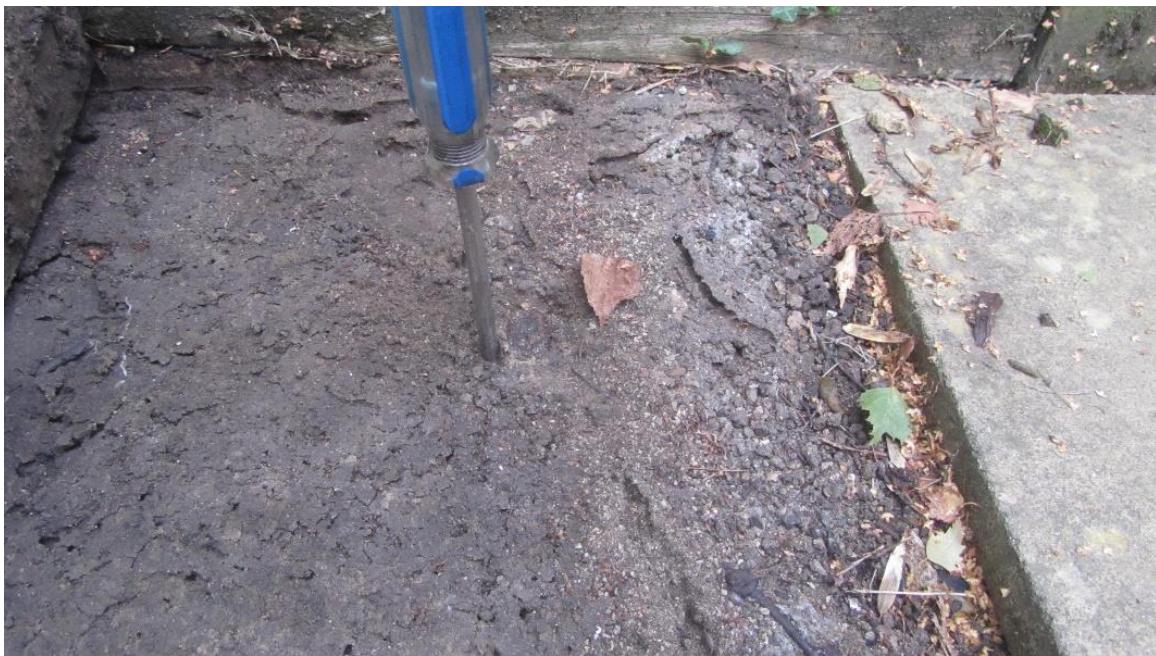
4.3 The third tree inspected is a third-party owned birch tree. It is in good physiological and structural condition but as is common with this species roots have grown extensively and are now encroaching into the garden of No. 1. They have grown under the paving to the side and rear of the dwelling house causing uplift, distortion, and breakage of the slabs. Unless the roots are removed this damage will continue to increase.

**PHOTOGRAPH NO. 11 - T3 – BIRCH TREE ROOTS IN DISTAL CORNER OF
PAVED AREA NEAREST THE TREE**

7.3 **T3 – Birch** – sever all roots along the eastern boundary of No. 1, install a concrete strip along the entire boundary length, which should be about 450 mm deep and 300 mm wide to restrict future root growth. Alternatively, remove the tree.

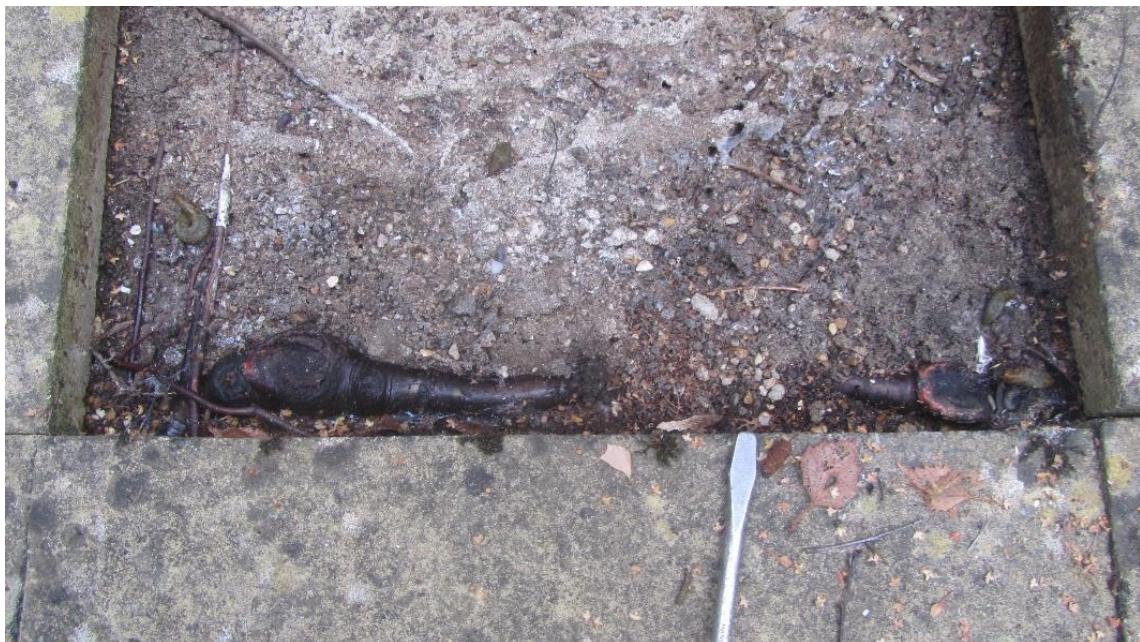
**PHOTOGRAPH NO. 12 - T3 – BIRCH TREE ROOTS IN DISTAL CORNER OF
PAVED AREA NEAREST THE TREE AND 2.5 M FROM BOUNDARY WITH NO. 2
ELMSDENE MEWS**

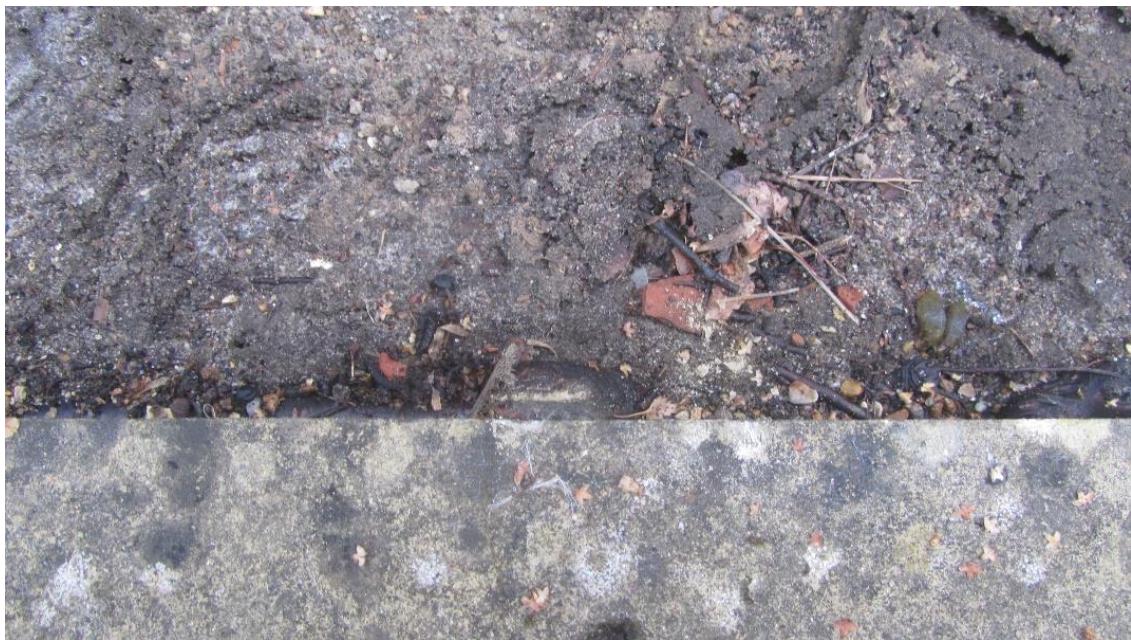
PHOTOGRAPH NO. 13 - T3 – BIRCH TREE ROOTS CLOSE TO THE REAR ELEVATION OF NO. 1

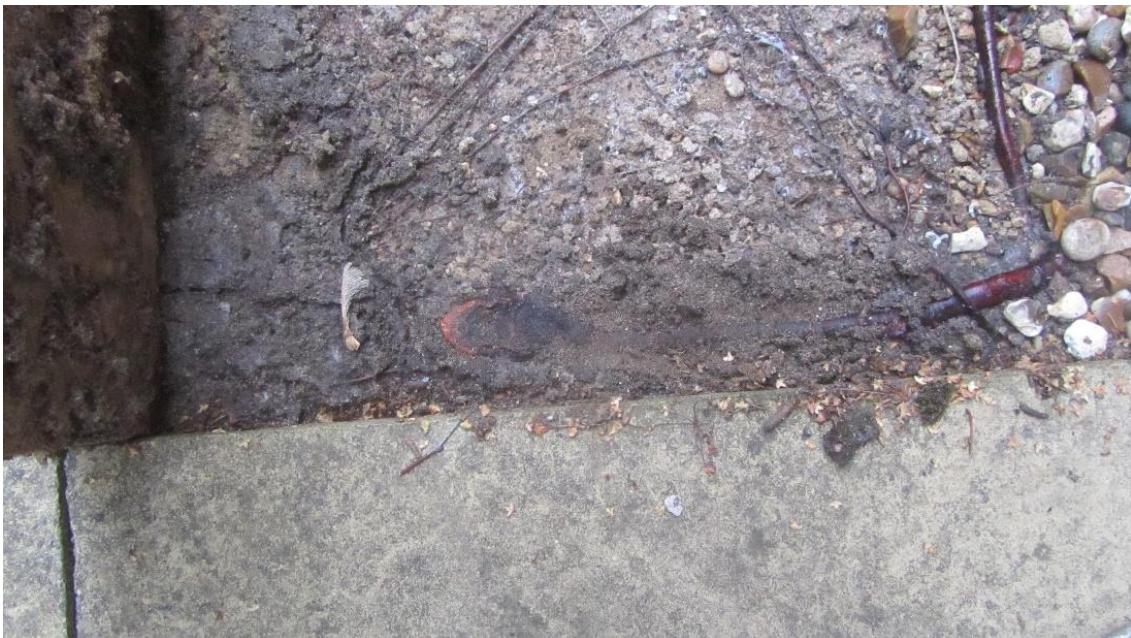
PHOTOGRAPH NO. 14 - T3 – BIRCH TREE ROOTS IN SIDE PASSAGeway BY EASTERN FLANK WALL

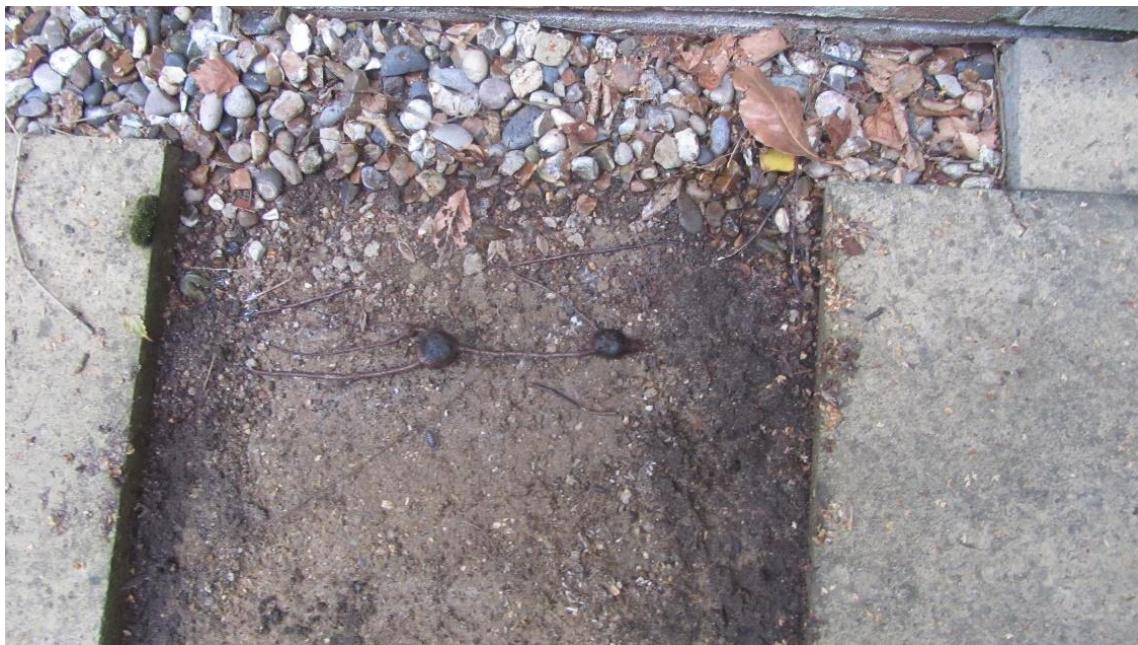
PHOTOGRAPH NO. 15 - T3 – BIRCH TREE ROOTS BY SIDE DOORWAY

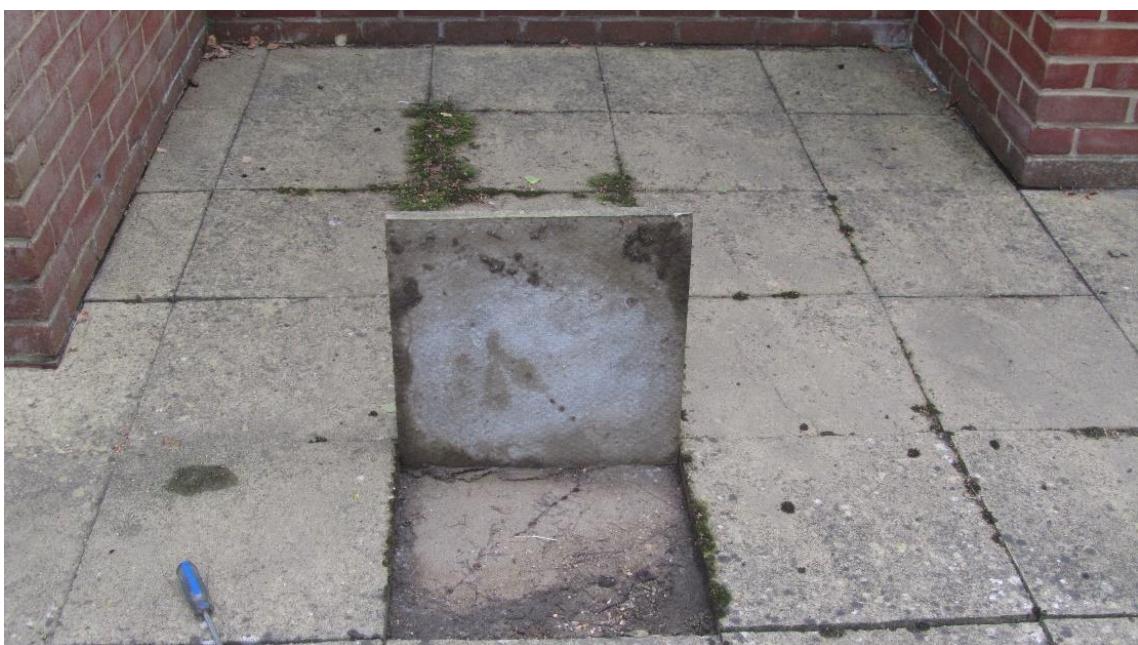
**PHOTOGRAPH NO. 16 - T3 – BIRCH TREE ROOTS NORTH OF CENTRAL REAR
DOORWAY AT LEAST 10 M FROM T3**
