ASSESSMENT OF ONE CHERRY TREE AND ITS POSSIBLE IMPLICATION IN THE DRIVEWAY DAMAGE AT NO. 20 WOODSTOCK DRIVE, ICKENHAM, UXBRIDGE UB10 8EF

CLIENT:	Mr Satish Mistry
CLIENT REF:	SM/WDIU
AAAL REF:	SAL/KMA/11568
AAAL CONSULTANT:	Shane A Lanigan
REPORT DATE:	19th June 2023

Assessment of One Cherry Tree and its Possible Implication in the Driveway Damage at:

No. 20 Woodstock Drive, Ickenham, Uxbridge UB10 8EF

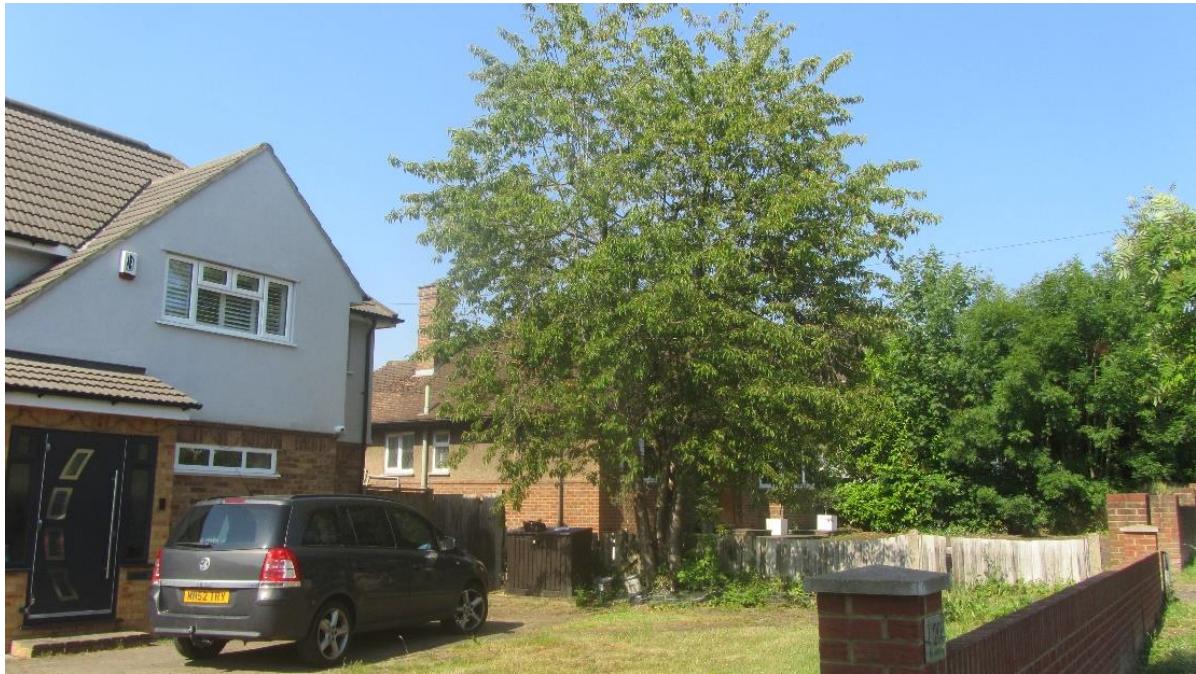
2.1 **Inspection of tree that is the likely source of the roots:** I saw that there is just one tree growing within the curtilage of No. 20 (see photographs 1, 3 & 6, Appendix 1 at the back of this report). It is a cherry (*Prunus avium* L.) that is growing around 5 m northwest of the first inner corner of the dwelling house (see photographs 3 & 11, Appendix 1 at the back of this report) and is immediately adjacent to the boundary with No. 18 to the west. There is significant disturbance to the driveway of No. 20 which extends in a semi-circle around the tree base from south through southeast to almost due north (see photographs 3, 7, 8, & 10, Appendix 1 at the back of this report). Similar upheave type damage is apparent to the driveway surface within the curtilage of No. 18 though is less severe. Tree details are shown in the tabulation below.

PHOTOGRAPH NO. 1 - T1 – cherry viewed from the northeast

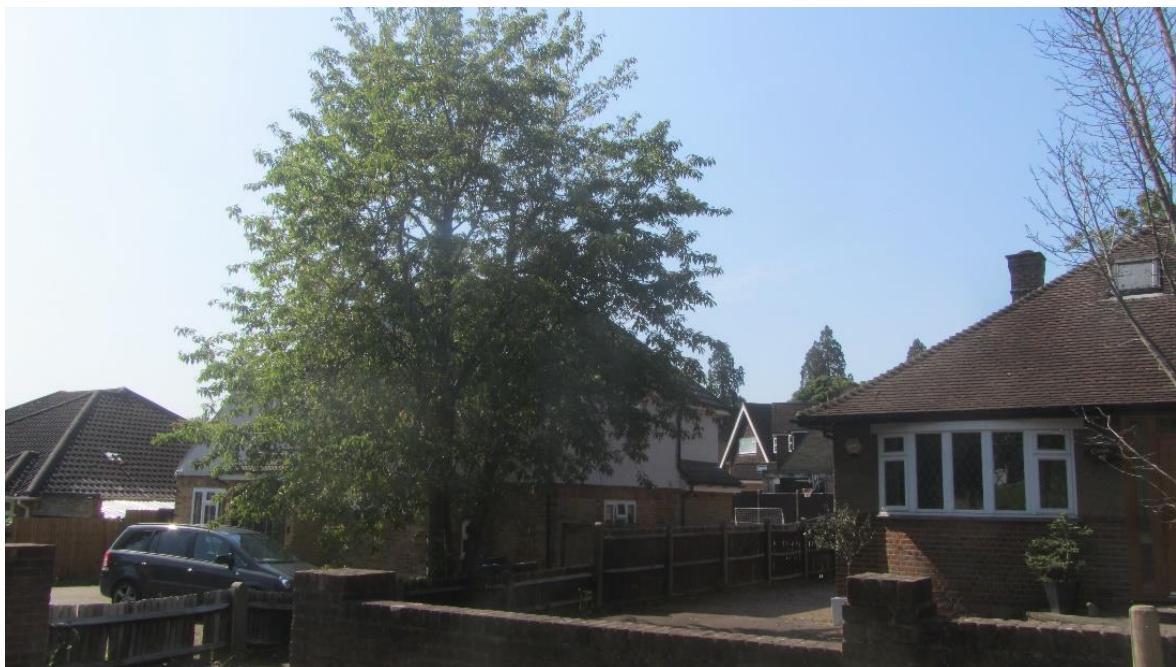
5.4 This tree has caused, and continues to cause, direct damage to both driveways: it has potential to exacerbate any existing damage to the foul water drainage system which passes immediately east of the tree base (see photograph 4, Appendix 1 at the back of this report). Moreover, it is a large-growing, likely self-seeded tree which has arisen in a wholly inappropriate location. It has a calculated TJI of 12.75 and so has potential to cause subsidence (indirect damage) to No. 20 (see photographs 1 & 2, Appendix 1 at the back of this report).

PHOTOGRAPH NO. 2 - T1 – cherry viewed from the northwest

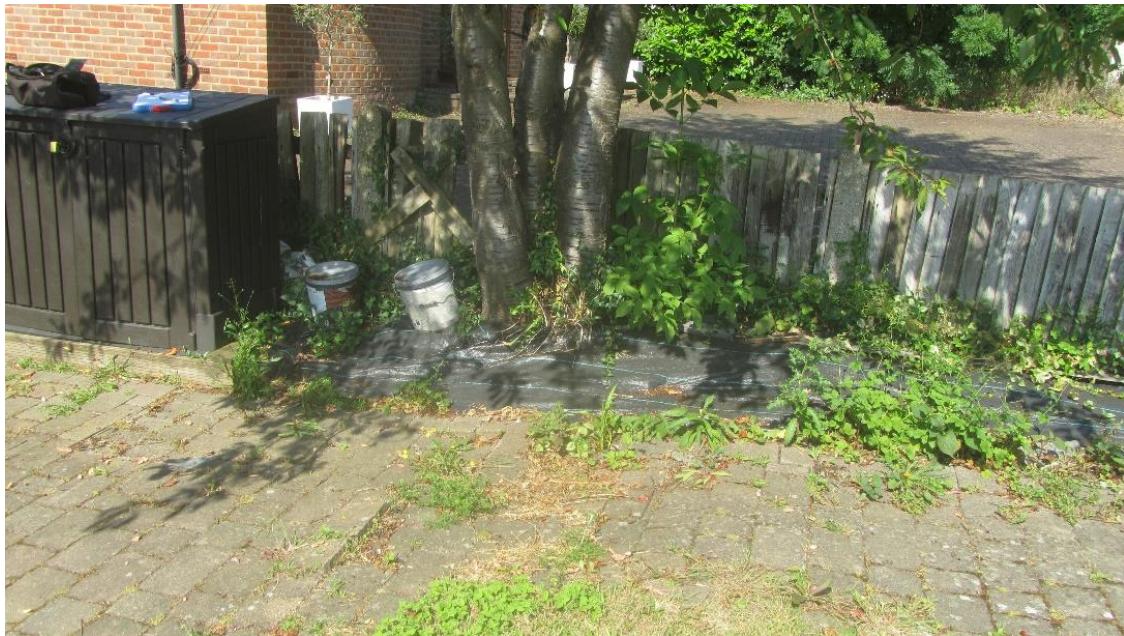
PHOTOGRAPH NO. 3 – base of T1 with visible uplift of the nearby paviours

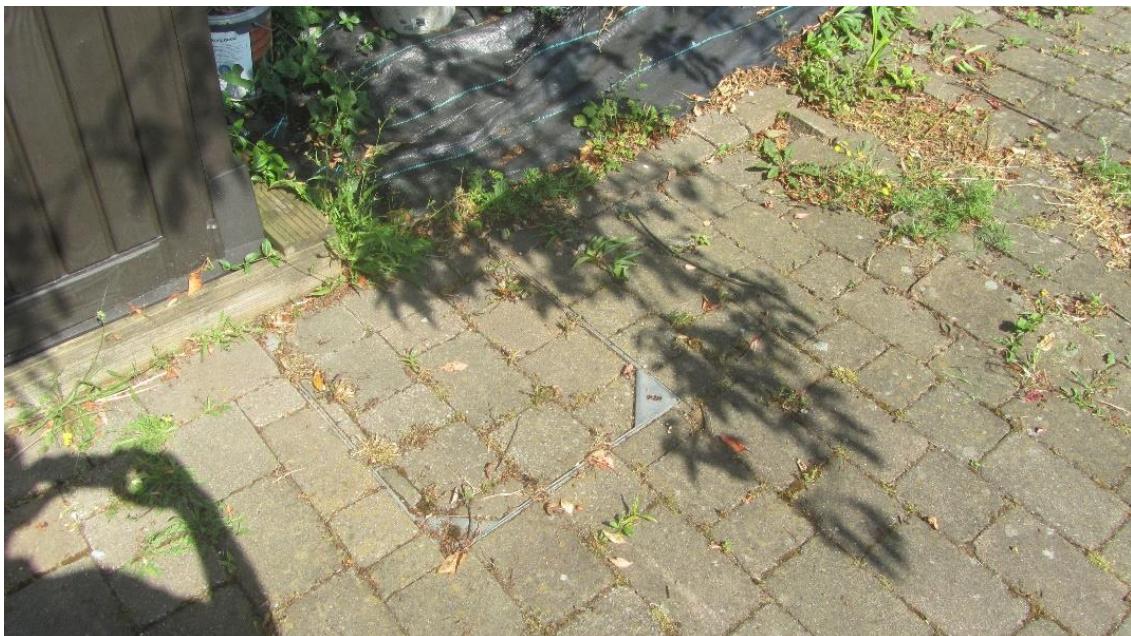
PHOTOGRAPH NO. 4 – foul water drain cover around 1 m southeast of the tree base

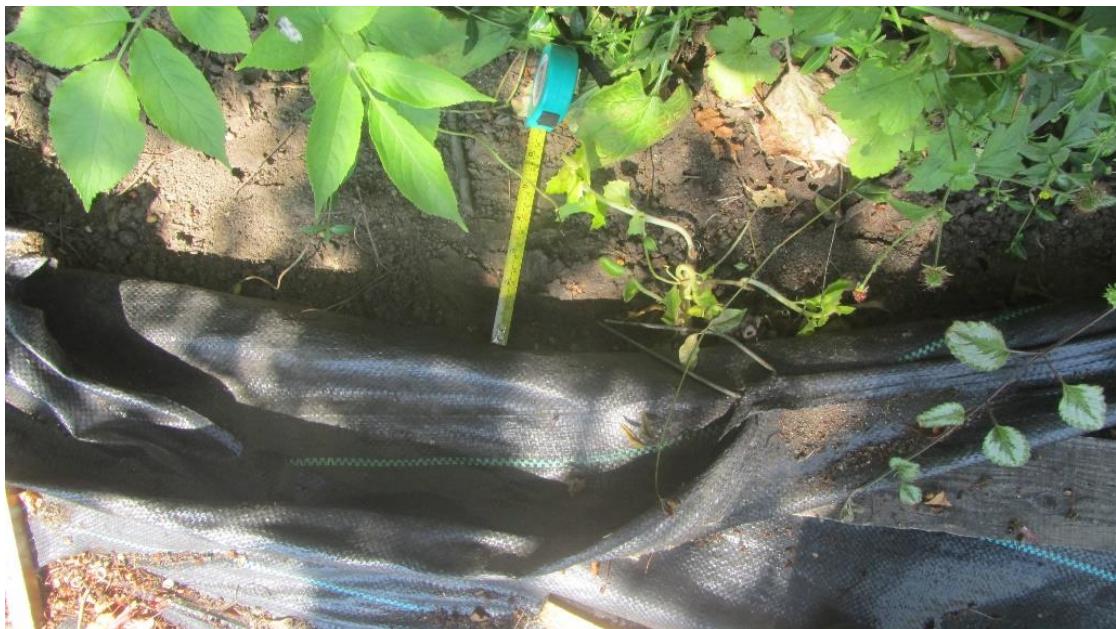
4.2 The tree is a wild cherry which has a species propensity – much more than most other trees – to develop disproportionately large roots: these tend to grow close to, and sometimes partly above the soil surface. This trait is much in evidence on this site (see photographs 5, 6, 7, 8 & 10, Appendix 1 at the back of this report).

PHOTOGRAPH NO. 5 – large lateral root growing from the northeast side of the tree northwards toward the roadway

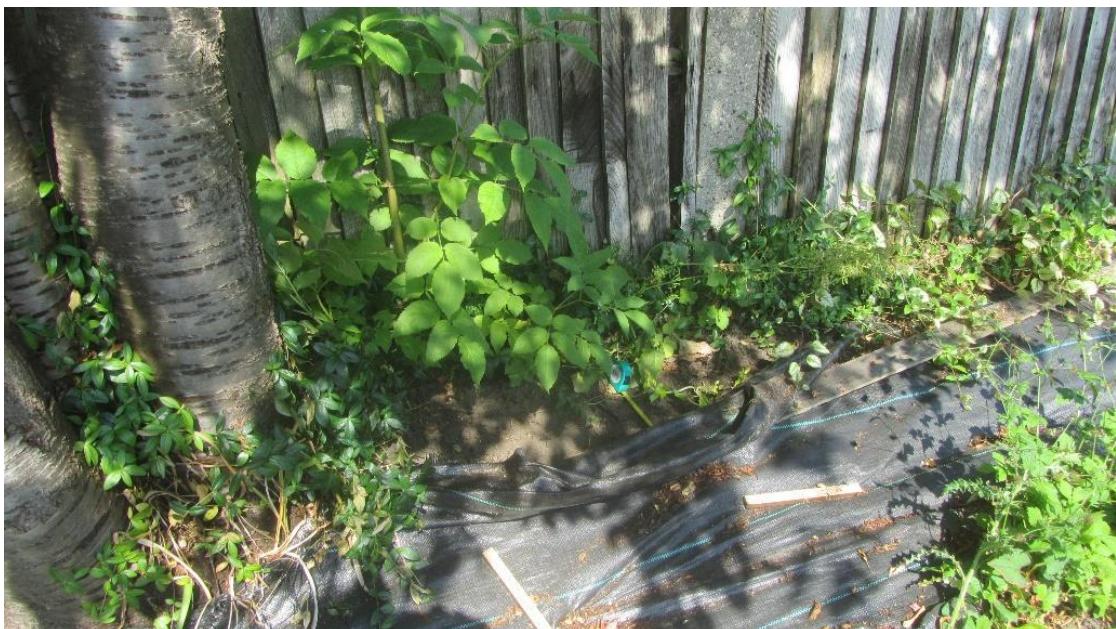
PHOTOGRAPH NO. 6 – large lateral root growing from the northeast side of the tree northwards toward the roadway

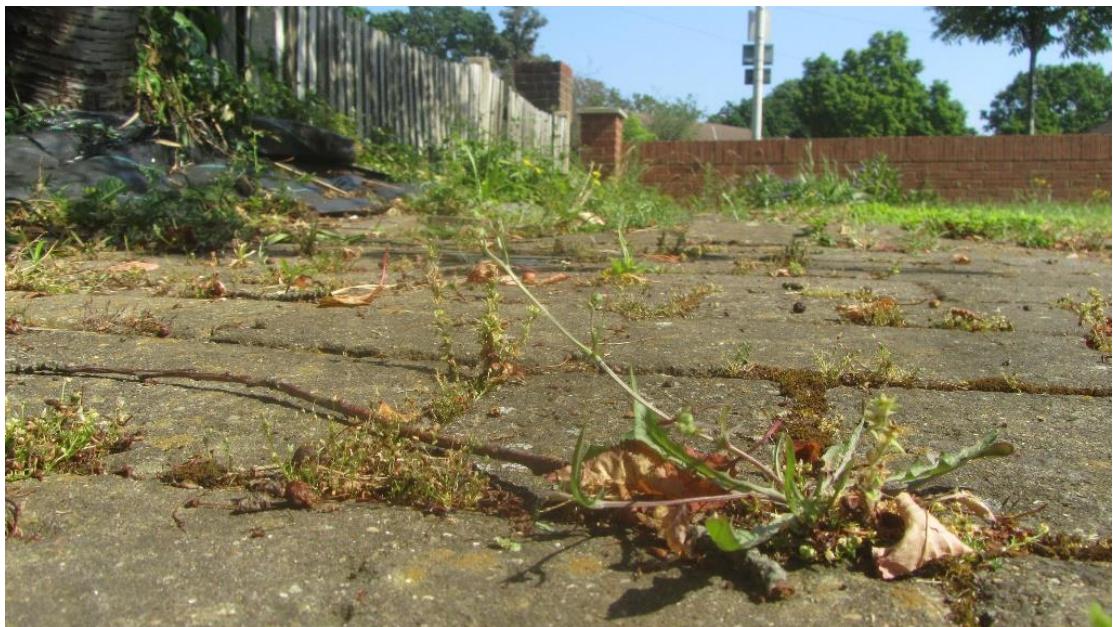
PHOTOGRAPH NO. 7 – upheaved and disturbed surface of the driveway

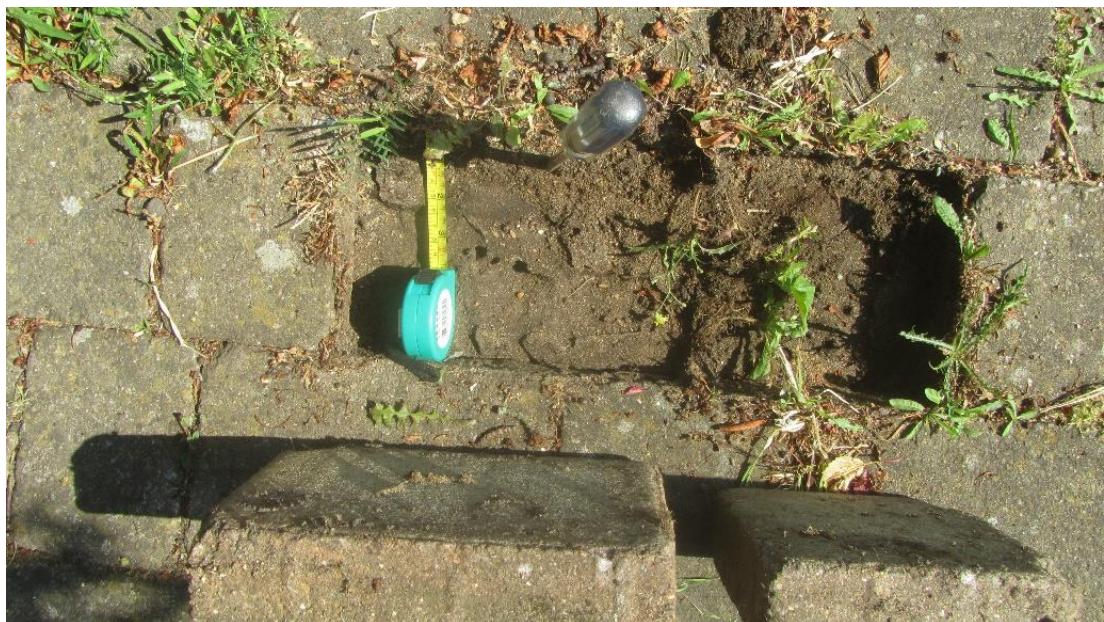
PHOTOGRAPH NO. 8 – cherry tree root 1.5 m southeast of the tree base

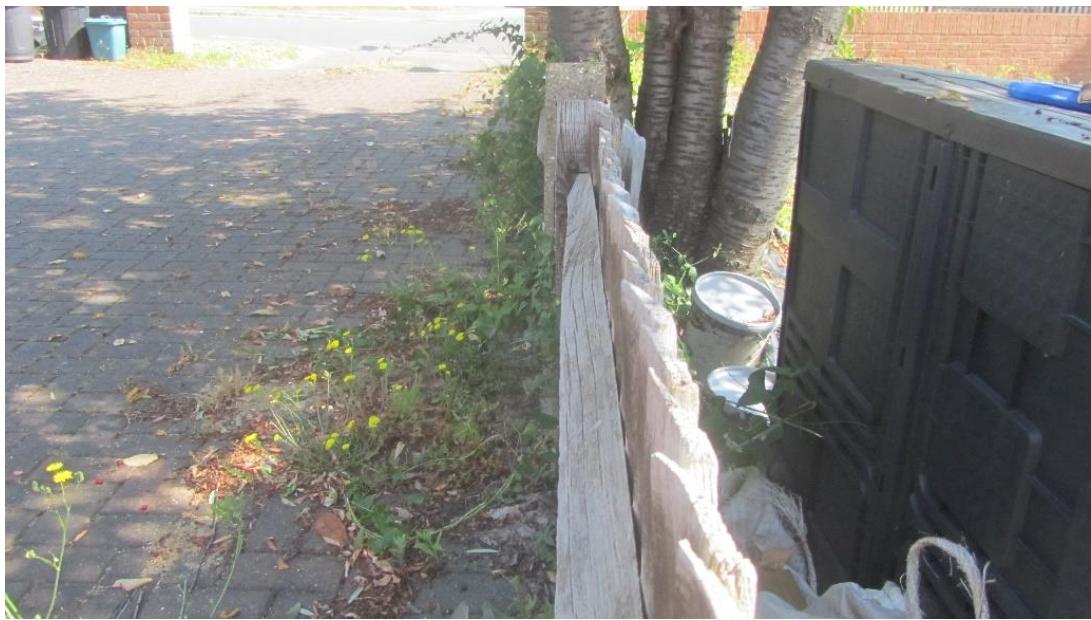
PHOTOGRAPH NO. 9 – base of T1 viewed from the southwest showing proximity to the boundary fence

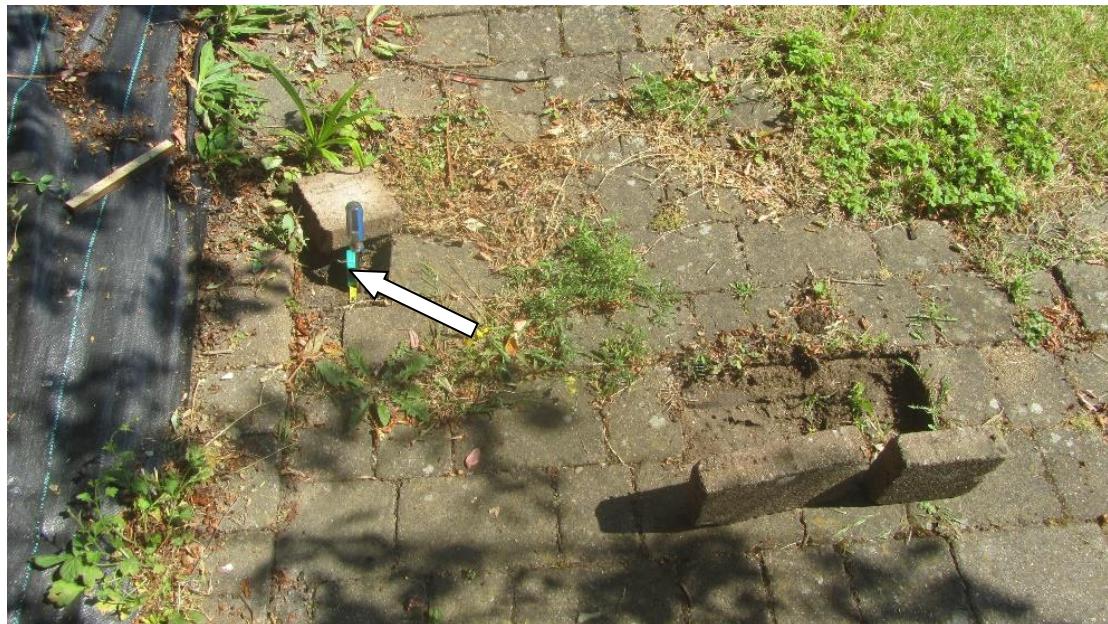
PHOTOGRAPH NO. 10 – cherry tree root 1 m east of the tree base (arrowed)

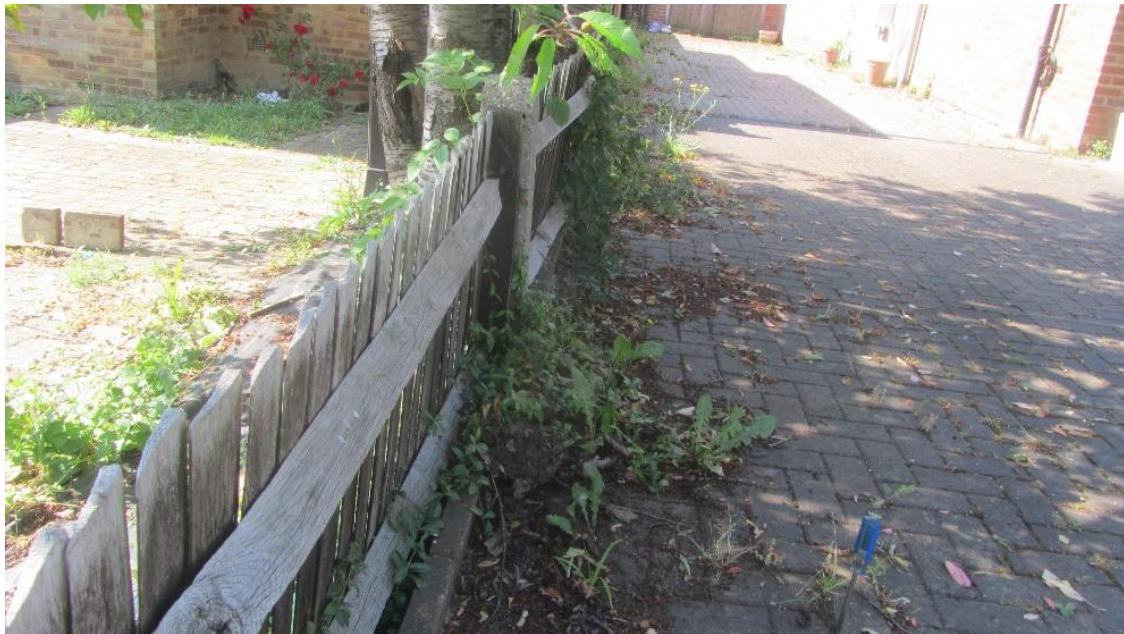
5.3 A simple site inspection showed that roots of the cherry tree have uplifted a large area of the driveway within the curtilage of No. 20 and have similarly damaged a smaller area of the front block-paved area of No. 18 (see photograph 11, Appendix 1 at the back of this report). I lifted pavements to the front of no. 20 and found cherry tree roots beneath them: it is probable that the damage – which is already significant – will increase. This area is no longer serviceable, the damage means that Mr Mistry cannot fulfil his duty to users of his land under both the:

PHOTOGRAPH NO. 11 – uplift of the driveway of No. 18 – likely due to tree root growth

7.1 **Tree 1 – Wild cherry** – fell and treat against regrowth by the following methodology:

- i) Treat with herbicide in the growing season of 2023 or 2024
- ii) Fell tree at least six months later when no new root sucker growth is apparent.
