# Site Investigation Report

**118594.1.TSI**

Client	Crawford & Co - Axa (Subsidence)
Client ref	SU2005239
Visit date	24/02/2021
Report date	25/02/2021

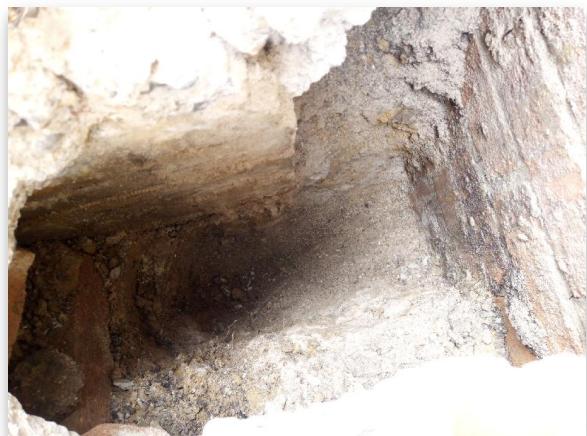
<b>Brief</b>	Auger were commissioned by Crawford & Co - Axa (Subsidence) to undertake a site investigation within the area of concern at the property.
<b>Trial Hole Findings</b>	<p>When carrying out TH1 we were unable to expose the underside of the footing and confirm the projection, we discovered the foundation to be potentially underpinned. We were unable to trench the foundation further back due to a drainage run being in this location and the concrete being 300mm thick in this location at the surface. If the loss adjuster wishes, Auger can return to site to undertake a deep excavation with two men to break through thick concrete and replace a 1.0m section of pipework to expose the footing.</p> <p>Due to not being able to trench the TH back any further we carried out a remote borehole in the soil at the property and collected samples from a depth of 0.9m.</p>

Fig 1.2: Trial Hole 1 Footing

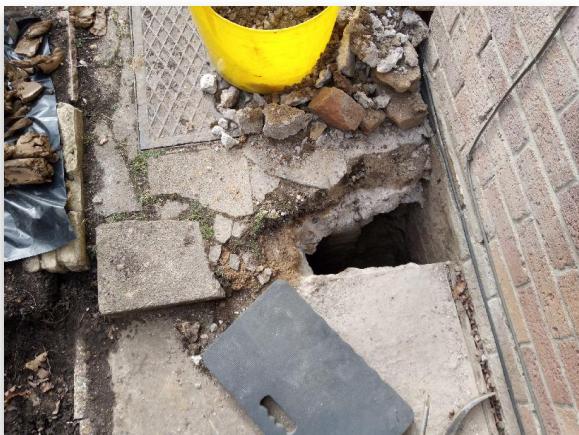
Fig 1.3: Trial Hole 1

Depth (m)	Symbolic Log	Strata Description	Insitu Tests		Soil Sample	Root Sample
			SV(19)			
0.0		400+mm Ground Level Concrete 300mm thick Brickwork Concrete Concrete potentially underpinned				
1.0			112kpa		Soil @ 0.9m	Root @ 0.9m
1.5		Dry very stiff Brown slightly sandy fine to medium gravelly silty CLAY	140kpa		Soil @ 1.5m	
2.0			140kpa		Soil @ 2.0m	Root @ 2.0m
2.5			140kpa		Soil @ 2.5m	
3.0		TRIAL HOLE TERMINATED	140kpa		Soil @ 3m

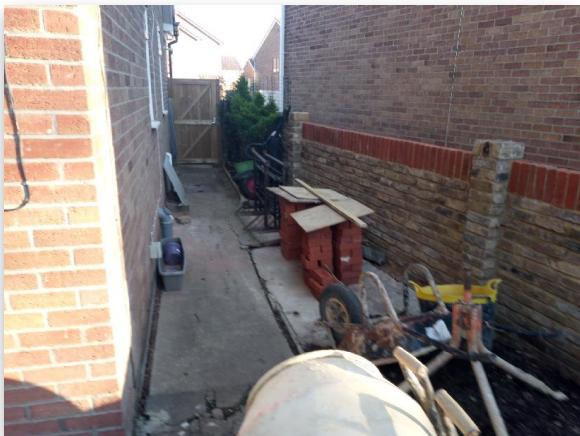
Fig 2.1: Side of property

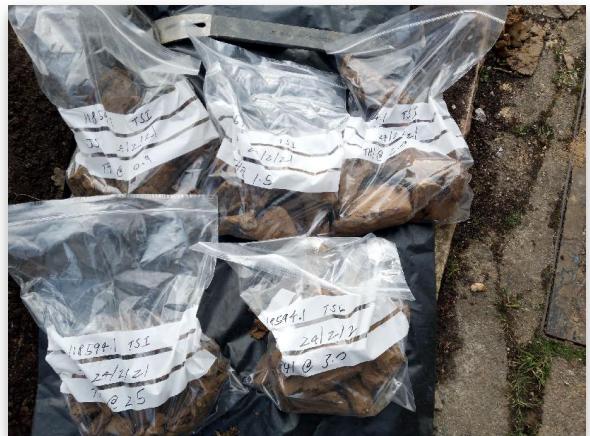
Fig 2.2: Soil samples collected
