TECHNICAL REPORT ON A SUBSIDENCE CLAIM

Crawford Reference: SU2005239

23 Three Oaks Close
Ickenham
Uxbridge
UB10 8DU

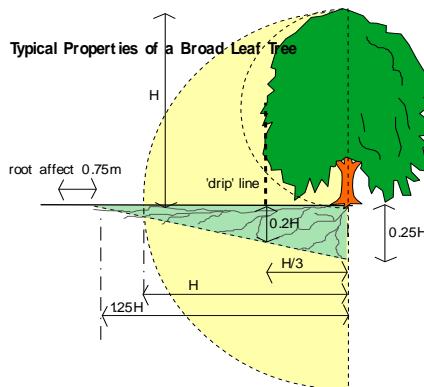
Typical proportions of an Oak showing the potential root zone. They have by far the most aggressive of root systems, often spreading considerable distances (1.5 x height or more).

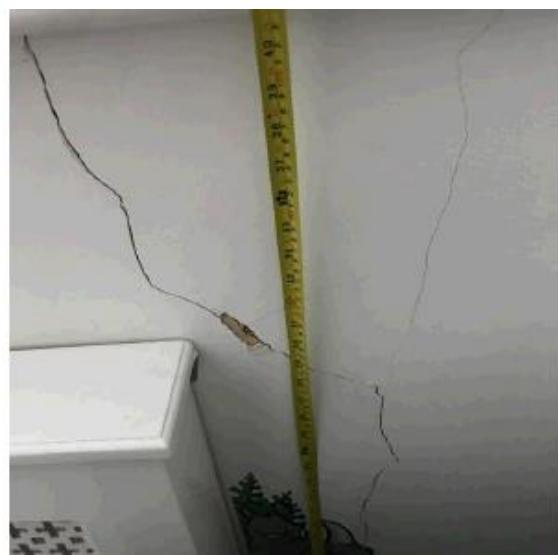
**REAR BEDROOM**

- Vertical crack noted both sides of the door opening.
- Diagonal cracking above and below the rear window.

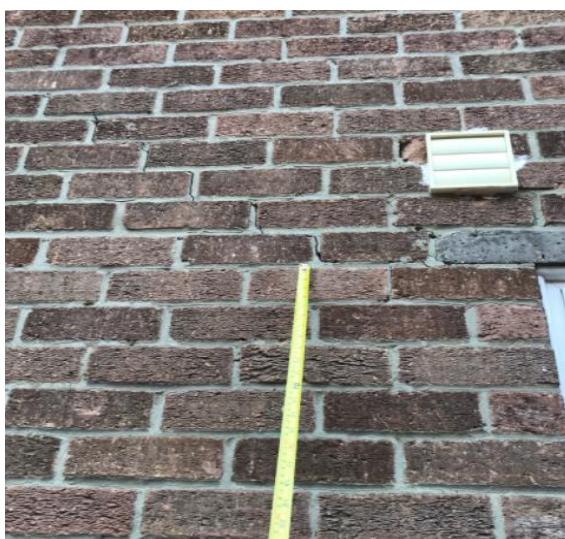
Flank wall cracking

- Diagonal cracking extending from the top of window up to the intersection with the sloping roof.

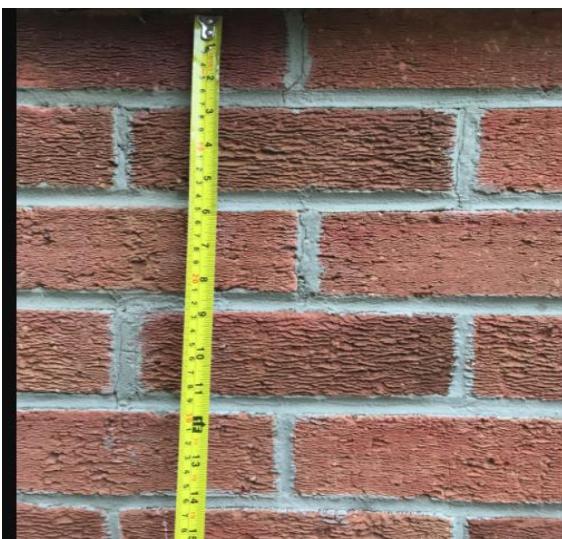
Rear wall cracking

- Minor cracking below the rear window.

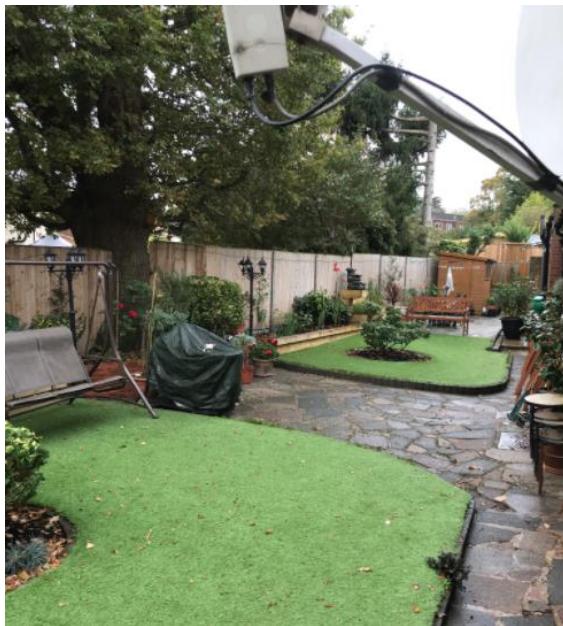
Rear Oak tree

The cause of the movement needs to be dealt with first. However, in view of the extent of vegetation that is within influencing distance, particularly the Oak tree. We are obtaining an Arboricultural Report to provide recommendations on the extent of tree mitigation works warranted.

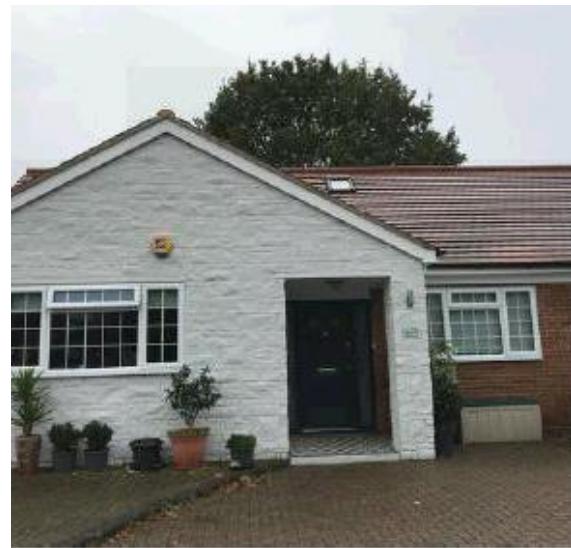
Note location of Oak tree behind the risk address

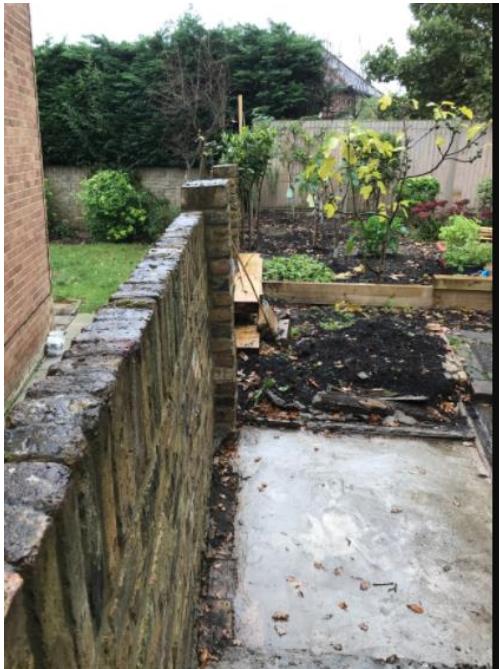
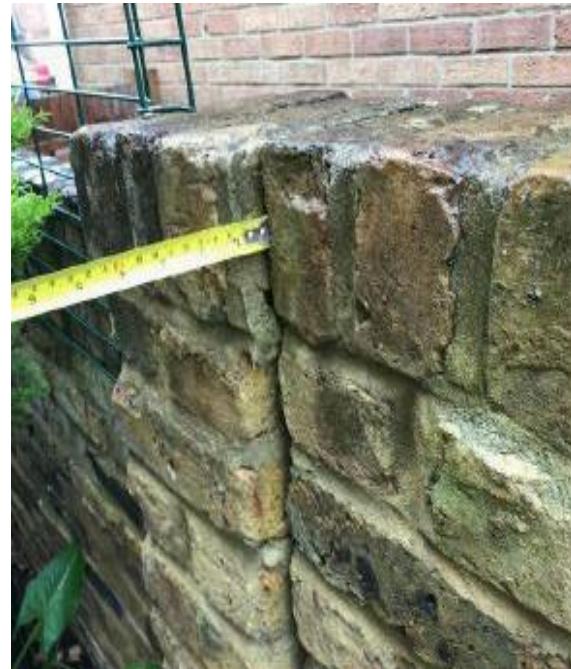
- Opening noted between the sections of the wall that is not tied into the vertical brick column. (Not subsidence related)

Leaning boundary wall
